**FCC PART 15 SUBPART B TEST REPORT**  
**for**  
**Tablet Computer**  
**Model No.: DT13**

Applicant: **MilDef Crete Inc.**

**Worldwide Testing Services (Taiwan) Co., Ltd.**

**Report No.: W6M21906-19108-P-15B**

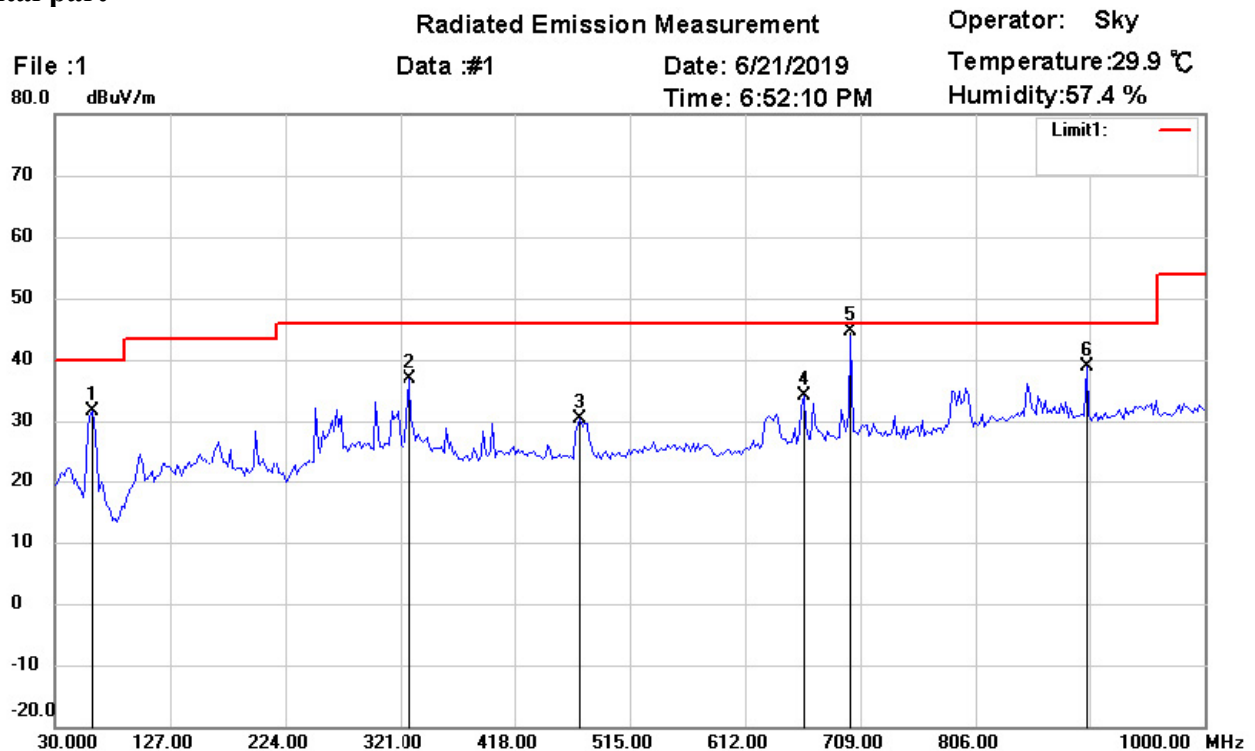
Site : 966 Chamber

Condition : FCC\_part 15 RE-Class B\_30-1000MHz

1. Correction Factor = Antenna factor + Cable loss - Preamplifier
2. The formula of measured value as: Test Result = Reading + Correction Factor
3. Detector function in the form : PK = Peak, QP = Quasi Peak, AV = Average
4. All not in the table noted test results are more than 20 dB below the relevant limits.
5. Up Line: PK Limit Line, Down Line: Ave Limit Line.
