Radiated Emission Measurement

Condition : FCC\_part 15E RE\_Above 1GHz\_PK

EUT : W6M22409-23739

Test Mode : TX 802.11a CH105

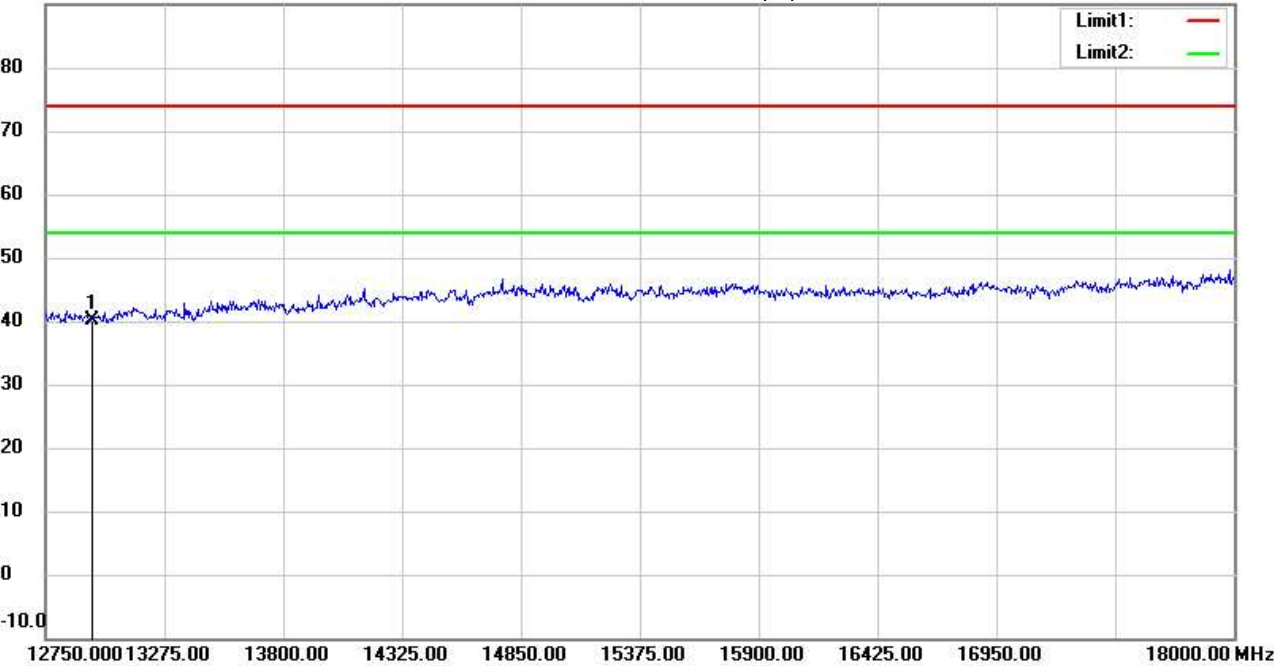
Data :#4

Site : 966A Chamber  
Condition : FCC\_part 15E RE\_Above 1GHz\_PK  
EUT : W6M22409-23739  
M/N:  
Test Mode : TX 802.11a CH105  
Note :

Polarization: *Horizontal*  
Power : 120 Va.c.  
Distance: 3m

| Mk. | Frequency (MHz) | Reading (dBuV) | Detector | Corr. factor (dB/m) | Result (dBuV/m) | Limit (dBuV/m) | Ant.Pos (cm) | Tab.Pos (deg.) | Margin (dB) | Comment |
|---|---|---|---|---|---|---|---|---|---|---|
| * | 12950.000 | 22.92 | peak | 17.30 | 40.22 | 74.00 | 150 | 65 | -33.78 | |

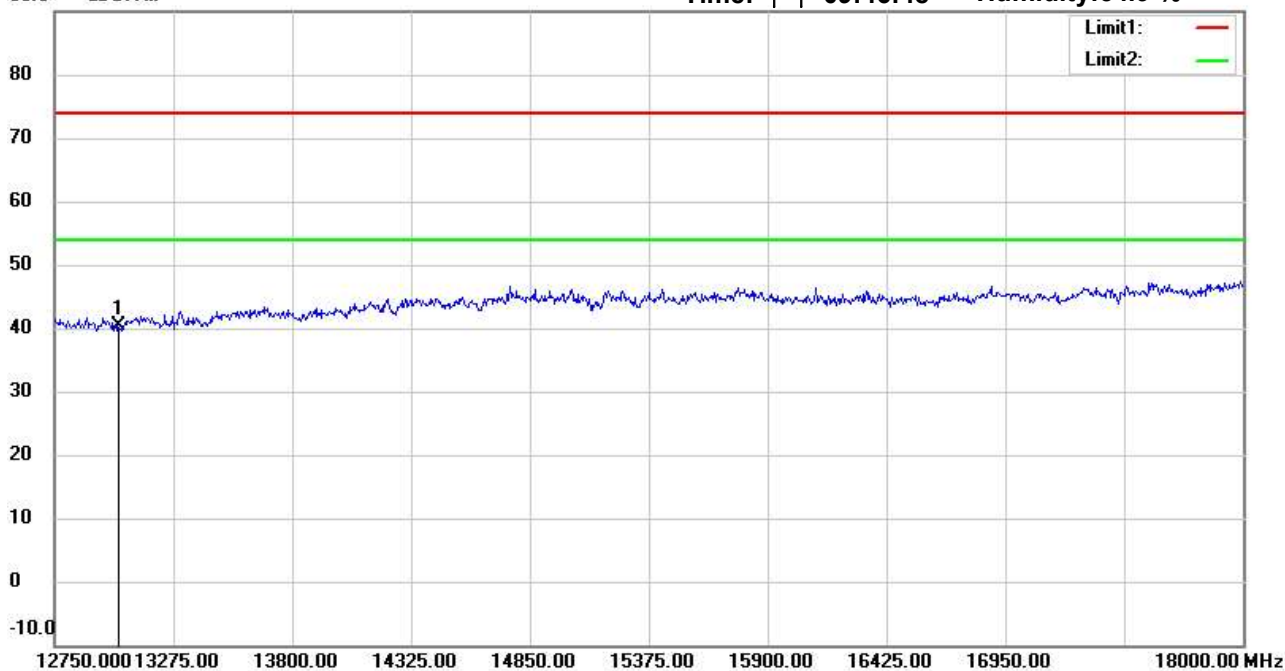
Data : #10

Condition : FCC\_part 15E RE\_Above 1GHz\_PK

Test Mode : TX 802.11a CH113

Polarization: **Vertical**

| Mk. | Frequency (MHz) | Reading (dBuV) | Detector | Corr. factor (dB/m) | Result (dBuV/m) | Limit (dBuV/m) | Ant.Pos (cm) | Tab.Pos (deg.) | Margin (dB) | Comment |
|---|---|---|---|---|---|---|---|---|---|---|
| * | 13030.000 | 23.19 | peak | 17.10 | 40.29 | 74.00 | 150 | 237 | -33.71 | |
