Radiated Emission Measurement

Condition : FCC\_part 15E RE\_Above 1GHz\_PK

EUT : W6M22409-23739

Test Mode : TX 802.11ax20 CH149

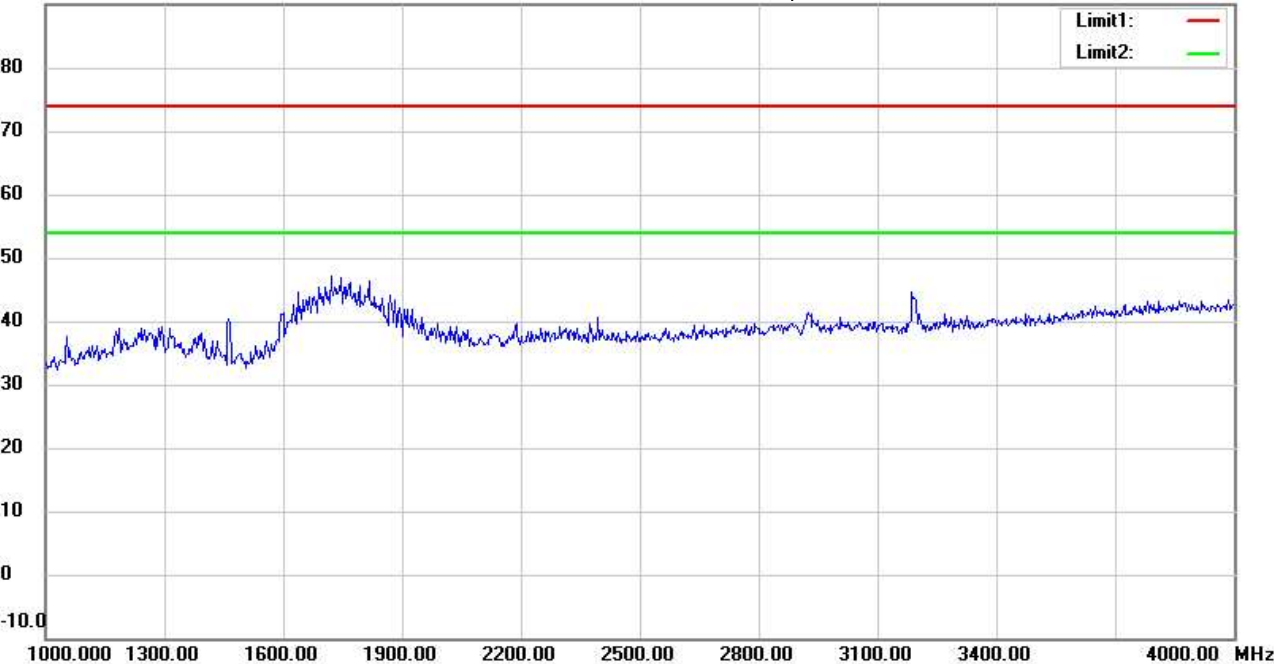
Data :#7

Polarization: Vertical

Distance: 3m

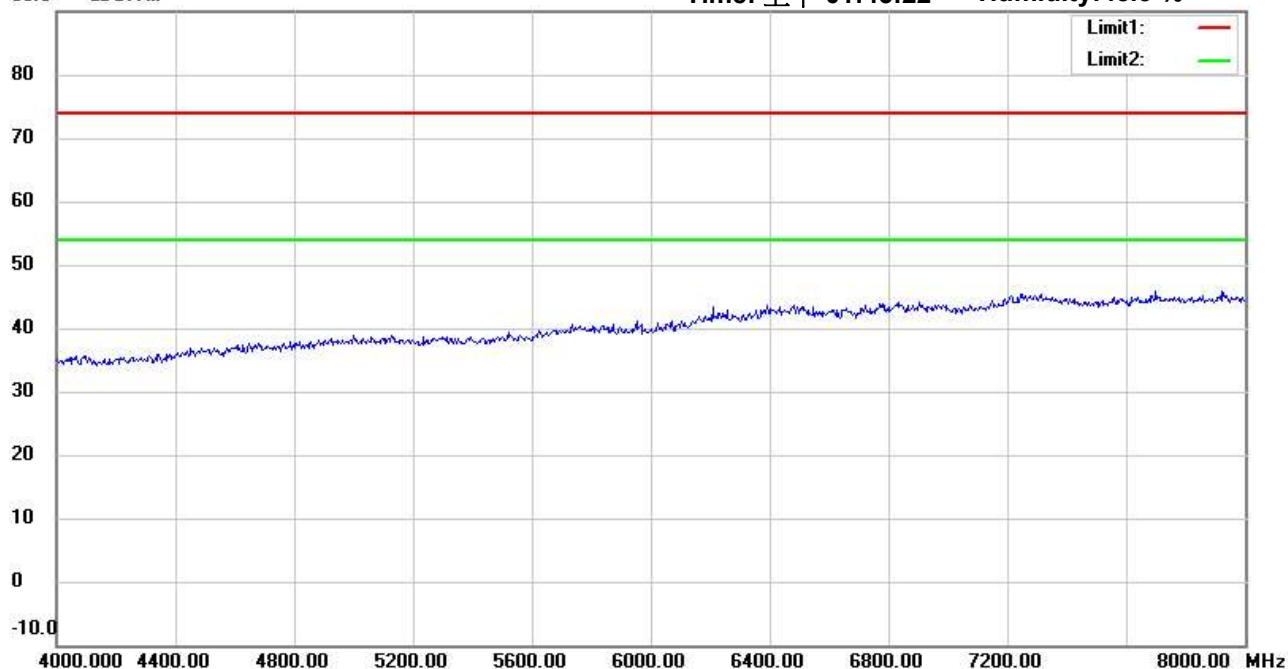
Data : #2

Condition : FCC\_part 15E RE\_Above 1GHz\_PK

Test Mode : TX 802.11ax20 CH149

Polarization: **Horizontal**

Distance: 3m

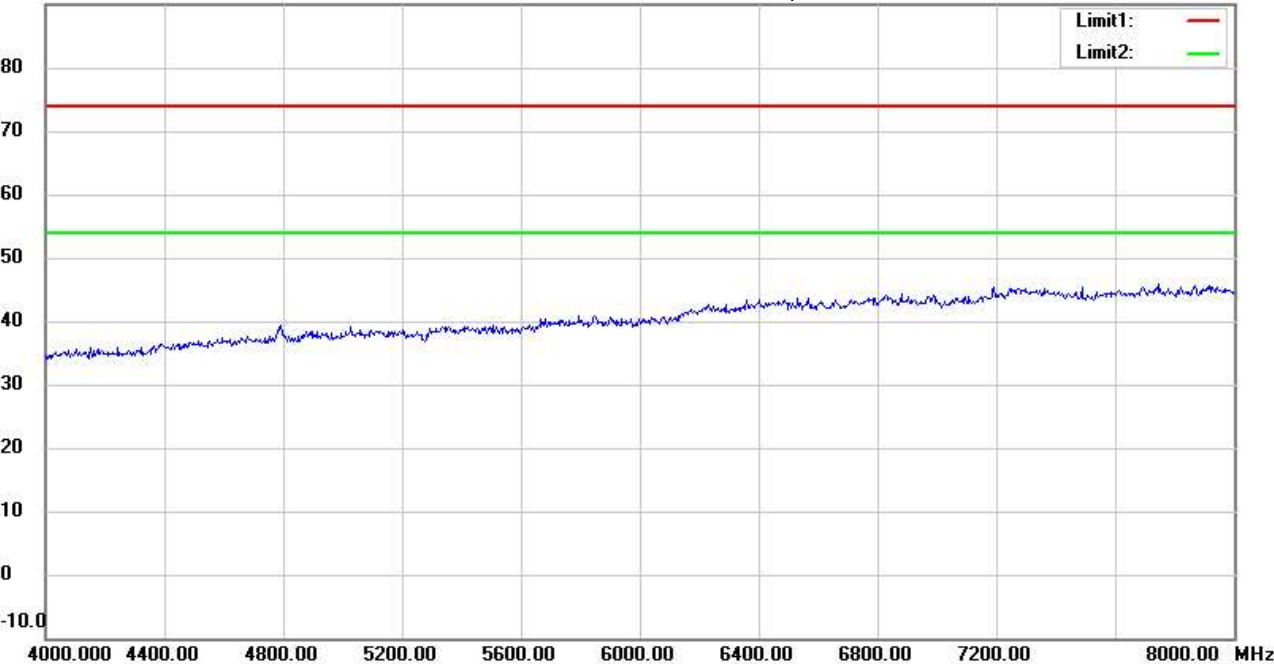
Data :#8

Condition : FCC\_part 15E RE\_Above 1GHz\_PK

Test Mode : TX 802.11ax20 CH149

Polarization: Vertical

Distance: 3m

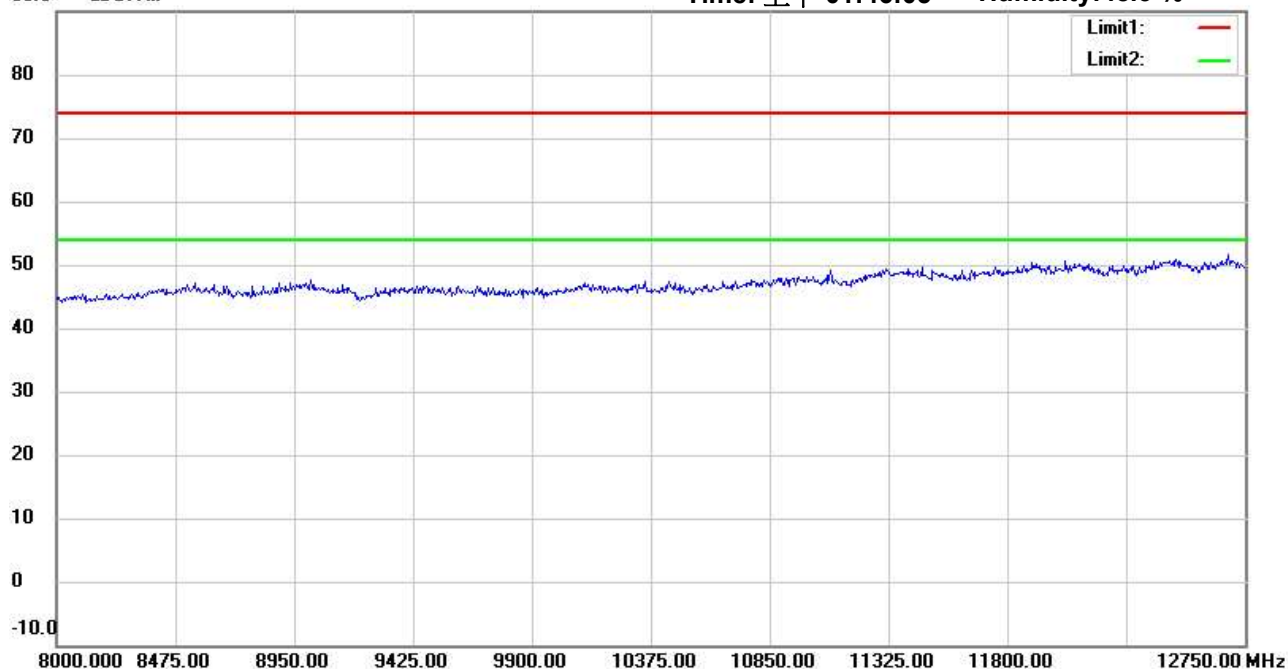
Data : #3

Condition : FCC\_part 15E RE\_Above 1GHz\_PK

Test Mode : TX 802.11ax20 CH149

Polarization: **Horizontal**

Distance: 3m

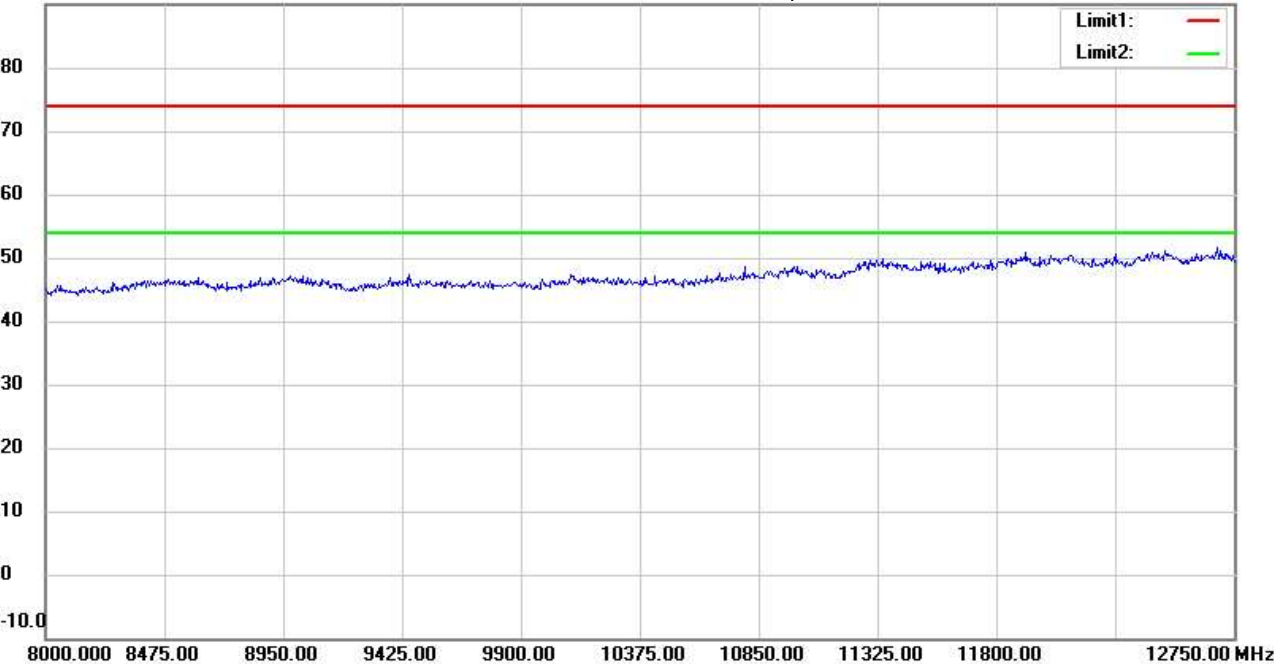
Data :#9

Condition : FCC\_part 15E RE\_Above 1GHz\_PK

Test Mode : TX 802.11ax20 CH149

Polarization: Vertical

Distance: 3m

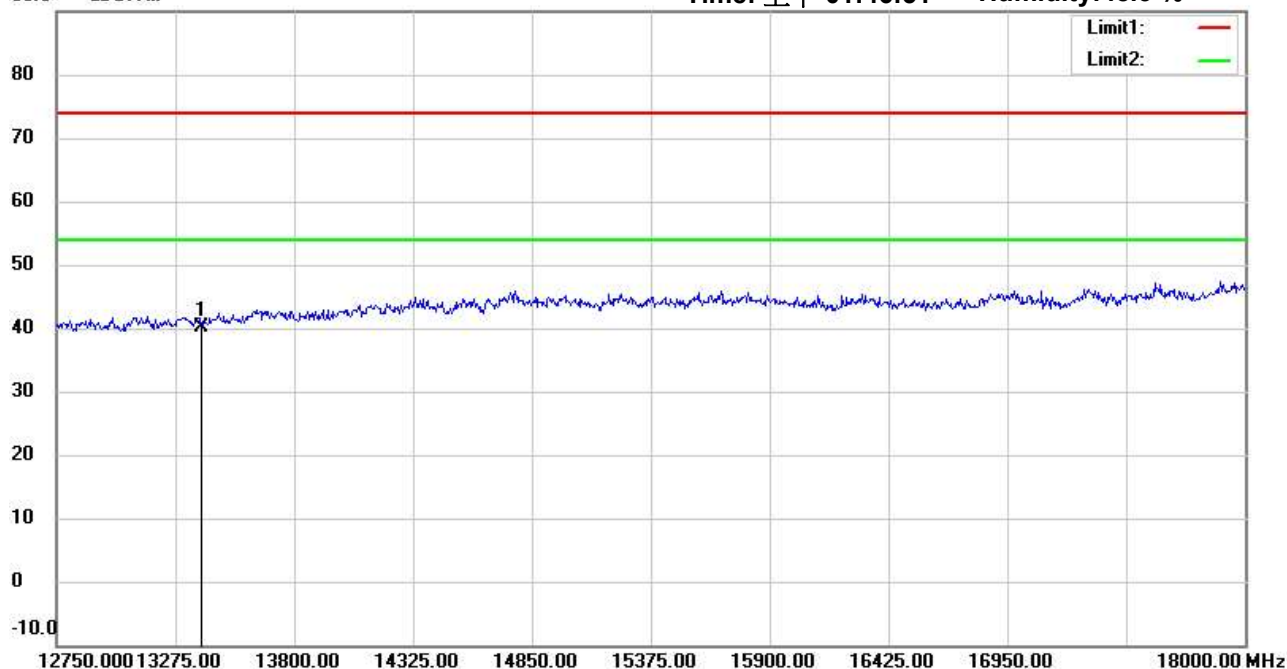
Data : #4

Site : 966A Chamber

Condition : FCC\_part 15E RE\_Above 1GHz\_PK

Test Mode : TX 802.11ax20 CH149

Polarization: **Horizontal**

| Mk. | Frequency (MHz) | Reading (dBuV) | Detector | Corr. factor (dB/m) | Result (dBuV/m) | Limit (dBuV/m) | Ant.Pos (cm) | Tab.Pos (deg.) | Margin (dB) | Comment |
|---|---|---|---|---|---|---|---|---|---|---|
| * | 13390.000 | 21.91 | peak | 18.10 | 40.01 | 74.00 | 150 | 64 | -33.99 | |

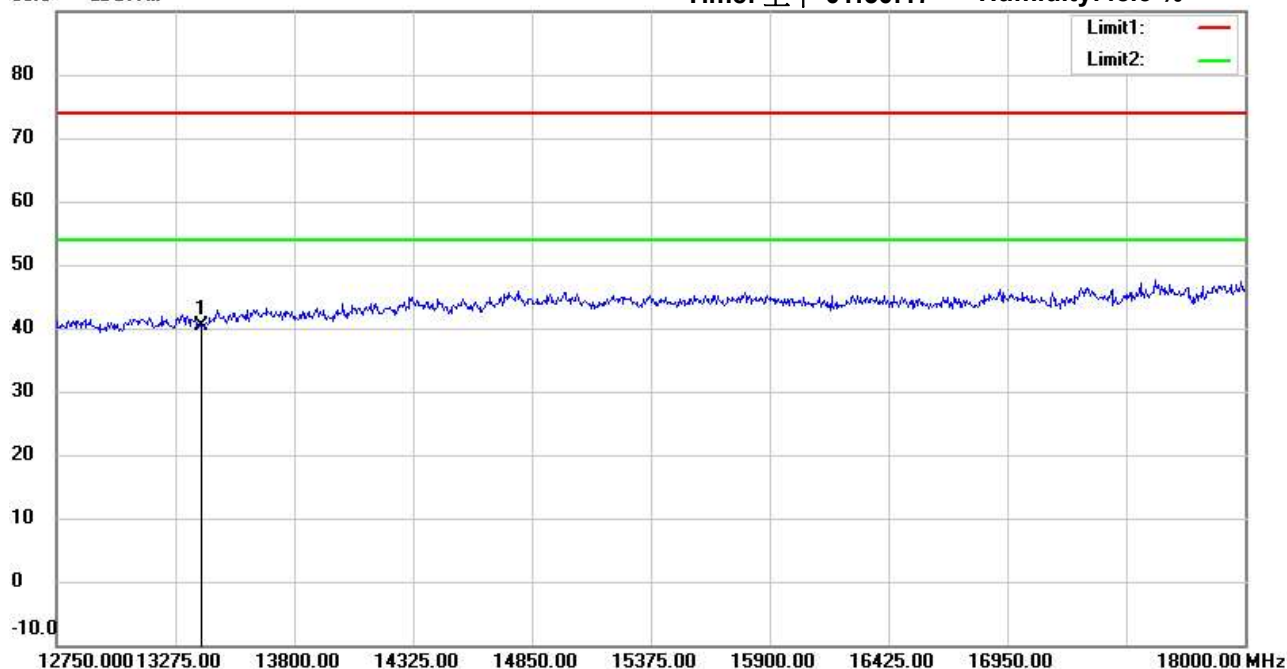
Data : #10

Site : 966A Chamber

Condition : FCC\_part 15E RE\_Above 1GHz\_PK

Test Mode : TX 802.11ax20 CH149

Polarization: Vertical

| Mk. | Frequency (MHz) | Reading (dBuV) | Detector | Corr. factor (dB/m) | Result (dBuV/m) | Limit (dBuV/m) | Ant.Pos (cm) | Tab.Pos (deg.) | Margin (dB) | Comment |
|---|---|---|---|---|---|---|---|---|---|---|
| * | 13390.000 | 22.40 | peak | 18.10 | 40.50 | 74.00 | 150 | 149 | -33.50 | |

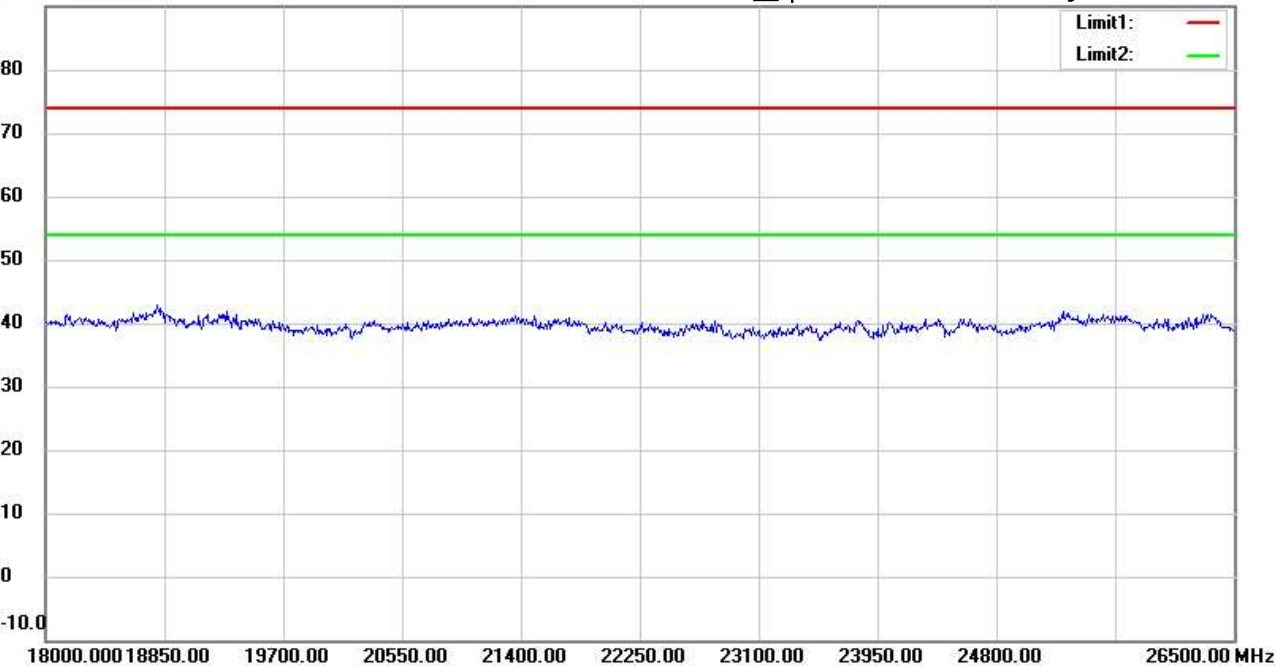
Data :#5

Condition : FCC\_part 15E RE\_Above 1GHz\_PK

Test Mode : TX 802.11ax20 CH149

Polarization: *Horizontal*

Distance: 3m

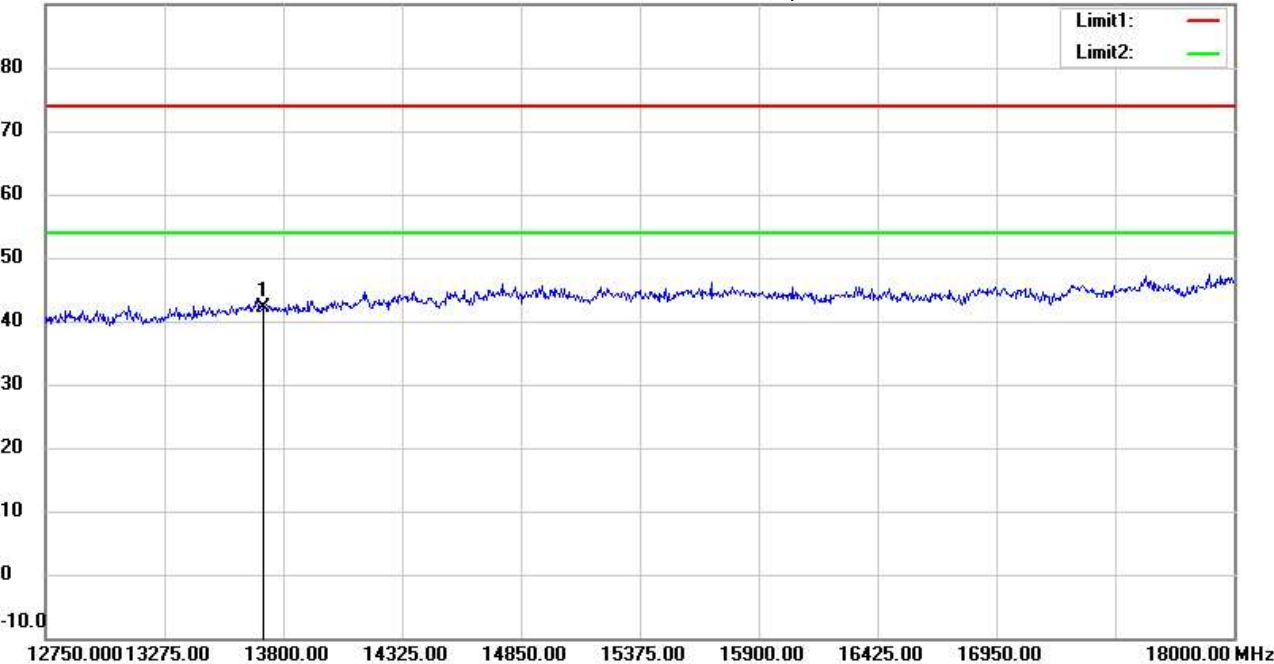
Data :#4

Site : 966A Chamber

Condition : FCC\_part 15E RE\_Above 1GHz\_PK

Test Mode : TX 802.11ax20 CH181

Polarization: **Horizontal**

| Mk. | Frequency (MHz) | Reading (dBuV) | Detector | Corr. factor (dB/m) | Result (dBuV/m) | Limit (dBuV/m) | Ant.Pos (cm) | Tab.Pos (deg.) | Margin (dB) | Comment |
|---|---|---|---|---|---|---|---|---|---|---|
| * | 13710.000 | 22.00 | peak | 20.03 | 42.03 | 74.00 | 150 | 102 | -31.97 | |

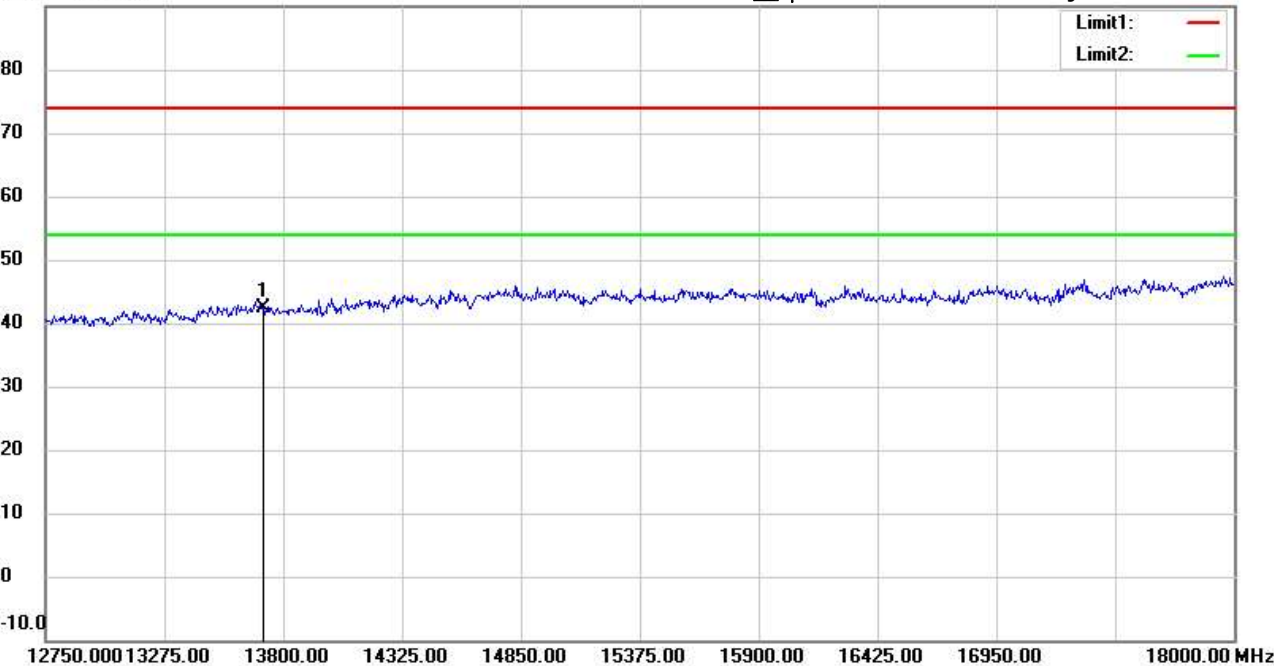
Data :#10

Site : 966A Chamber

Condition : FCC\_part 15E RE\_Above 1GHz\_PK

Test Mode : TX 802.11ax20 CH181

Polarization: Vertical

| Mk. | Frequency (MHz) | Reading (dBuV) | Detector | Corr. factor (dB/m) | Result (dBuV/m) | Limit (dBuV/m) | Ant.Pos (cm) | Tab.Pos (deg.) | Margin (dB) | Comment |
|---|---|---|---|---|---|---|---|---|---|---|
| * | 13710.000 | 22.44 | peak | 20.03 | 42.47 | 74.00 | 150 | 355 | -31.53 | |
