Radiated Emission Measurement

Condition : FCC\_part 15E RE\_Above 1GHz\_PK

EUT : W6M22409-23739

Test Mode : TX 802.11ax40 CH123

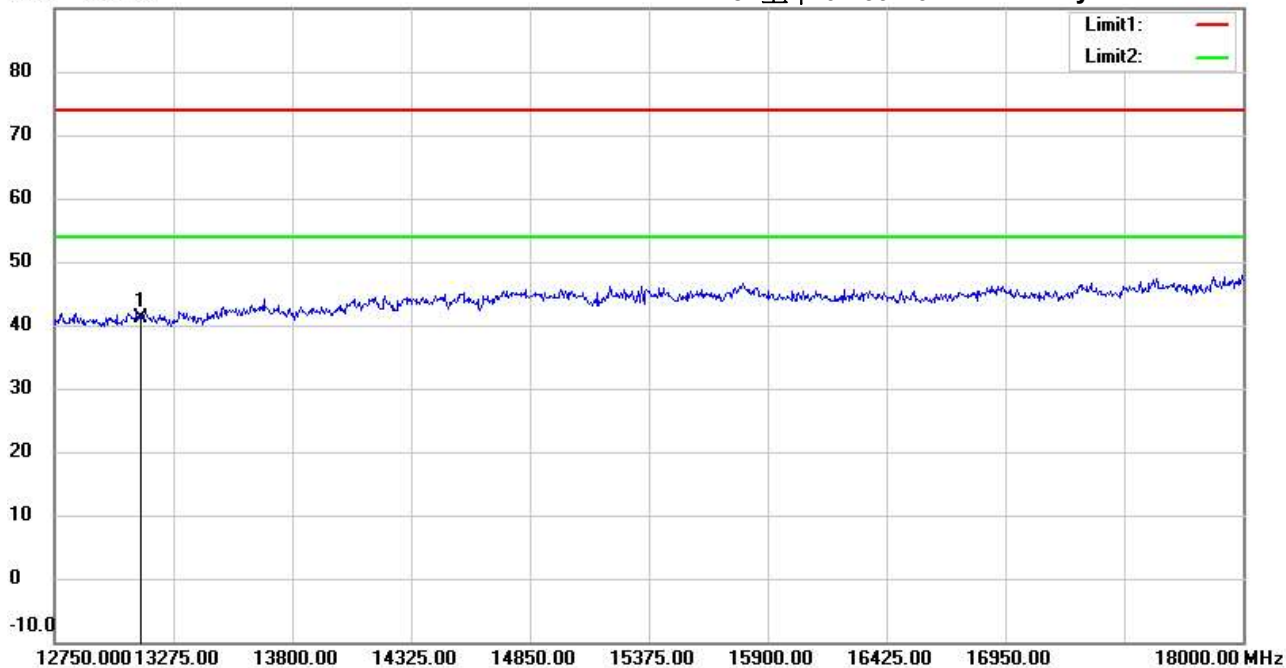
Data : #10

Condition : FCC\_part 15E RE\_Above 1GHz\_PK

Test Mode : TX 802.11ax40 CH123

Polarization: Vertical

| Mk. | Frequency (MHz) | Reading (dBuV) | Detector | Corr. factor (dB/m) | Result (dBuV/m) | Limit (dBuV/m) | Ant.Pos (cm) | Tab.Pos (deg.) | Margin (dB) | Comment |
|---|---|---|---|---|---|---|---|---|---|---|
| * | 13130.000 | 23.93 | peak | 17.31 | 41.24 | 74.00 | 150 | 277 | -32.76 | |

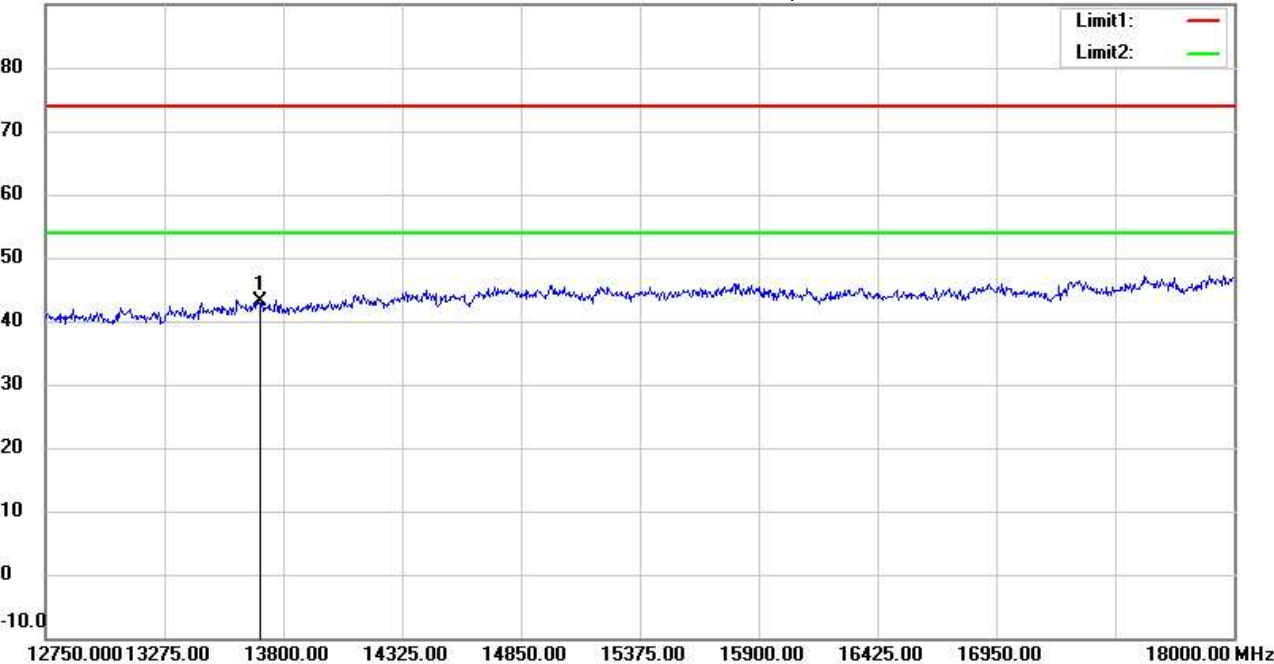
Data :#4

Condition : FCC\_part 15E RE\_Above 1GHz\_PK

Test Mode : TX 802.11ax40 CH179

Polarization: **Horizontal**

| Mk. | Frequency (MHz) | Reading (dBuV) | Detector | Corr. factor (dB/m) | Result (dBuV/m) | Limit (dBuV/m) | Ant.Pos (cm) | Tab.Pos (deg.) | Margin (dB) | Comment |
|---|---|---|---|---|---|---|---|---|---|---|
| * | 13690.000 | 23.01 | peak | 20.04 | 43.05 | 74.00 | 150 | 143 | -30.95 | |
