## 12 COMPLIANCE WITH THE RESTRICTED BAND EDGE TEST DATA

## 15 BANDEDGE PLOTS

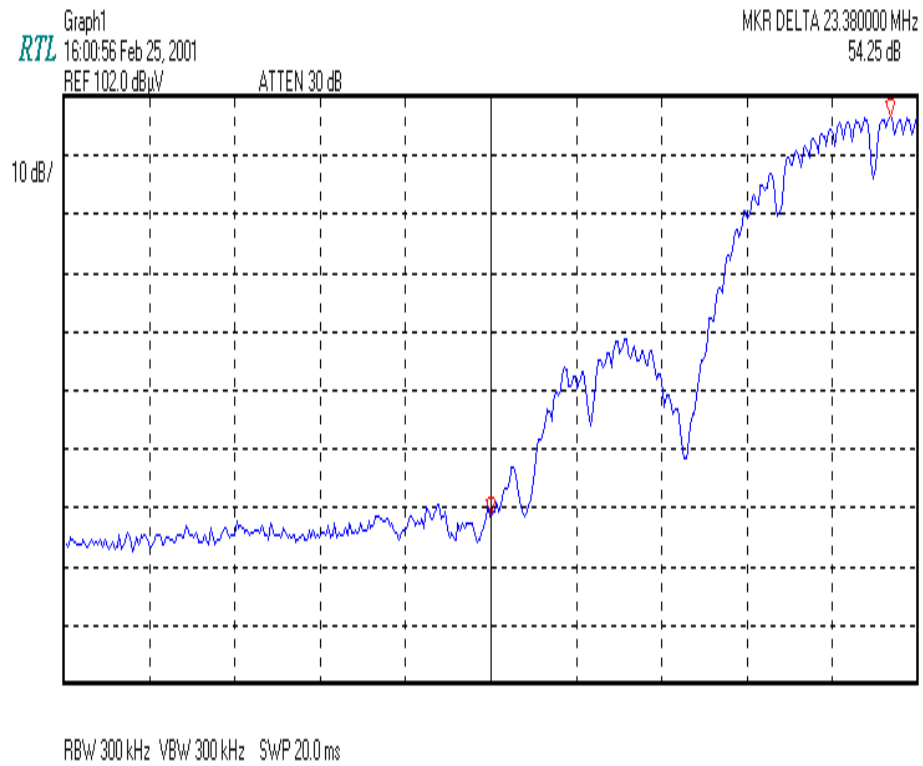
PLOT 1: CHANNEL 1 CISCO DIPOLE ANTENNA 1MHZ/10HZ

| Band edge Measurement | | | | | |
|---|---|---|---|---|---|
| Cisco Dipole | 1 | 2390.0 | 53.1 | 54.0 | -0.9 |

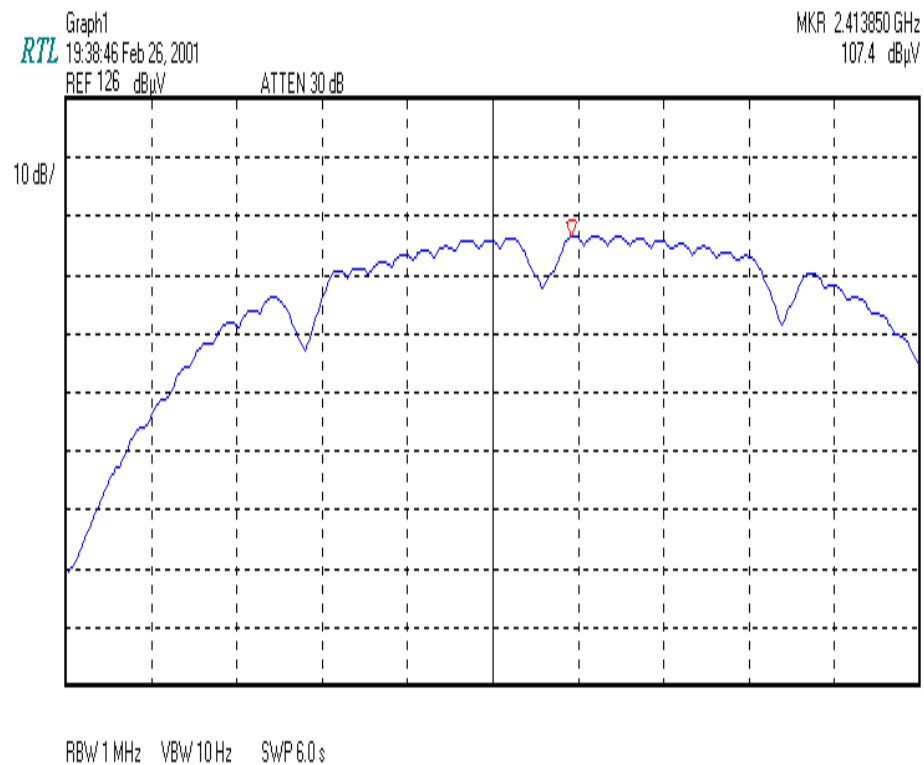
PLOT 2: CHANNEL 1 CISCO DIPOLE ANTENNA

**Note site factor entered into analyzer register for corrected final result.**

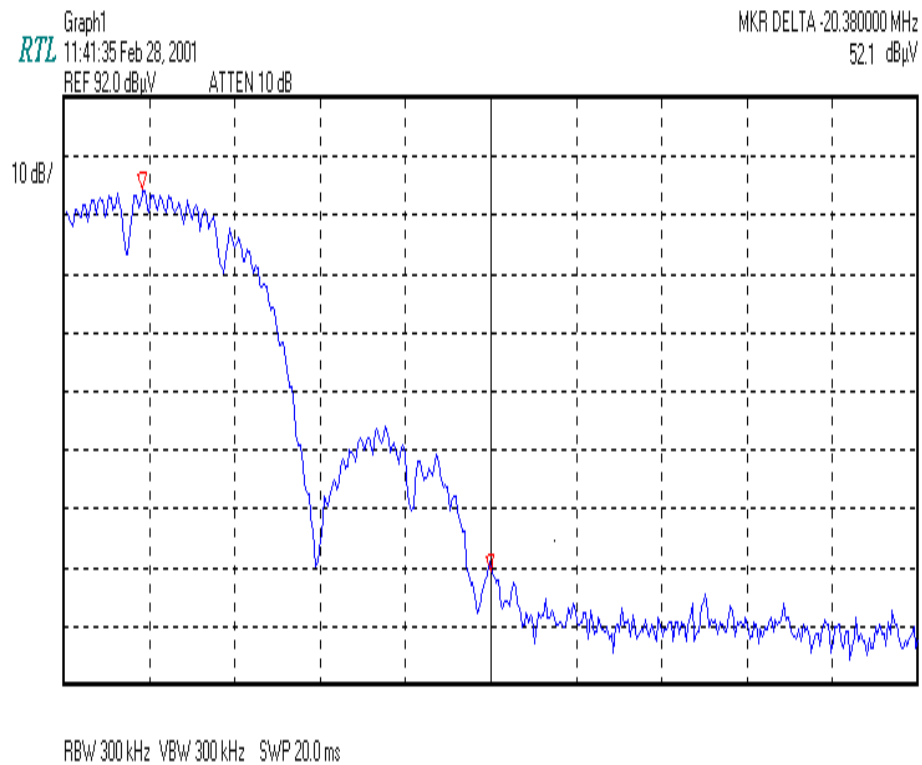
### PLOT 3: CHANNEL 11 CISCO DIPOLEANTENNA

| Band edge Measurement | | | | | |
|---|---|---|---|---|---|
| | 11 | 2483.5 | 53.9 | 54.0 | -0.1 |

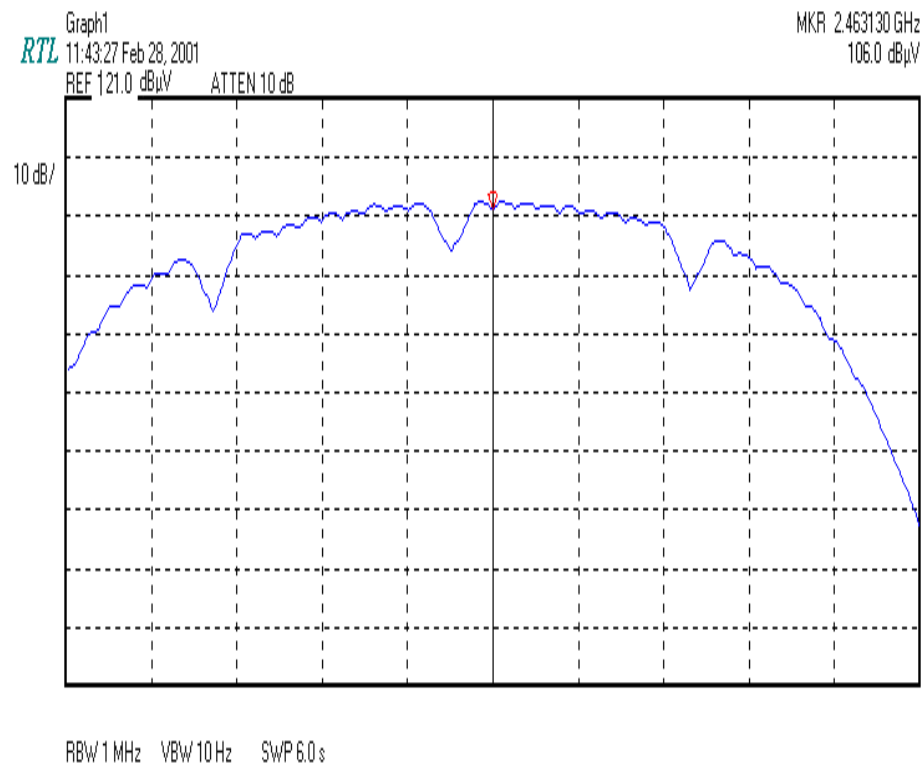
PLOT 4: CHANNEL 11 CISCO DIPOLE ANTENNA

**Note site factor entered into analyzer register for corrected final result.**

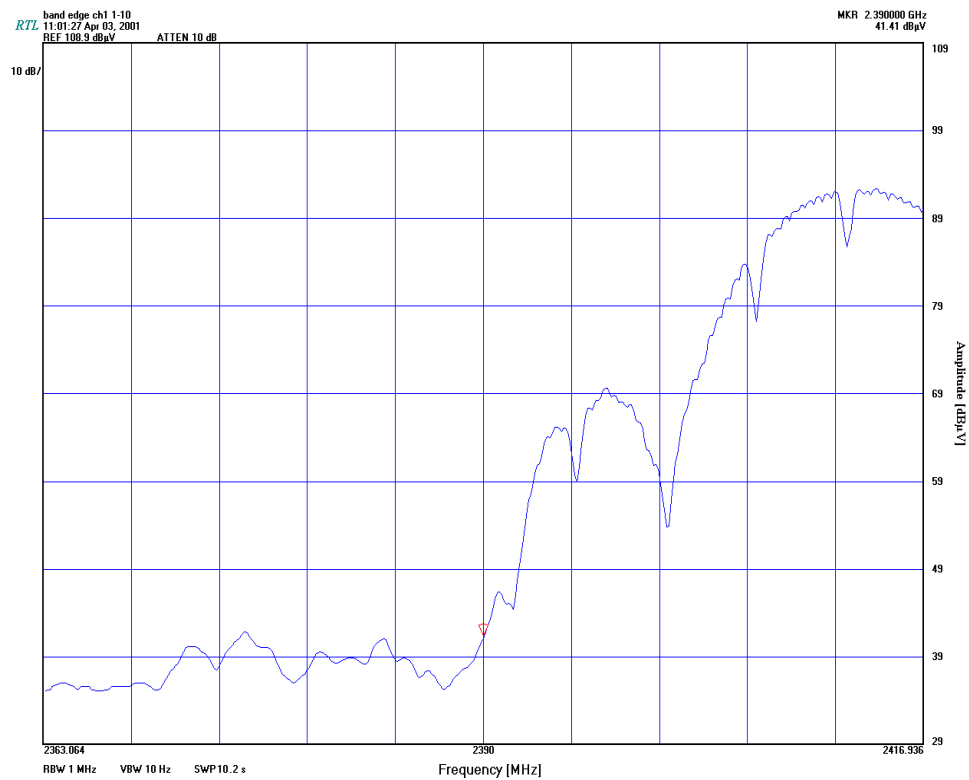
PLOT 5: CHANNEL 1 DELL DIPOLE ANTENNA 1MHZ/10HZ

| Band edge Measurement | | | | | |
|---|---|---|---|---|---|
| Dell Dipole | 1 | 2390.0 | 41.4 | 54.0 | -12.6 |

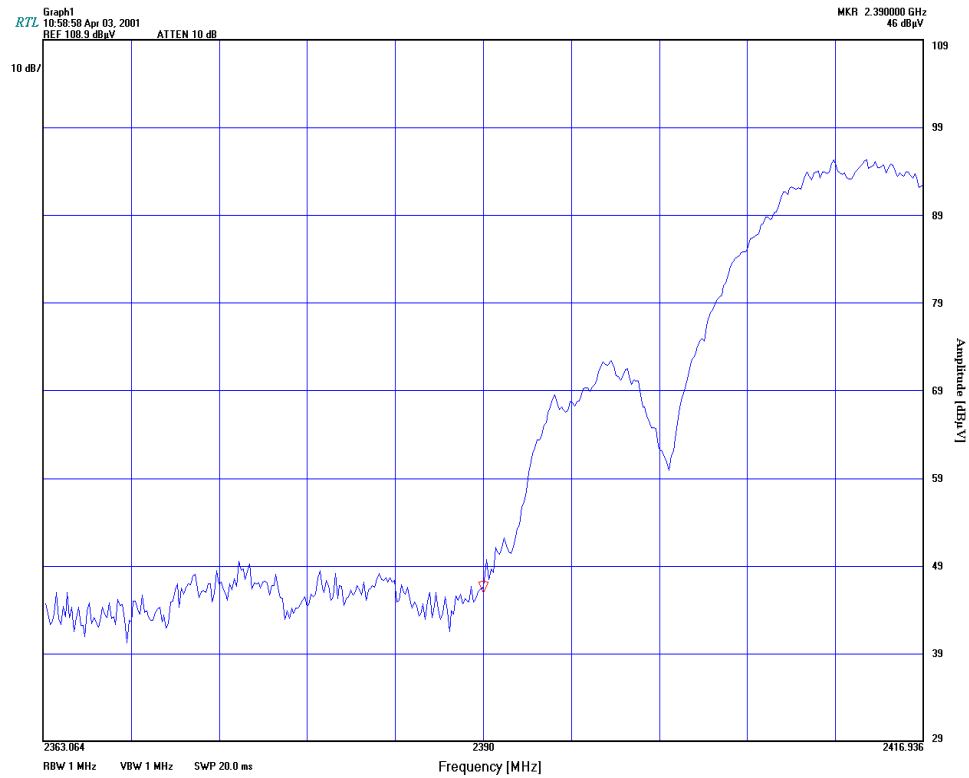
PLOT 6

CHANNEL 1 DELL DIPOLE ANTENNA 1MHZ/1MHZ

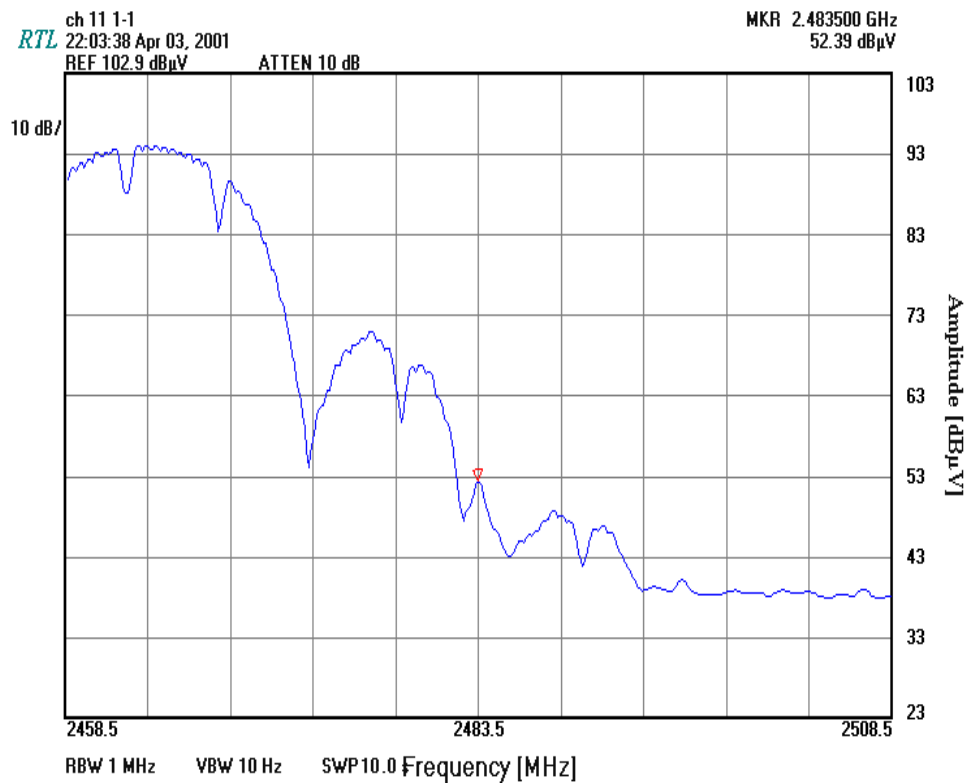
PLOT 7 CHANNEL 11 DELL DIPOLE ANTENNA 1MHZ/10HZ

| Band edge Measurement | | | | | |
|---|---|---|---|---|---|
| | 11 | 2483.5 | 52.4 | 54.0 | -1.6 |

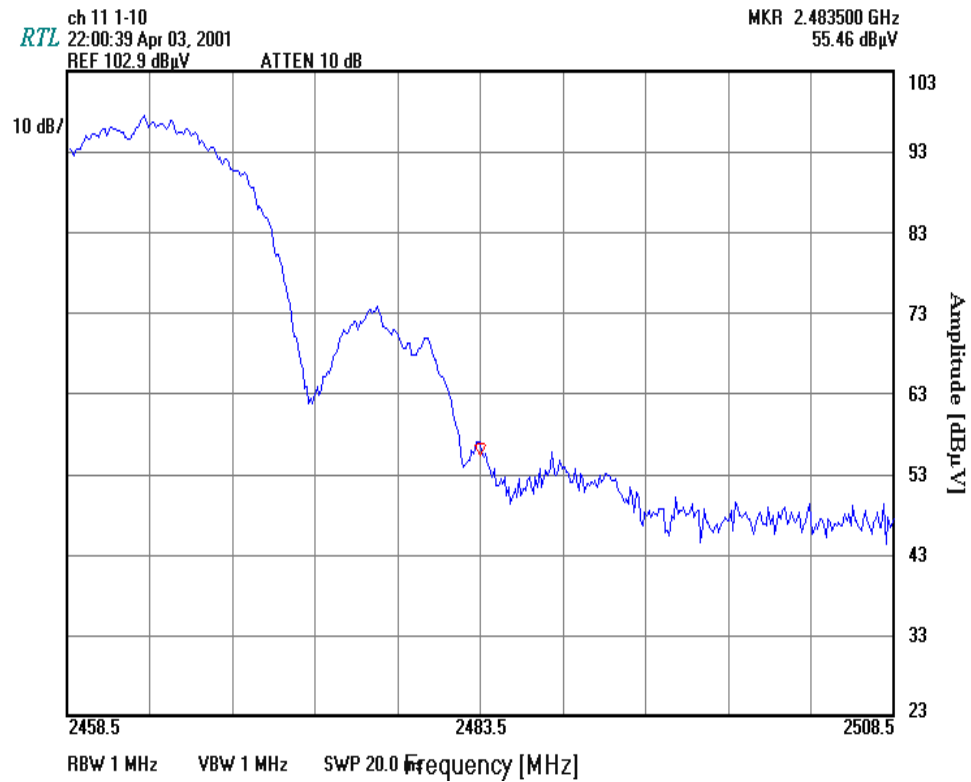
PLOT 8

CHANNEL 11 DELL DIPOLE ANTENNA 1MHZ/1MHZ

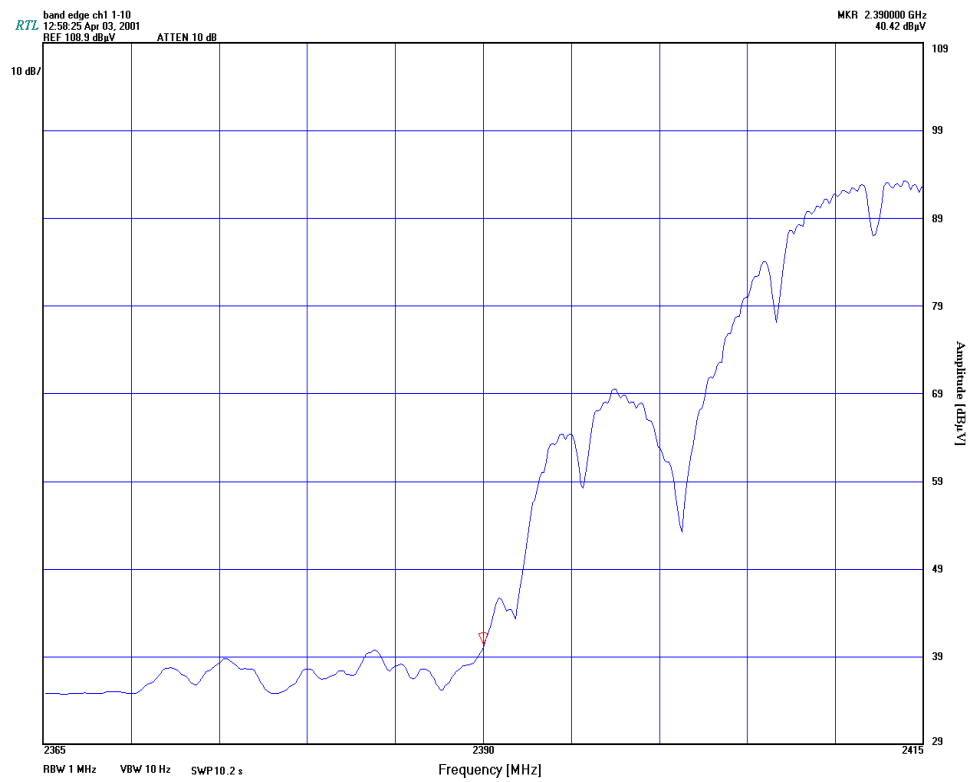
PLOT 9

CHANNEL 1 DELL INVERTED F ANTENNA 1MHZ/10HZ

| Band edge Measurement | | | | | |
|---|---|---|---|---|---|
| Dell Inverted F | 1 | 2390.0 | 40.4 | 54.0 | -13.6 |

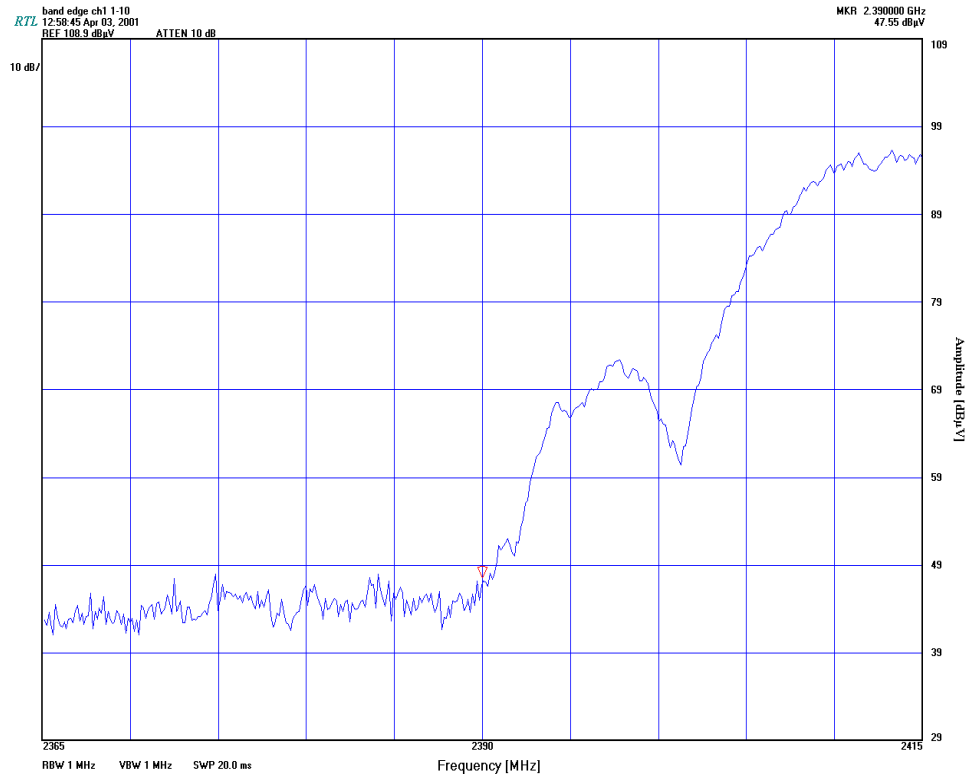
PLOT 10 CHANNEL 1 DELL INVERTED F ANTENNA 1MHZ/1MHZ

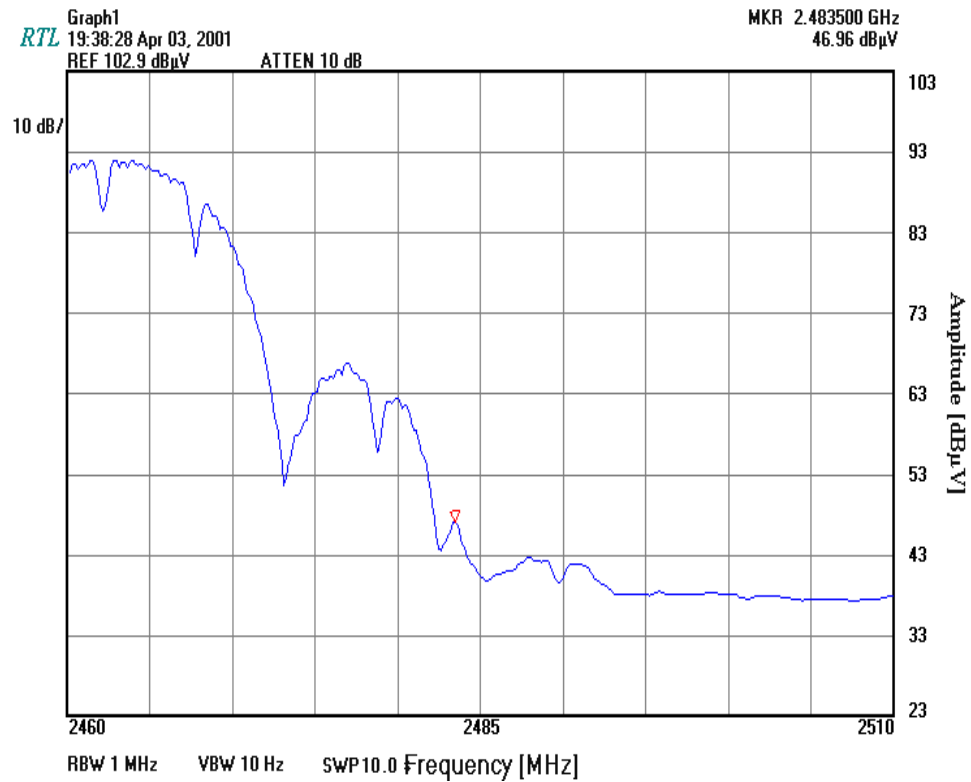
PLOT 11 CHANNEL 11 DELL INVERTED F ANTENNA 1MHZ/10HZ

| Band edge Measurement | | | | | |
|---|---|---|---|---|---|
| | 11 | 2483.5 | 46.9 | 54.0 | -7.1 |

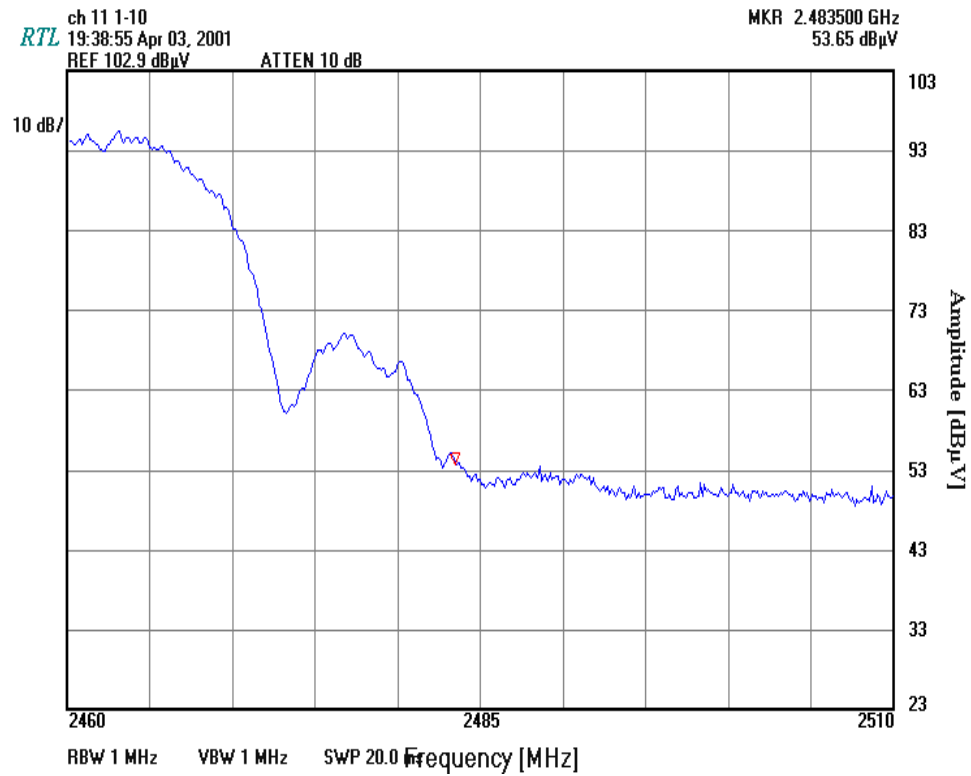
PLOT 12 CHANNEL 11 DELL INVERTED F ANTENNA 1MHZ/1MHZ

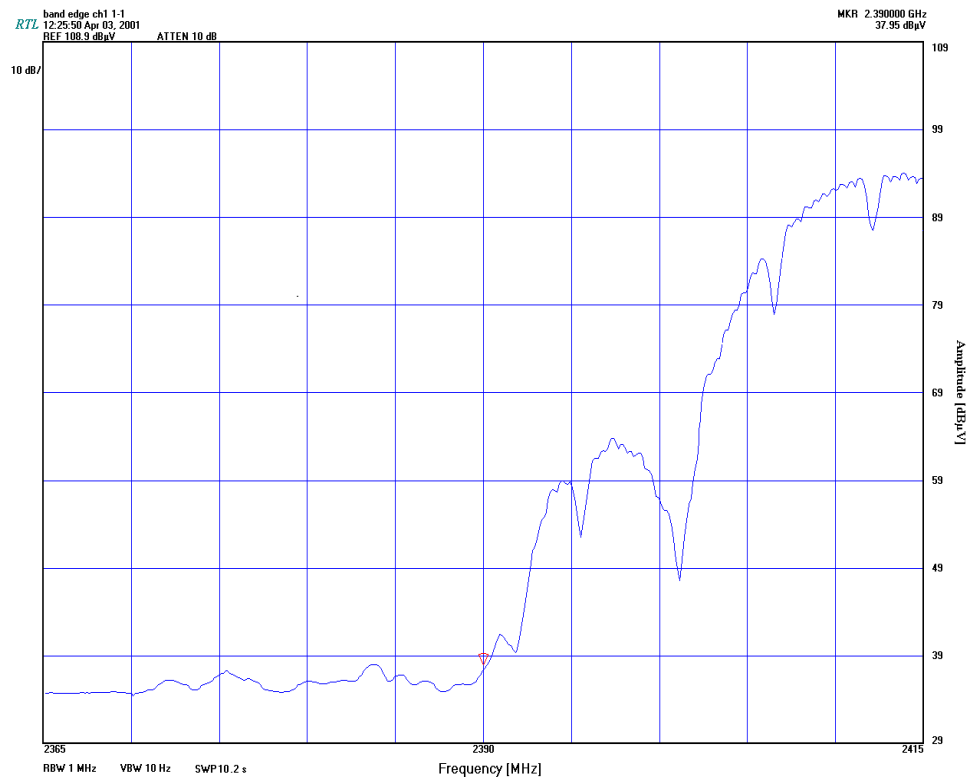
PLOT 13 CHANNEL 1 TOSHIBA CHIP ANTENNA 1MHZ/10HZ

| Band edge Measurement | | | | | |
|---|---|---|---|---|---|
| Toshiba Chip | 1 | 2390.0 | 37.9 | 54.0 | -16.1 |

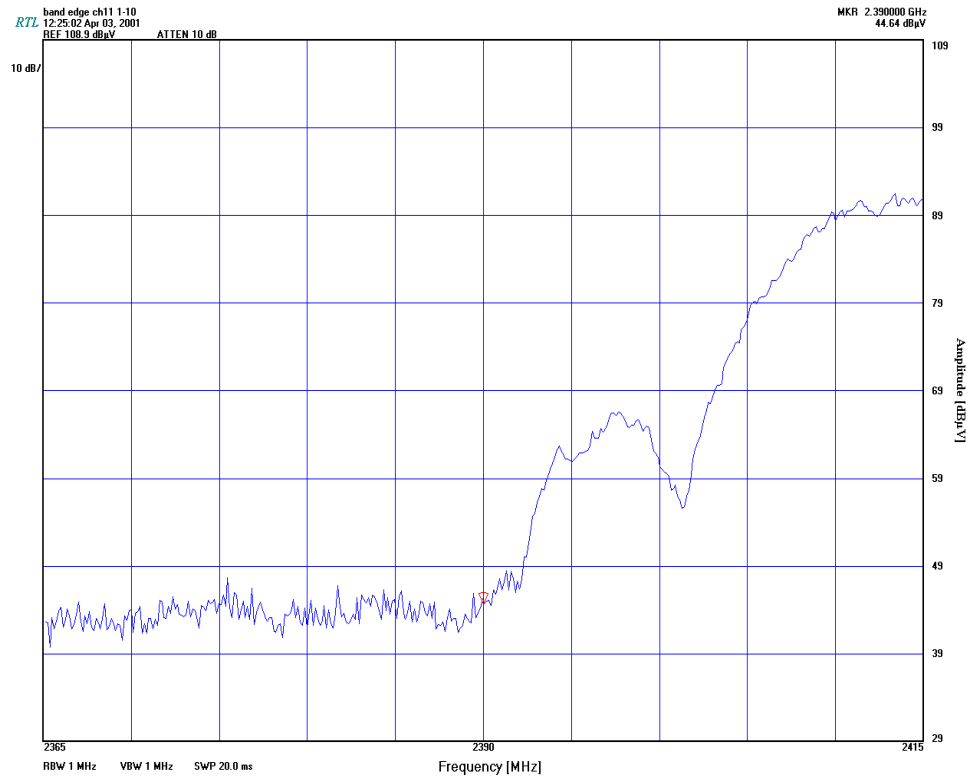
PLOT 14 CHANNEL 1 TOSHIBA CHIP ANTENNA 1MHZ/1MHZ

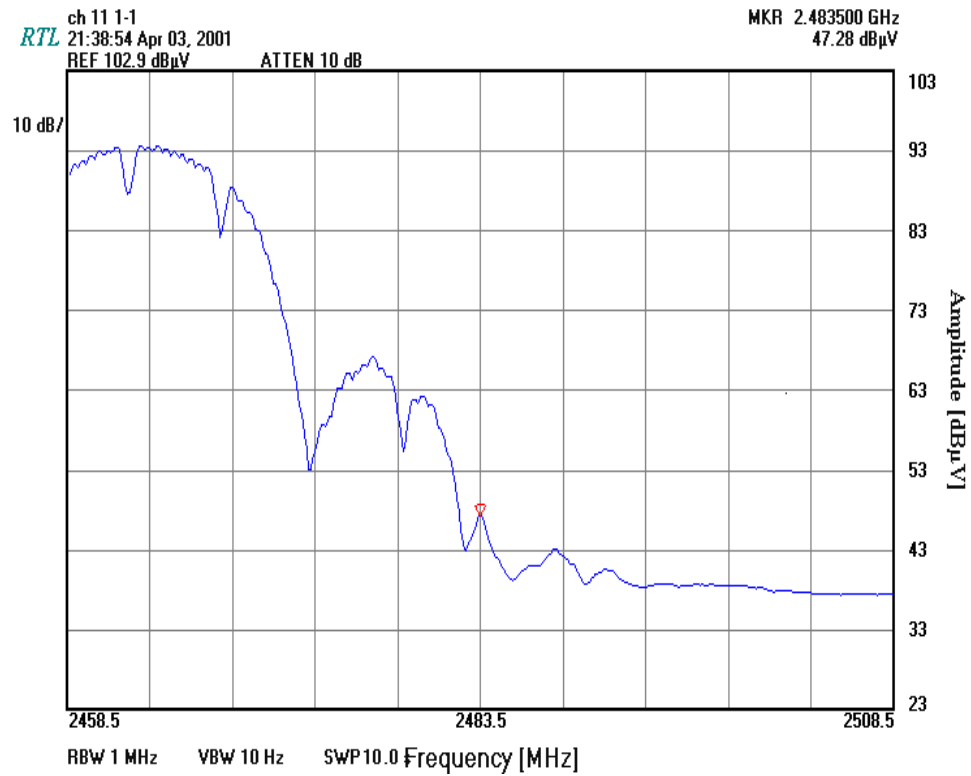
PLOT 15 CHANNEL 11 TOSHIBA CHIP ANTENNA 1MHZ/10HZ

| Band edge Measurement | | | | | |
|---|---|---|---|---|---|
| | 11 | 2483.5 | 47.2 | 54.0 | -6.8 |

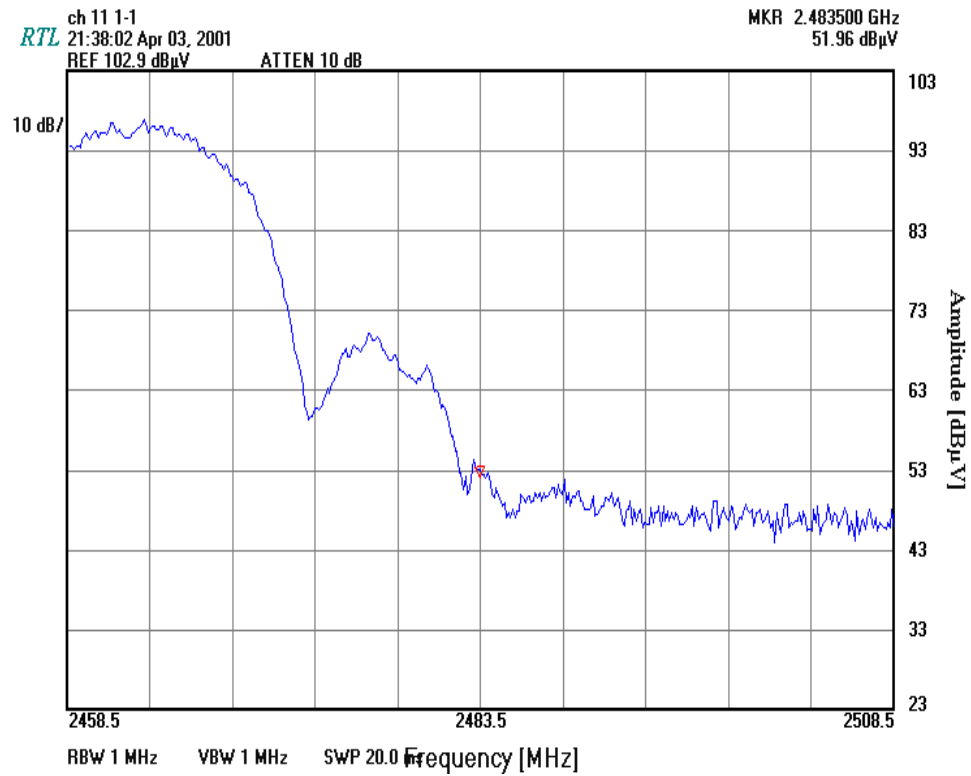
PLOT 16 CHANNEL 11 TOSHIBA CHIP ANTENNA 1MHZ/1MHZ

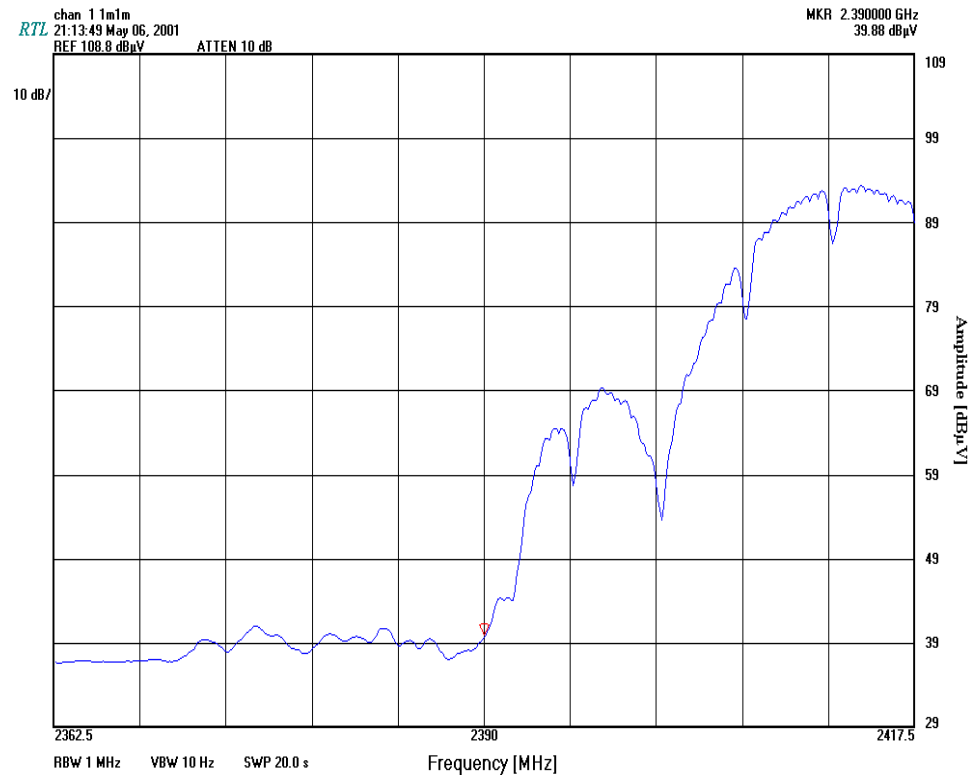
PLOT 17 CHANNEL 1 INVERTED F TOSHIBA ANTENNA 1MHZ/10HZ

| Band edge Measurement | | | | | |
|---|---|---|---|---|---|
| Toshiba Inverted F | 1 | 2390.0 | 39.8 | 54.0 | -14.2 |

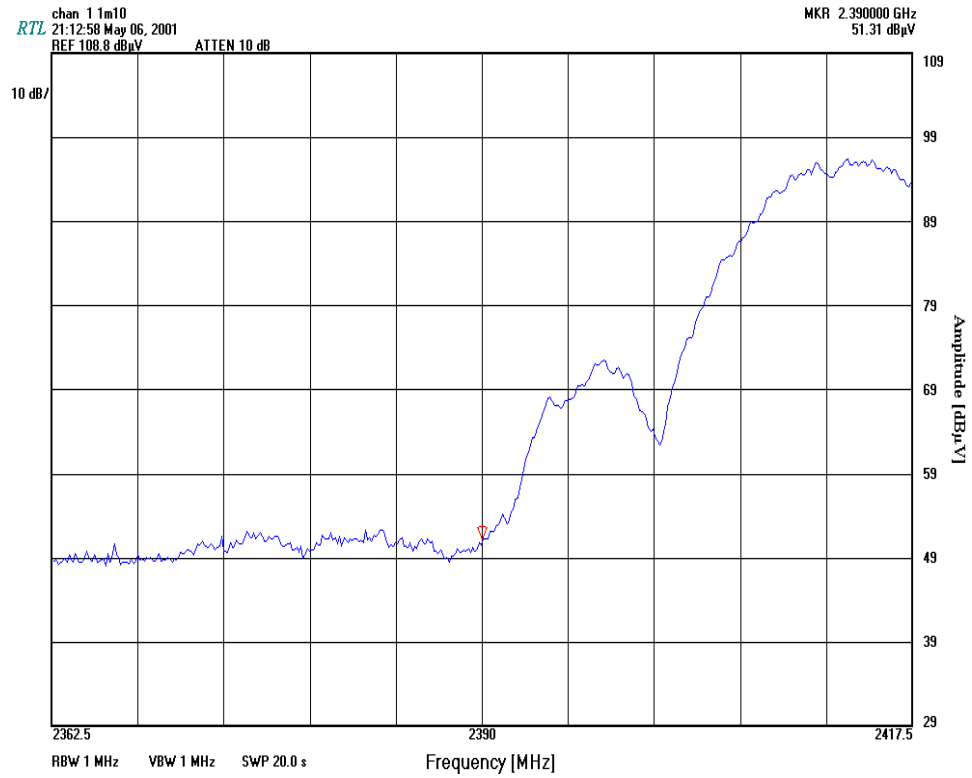
PLOT 18 CHANNEL 1 INVERTED F TOSHIBA ANTENNA 1MHZ/1MHZ

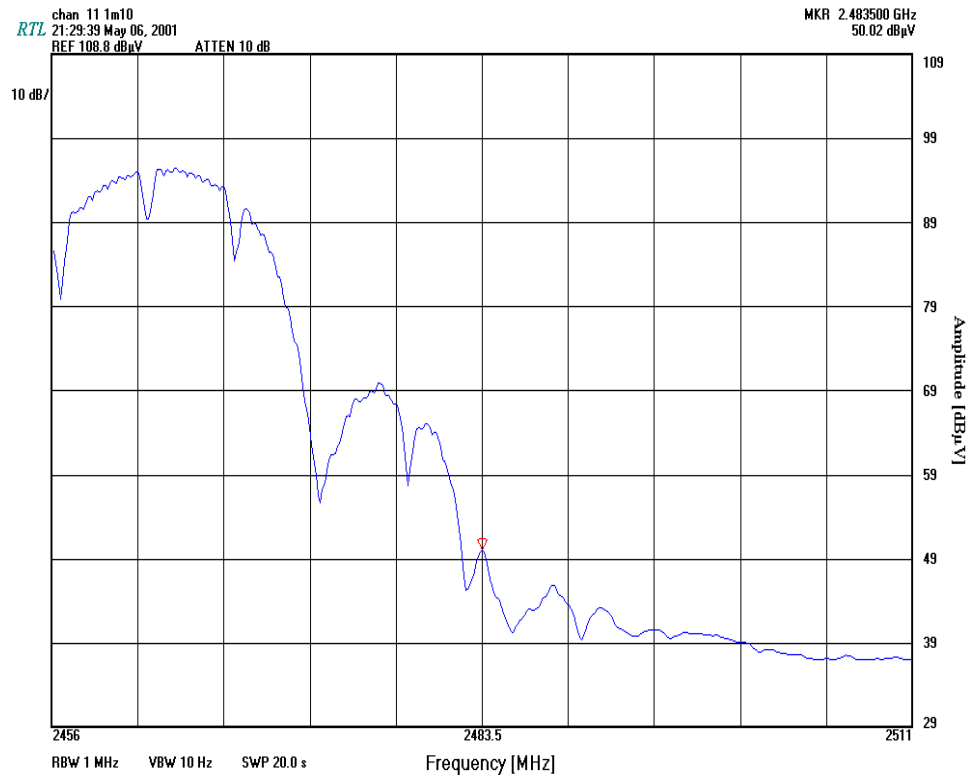
PLOT 19 CHANNEL 11 INVERTED F TOSHIBA ANTENNA 1MHZ/10HZ

| Band edge Measurement | | | | | |
|---|---|---|---|---|---|
| | 11 | 2483.5 | 50.2 | 54.0 | -3.8 |

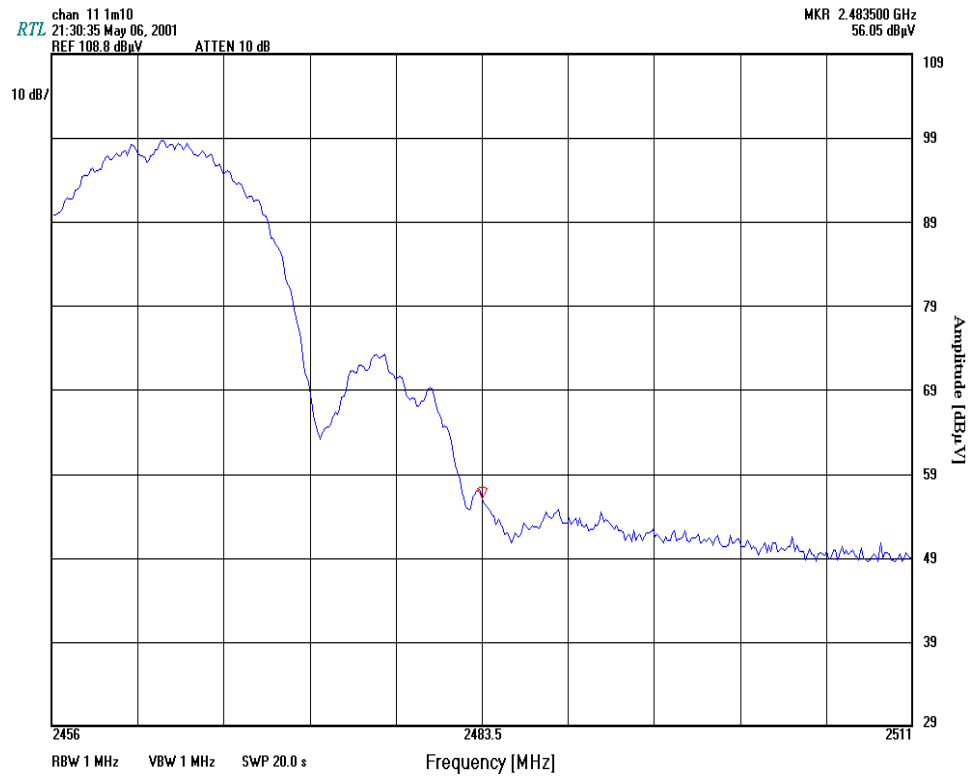
PLOT 20 CHANNEL 11 INVERTED F TOSHIBA ANTENNA 1MHZ/1MHZ
