## Appendix B: Photographs of Test Setup

Product: Pet Smart Video Feeder

Model: AFF140

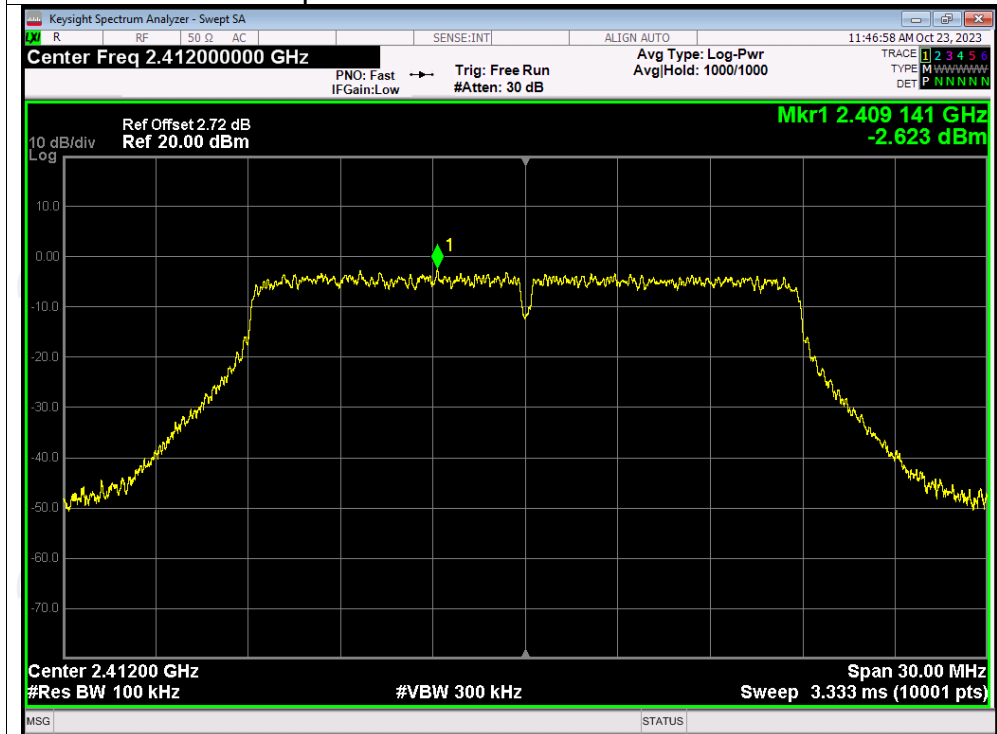
## Tx. Spurious NVNT n20 2412MHz Ref

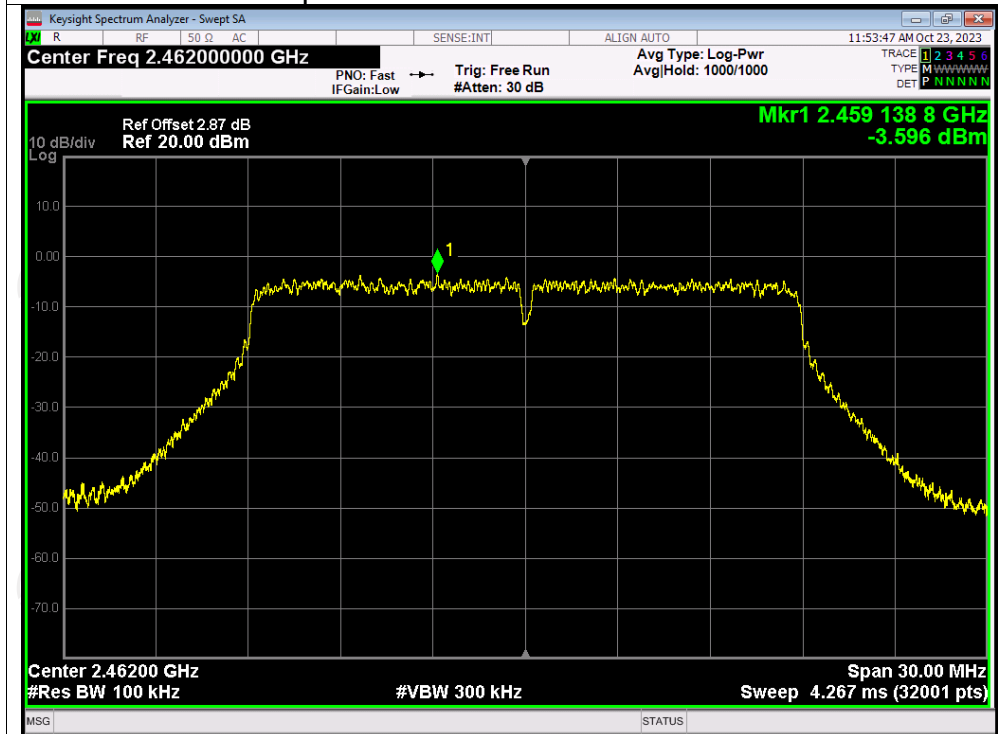
## Tx. Spurious NVNT n20 2462MHz Ref

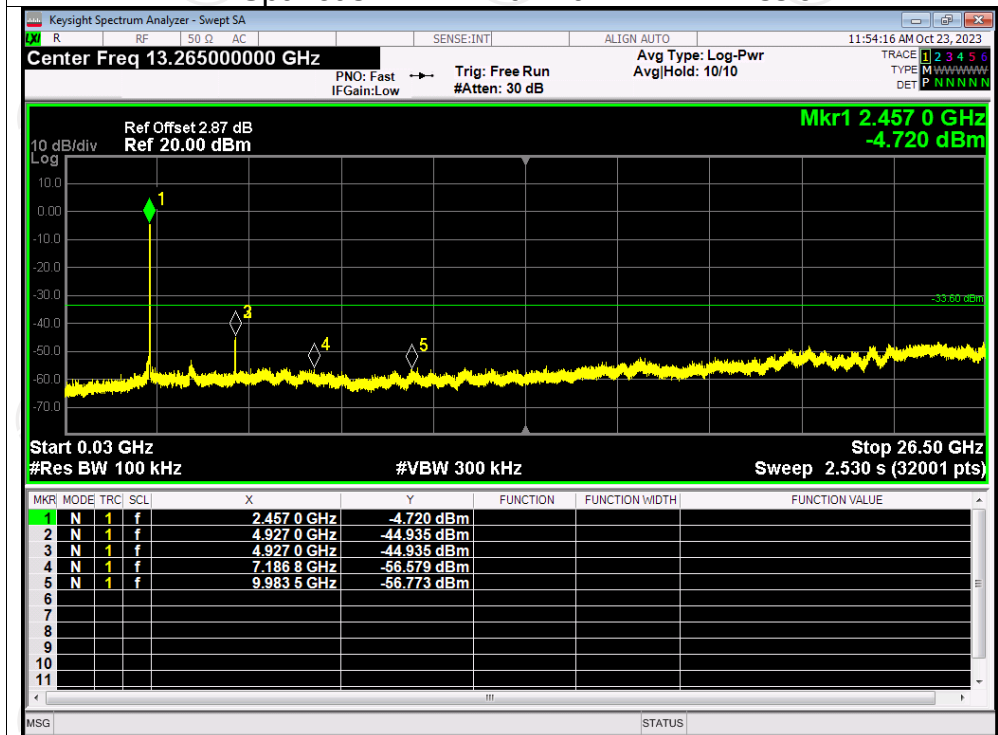
## Tx. Spurious NVNT n20 2462MHz Emission

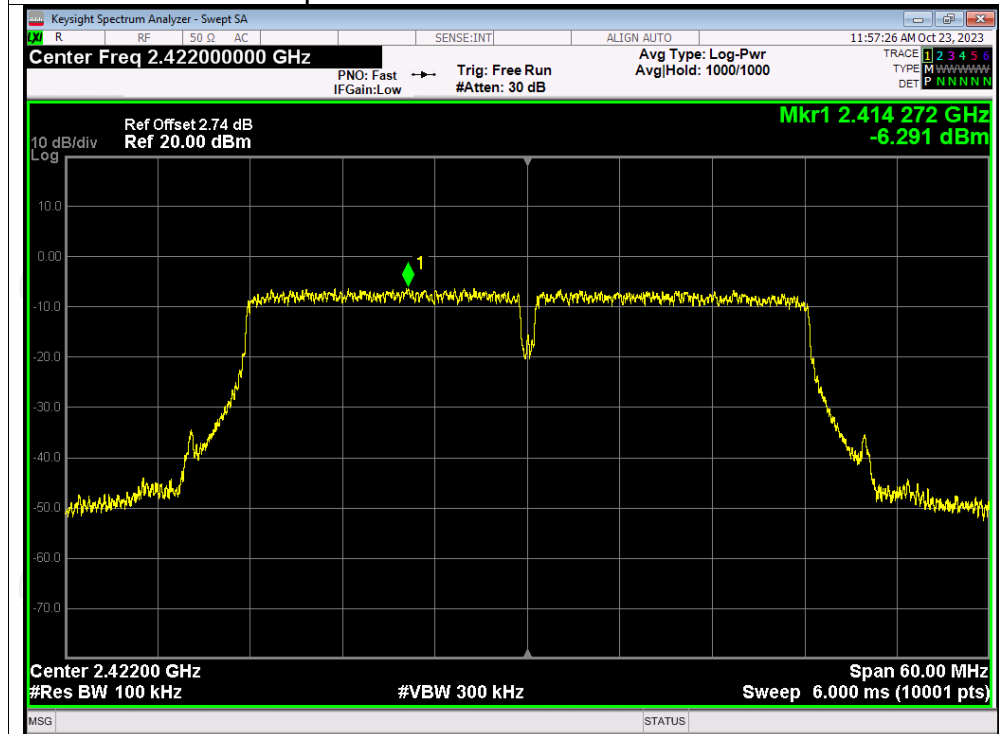
## Tx. Spurious NVNT n40 2422MHz Ref

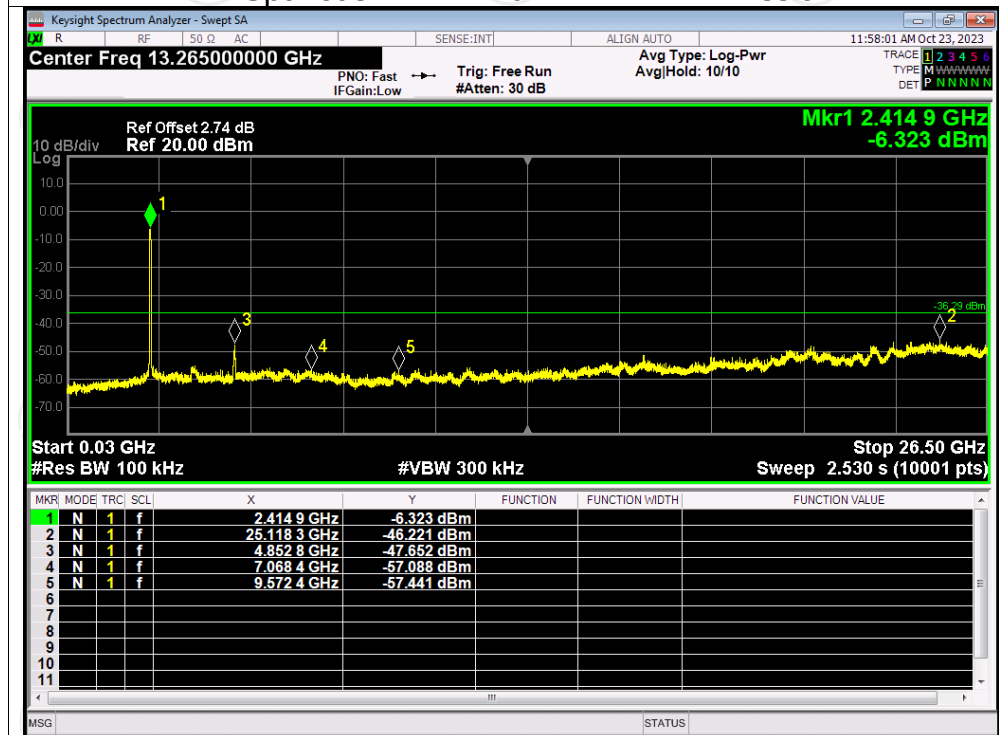
## Tx. Spurious NVNT n40 2422MHz Emission

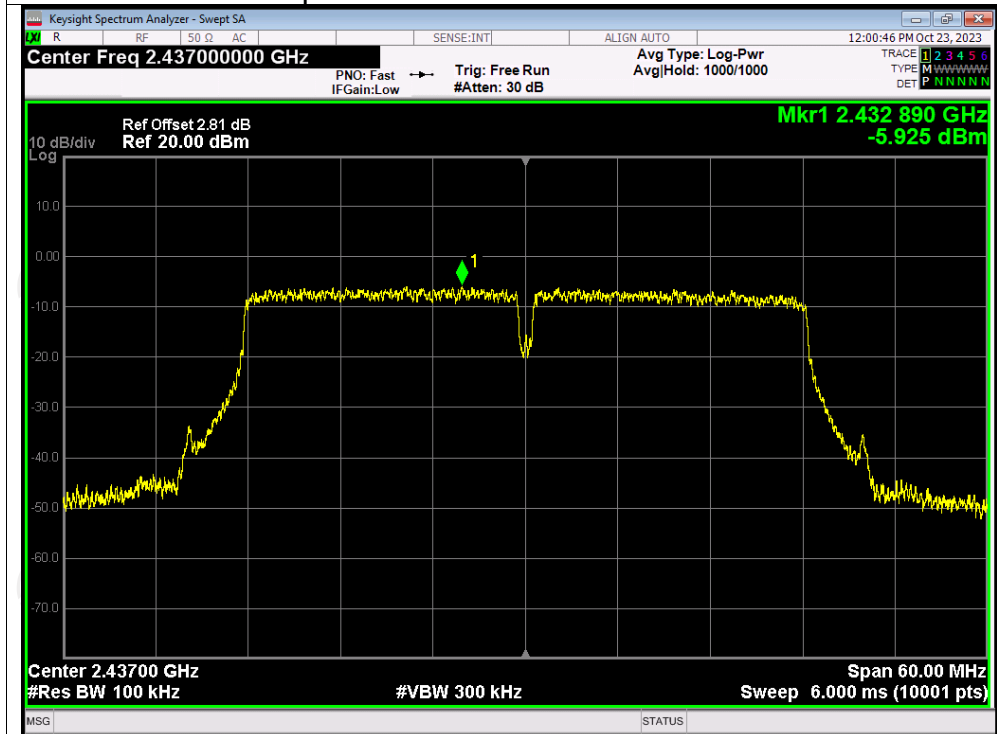
## Tx. Spurious NVNT n40 2437MHz Ref

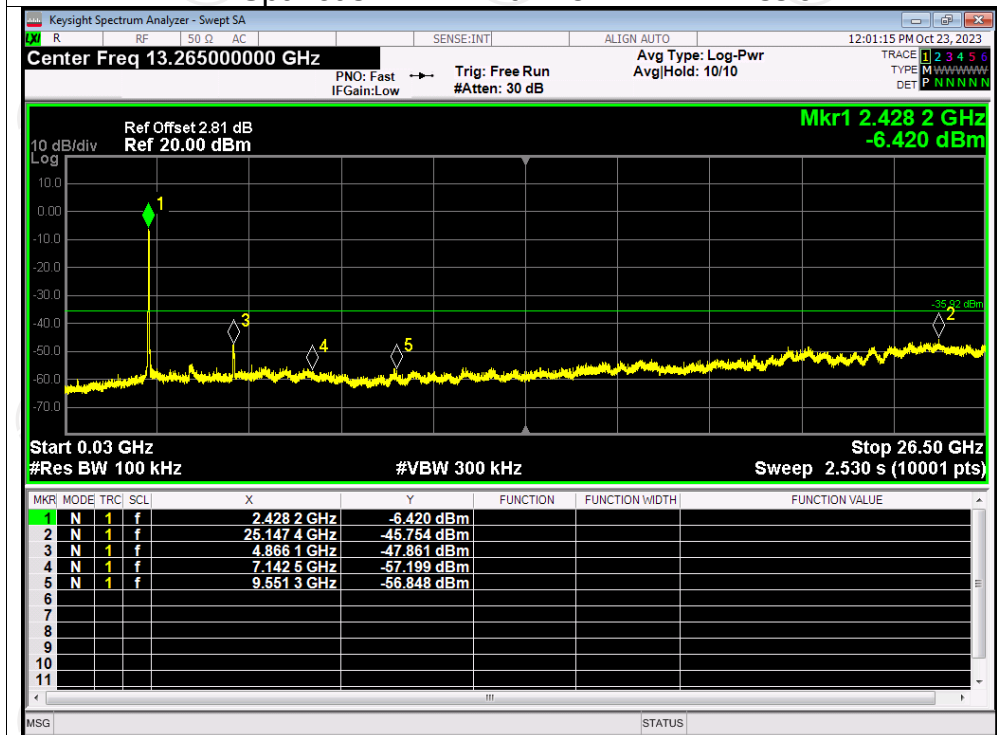
## Tx. Spurious NVNT n40 2437MHz Emission

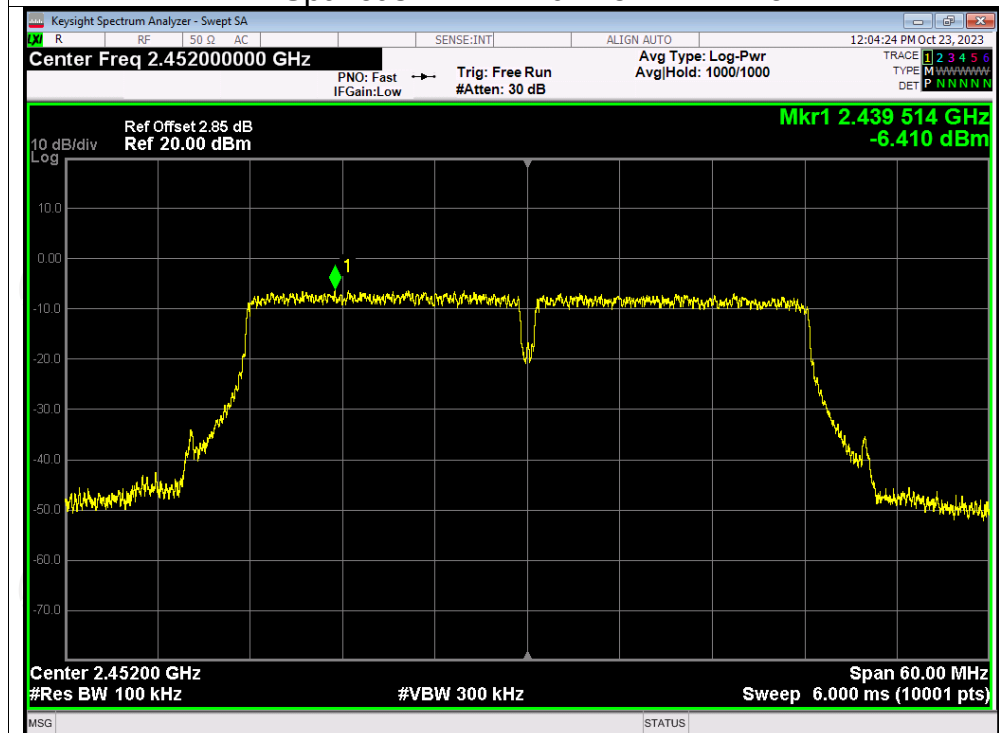
## Tx. Spurious NVNT n40 2452MHz Ref

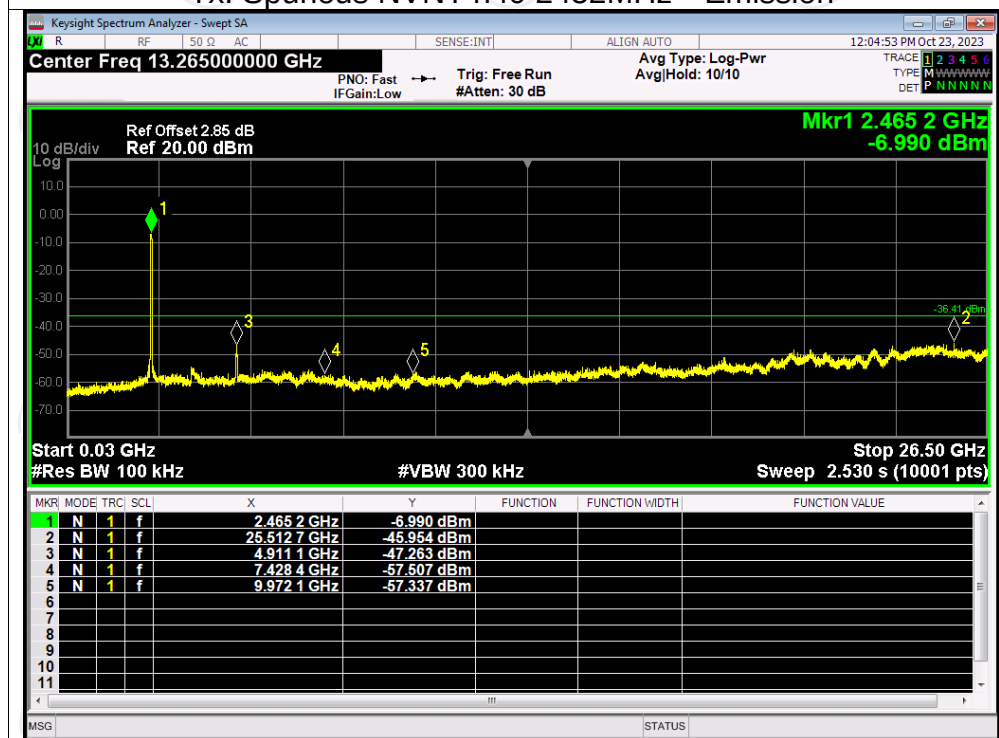
## Tx. Spurious NVNT n40 2452MHz Emission

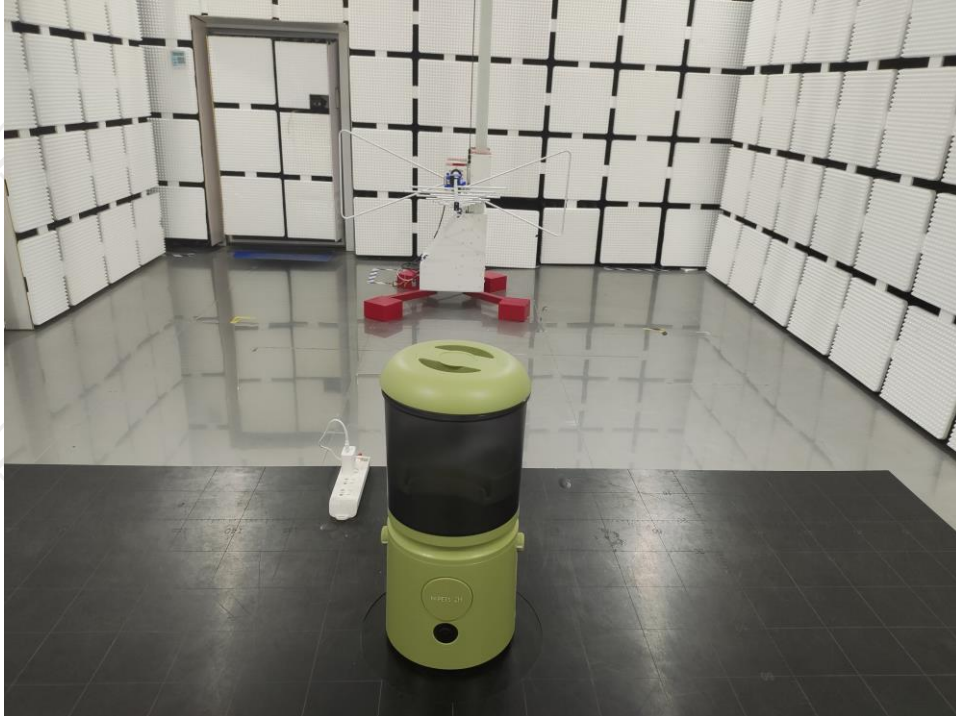
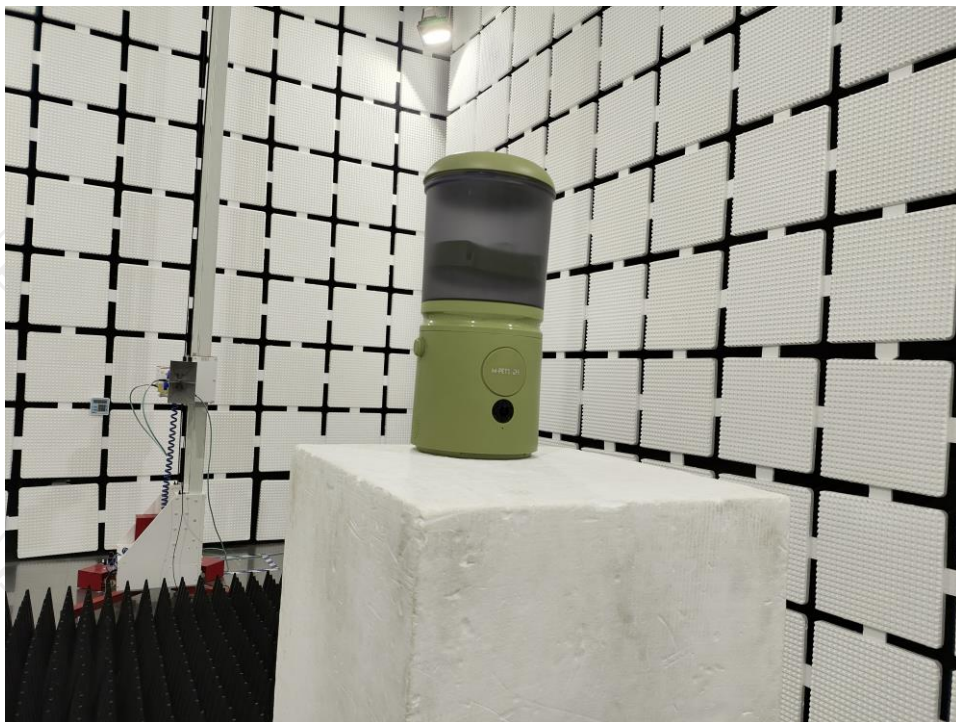
Radiated Emission

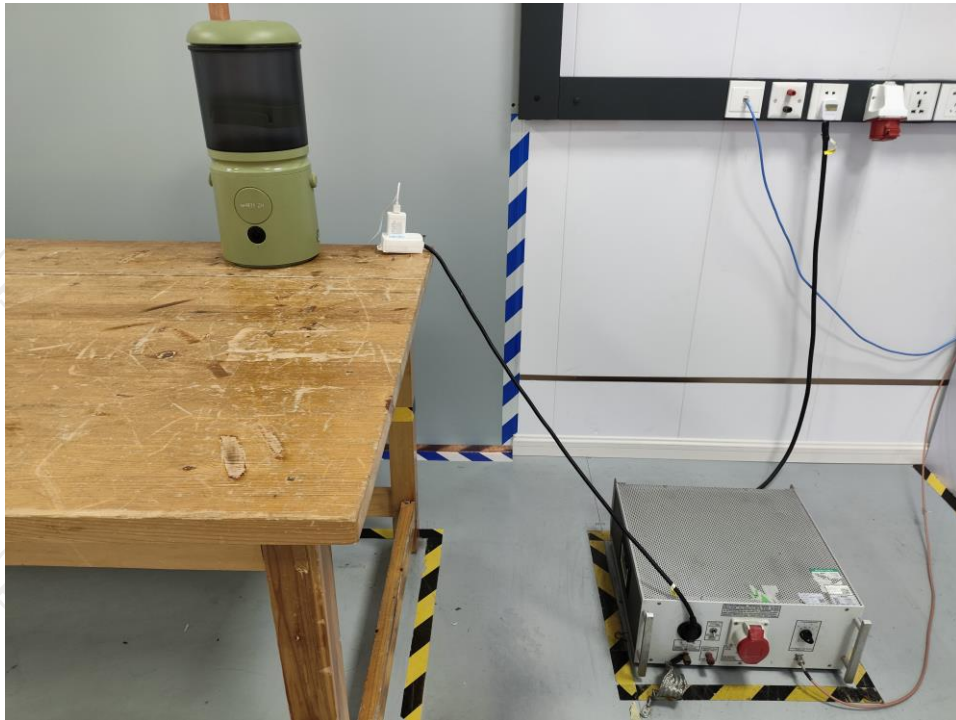
### Conducted Emission
