Radiated Emission Measurement

Condition : FCC\_part 15E RE\_Above 1GHz\_PK

EUT : W6M22409-23739

Test Mode : TX 802.11a CH189

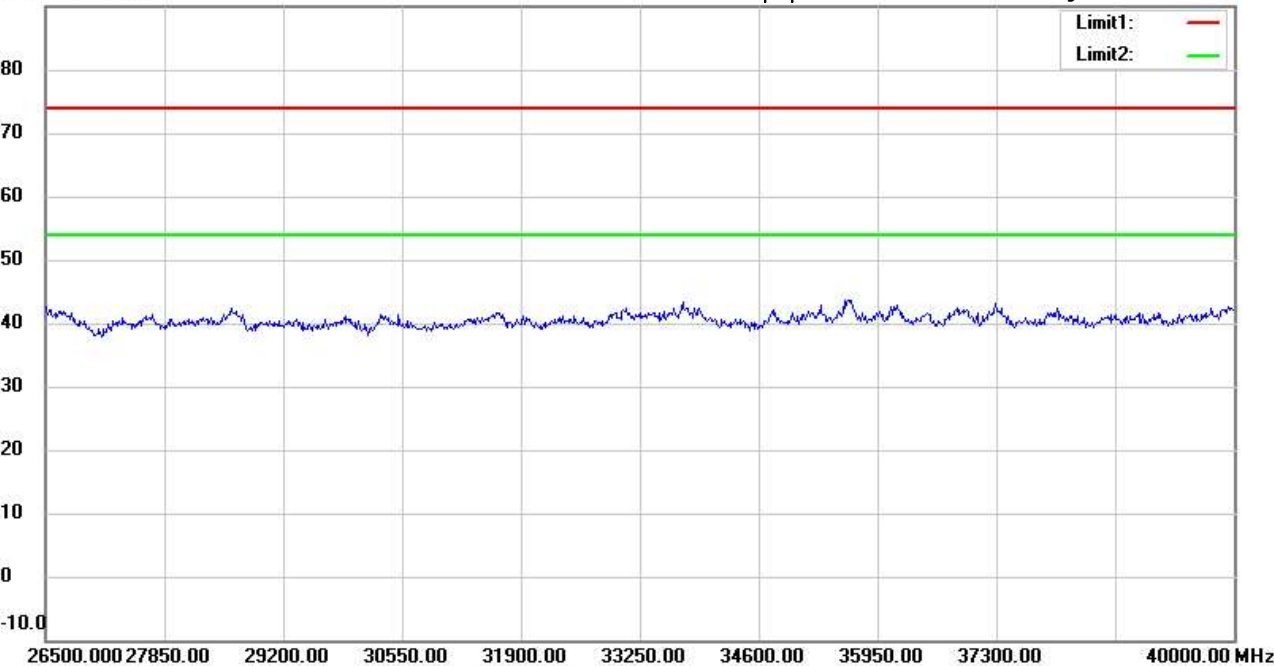
Polarization: Horizontal

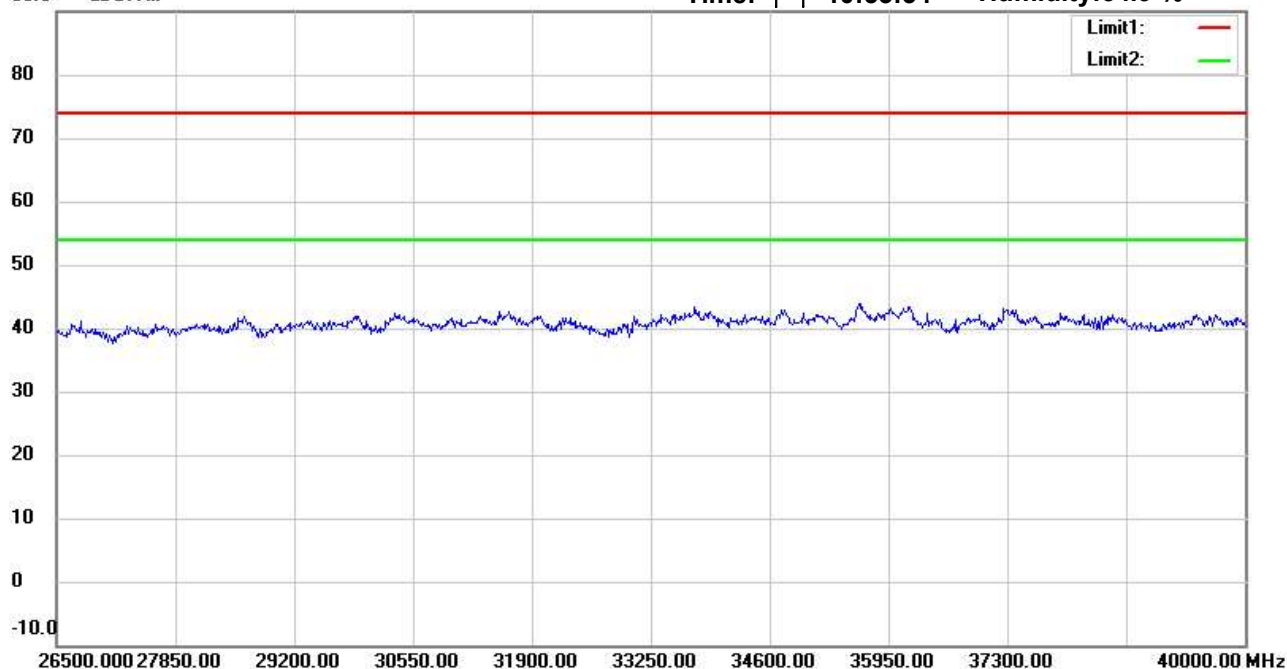
Condition : FCC\_part 15E RE\_Above 1GHz\_PK

Test Mode : TX 802.11a CH189

Polarization: **Vertical**

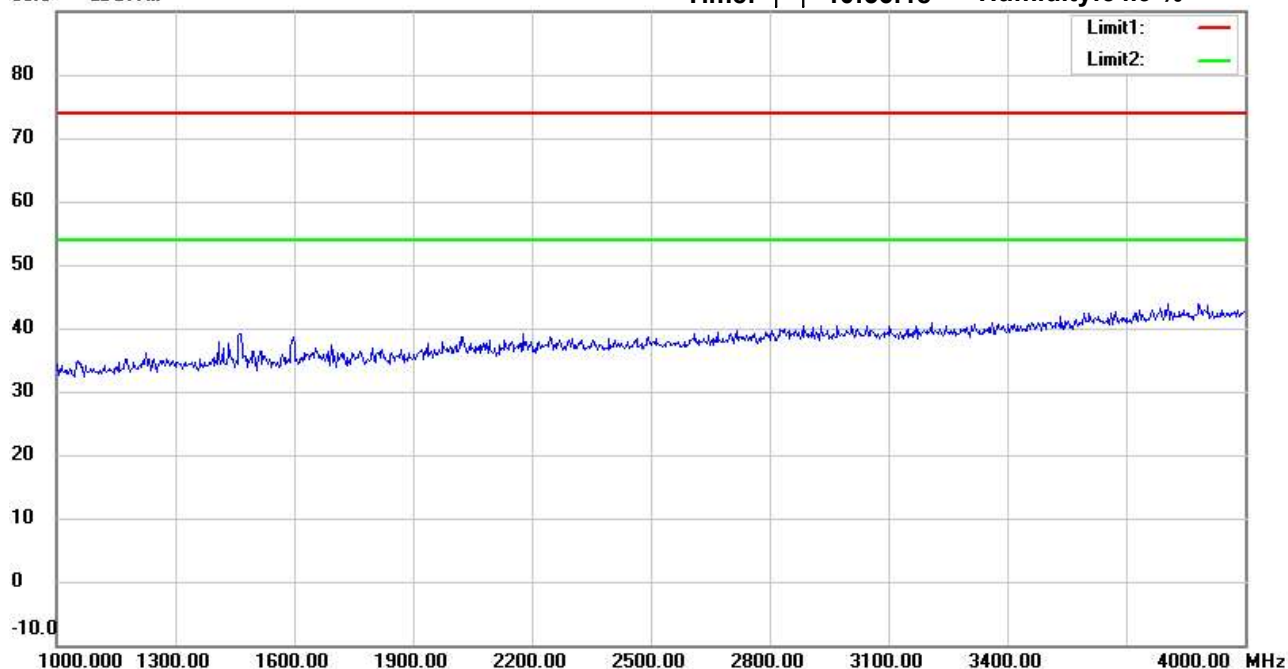
Condition : FCC\_part 15E RE\_Above 1GHz\_PK

Test Mode : TX 802.11a CH209

Polarization: **Horizontal**

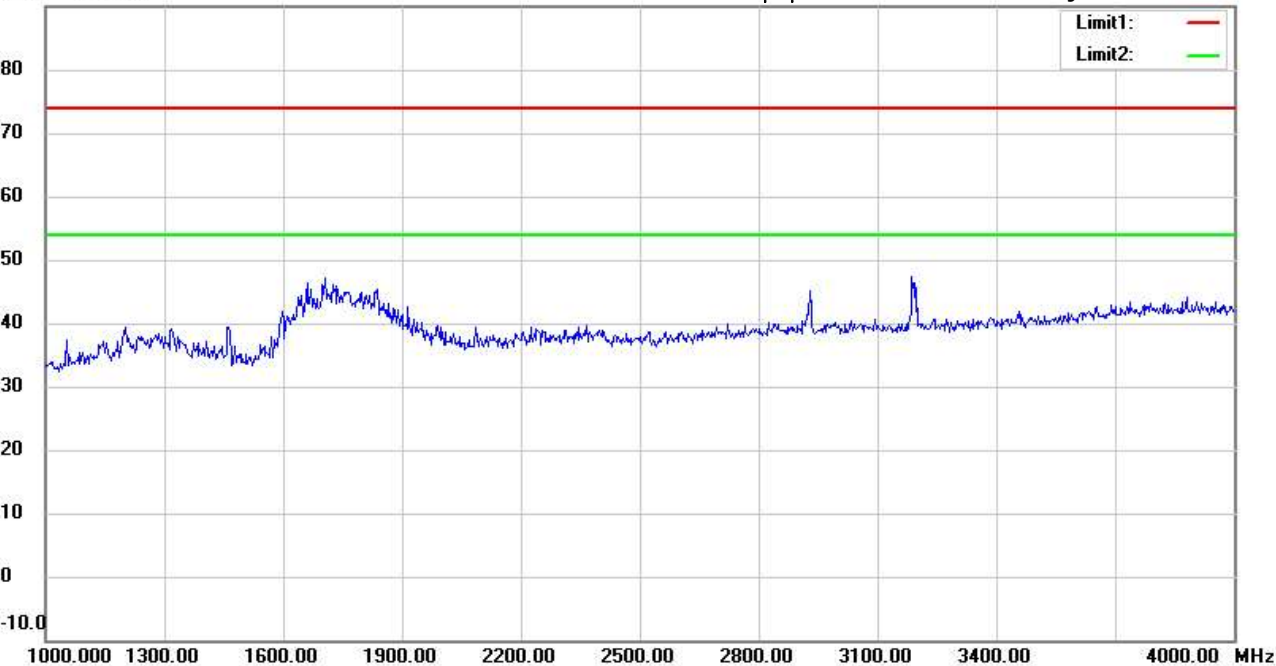
Condition : FCC\_part 15E RE\_Above 1GHz\_PK

Test Mode : TX 802.11a CH209

Polarization: Vertical

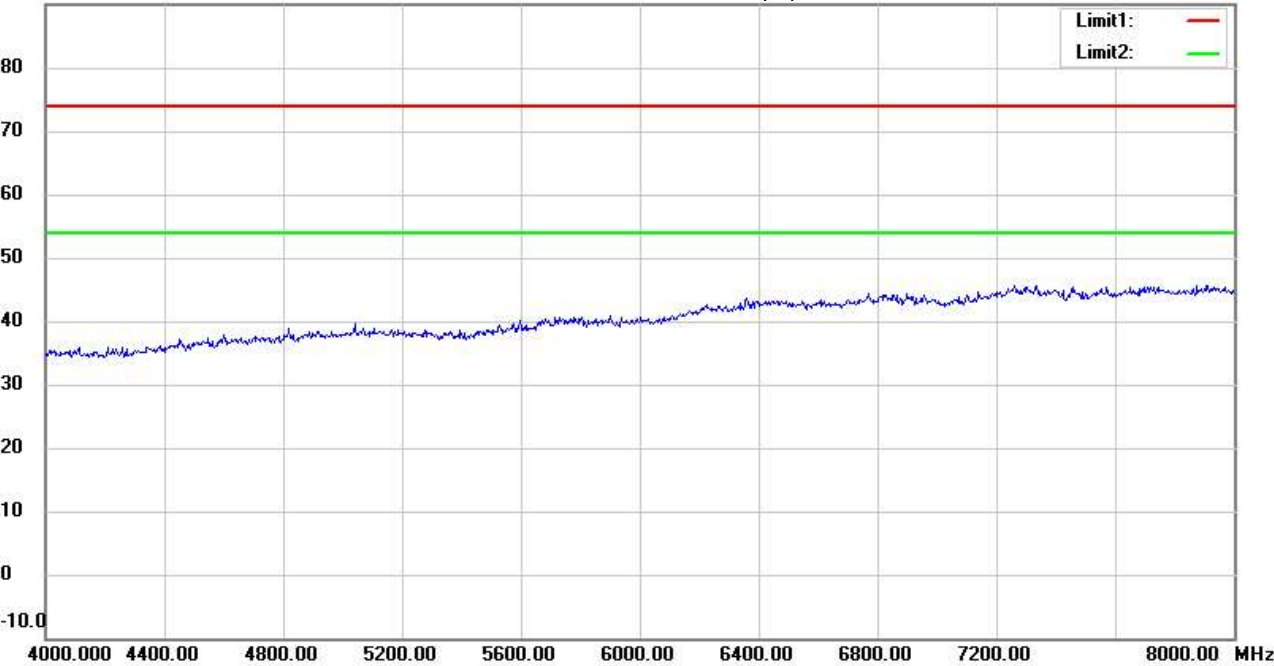
Site : 966A Chamber  
Condition : FCC\_part 15E RE\_Above 1GHz\_PK  
EUT : W6M22409-23739  
M/N:  
Test Mode : TX 802.11a CH209  
Note :

Polarization: *Horizontal*  
Power : 120 Va.c.  
Distance: 3m

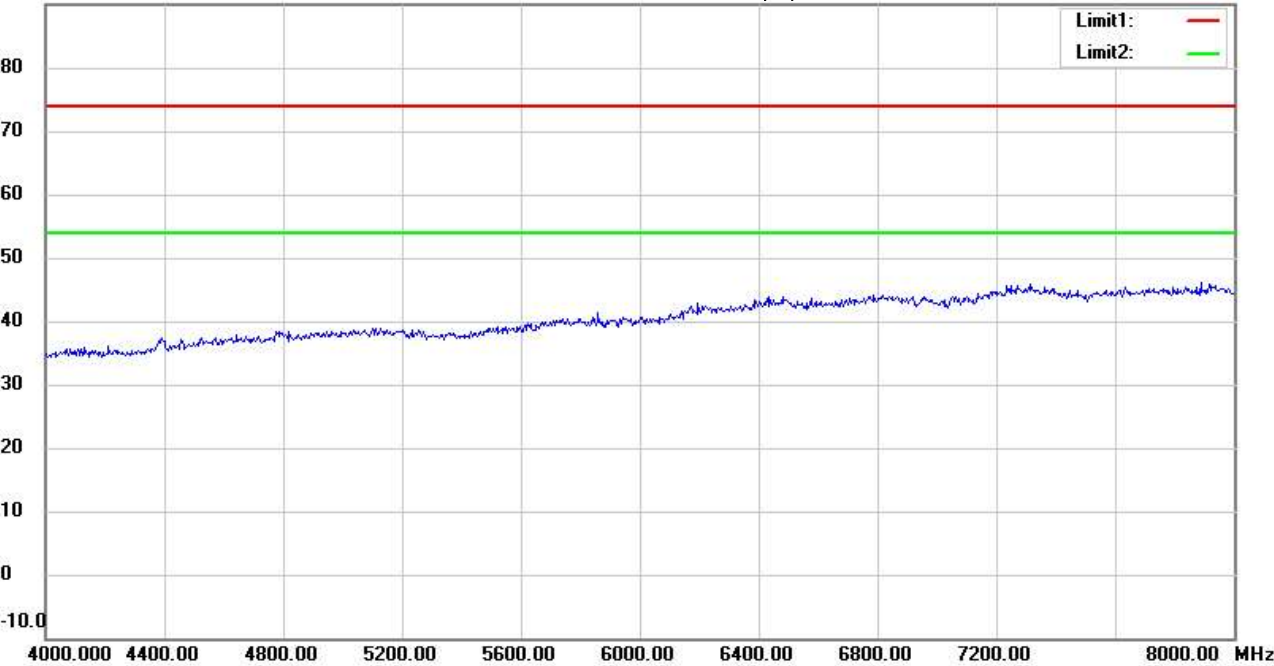
Site : 966A Chamber  
Condition : FCC\_part 15E RE\_Above 1GHz\_PK  
EUT : W6M22409-23739  
M/N:  
Test Mode : TX 802.11a CH209  
Note :

Polarization: Vertical  
Power : 120 Va.c.  
Distance: 3m

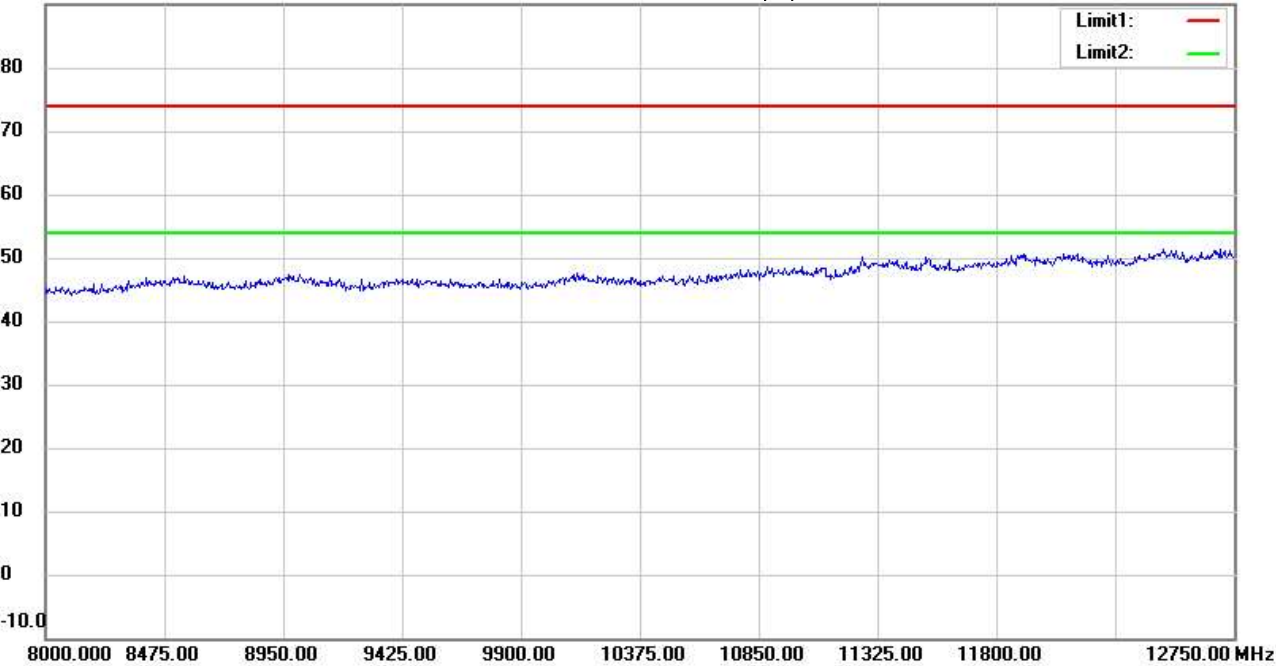
Condition : FCC\_part 15E RE\_Above 1GHz\_PK

Test Mode : TX 802.11a CH209

Polarization: *Horizontal*

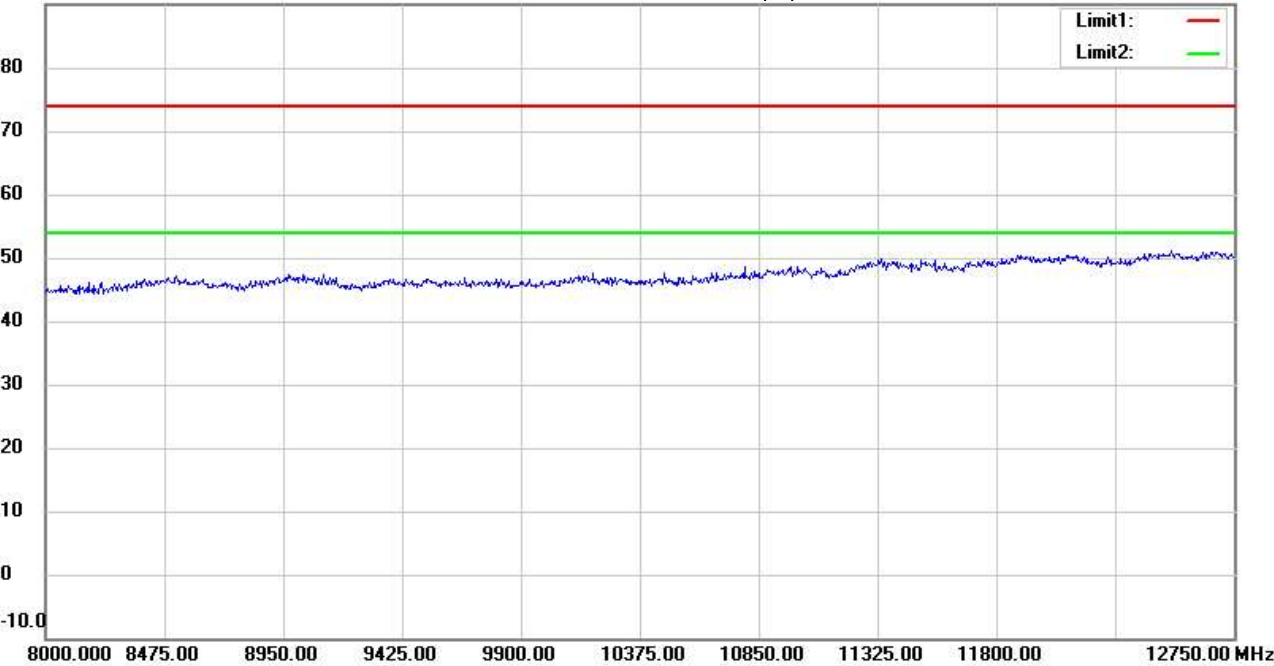
Site : 966A Chamber  
Condition : FCC\_part 15E RE\_Above 1GHz\_PK  
EUT : W6M22409-23739  
M/N:  
Test Mode : TX 802.11a CH209  
Note :

Polarization: Vertical  
Power : 120 V.a.c.  
Distance: 3m

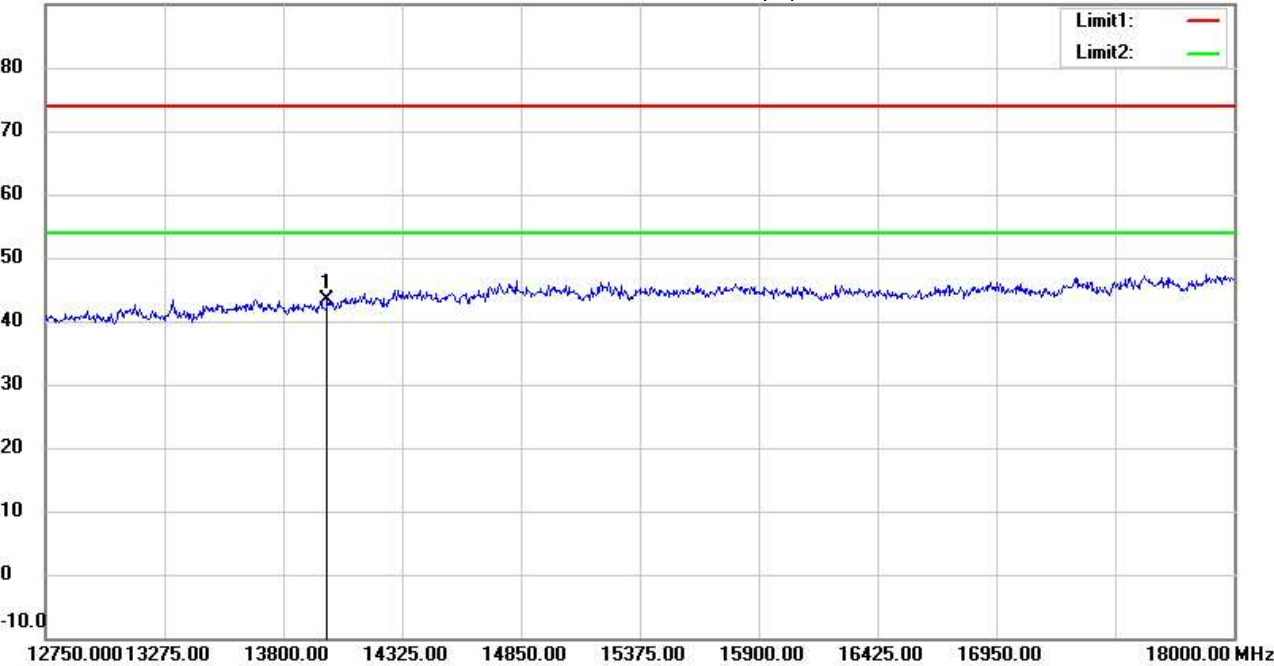
Site : 966A Chamber  
Condition : FCC\_part 15E RE\_Above 1GHz\_PK  
EUT : W6M22409-23739  
M/N:  
Test Mode : TX 802.11a CH209  
Note :

Polarization: *Horizontal*  
Power : 120 Va.c.  
Distance: 3m

| Mk. | Frequency (MHz) | Reading (dBuV) | Detector | Corr. factor (dB/m) | Result (dBuV/m) | Limit (dBuV/m) | Ant.Pos (cm) | Tab.Pos (deg.) | Margin (dB) | Comment |
|---|---|---|---|---|---|---|---|---|---|---|
| * | 13990.000 | 22.40 | peak | 20.93 | 43.33 | 74.00 | 150 | 271 | -30.67 | |

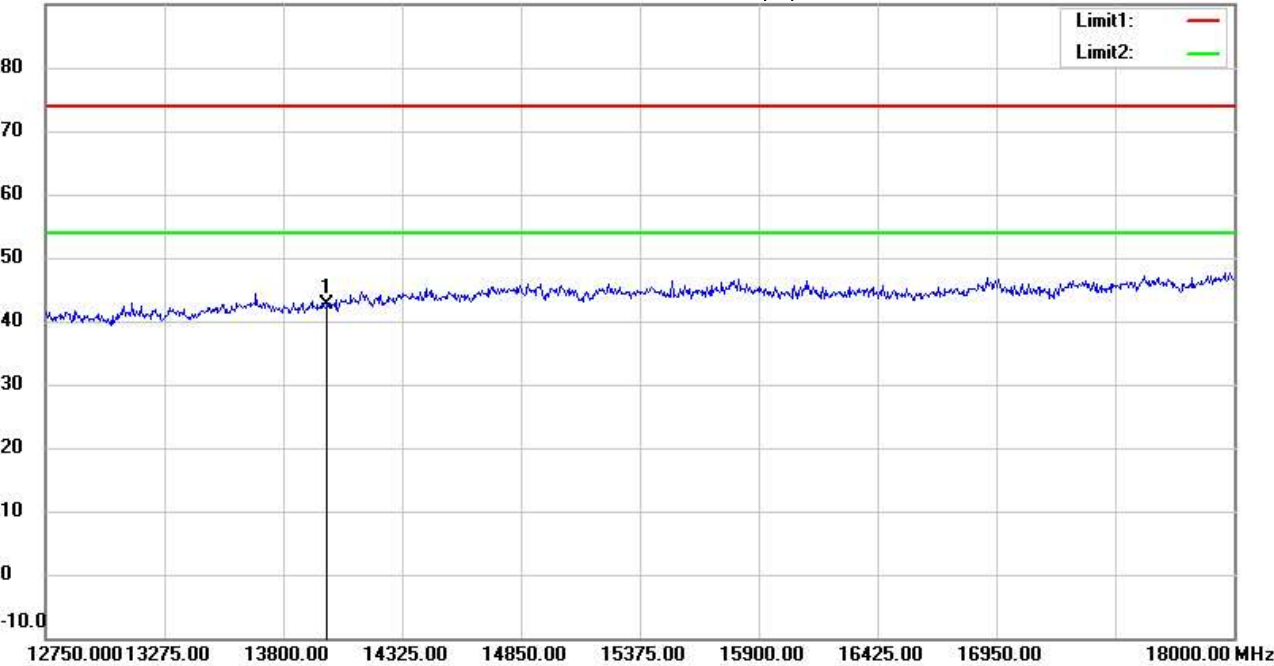
Condition : FCC\_part 15E RE\_Above 1GHz\_PK

Test Mode : TX 802.11a CH209

Polarization: Vertical

| Mk. | Frequency (MHz) | Reading (dBuV) | Detector | Corr. factor (dB/m) | Result (dBuV/m) | Limit (dBuV/m) | Ant.Pos (cm) | Tab.Pos (deg.) | Margin (dB) | Comment |
|---|---|---|---|---|---|---|---|---|---|---|
| * | 13990.000 | 21.78 | peak | 20.93 | 42.71 | 74.00 | 150 | 350 | -31.29 | |

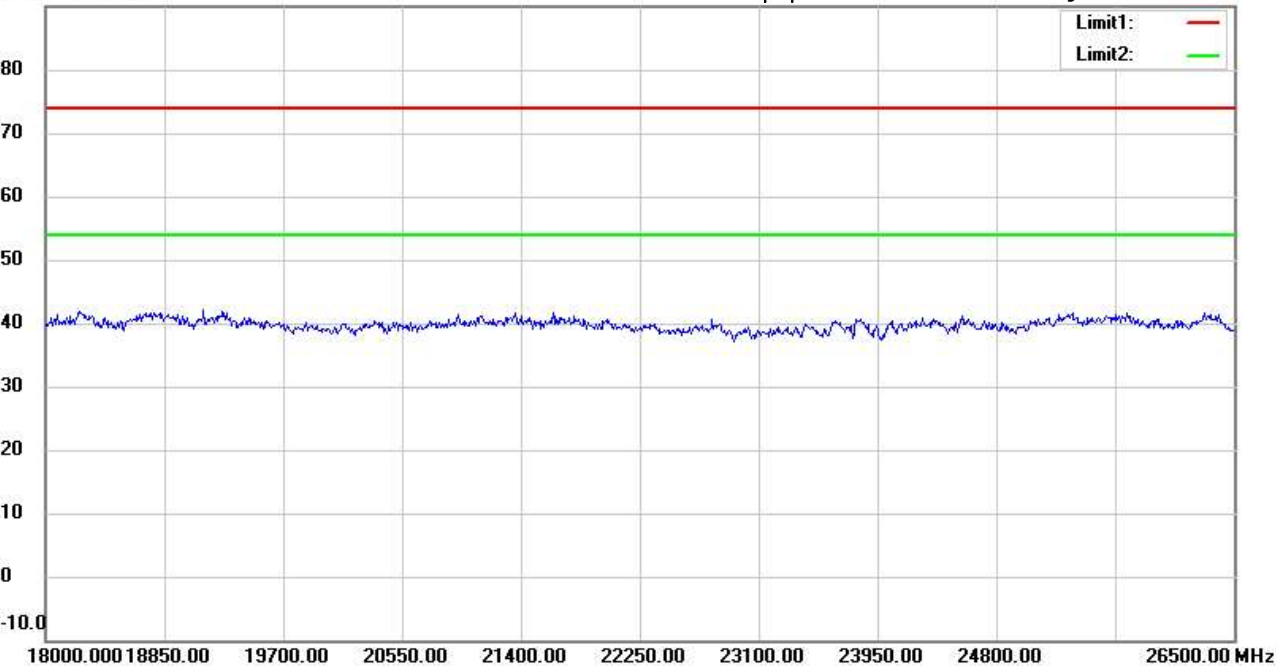
Condition : FCC\_part 15E RE\_Above 1GHz\_PK

Test Mode : TX 802.11a CH209

Polarization: Horizontal

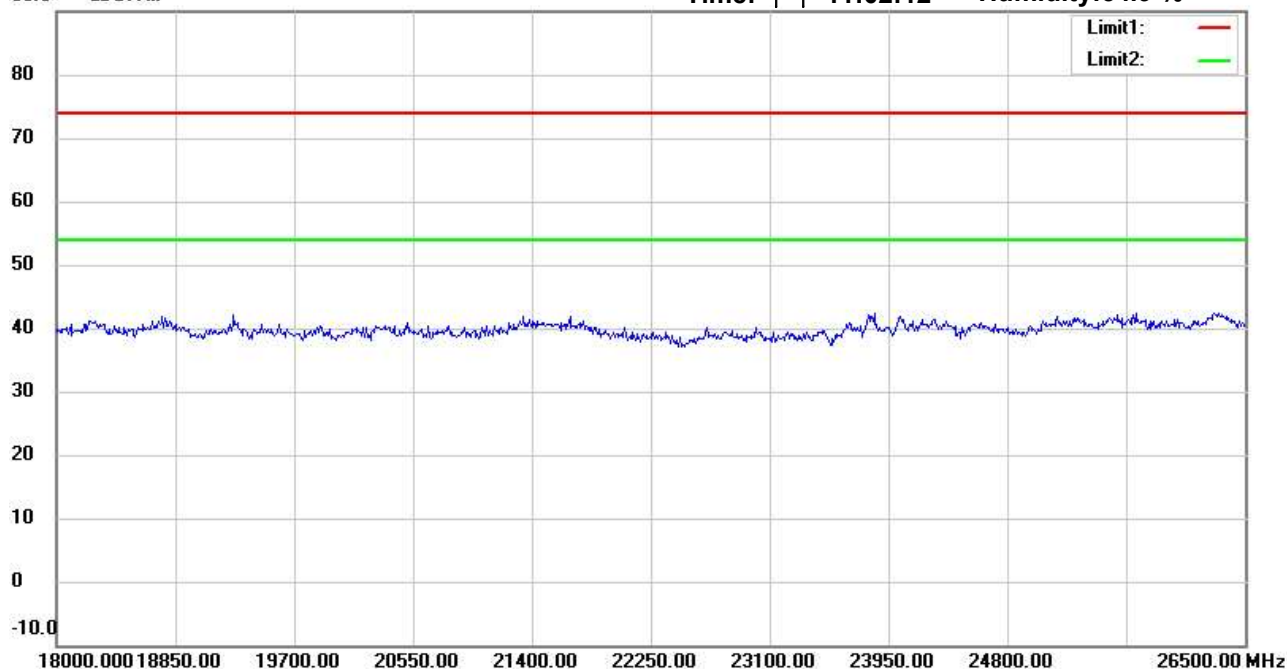
Condition : FCC\_part 15E RE\_Above 1GHz\_PK

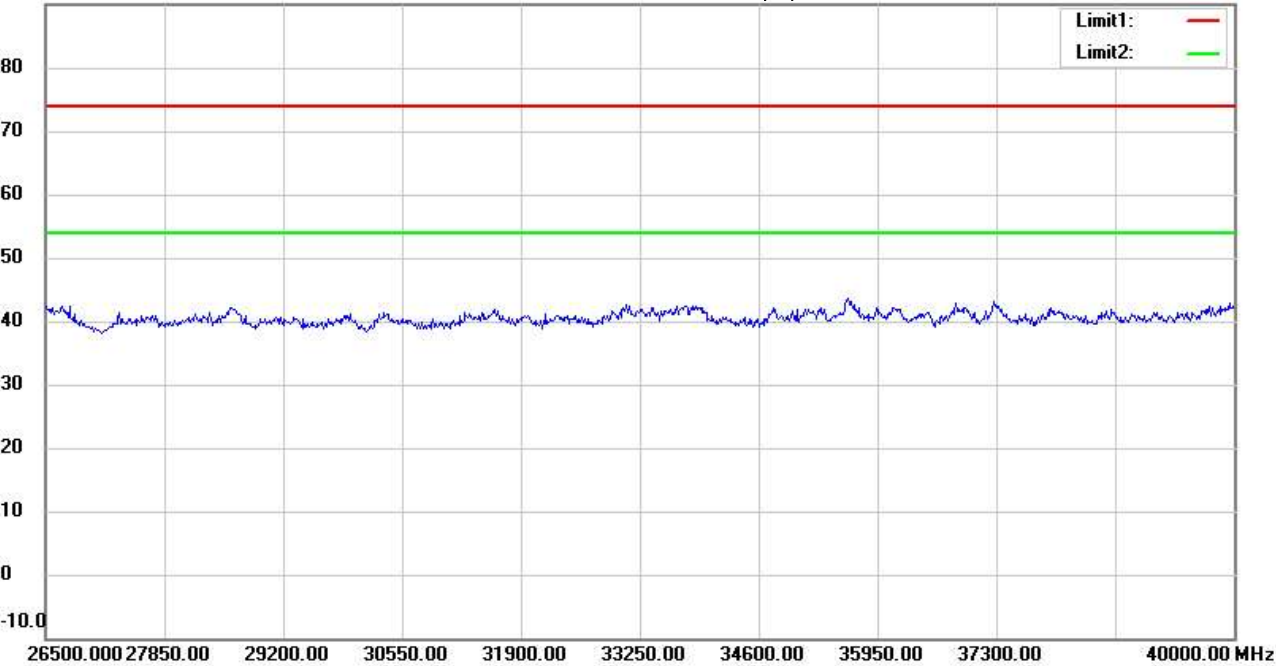
Condition : FCC\_part 15E RE\_Above 1GHz\_PK

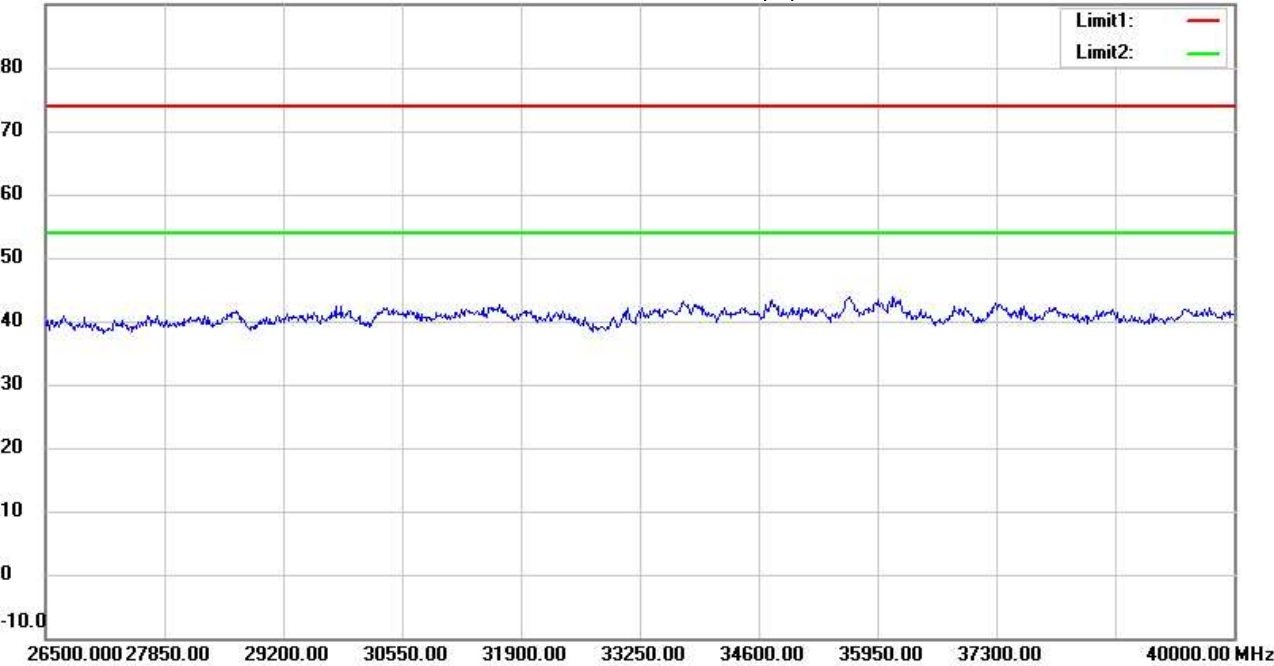
Site : 966A Chamber  
Condition : FCC\_part 15E RE\_Above 1GHz\_PK  
EUT : W6M22409-23739  
M/N:  
Test Mode : TX 802.11a CH209  
Note :

Polarization: Vertical  
Power : 120 Va.c.  
Distance: 3m

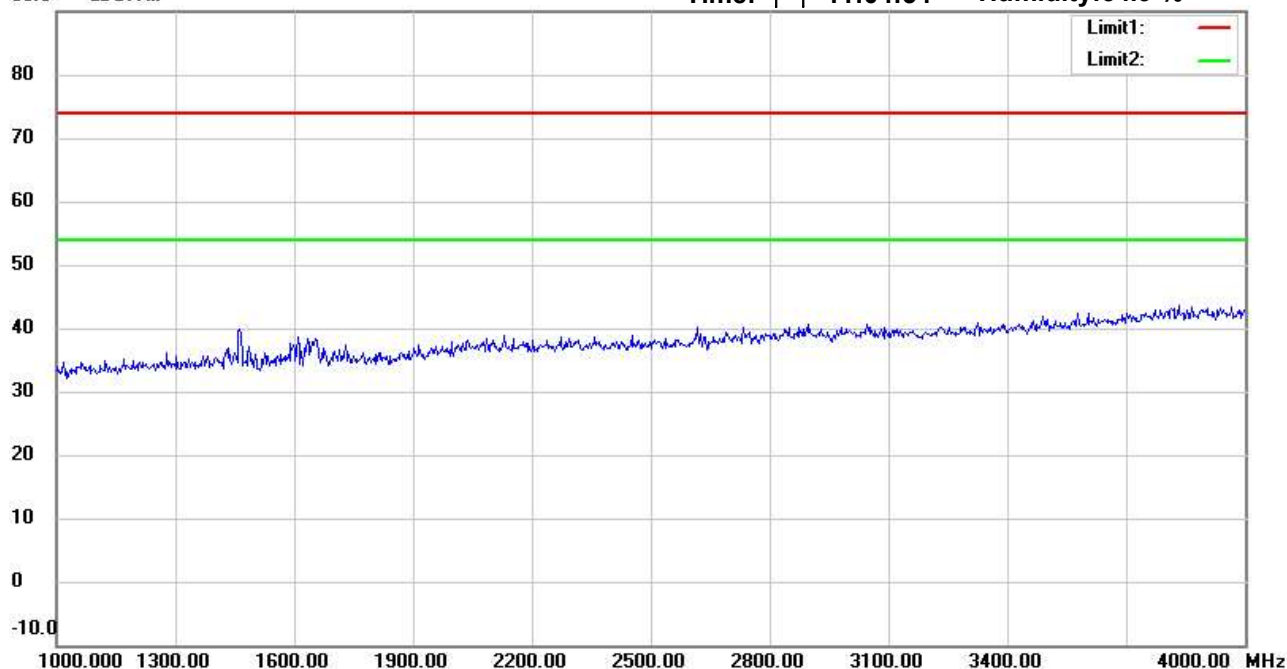
Condition : FCC\_part 15E RE\_Above 1GHz\_PK

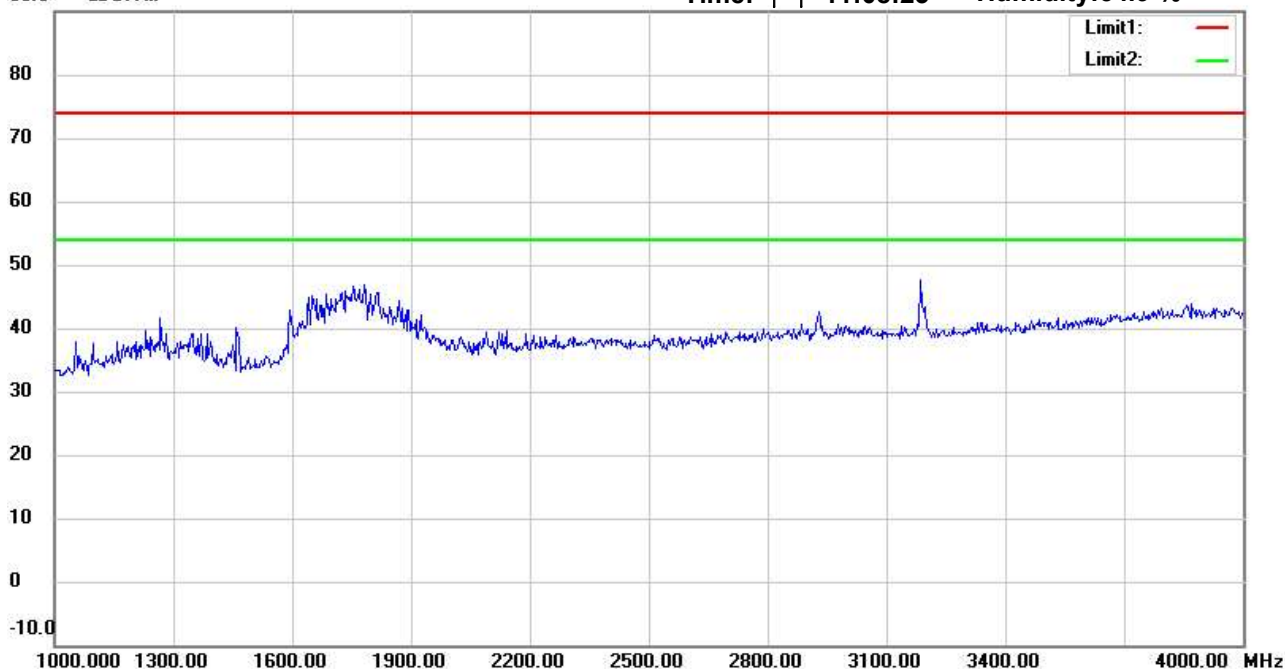
Condition : FCC\_part 15E RE\_Above 1GHz\_PK

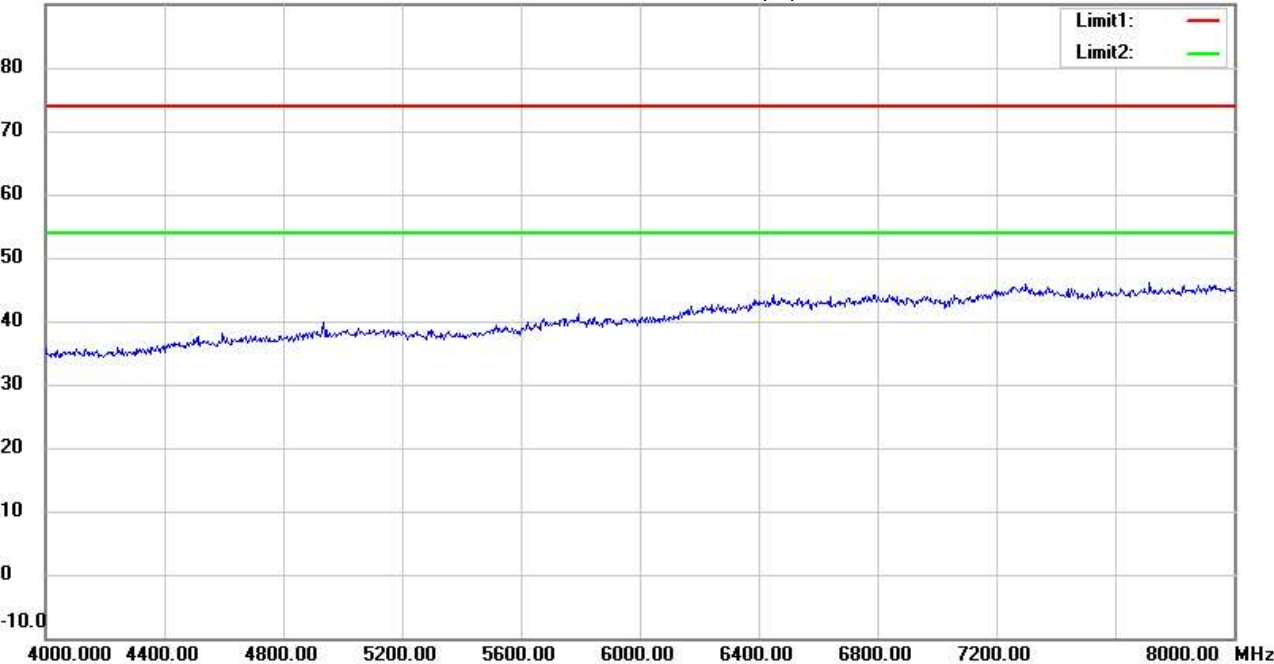
Site : 966A Chamber  
Condition : FCC\_part 15E RE\_Above 1GHz\_PK  
EUT : W6M22409-23739  
M/N:  
Test Mode : TX 802.11a CH229  
Note :

Polarization: Horizontal  
Power : 120 Va.c.  
Distance: 3m

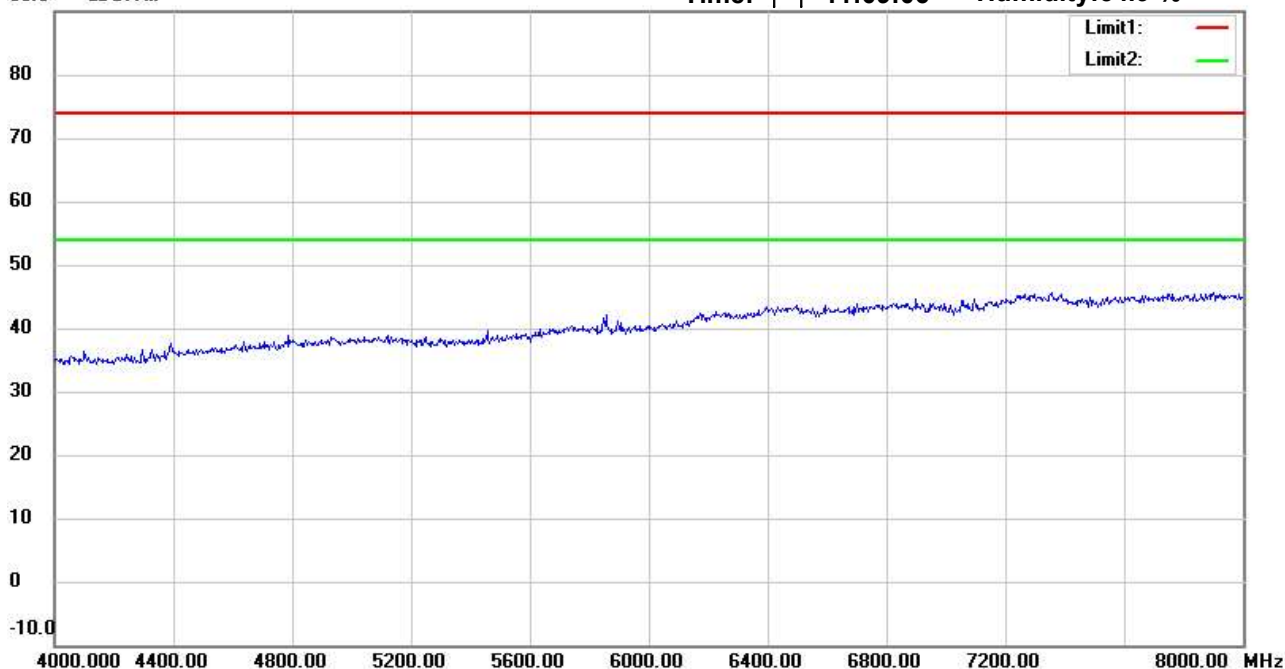
Condition : FCC\_part 15E RE\_Above 1GHz\_PK

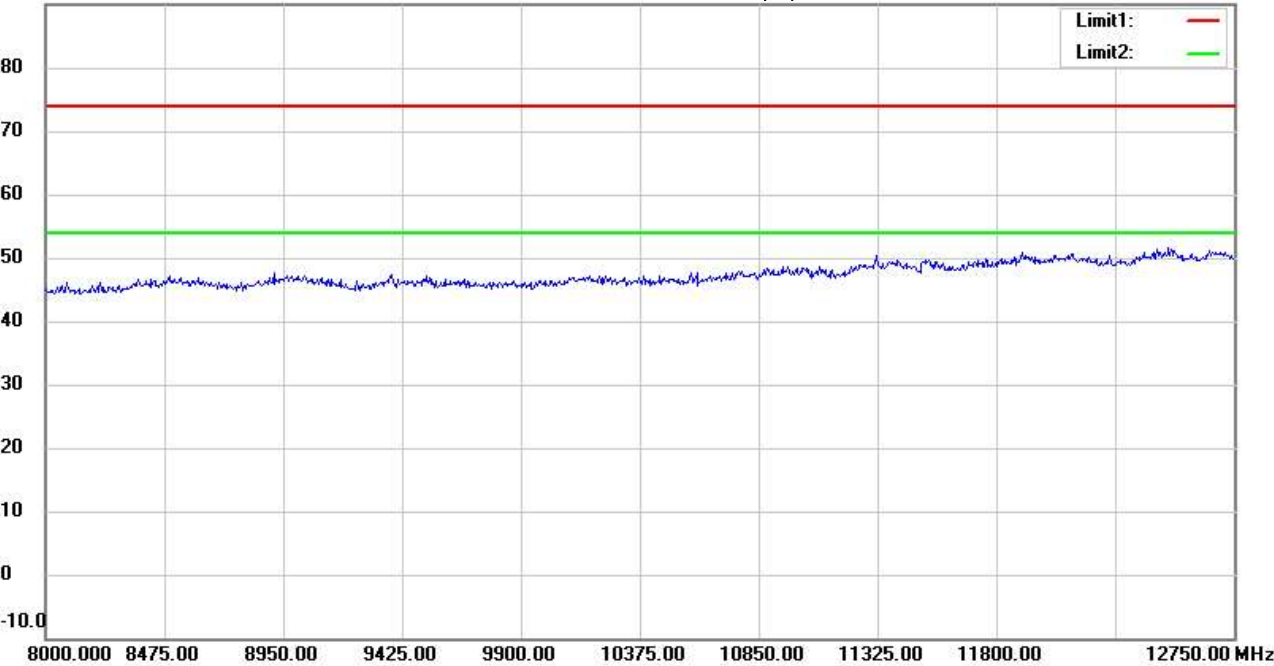
Condition : FCC\_part 15E RE\_Above 1GHz\_PK

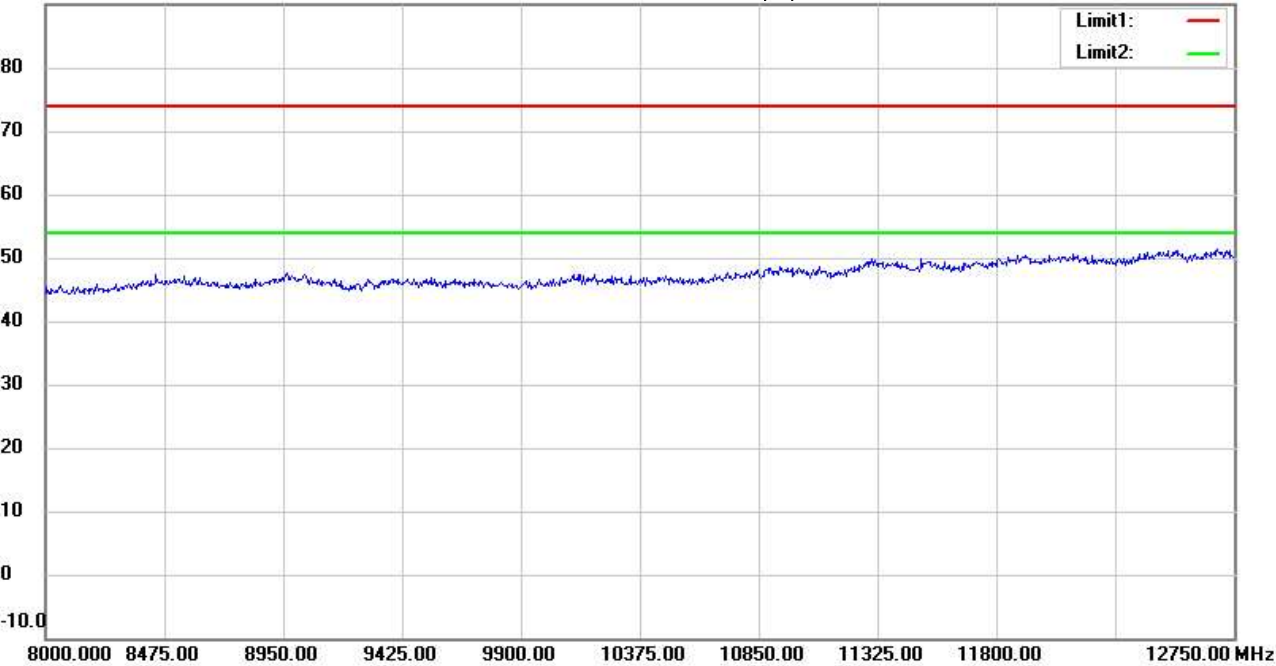
Site : 966A Chamber  
Condition : FCC\_part 15E RE\_Above 1GHz\_PK  
EUT : W6M22409-23739  
M/N:  
Test Mode : TX 802.11a CH229  
Note :

Polarization: Vertical  
Power : 120 Va.c.  
Distance: 3m

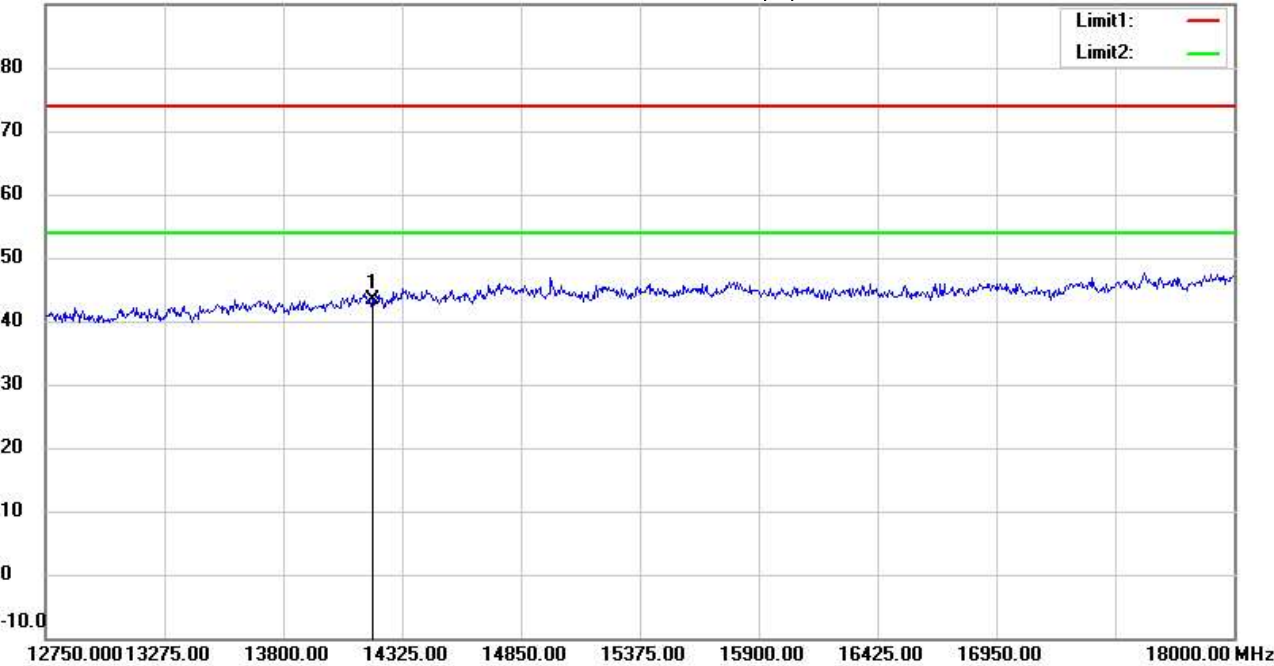
Site : 966A Chamber  
Condition : FCC\_part 15E RE\_Above 1GHz\_PK  
EUT : W6M22409-23739  
M/N:  
Test Mode : TX 802.11a CH229  
Note :

Polarization: **Horizontal**  
Power : 120 Va.c.  
Distance: 3m

| Mk. | Frequency (MHz) | Reading (dBuV) | Detector | Corr. factor (dB/m) | Result (dBuV/m) | Limit (dBuV/m) | Ant.Pos (cm) | Tab.Pos (deg.) | Margin (dB) | Comment |
|---|---|---|---|---|---|---|---|---|---|---|
| * | 14190.000 | 21.32 | peak | 21.94 | 43.26 | 74.00 | 150 | 224 | -30.74 | |

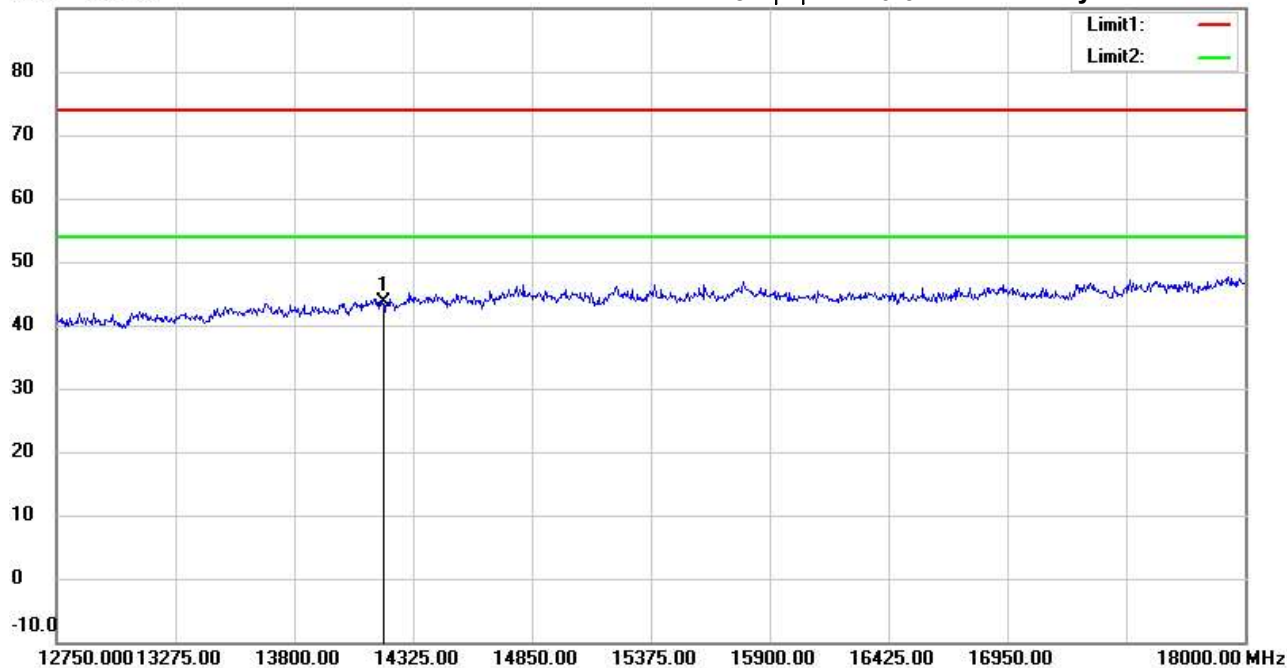
Condition : FCC\_part 15E RE\_Above 1GHz\_PK

Test Mode : TX 802.11a CH229

Polarization: Vertical

| Mk. | Frequency (MHz) | Reading (dBuV) | Detector | Corr. factor (dB/m) | Result (dBuV/m) | Limit (dBuV/m) | Ant.Pos (cm) | Tab.Pos (deg.) | Margin (dB) | Comment |
|---|---|---|---|---|---|---|---|---|---|---|
| * | 14190.000 | 21.57 | peak | 21.94 | 43.51 | 74.00 | 150 | 359 | -30.49 | |

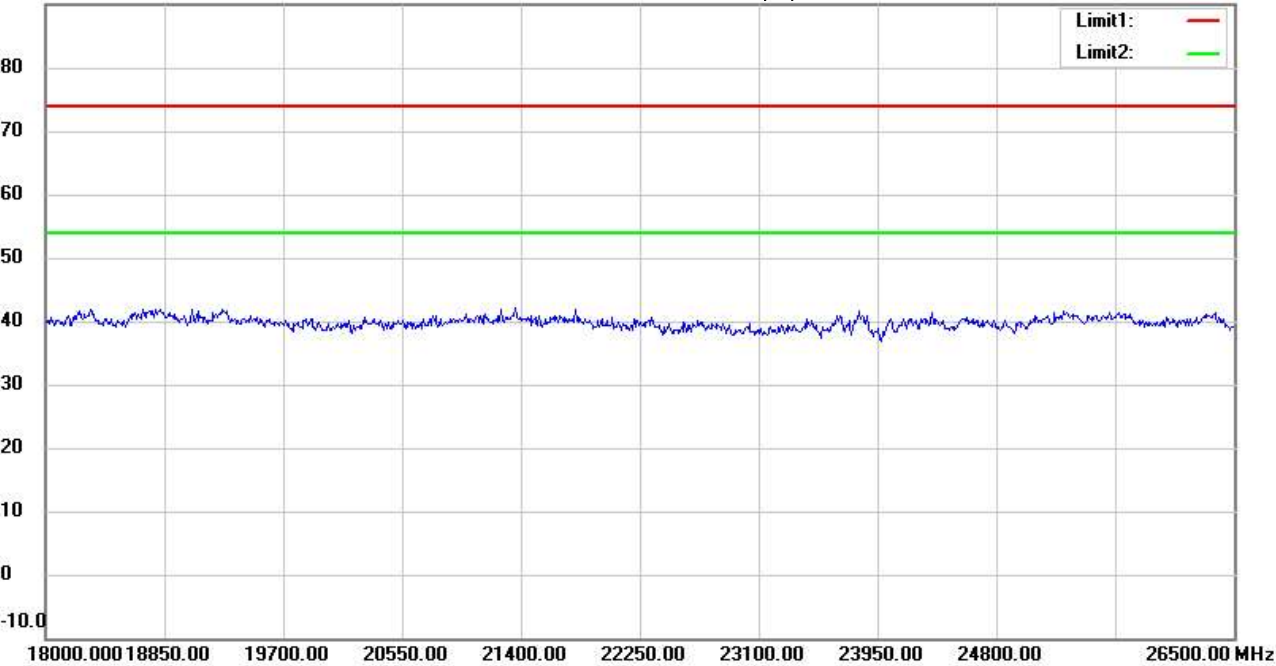
Site : 966A Chamber  
Condition : FCC\_part 15E RE\_Above 1GHz\_PK  
EUT : W6M22409-23739  
M/N:  
Test Mode : TX 802.11a CH229  
Note :

Polarization: **Horizontal**  
Power : 120 Va.c.  
Distance: 3m

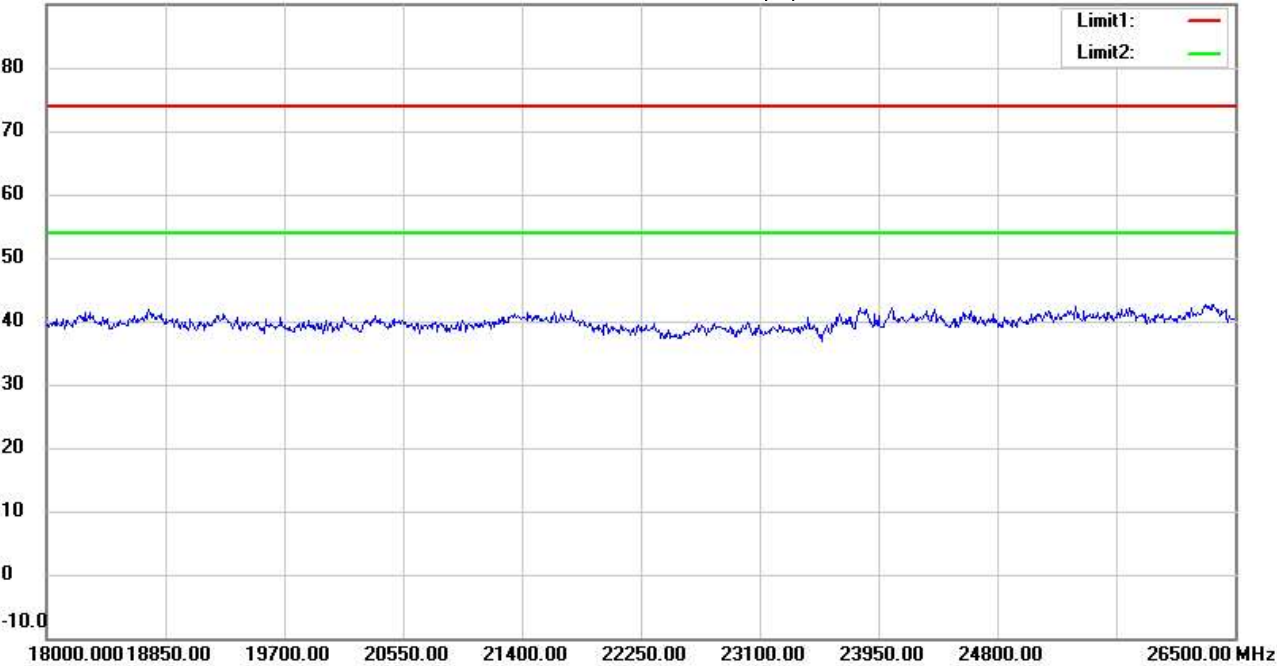
Site : 966A Chamber  
Condition : FCC\_part 15E RE\_Above 1GHz\_PK  
EUT : W6M22409-23739  
M/N:  
Test Mode : TX 802.11a CH229  
Note :

Polarization: Vertical  
Power : 120 Va.c.  
Distance: 3m

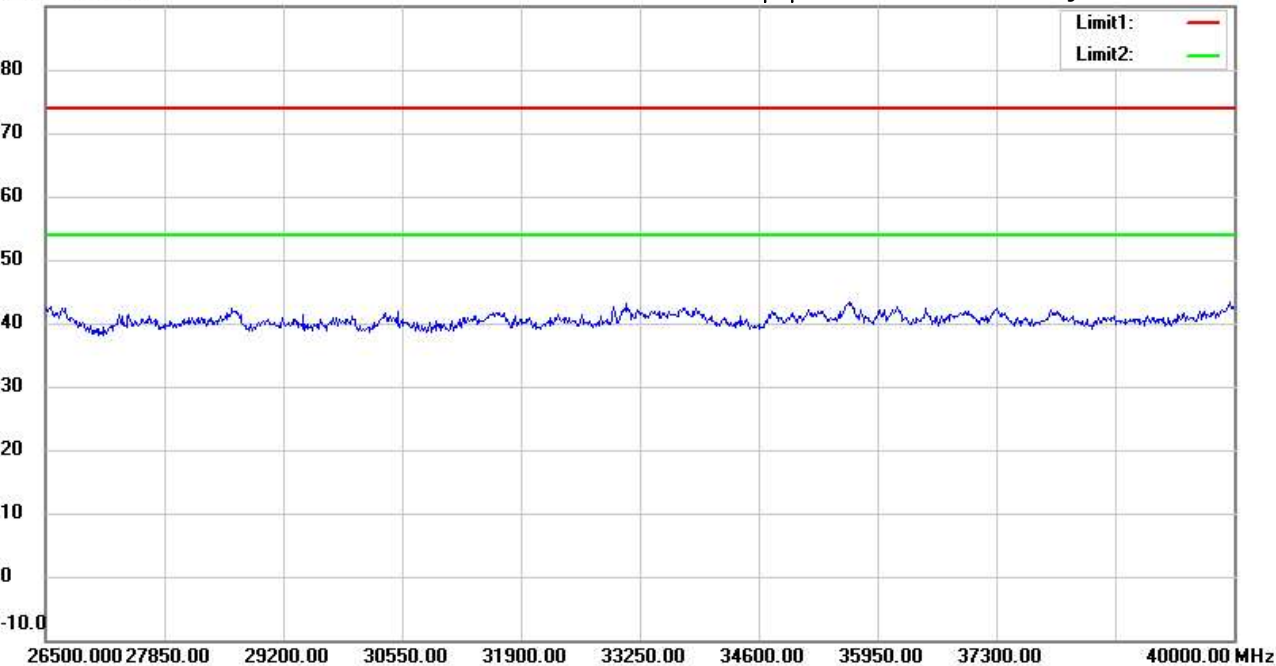
Condition : FCC\_part 15E RE\_Above 1GHz\_PK
