Radiated Emission Measurement

Condition : FCC\_part 15E RE\_Above 1GHz\_PK

EUT : W6M22409-23739

Test Mode : TX 802.11a CH189

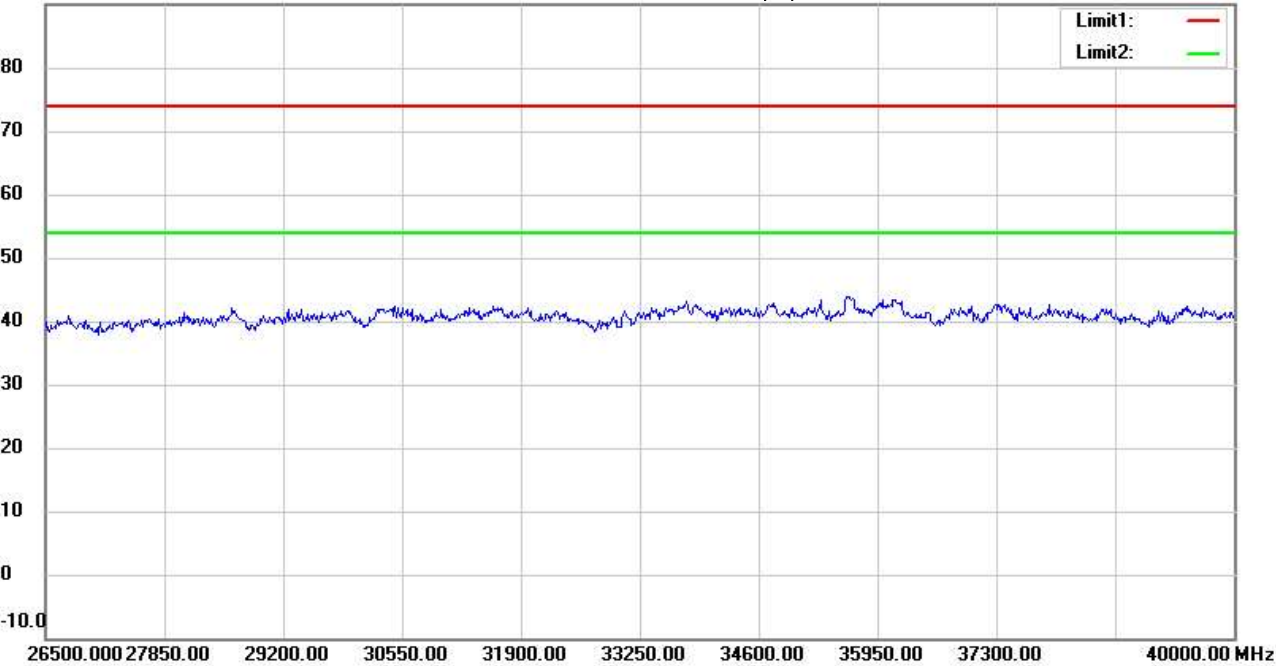
Site : 966A Chamber  
Condition : FCC\_part 15E RE\_Above 1GHz\_PK  
EUT : W6M22409-23739  
M/N:  
Test Mode : TX 802.11a CH229  
Note :

Polarization: Vertical  
Power : 120 Va.c.  
Distance: 3m

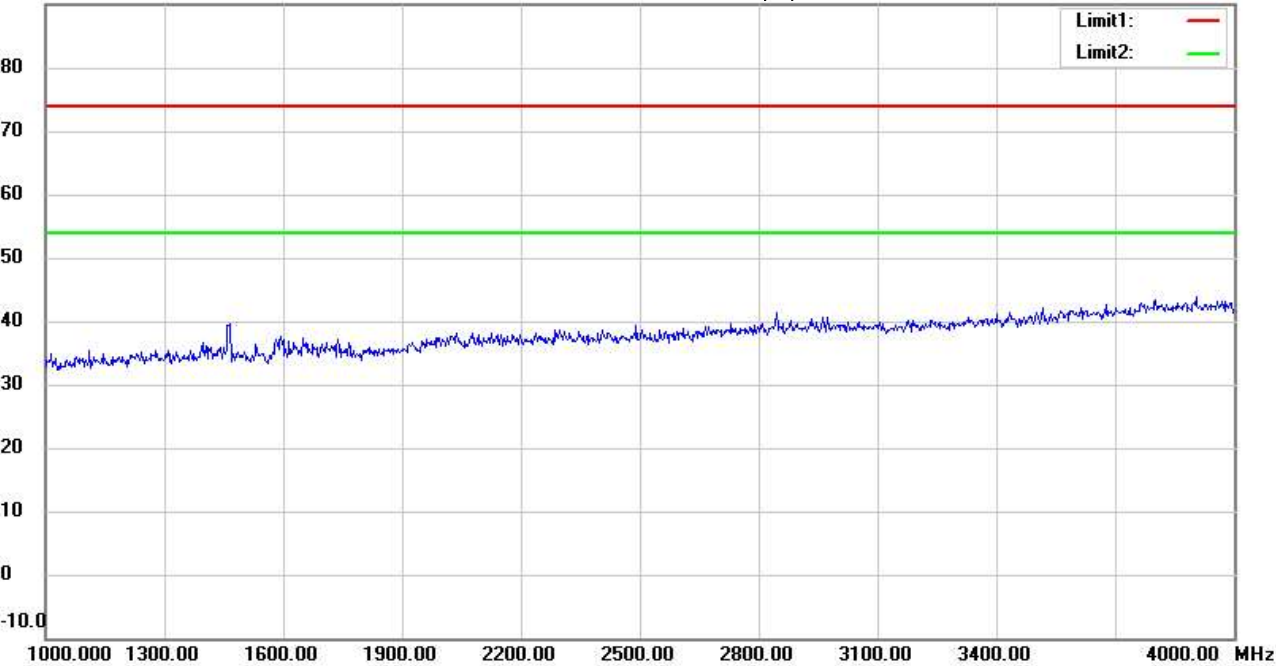
Site : 966A Chamber  
Condition : FCC\_part 15E RE\_Above 1GHz\_PK  
EUT : W6M22409-23739  
M/N:  
Test Mode : TX 802.11a CH189  
Note :

Polarization: Horizontal  
Power : 120 Va.c.  
Distance: 3m
