Radiated Emission Measurement

Condition : FCC\_part 15E RE\_Above 1GHz\_PK

EUT : W6M22409-23739

Test Mode : TX 802.11ax20 CH113

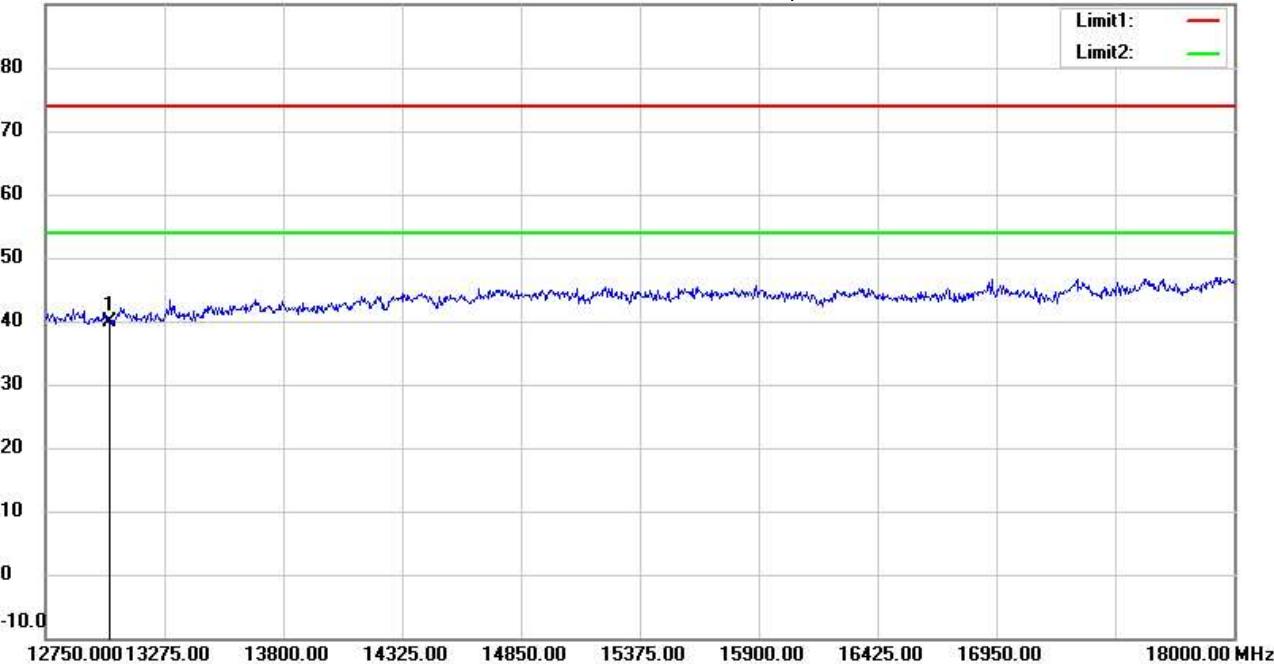
Data :#10

Polarization: Vertical

Distance: 3m

| Mk. | Frequency (MHz) | Reading (dBuV) | Detector | Corr. factor (dB/m) | Result (dBuV/m) | Limit (dBuV/m) | Ant.Pos (cm) | Tab.Pos (deg.) | Margin (dB) | Comment |
|---|---|---|---|---|---|---|---|---|---|---|
| * | 13030.000 | 22.79 | peak | 17.10 | 39.89 | 74.00 | 150 | 231 | -34.11 | |

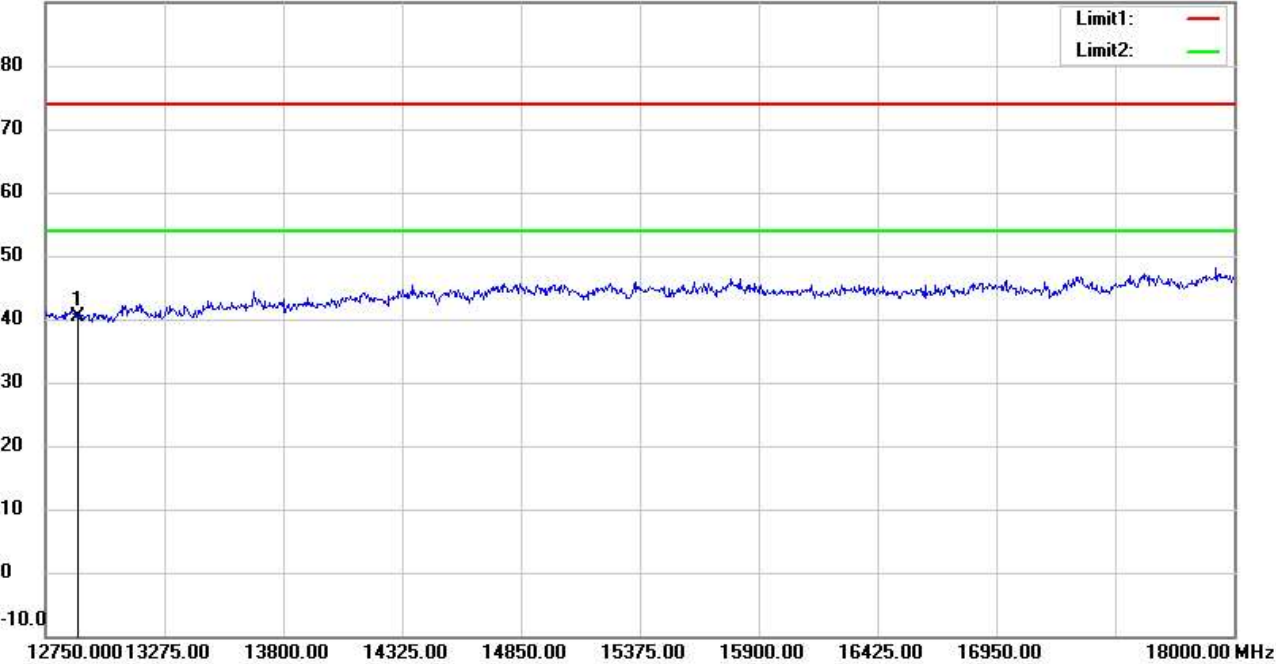
Data :#4

Condition : FCC\_part 15E RE\_Above 1GHz\_PK

Test Mode : TX 802.11ax40 CH99

Polarization: Horizontal

Distance: 3m

| Mk. | Frequency (MHz) | Reading (dBuV) | Detector | Corr. factor (dB/m) | Result (dBuV/m) | Limit (dBuV/m) | Ant.Pos (cm) | Tab.Pos (deg.) | Margin (dB) | Comment |
|---|---|---|---|---|---|---|---|---|---|---|
| * | 12890.000 | 22.97 | peak | 17.51 | 40.48 | 74.00 | 150 | 274 | -33.52 | |

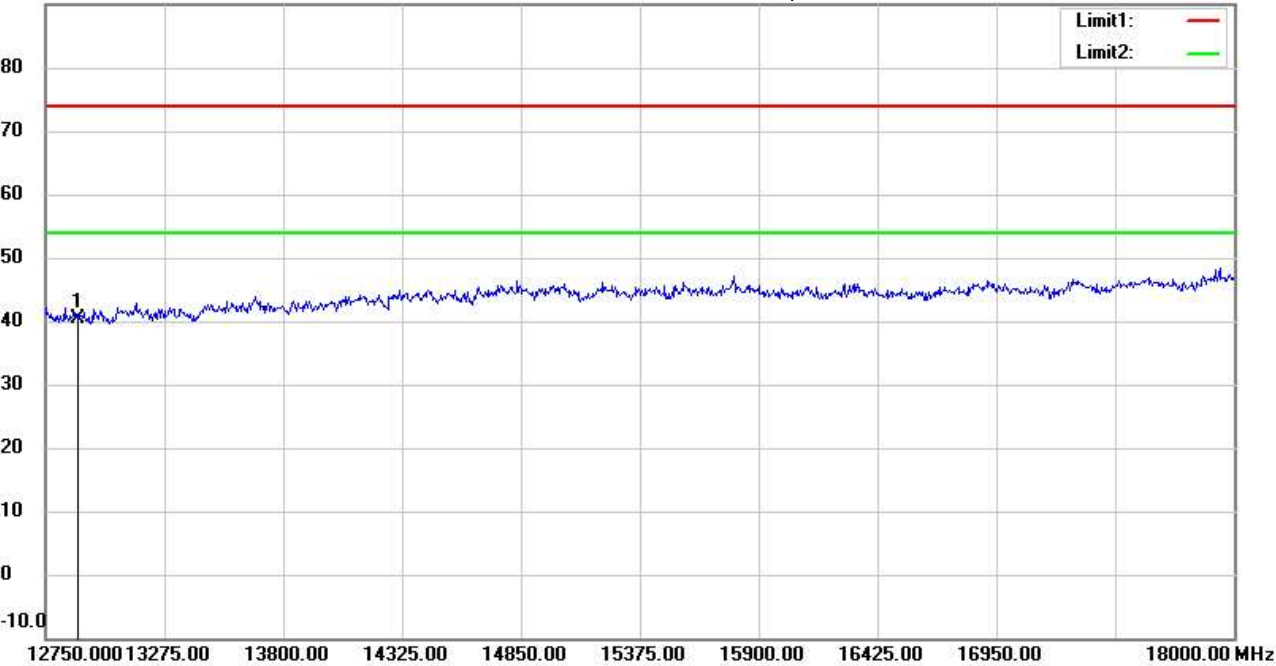
Data :#10

Condition : FCC\_part 15E RE\_Above 1GHz\_PK

Test Mode : TX 802.11ax40 CH99

Polarization: Vertical

Distance: 3m

| Mk. | Frequency (MHz) | Reading (dBuV) | Detector | Corr. factor (dB/m) | Result (dBuV/m) | Limit (dBuV/m) | Ant.Pos (cm) | Tab.Pos (deg.) | Margin (dB) | Comment |
|---|---|---|---|---|---|---|---|---|---|---|
| * | 12890.000 | 22.84 | peak | 17.51 | 40.35 | 74.00 | 150 | 359 | -33.65 | |

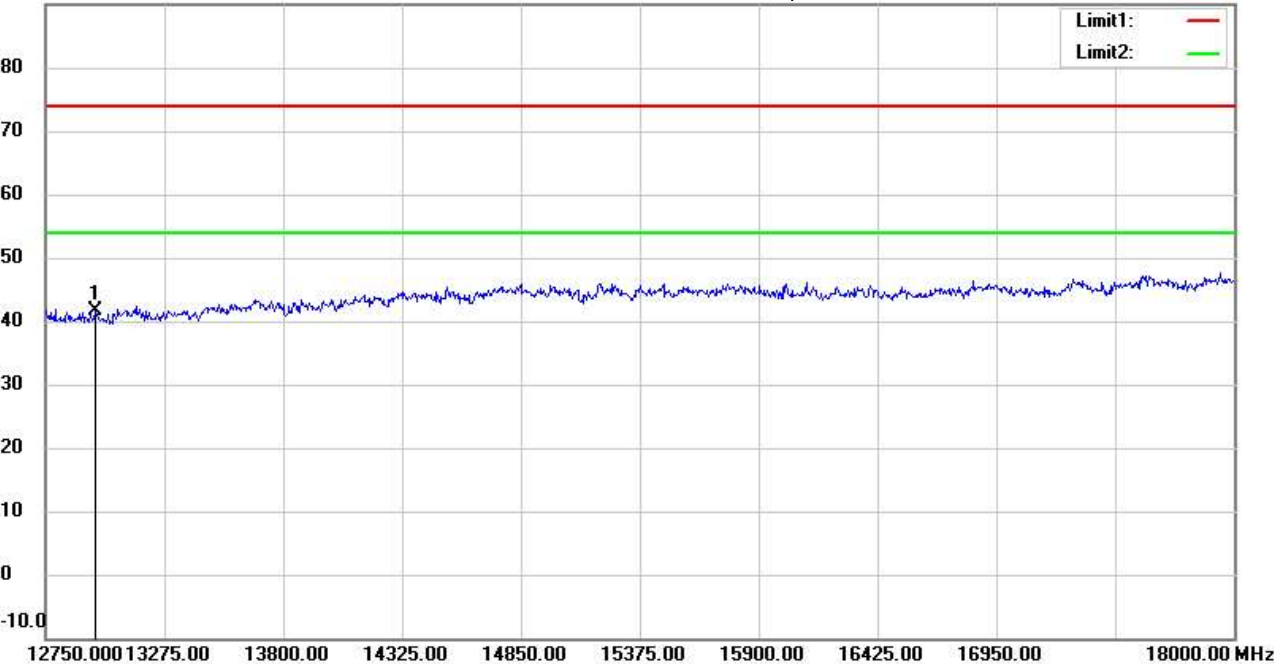
Data :#4

Condition : FCC\_part 15E RE\_Above 1GHz\_PK

Test Mode : TX 802.11ax40 CH107

Polarization: **Horizontal**

Distance: 3m

| Mk. | Frequency (MHz) | Reading (dBuV) | Detector | Corr. factor (dB/m) | Result (dBuV/m) | Limit (dBuV/m) | Ant.Pos (cm) | Tab.Pos (deg.) | Margin (dB) | Comment |
|---|---|---|---|---|---|---|---|---|---|---|
| * | 12970.000 | 24.42 | peak | 17.19 | 41.61 | 74.00 | 150 | 67 | -32.39 | |

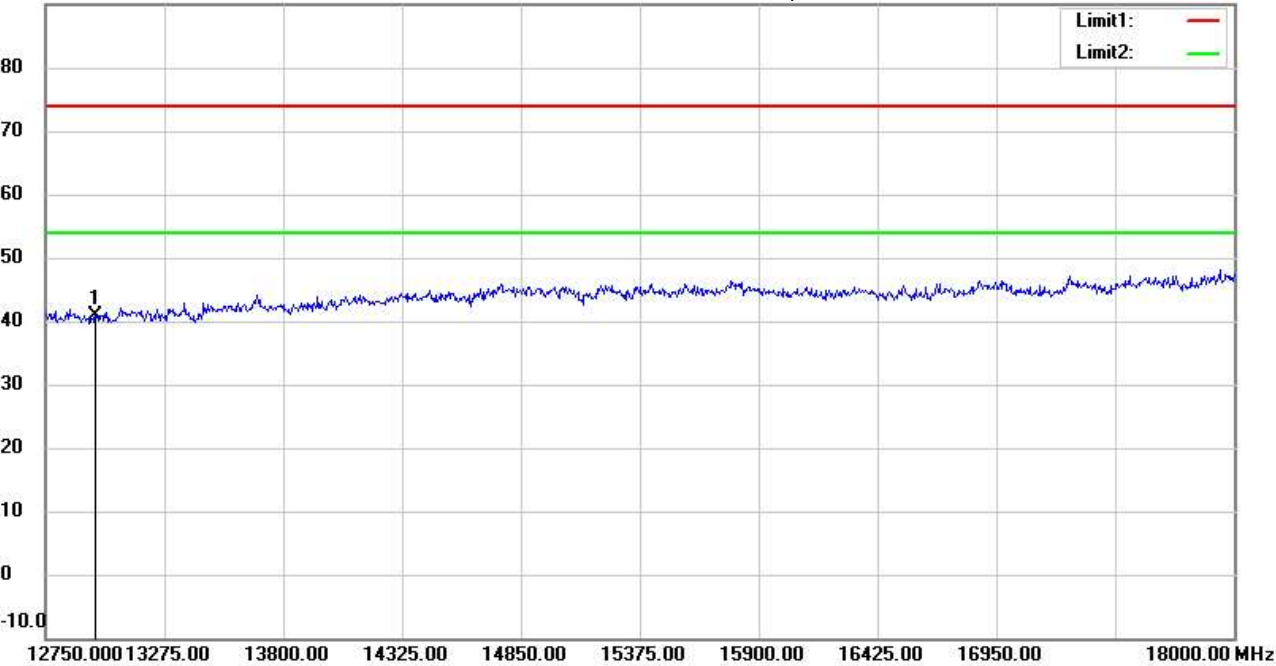
Data :#10

Condition : FCC\_part 15E RE\_Above 1GHz\_PK

Test Mode : TX 802.11ax40 CH107

Polarization: Vertical

Distance: 3m

| Mk. | Frequency (MHz) | Reading (dBuV) | Detector | Corr. factor (dB/m) | Result (dBuV/m) | Limit (dBuV/m) | Ant.Pos (cm) | Tab.Pos (deg.) | Margin (dB) | Comment |
|---|---|---|---|---|---|---|---|---|---|---|
| * | 12970.000 | 23.69 | peak | 17.19 | 40.88 | 74.00 | 150 | 150 | -33.12 | |
