## Appendix G: Conducted Spurious Emission Test Result

## Appendix H: Reference level measurement Test Result

## 14. TEST SETUP PHOTO

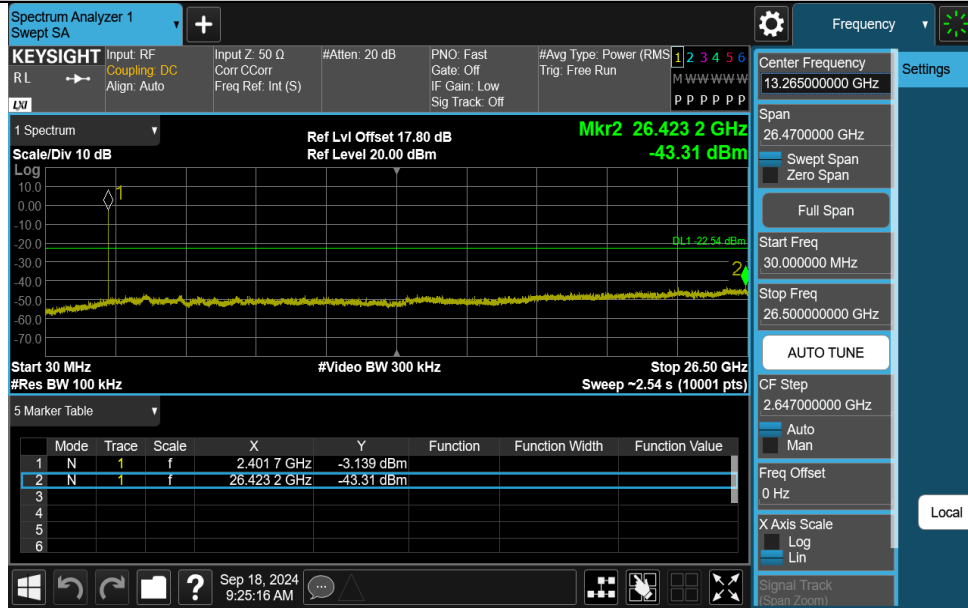
## DH5-Ant1-2402-30~26500-PASS

| TestMode | Antenna | Frequency[MHz] | FreqRange<br>[MHz] | RefLevel<br>[dBm] | Result<br>[dBm] | Limit<br>[dBm] | Verdict |
|---|---|---|---|---|---|---|---|
| DH5 | Ant1 | 2402 | 30~26500 | -2.54 | -43.31 | $\leq -22.54$ | PASS |

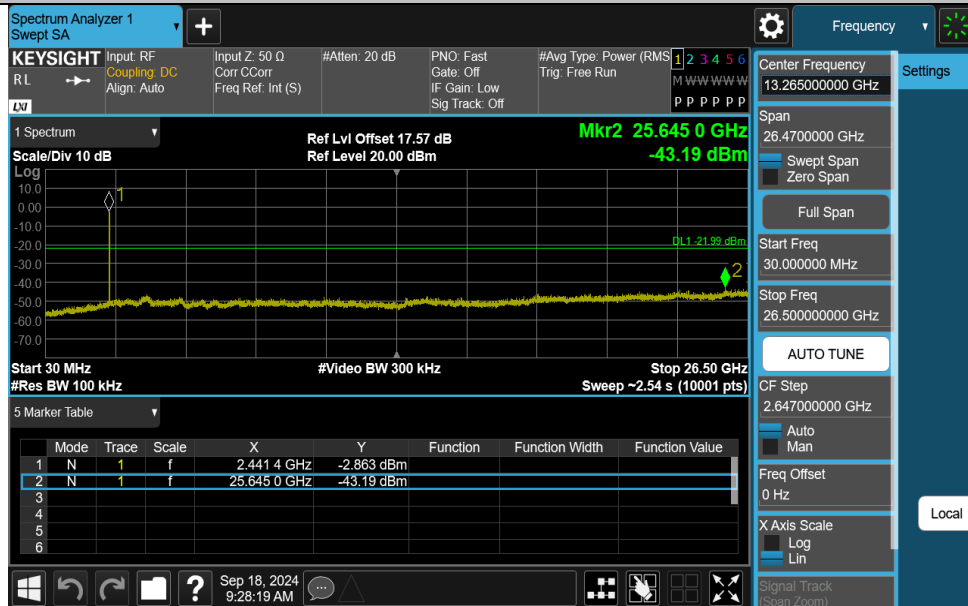
## DH5-Ant1-2441-30~26500-PASS

| TestMode | Antenna | Frequency[MHz] | FreqRange<br>[MHz] | RefLevel<br>[dBm] | Result<br>[dBm] | Limit<br>[dBm] | Verdict |
|---|---|---|---|---|---|---|---|
| DH5 | Ant1 | 2441 | 30~26500 | -1.99 | -43.19 | $\leq -21.99$ | PASS |

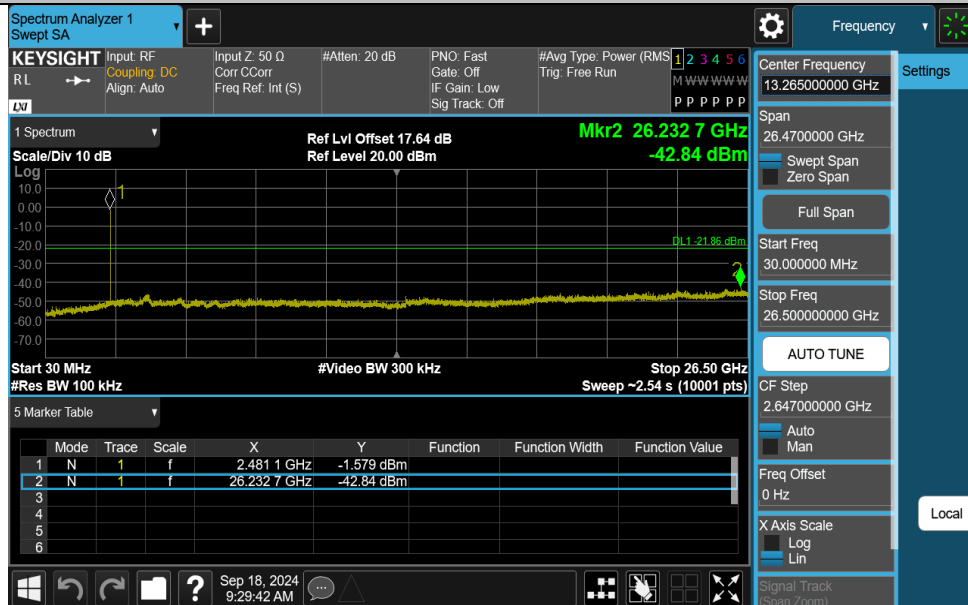
## DH5-Ant1-2480-30~26500-PASS

| TestMode | Antenna | Frequency[MHz] | FreqRange<br>[MHz] | RefLevel<br>[dBm] | Result<br>[dBm] | Limit<br>[dBm] | Verdict |
|---|---|---|---|---|---|---|---|
| DH5 | Ant1 | 2480 | 30~26500 | -1.86 | -42.84 | $\leq -21.86$ | PASS |

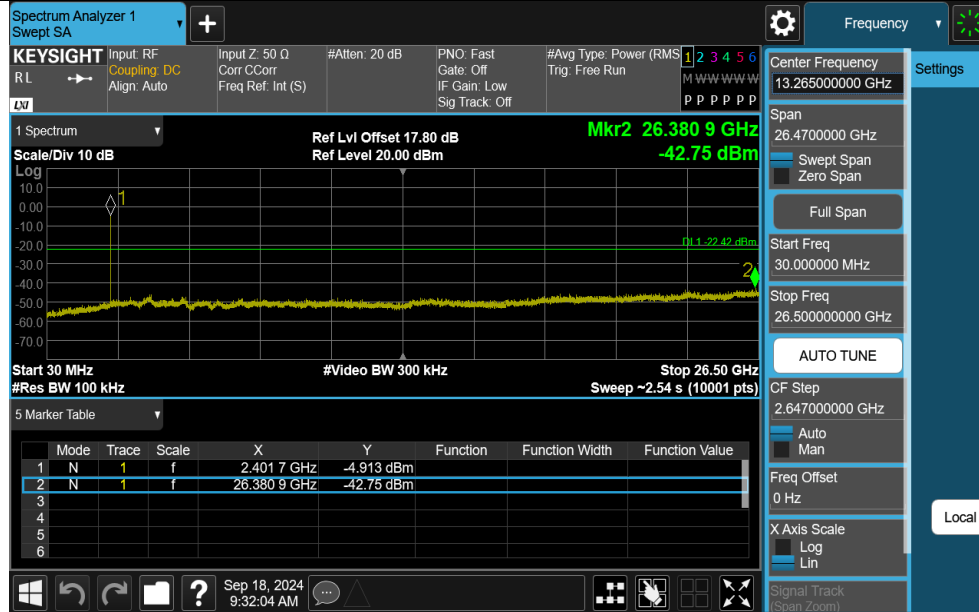
## 2DH5-Ant1-2402-30~26500-PASS

| TestMode | Antenna | Frequency[MHz] | FreqRange<br>[MHz] | RefLevel<br>[dBm] | Result<br>[dBm] | Limit<br>[dBm] | Verdict |
|---|---|---|---|---|---|---|---|
| 2DH5 | Ant1 | 2402 | 30~26500 | -2.42 | -42.75 | $\leq -22.42$ | PASS |

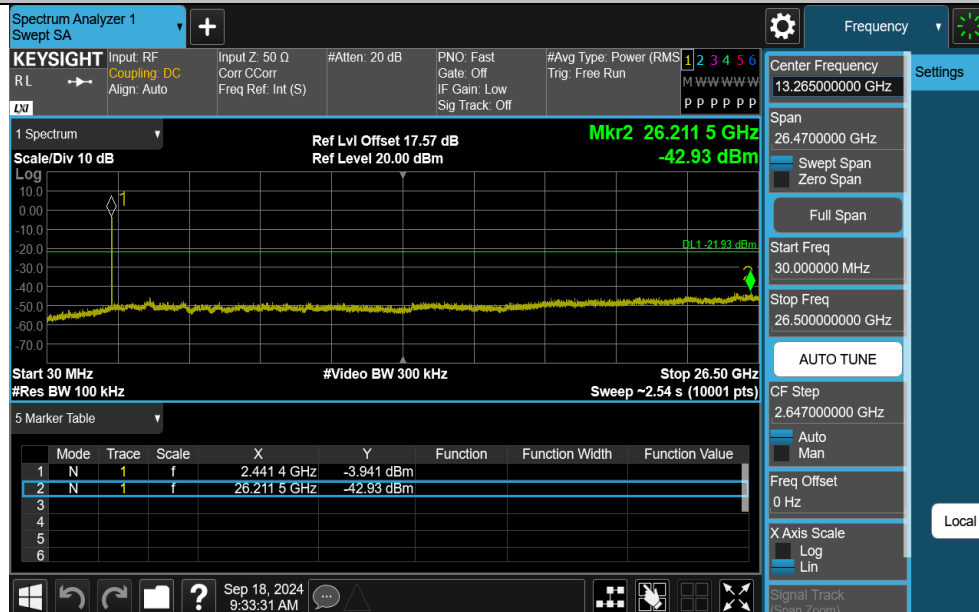
## 2DH5-Ant1-2441-30~26500-PASS

| TestMode | Antenna | Frequency[MHz] | FreqRange<br>[MHz] | RefLevel<br>[dBm] | Result<br>[dBm] | Limit<br>[dBm] | Verdict |
|---|---|---|---|---|---|---|---|
| 2DH5 | Ant1 | 2441 | 30~26500 | -1.93 | -42.93 | $\leq -21.93$ | PASS |

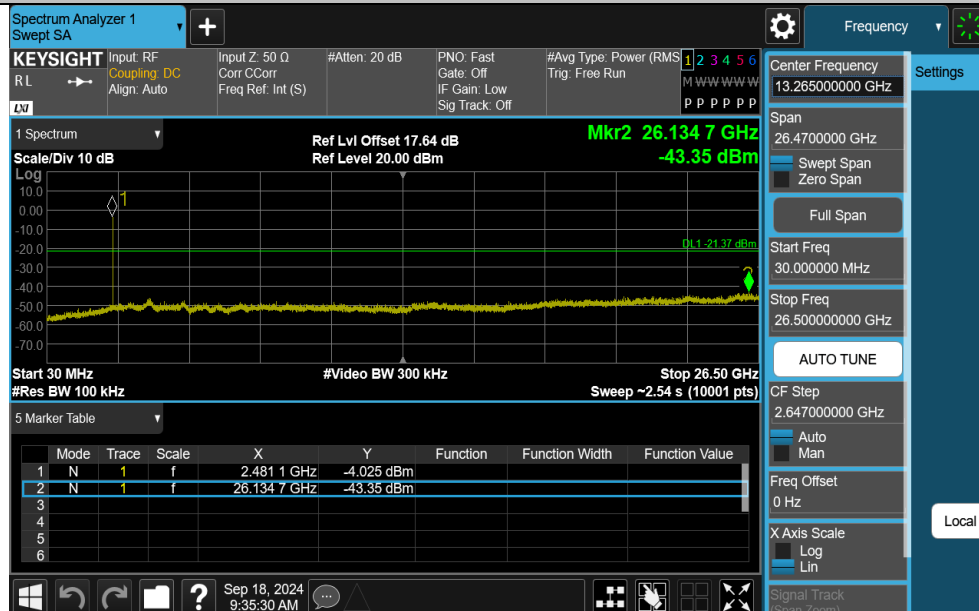
## 2DH5-Ant1-2480-30~26500-PASS

| TestMode | Antenna | Frequency[MHz] | FreqRange<br>[MHz] | RefLevel<br>[dBm] | Result<br>[dBm] | Limit<br>[dBm] | Verdict |
|---|---|---|---|---|---|---|---|
| 2DH5 | Ant1 | 2480 | 30~26500 | -1.37 | -43.35 | $\leq -21.37$ | PASS |

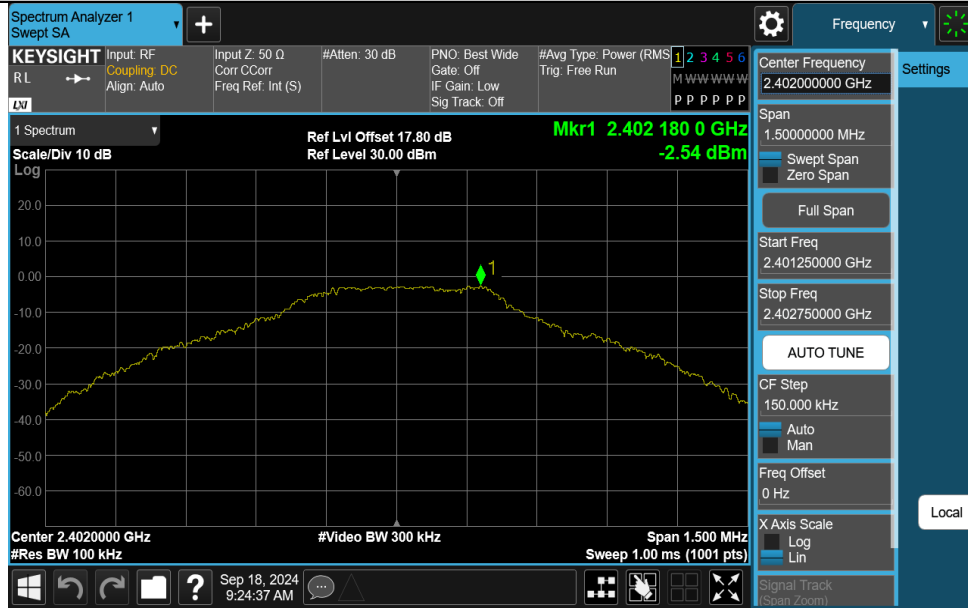
### DH5-Ant1-2402-PASS

| TestMode | Antenna | Freq(MHz) | Max.Point[MHz] | Result[dBm] |
|---|---|---|---|---|
| DH5 | Ant1 | 2402 | 2402.18 | -2.54 |

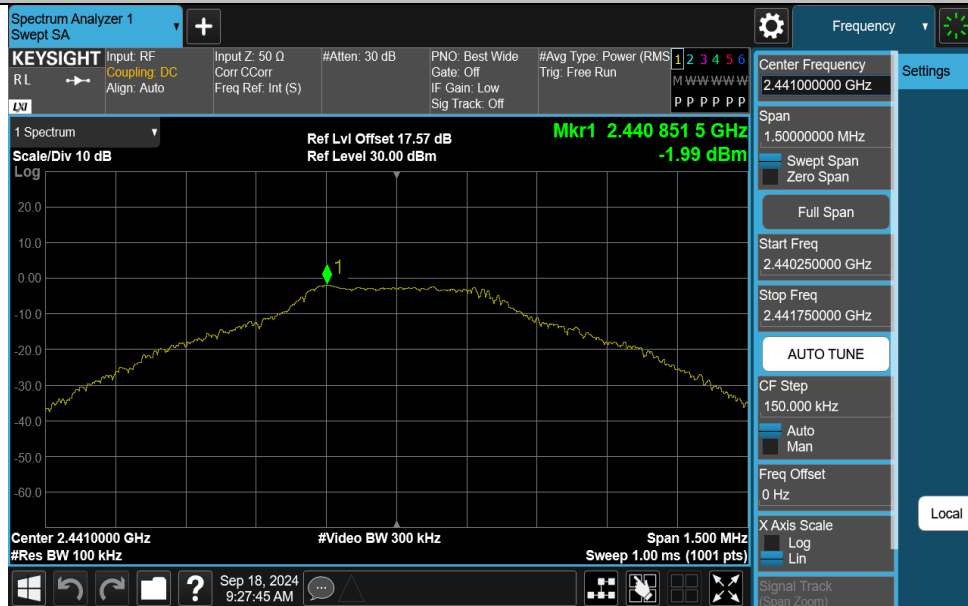
### DH5-Ant1-2441-PASS

| TestMode | Antenna | Freq(MHz) | Max.Point[MHz] | Result[dBm] |
|---|---|---|---|---|
| DH5 | Ant1 | 2441 | 2440.85 | -1.99 |

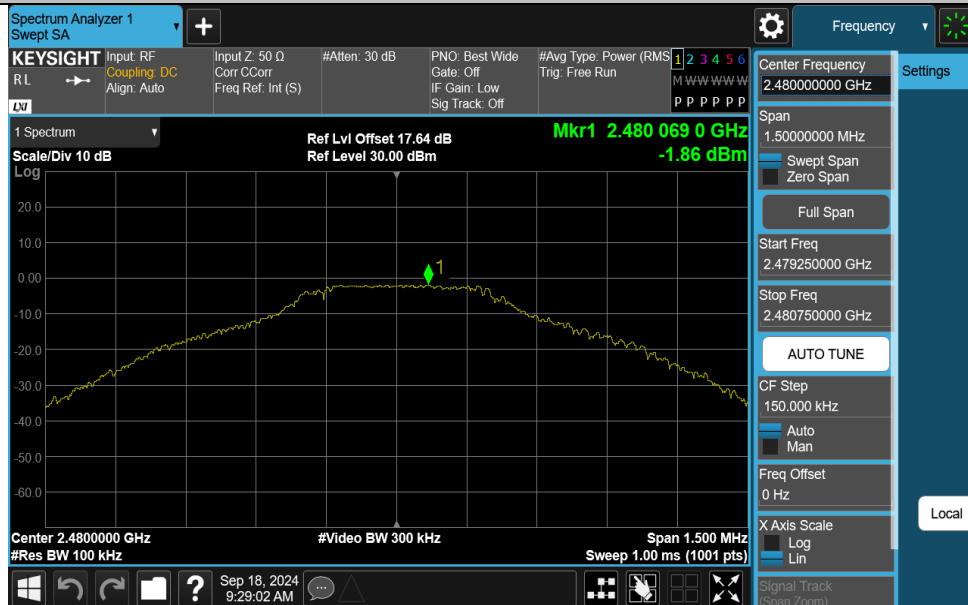
### DH5-Ant1-2480-PASS

| TestMode | Antenna | Freq(MHz) | Max.Point[MHz] | Result[dBm] |
|---|---|---|---|---|
| DH5 | Ant1 | 2480 | 2480.07 | -1.86 |

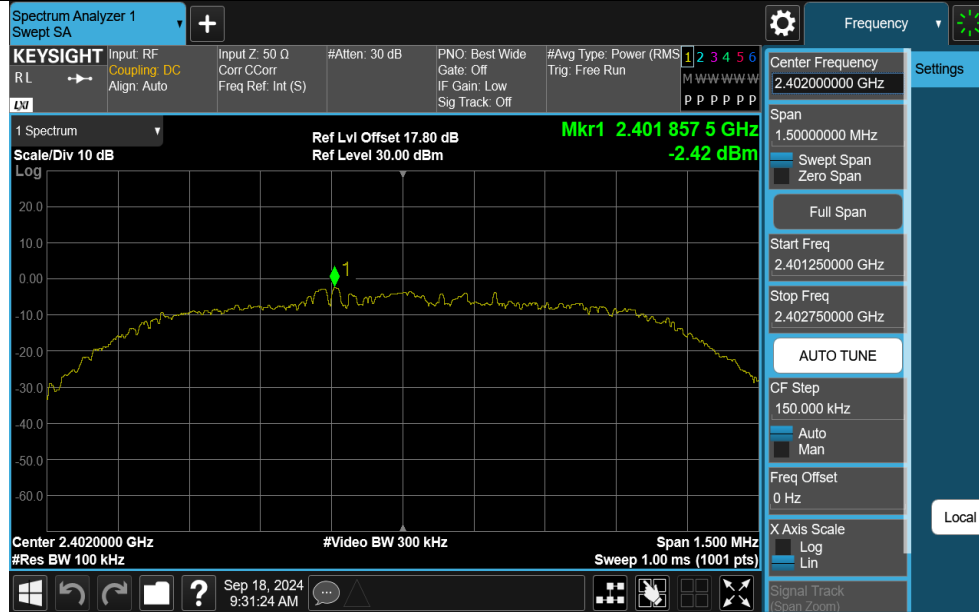
## 2DH5-Ant1-2402-PASS

| TestMode | Antenna | Freq(MHz) | Max.Point[MHz] | Result[dBm] |
|---|---|---|---|---|
| 2DH5 | Ant1 | 2402 | 2401.86 | -2.42 |

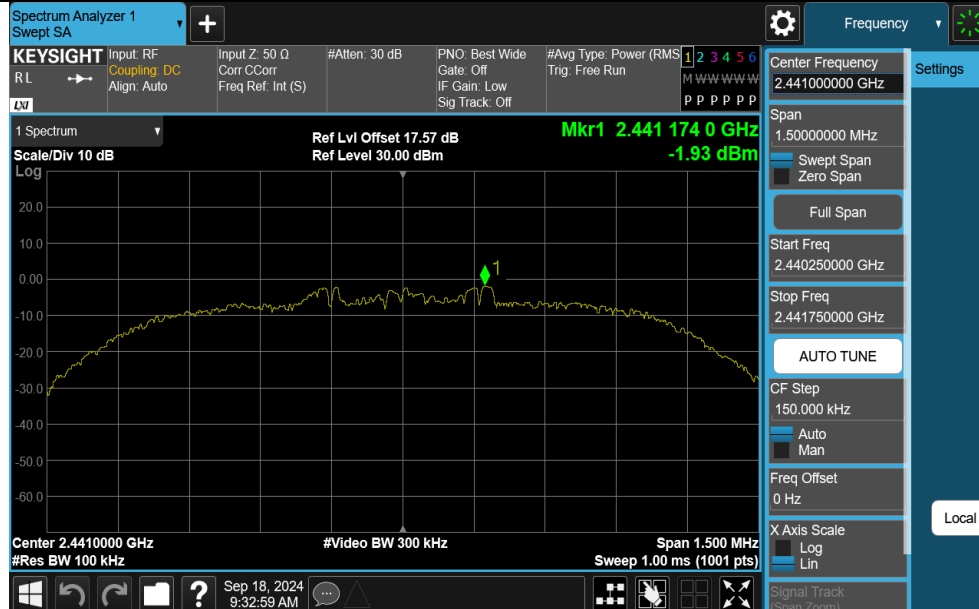
## 2DH5-Ant1-2441-PASS

| TestMode | Antenna | Freq(MHz) | Max.Point[MHz] | Result[dBm] |
|---|---|---|---|---|
| 2DH5 | Ant1 | 2441 | 2441.17 | -1.93 |

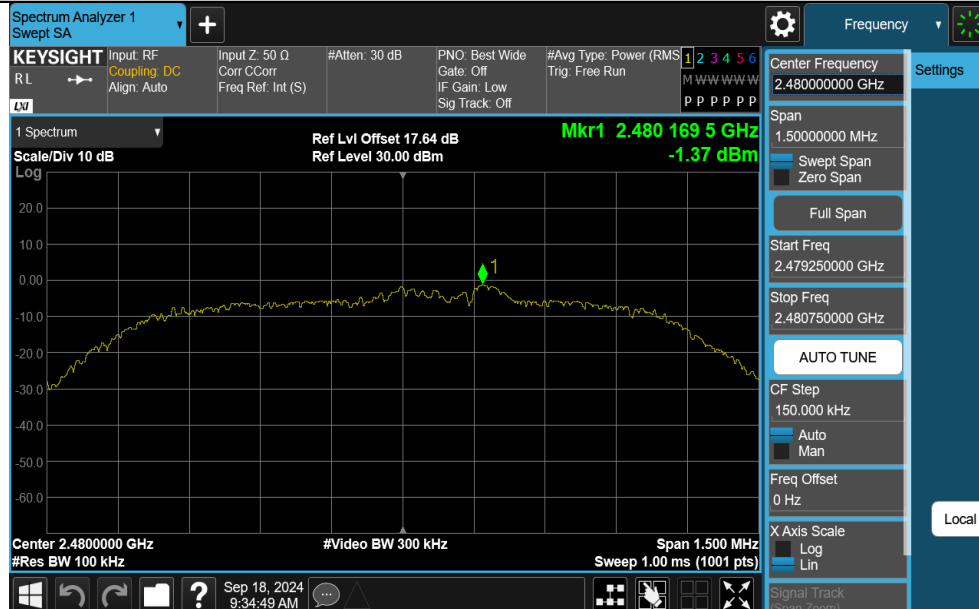
## 2DH5-Ant1-2480-PASS

| TestMode | Antenna | Freq(MHz) | Max.Point[MHz] | Result[dBm] |
|---|---|---|---|---|
| 2DH5 | Ant1 | 2480 | 2480.17 | -1.37 |
