ANNEX 1 - PLOTS OF MEASUREMENTS
TRANSIENT FREQUENCY BEHAVIOR

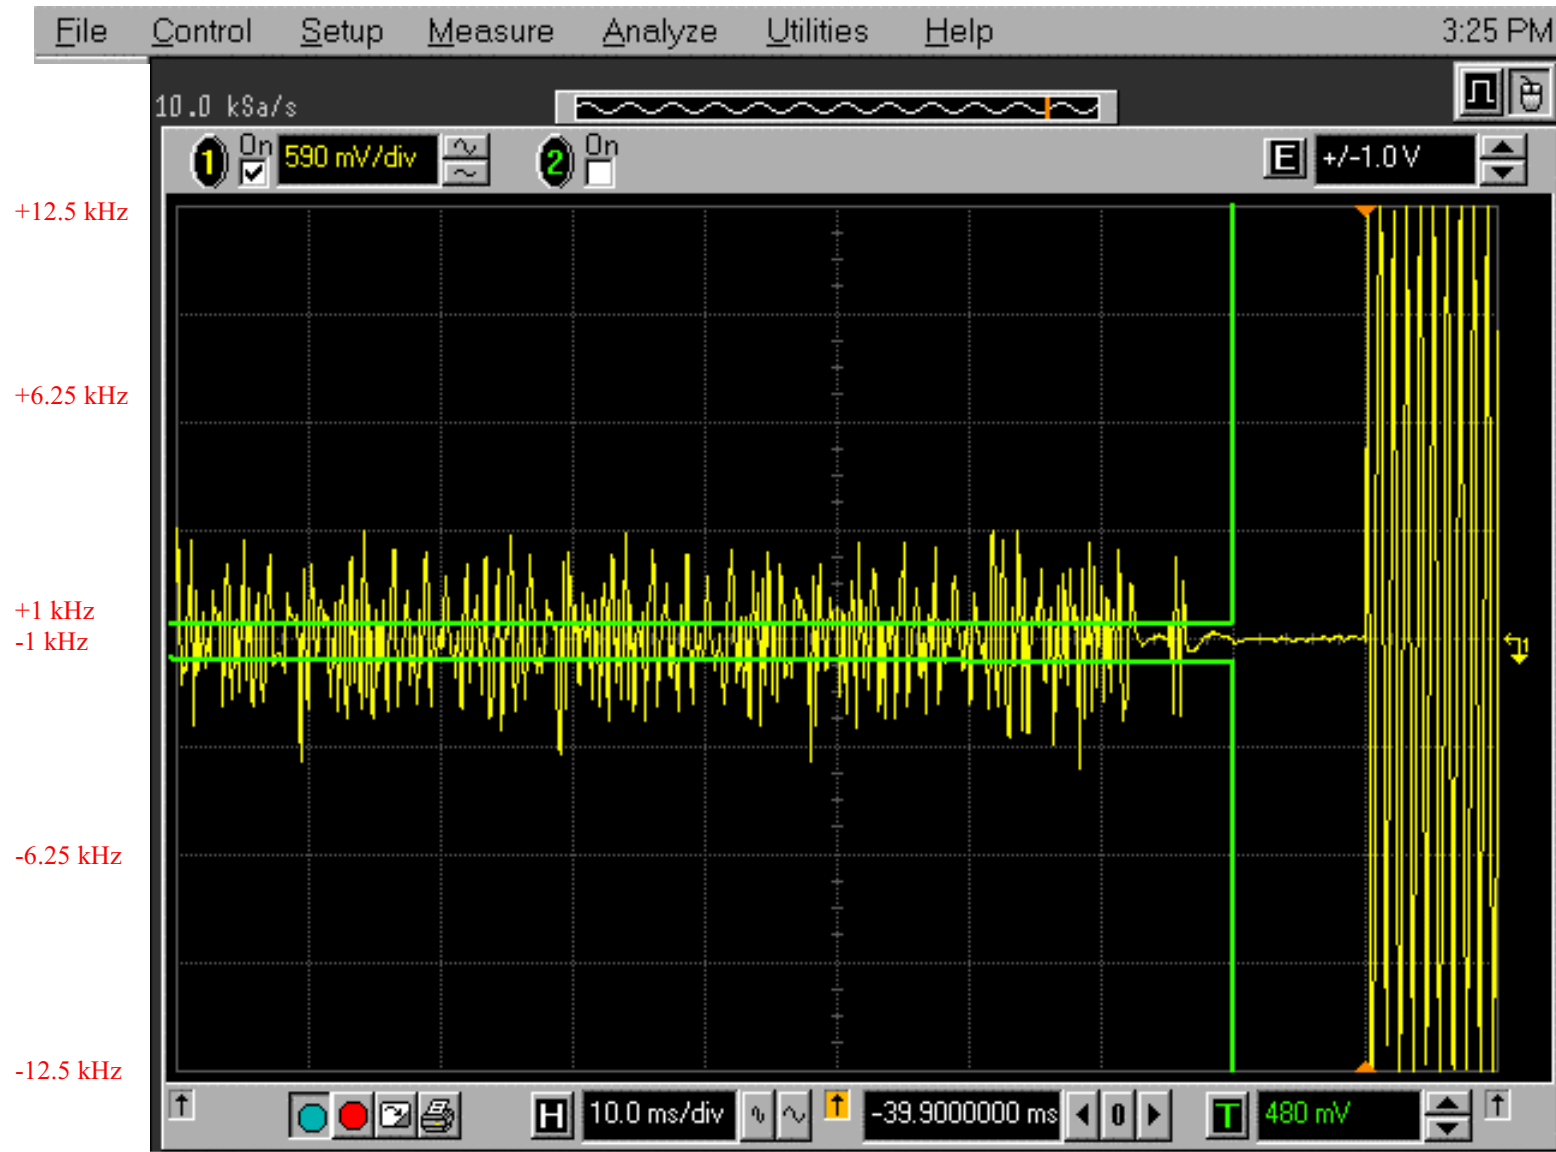
PLOT # 33

12.5 kHz Channel Spacing, Transmitter was being turned OFF, FM MODULATION with internal random data
