## Appendix A: Duty cycle Test Result

Test Report No.: EFGX20030111-IE-01-E01

Eurofins Electrical Testing Service (Shenzhen) Co., Ltd.

## Appendix B: 6dB bandwidth Test Result

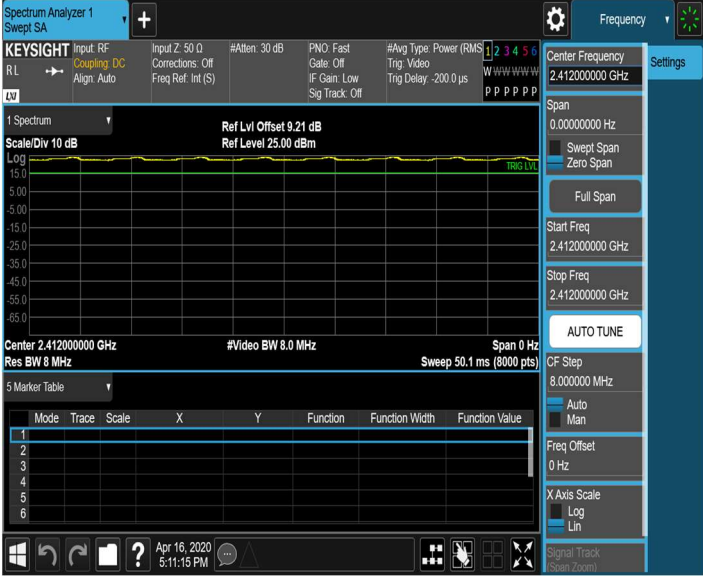
| <b>Result</b> | Duty Cycle:100%; Burst:50ms; Period:50ms |
| <b>Graph:</b> | <p>The screenshot shows a Keysight Spectrum Analyzer interface. The main display shows a flat spectrum line at 2.412 GHz with a level of 25.00 dBm. The interface includes various settings like Center Frequency, Span, and a Marker Table.</p> |

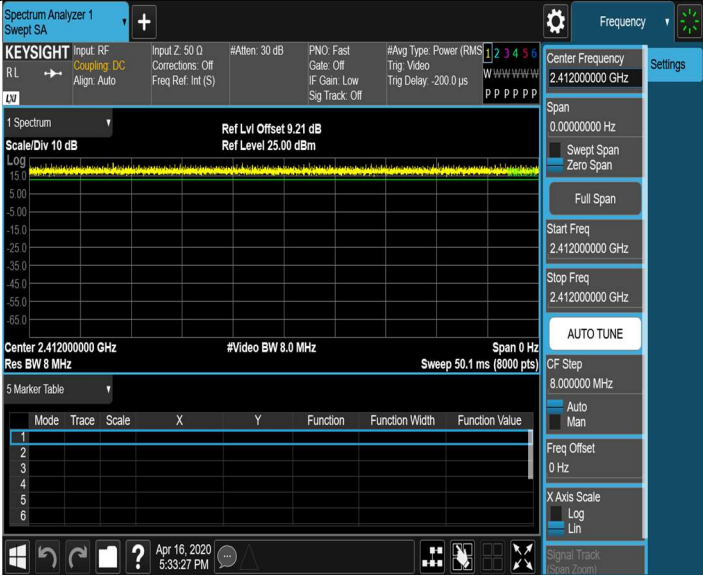
| <b>Graph:</b> | <p>The screenshot shows a Keysight Spectrum Analyzer interface. The main display shows a flat spectrum line at 2.412 GHz with a level of 25.00 dBm. The interface includes various settings like Center Frequency, Span, and a Marker Table.</p> |

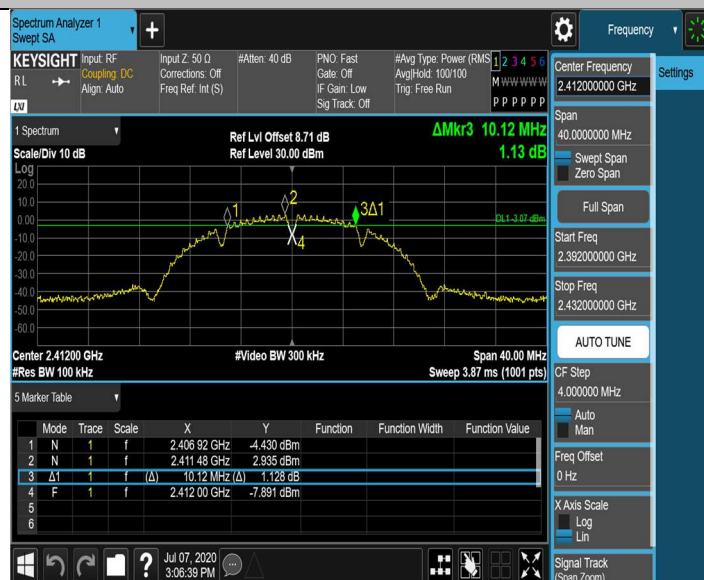
11B\_Ant1\_2412

| Test Mode | Antenna | Channel | DTS BW [MHz] | FL[MHz] | FH[MHz] | Limit[MHz] | Verdict |
|---|---|---|---|---|---|---|---|
| 11B | Ant1 | 2412 | 10.120 | 2406.920 | 2417.040 | $\geq 0.5$ | PASS |

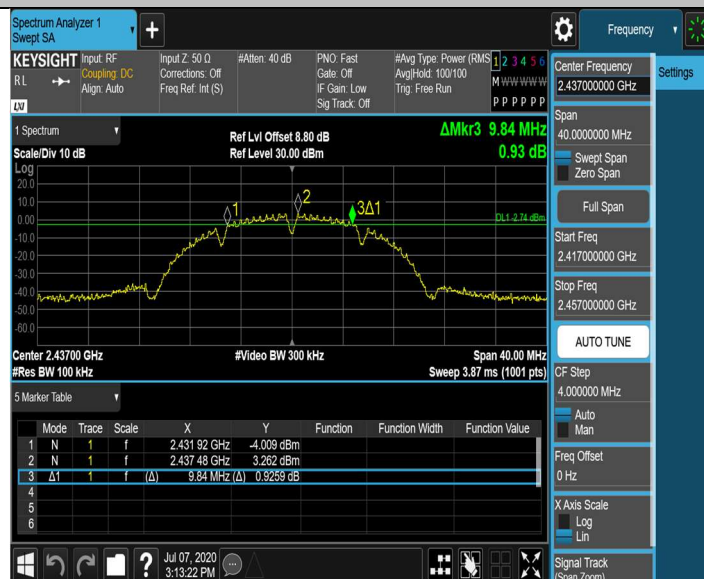
11B\_Ant1\_2437

| Test Mode | Antenna | Channel | DTS BW [MHz] | FL[MHz] | FH[MHz] | Limit[MHz] | Verdict |
|---|---|---|---|---|---|---|---|
| | | 2437 | 9.840 | 2431.920 | 2441.760 | $\geq 0.5$ | PASS |

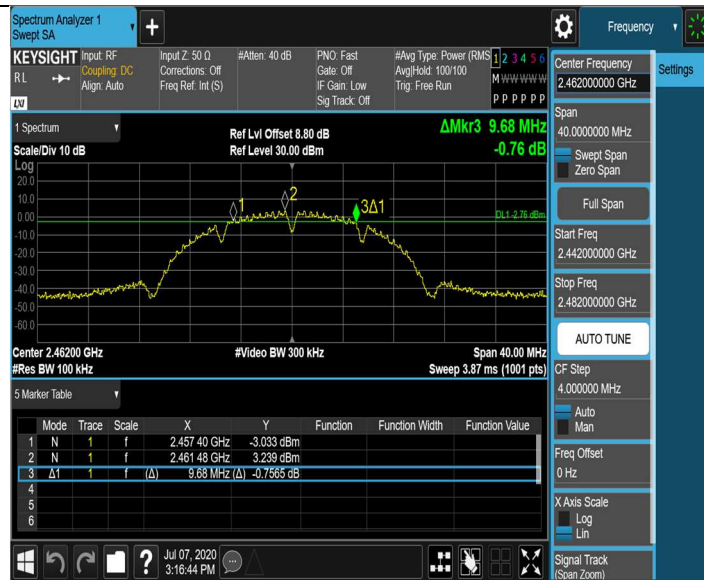
11B\_Ant1\_2462

| Test Mode | Antenna | Channel | DTS BW [MHz] | FL[MHz] | FH[MHz] | Limit[MHz] | Verdict |
|---|---|---|---|---|---|---|---|
| | | 2462 | 9.680 | 2457.400 | 2467.080 | $\geq 0.5$ | PASS |

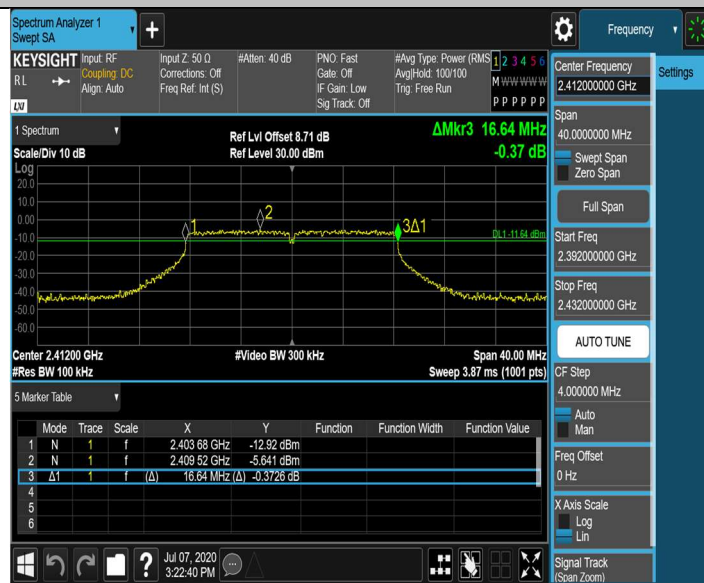
11G\_Ant1\_2412

| Test Mode | Antenna | Channel | DTS BW [MHz] | FL[MHz] | FH[MHz] | Limit[MHz] | Verdict |
|---|---|---|---|---|---|---|---|
| 11G | Ant1 | 2412 | 16.640 | 2403.680 | 2420.320 | $\geq 0.5$ | PASS |

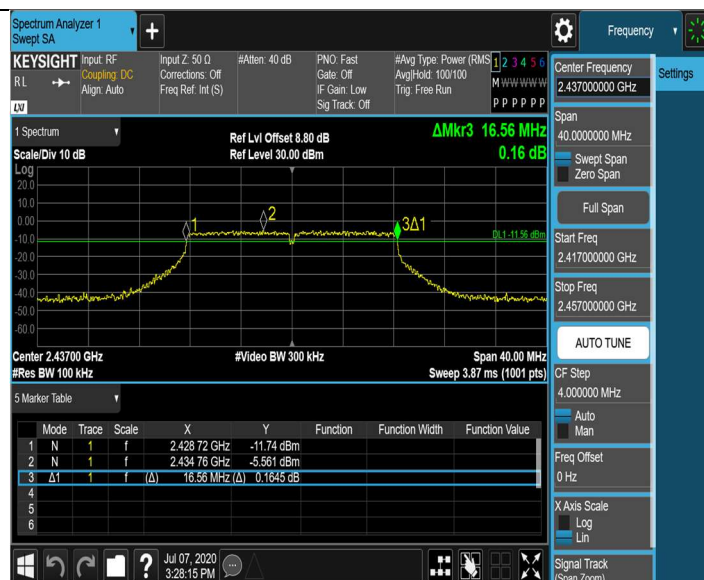
11G\_Ant1\_2437

| Test Mode | Antenna | Channel | DTS BW [MHz] | FL[MHz] | FH[MHz] | Limit[MHz] | Verdict |
|---|---|---|---|---|---|---|---|
| | | 2437 | 16.560 | 2428.720 | 2445.280 | $\geq 0.5$ | PASS |

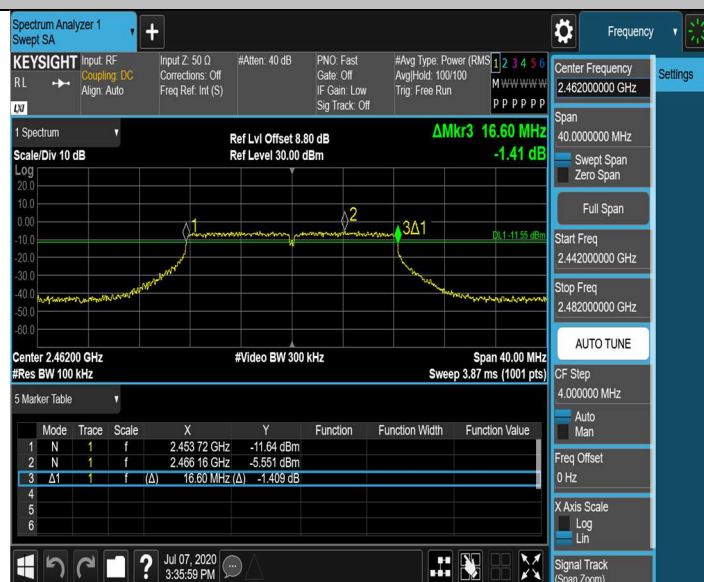
11G\_Ant1\_2462

| Test Mode | Antenna | Channel | DTS BW [MHz] | FL[MHz] | FH[MHz] | Limit[MHz] | Verdict |
|---|---|---|---|---|---|---|---|
| | | 2462 | 16.600 | 2453.720 | 2470.320 | $\geq 0.5$ | PASS |

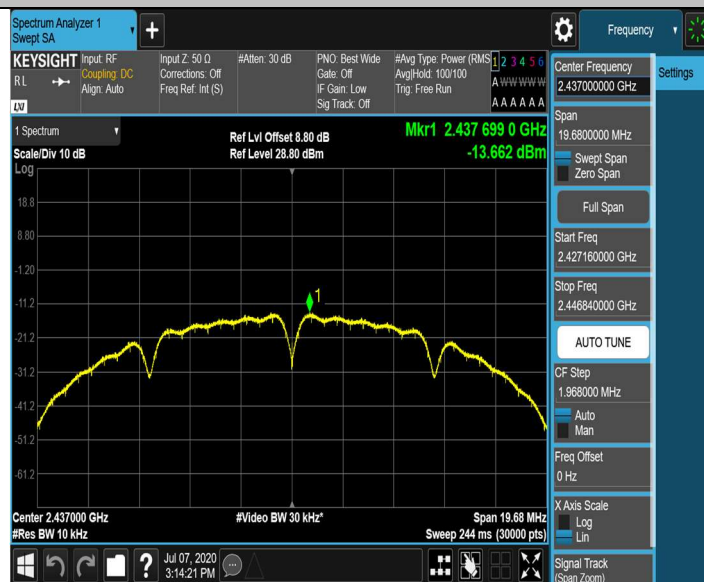
### 11B\_Ant1\_2437

| Test Mode | Antenna | Channel | Result [dBm/3-100kHz] | Limit [dBm/3kHz] | Verdict |
|---|---|---|---|---|---|
| | | 2437 | -13.66 | <=8 | PASS |

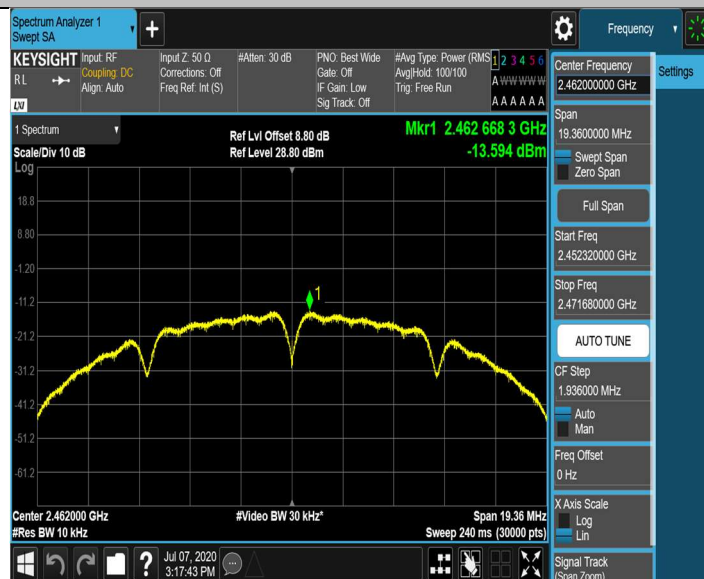
### 11B\_Ant1\_2462

| Test Mode | Antenna | Channel | Result [dBm/3-100kHz] | Limit [dBm/3kHz] | Verdict |
|---|---|---|---|---|---|
| | | 2462 | -13.59 | <=8 | PASS |

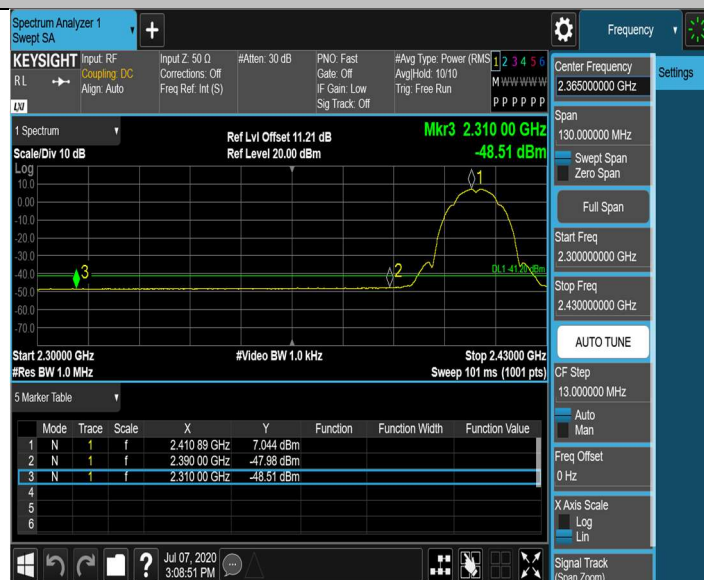
11B\_Ant1\_Low\_2412\_AV

| TestMode | Antenna | ChName | Channel | Detector | Freq<br>[MHz] | Result<br>[dBm] | Limit<br>[dBm] | Verdict |
|---|---|---|---|---|---|---|---|---|
| 11B | Ant1 | Low | 2412 | AV | 2310.000 | -48.51 | <=-41.20 | PASS |

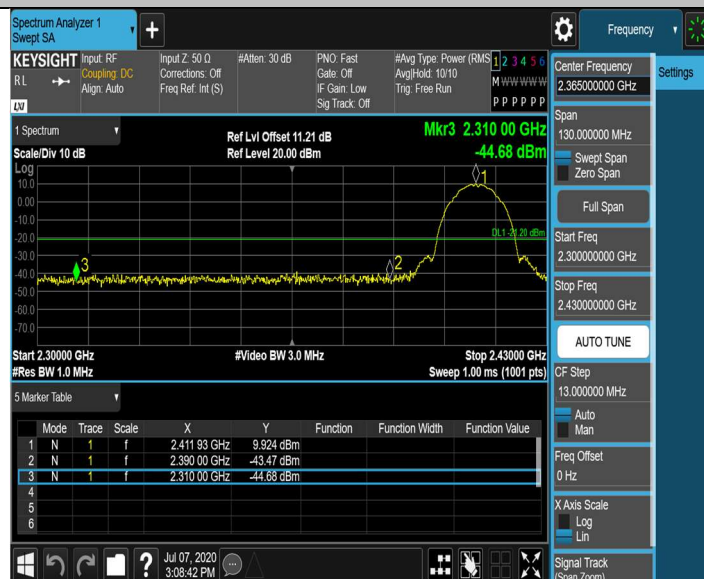
11B\_Ant1\_Low\_2412\_Peak

| TestMode | Antenna | ChName | Channel | Detector | Freq<br>[MHz] | Result<br>[dBm] | Limit<br>[dBm] | Verdict |
|---|---|---|---|---|---|---|---|---|
| | | | | Peak | 2310.000 | -44.68 | <=-21.20 | PASS |

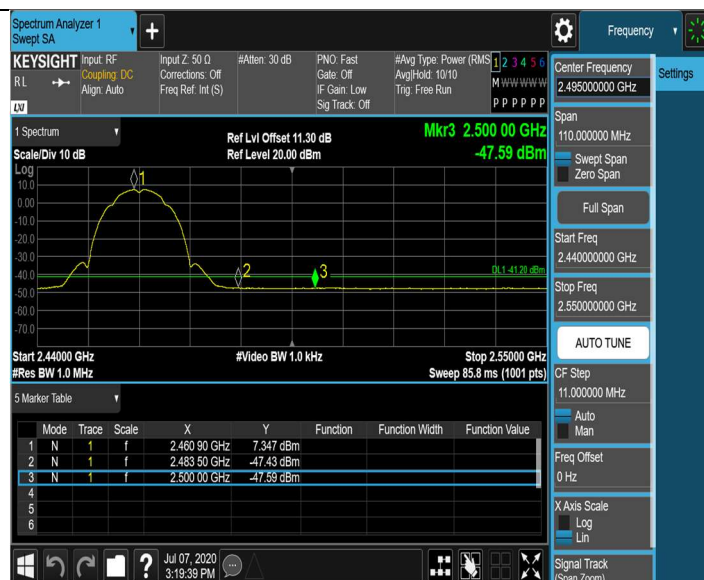
11B\_Ant1\_High\_2462\_AV

| TestMode | Antenna | ChName | Channel | Detector | Freq<br>[MHz] | Result<br>[dBm] | Limit<br>[dBm] | Verdict |
|---|---|---|---|---|---|---|---|---|
| | | High | 2462 | AV | 2483.500 | -47.43 | <=-41.20 | PASS |

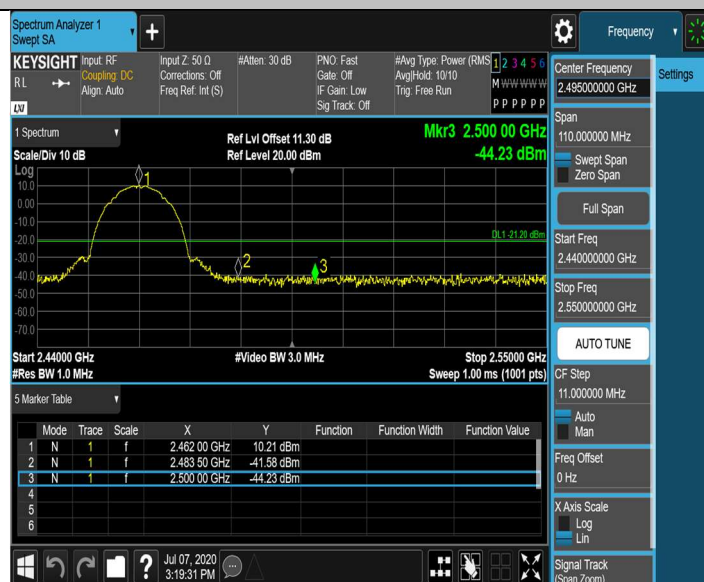
11B\_Ant1\_High\_2462\_Peak

| TestMode | Antenna | ChName | Channel | Detector | Freq<br>[MHz] | Result<br>[dBm] | Limit<br>[dBm] | Verdict |
|---|---|---|---|---|---|---|---|---|
| | | | | Peak | 2483.500 | -41.58 | <=-21.20 | PASS |
