### **APPENDIX 3: Photographs of test setup**

#### **Radiated Spurious Emission**

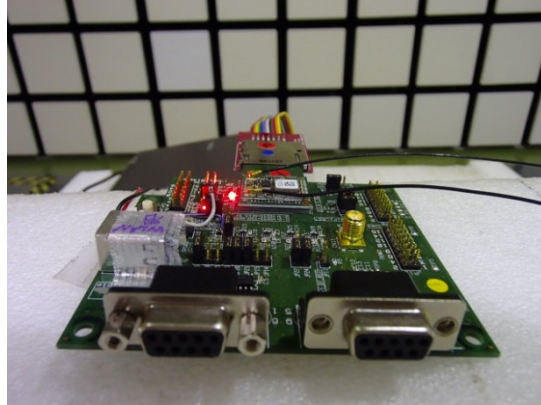
**X-axis**

**Worst Case Position (Horizontal: X-axis/ Vertical:X-axis)**

**Module**

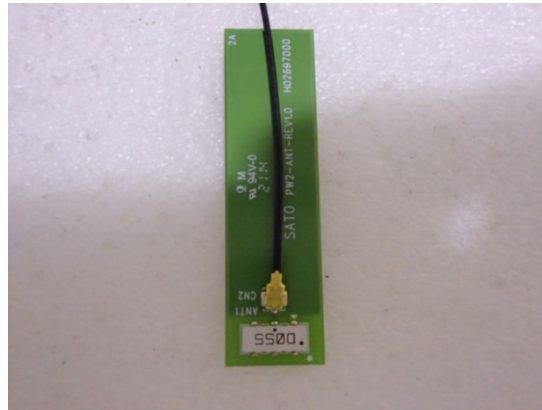
**Ant  
X-axis**

**Worst Case Position**  
**(Horizontal: X-axis/ Vertical:X-axis below 1GHz)**  
**(Horizontal: Z-axis/ Vertical:Y-axis above 1GHz)**
