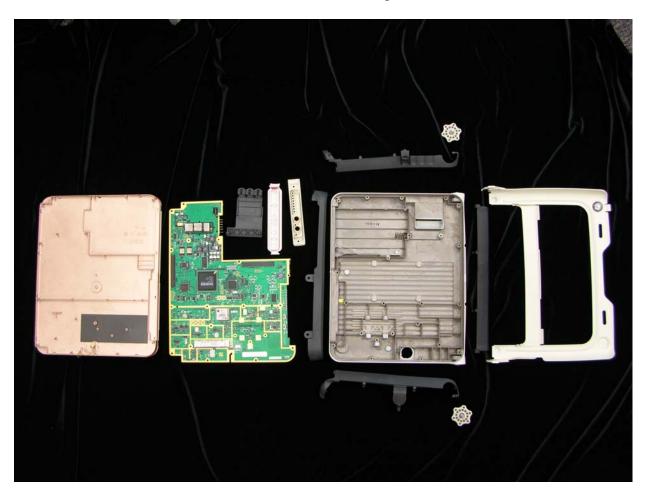
This picture shows the EUT dis-assembled into its main parts. The 4 main components are (starting from the left) the satellite antenna, PCB, bottom housing, stand. The PCB is sandwiched between the main antenna and bottom housing.

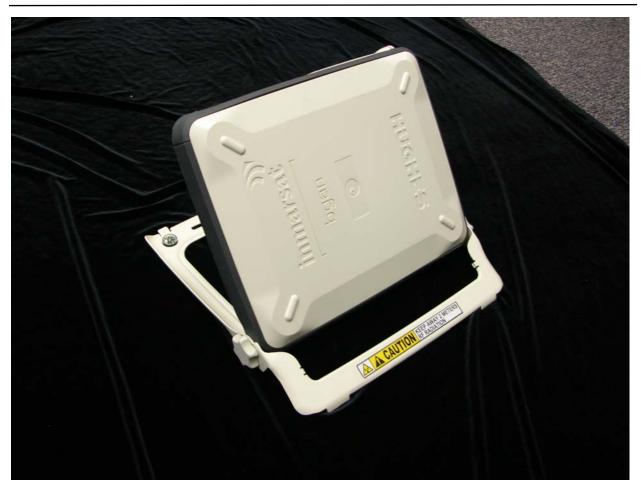
This picture shows the EUT positioned in its normal operating position, with the stand deployed. The internal antenna is the surface facing the user, and is pointing to the satellite.

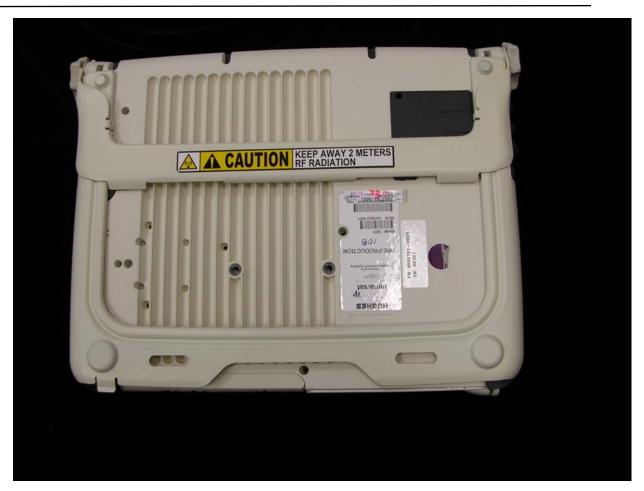
This picture shows the UT with its stand stowed, ready for transportation.
