### **APPENDIX 3: Photographs of test setup**

#### **Radiated Emission**

**Radiated Emission**  
**Worst Case Position**

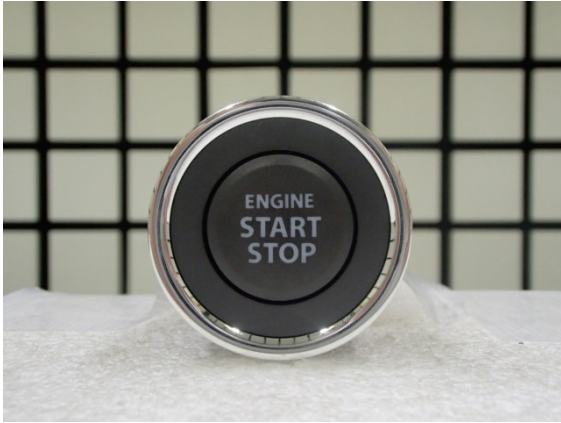
**Push Start Switch**

Below 30MHz: X  
Above 30MHz: Horizontal X, Vertical X  
X-axis

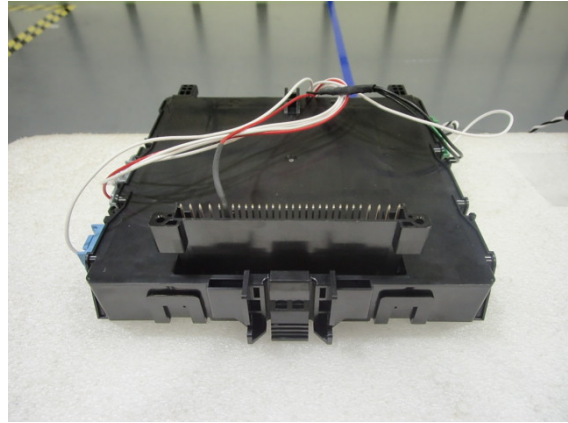
**ECU**

Below 30MHz: X  
Above 30MHz: Horizontal X, Vertical X  
X-axis

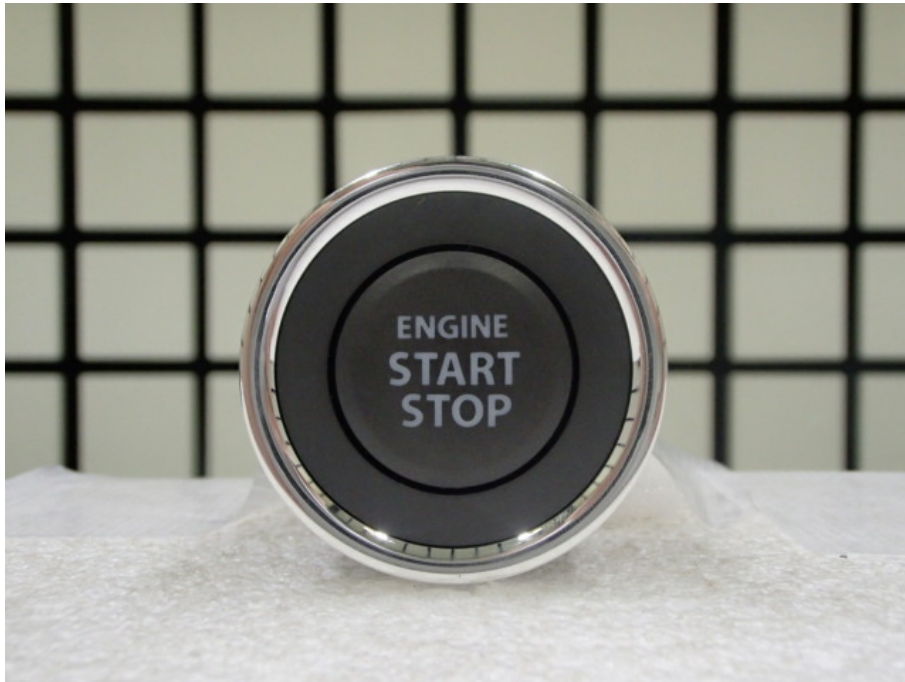
**Worst case position**

**Without Mechanical Key (Worst)**

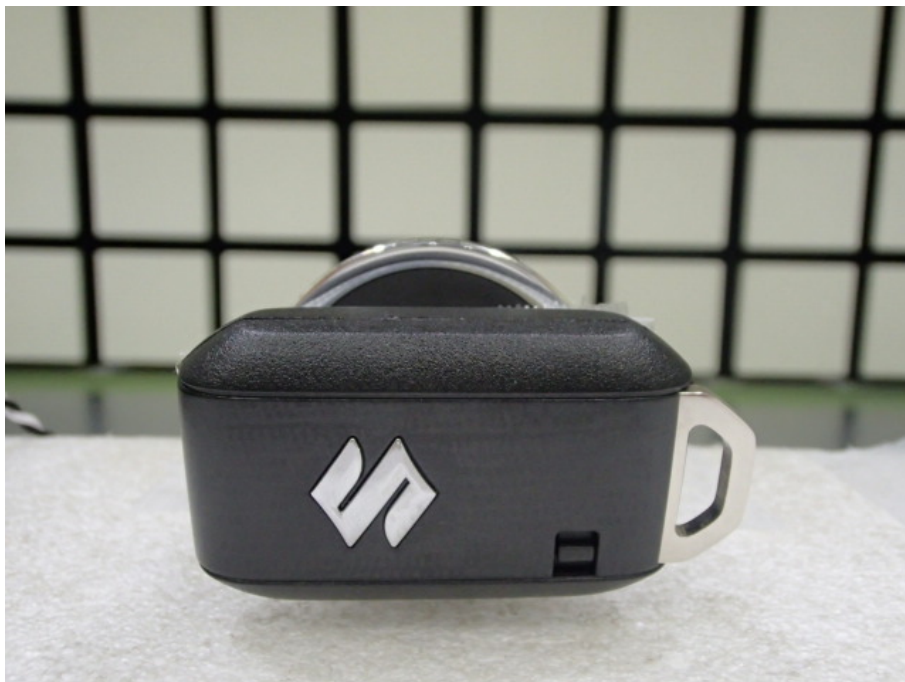
**With Mechanical Key**
