## 10.7 APPENDIX: CONDUCTED SPURIOUS EMISSION

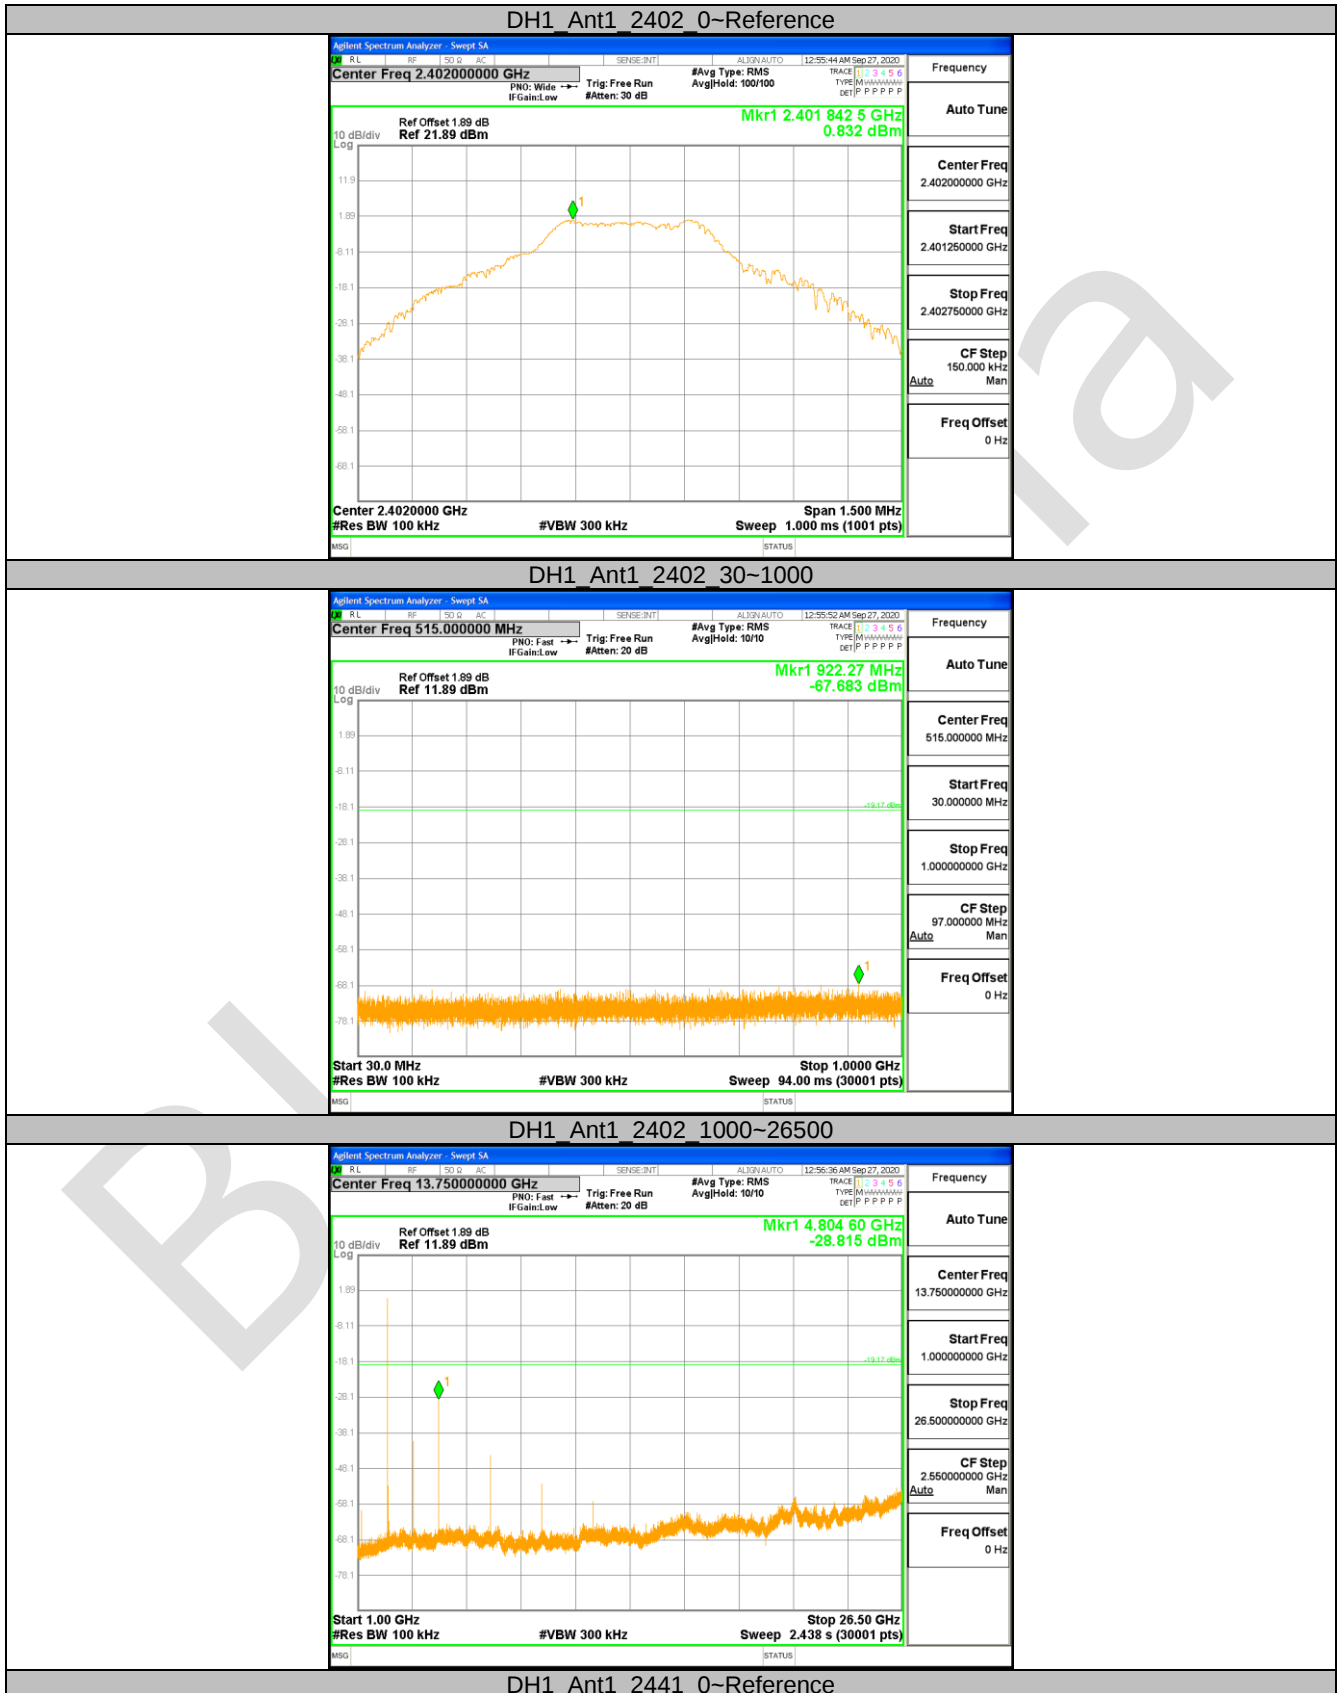
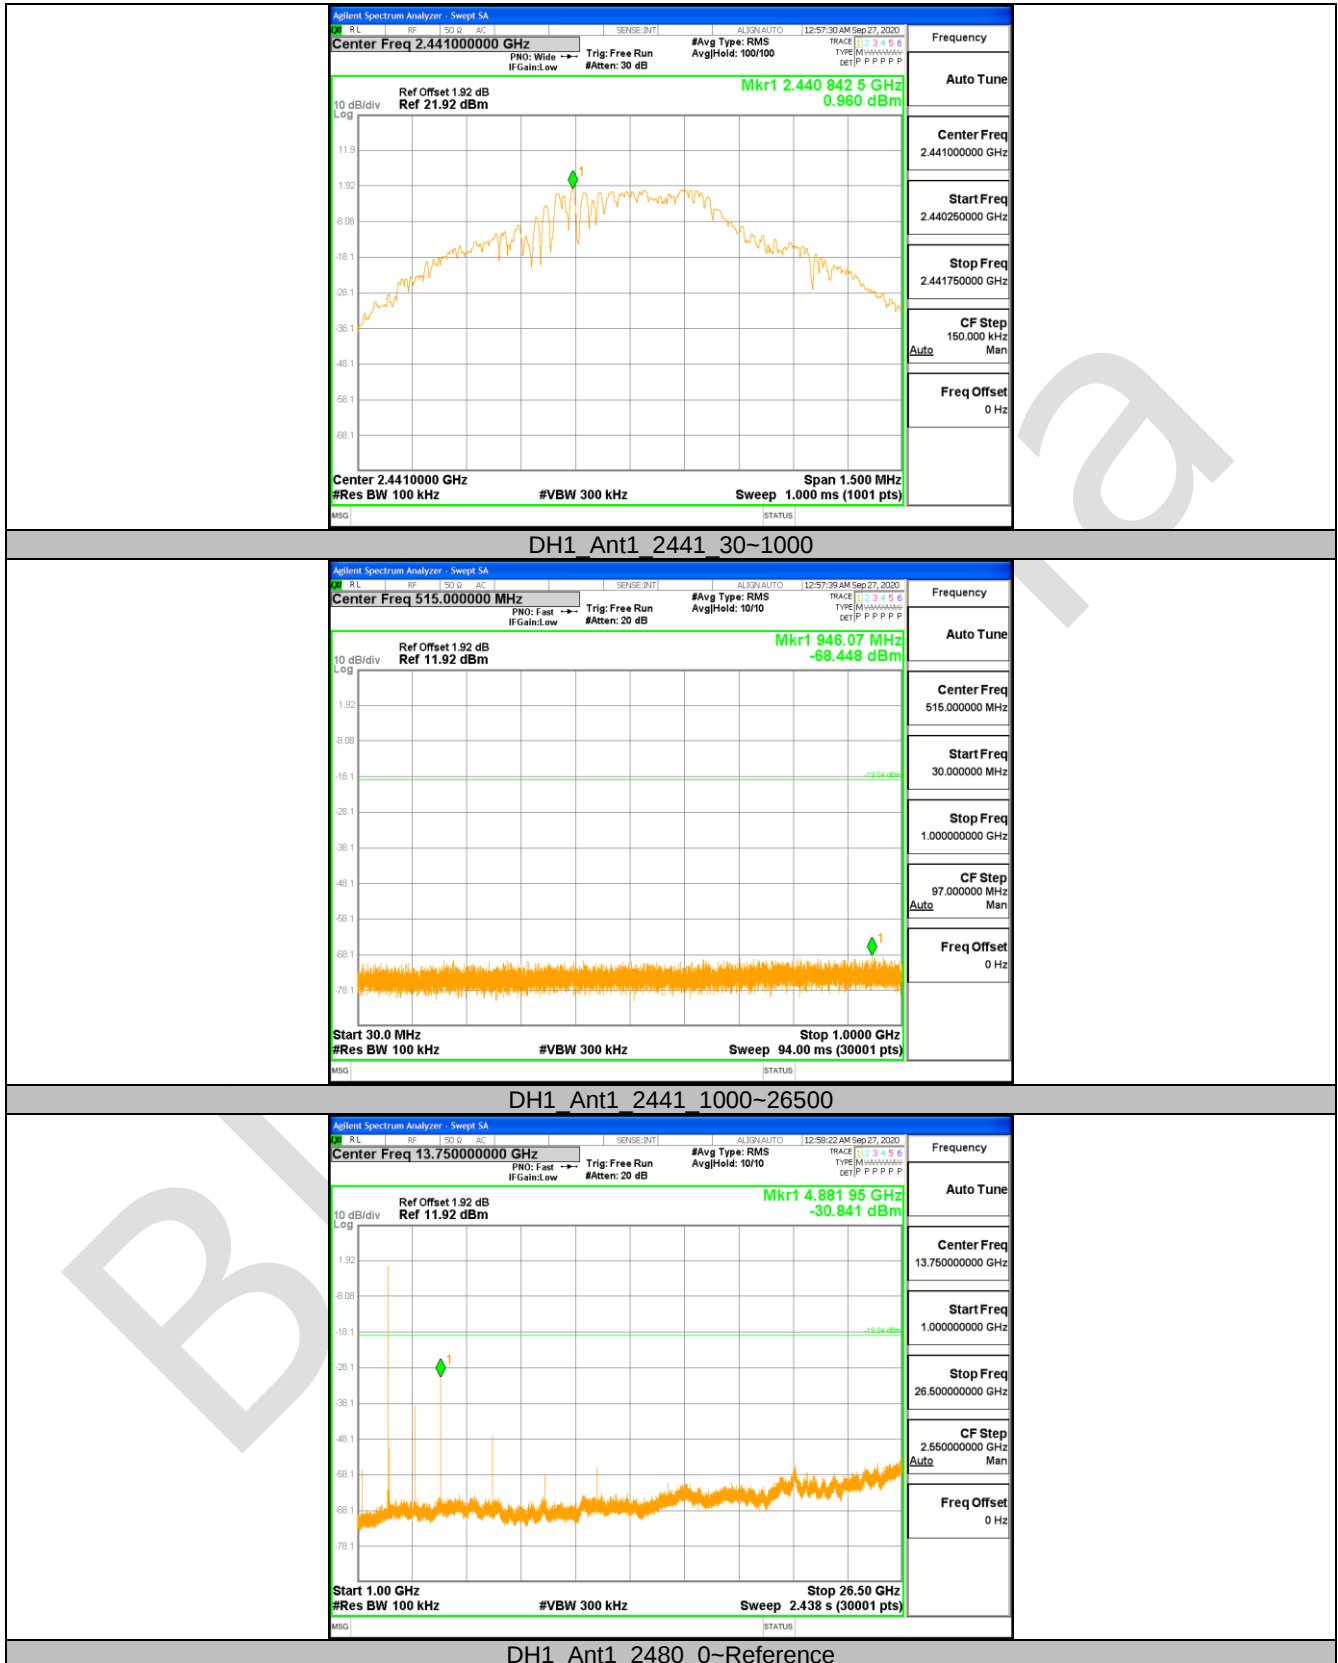
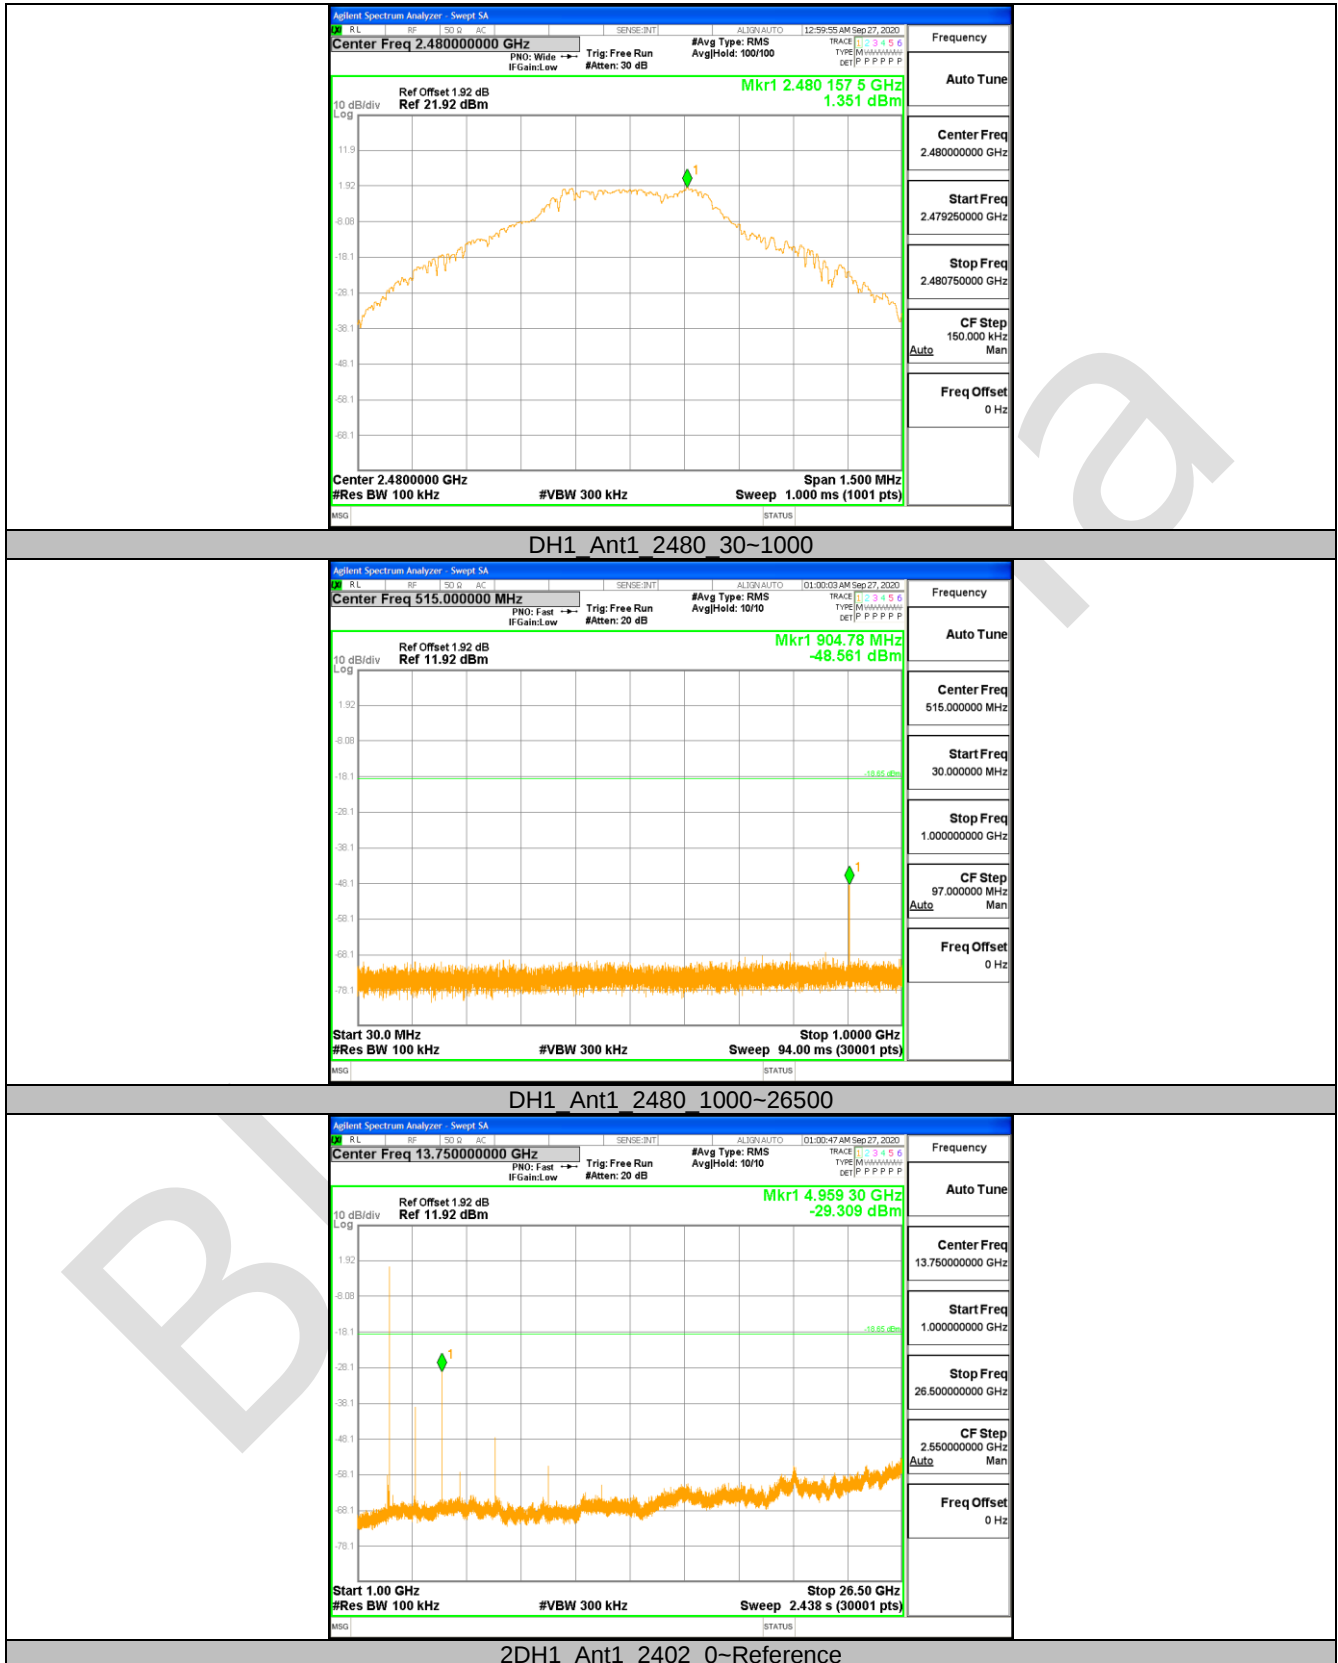
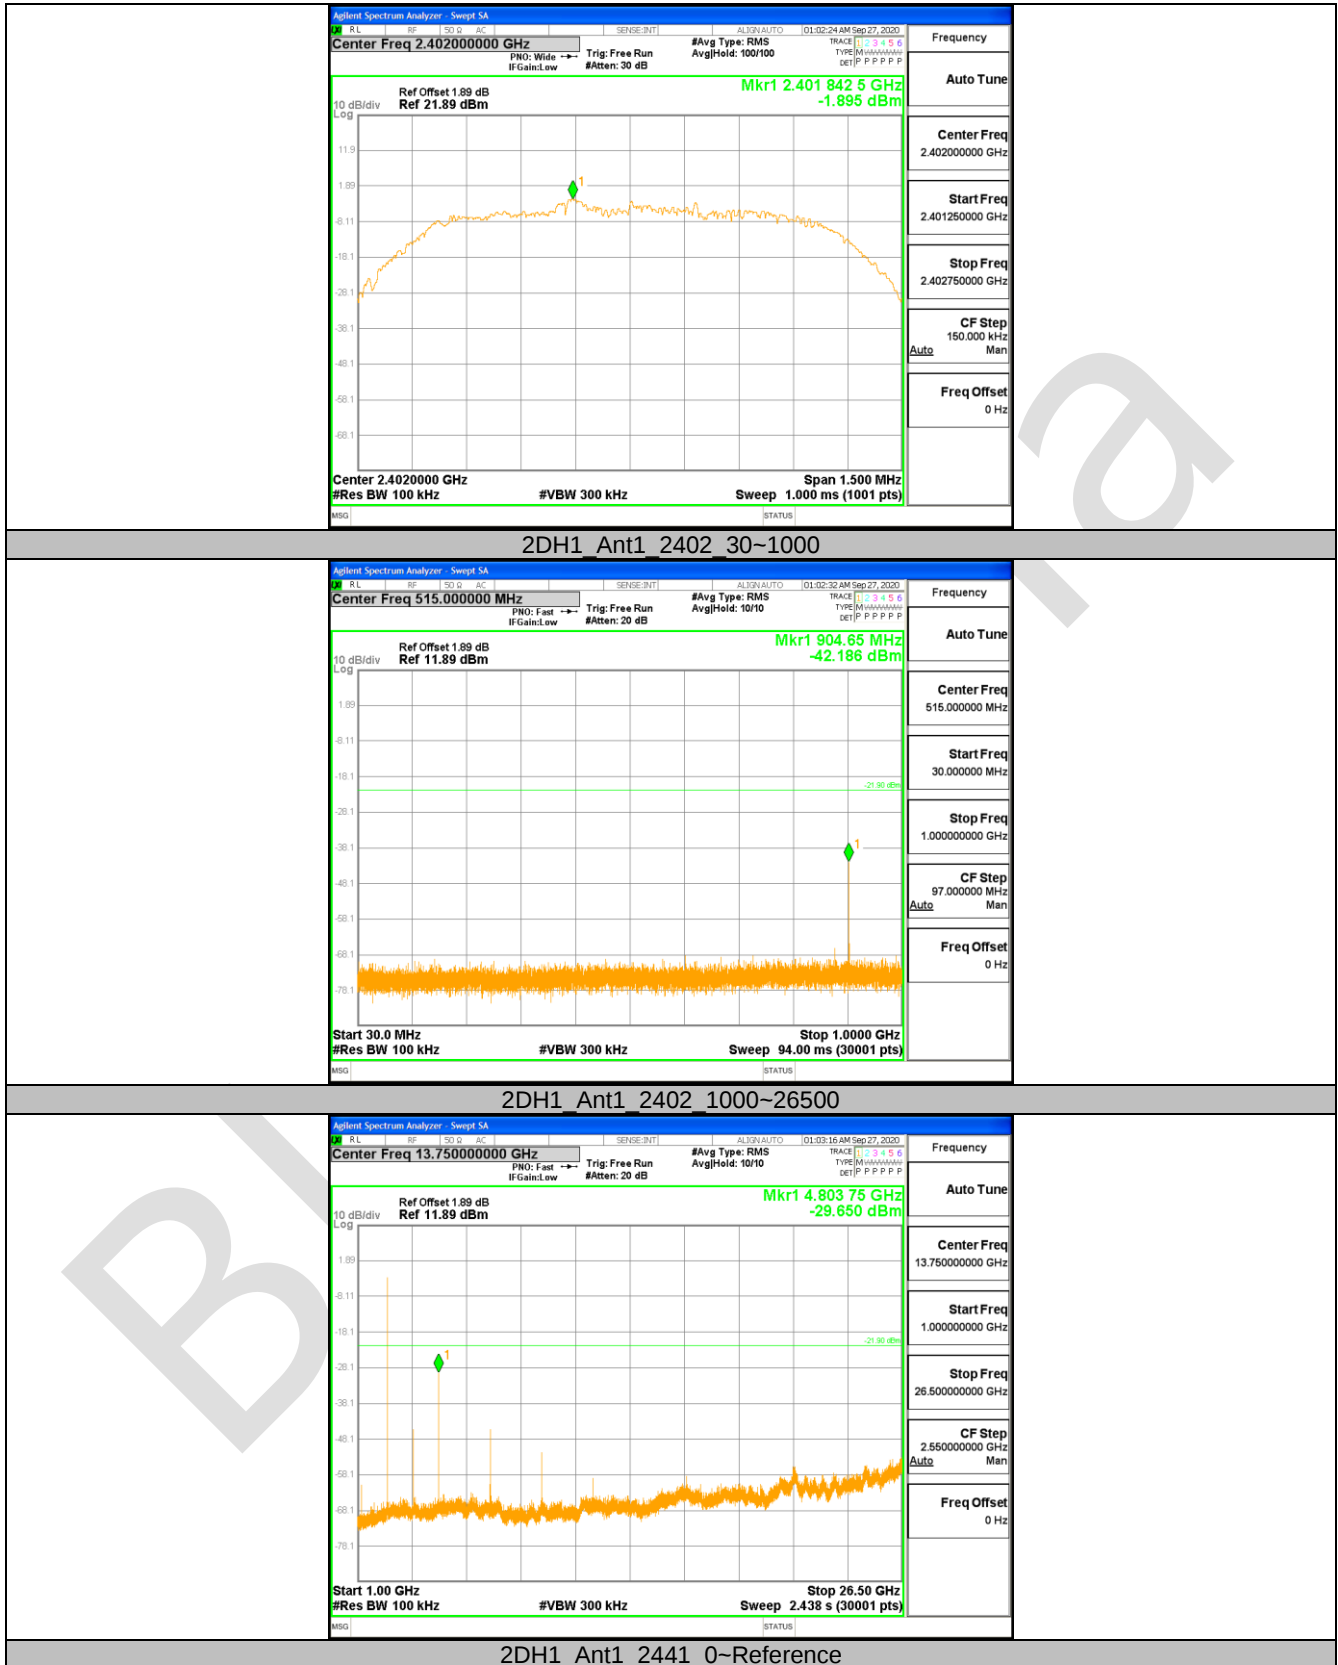
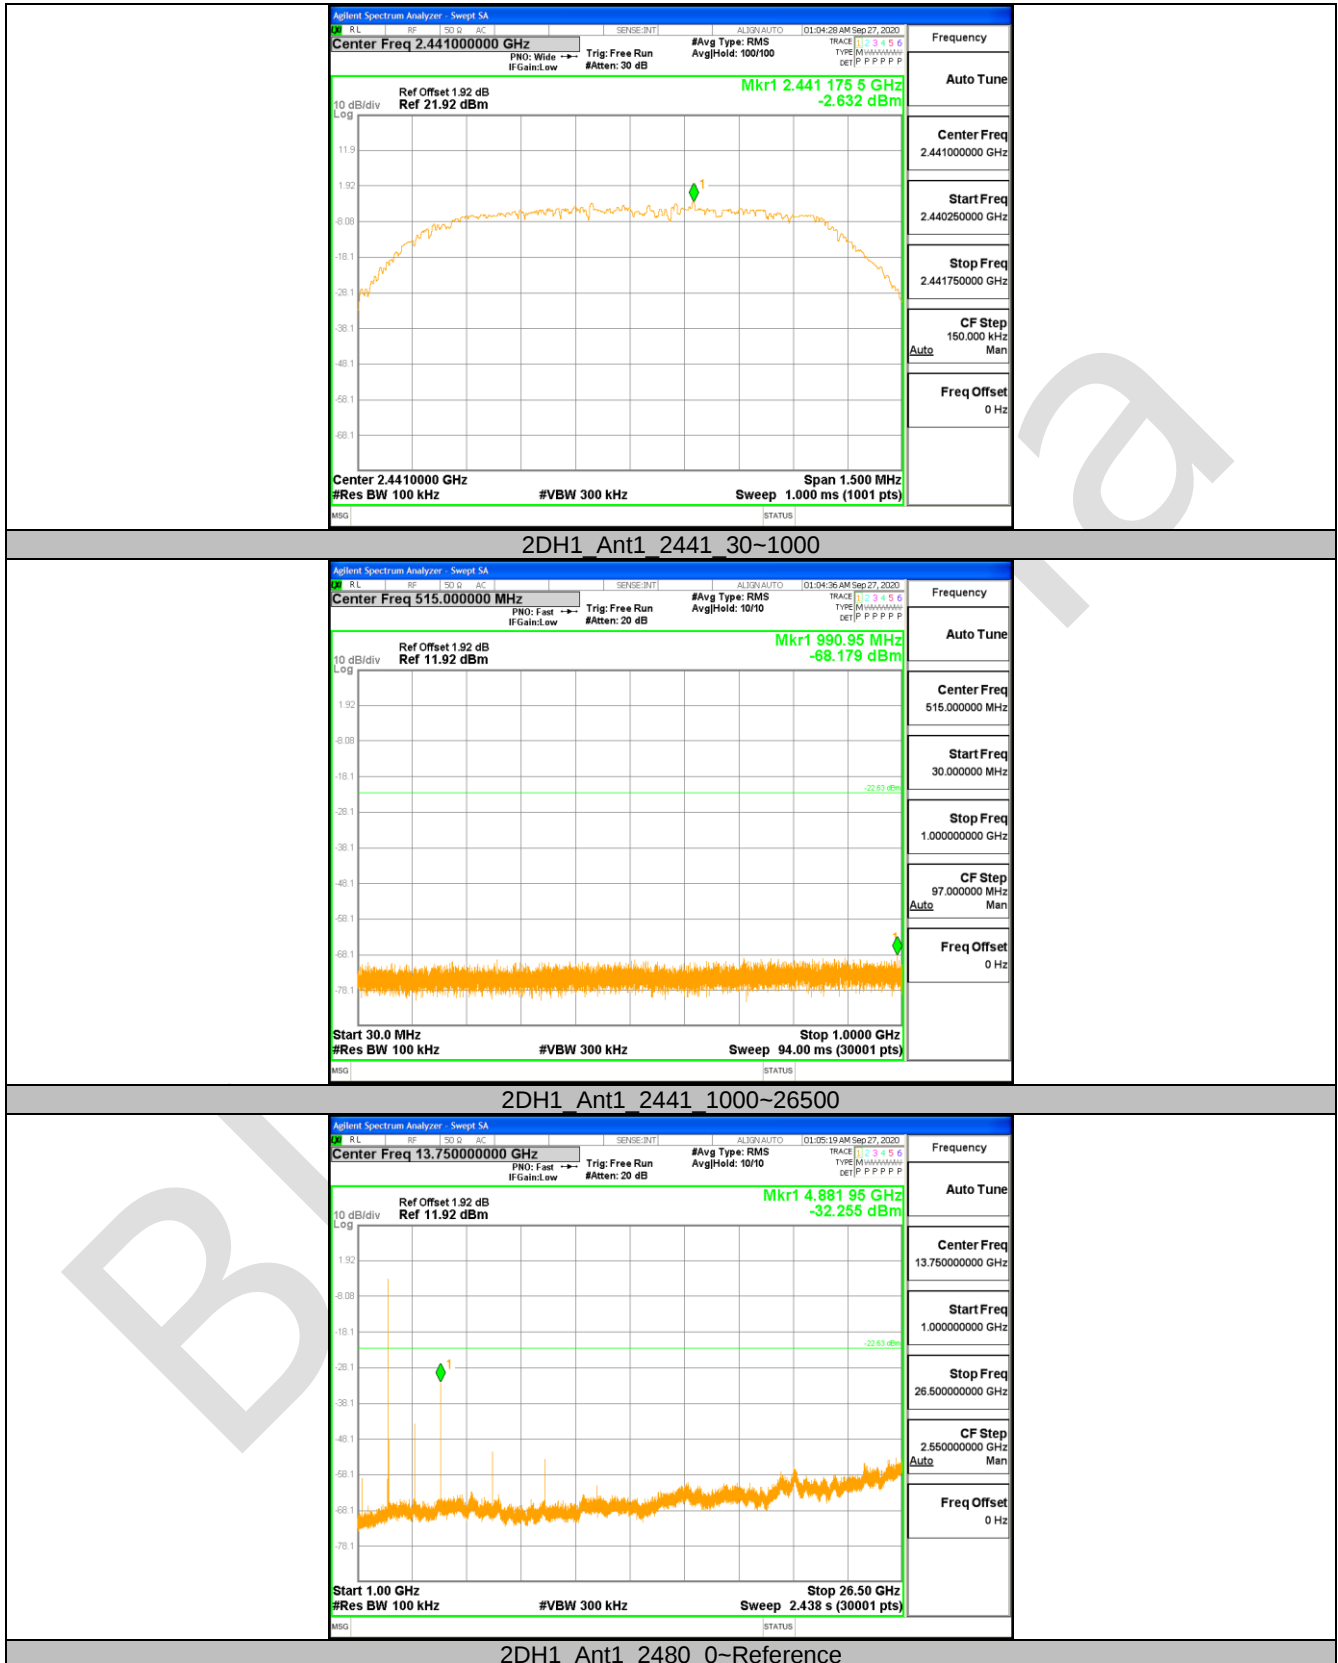
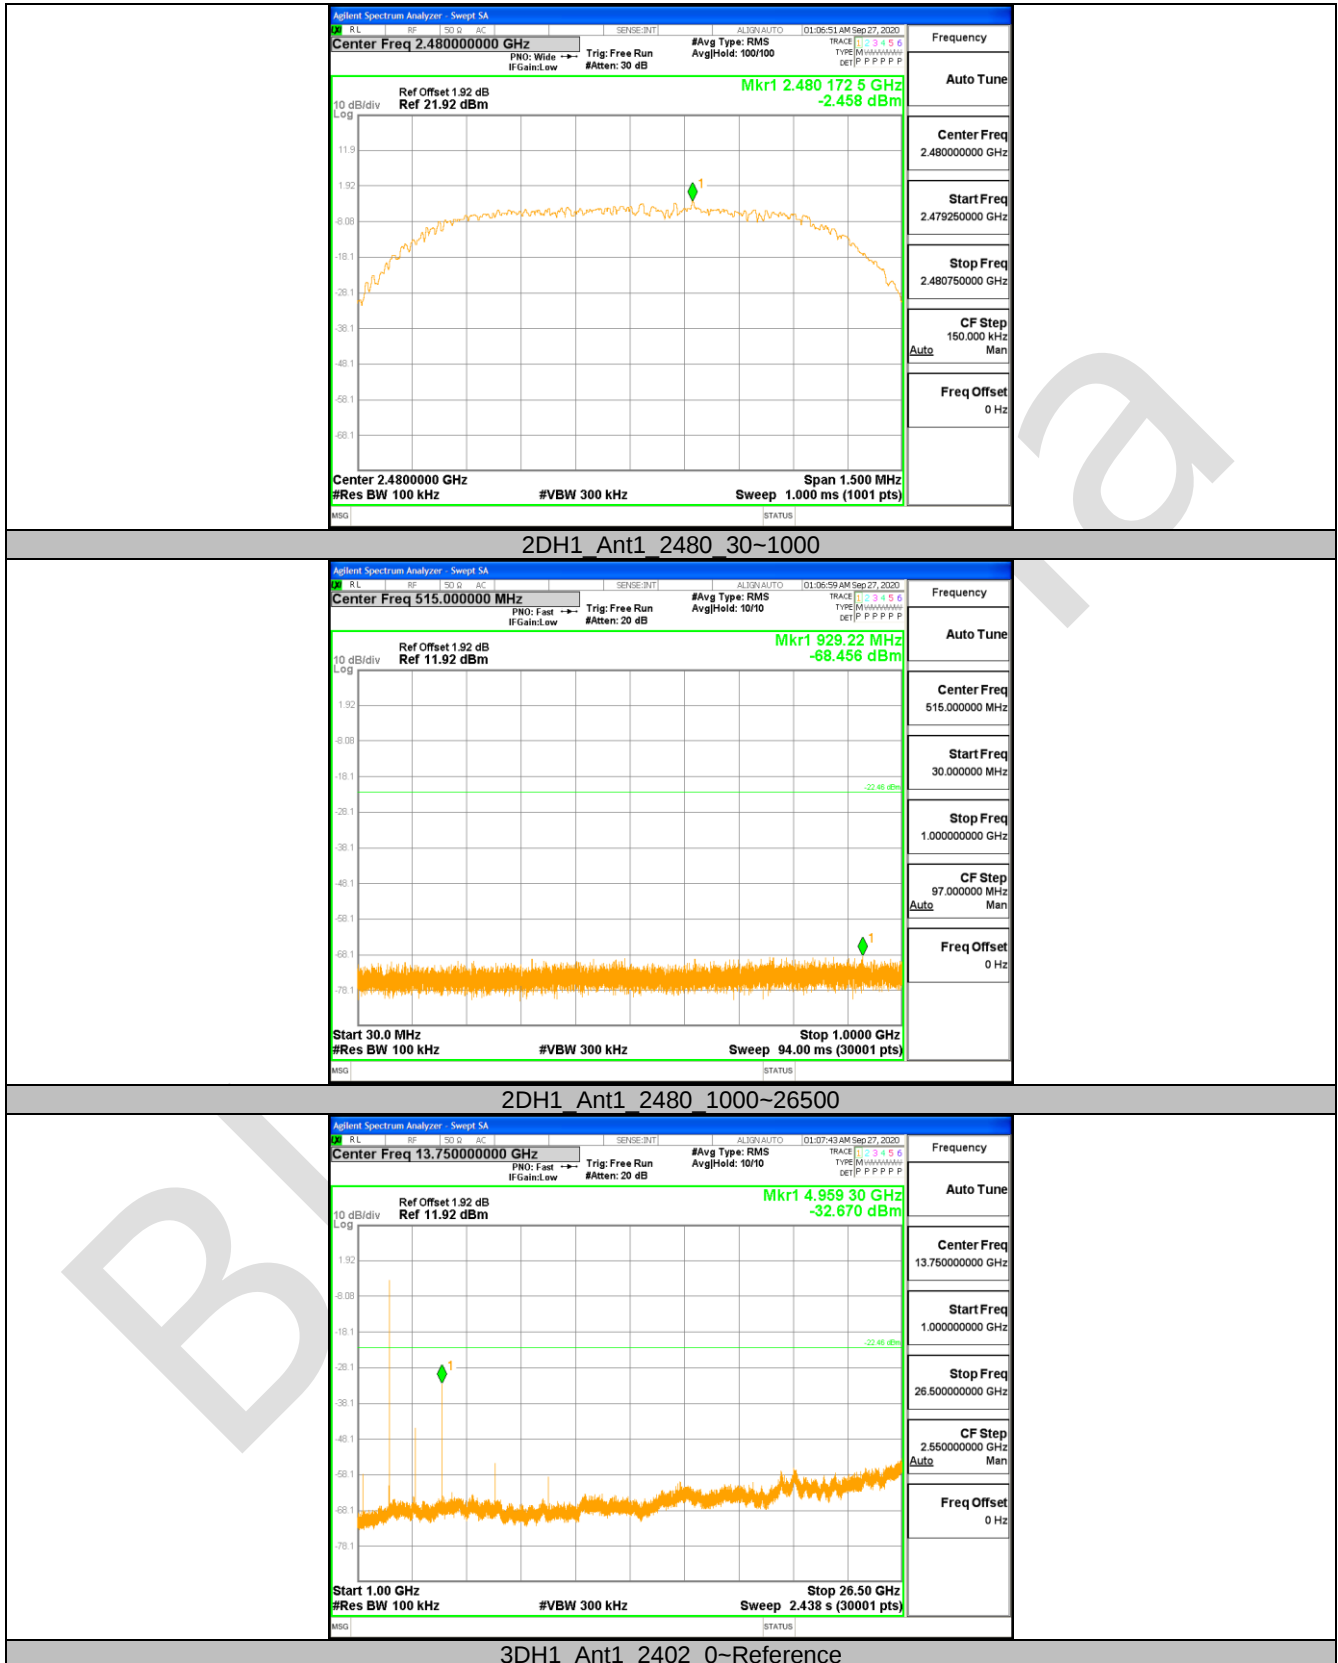
## Test Graphs

### Test Result

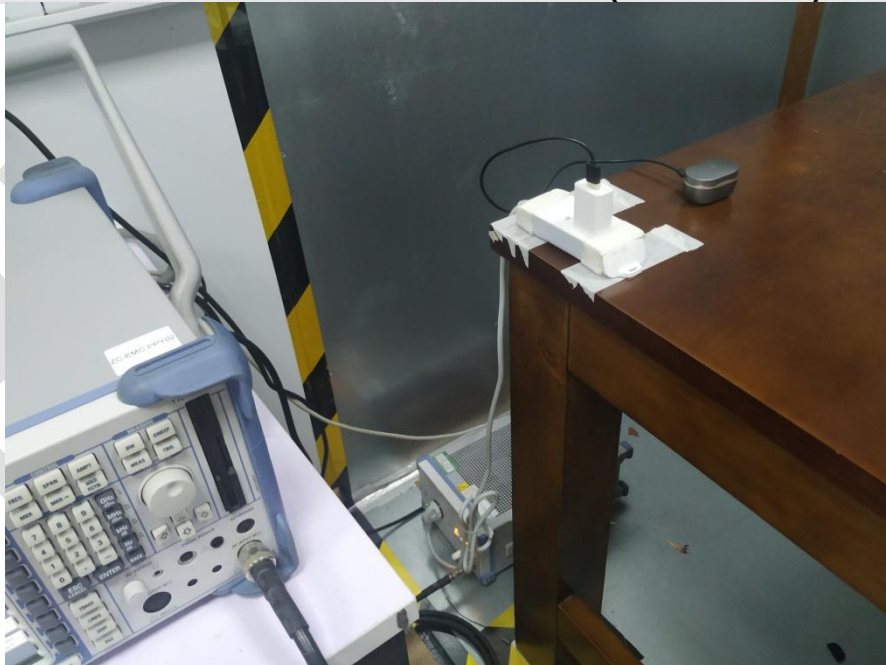
Conducted Emissions at AC Power Line (150kHz-30MHz)

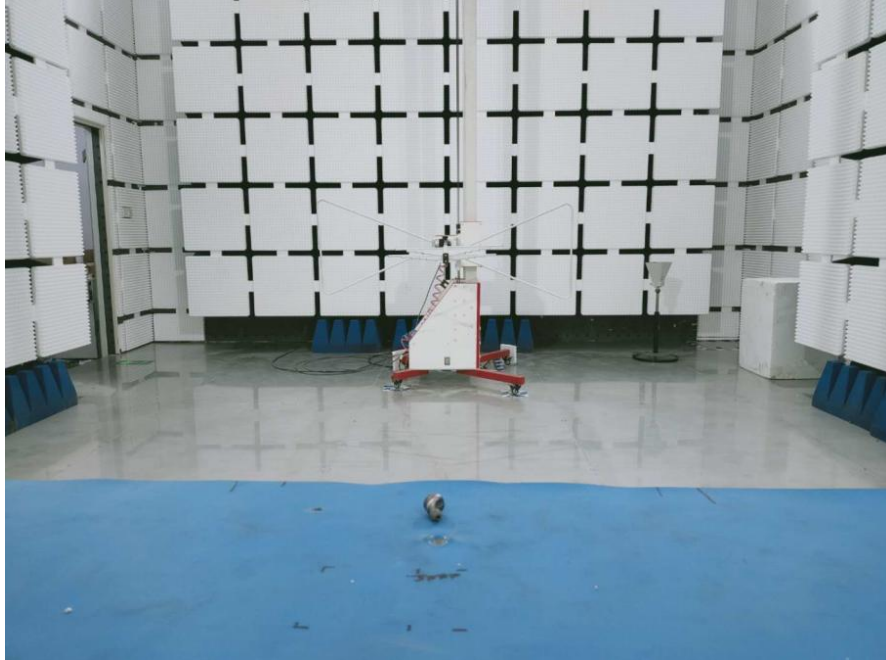
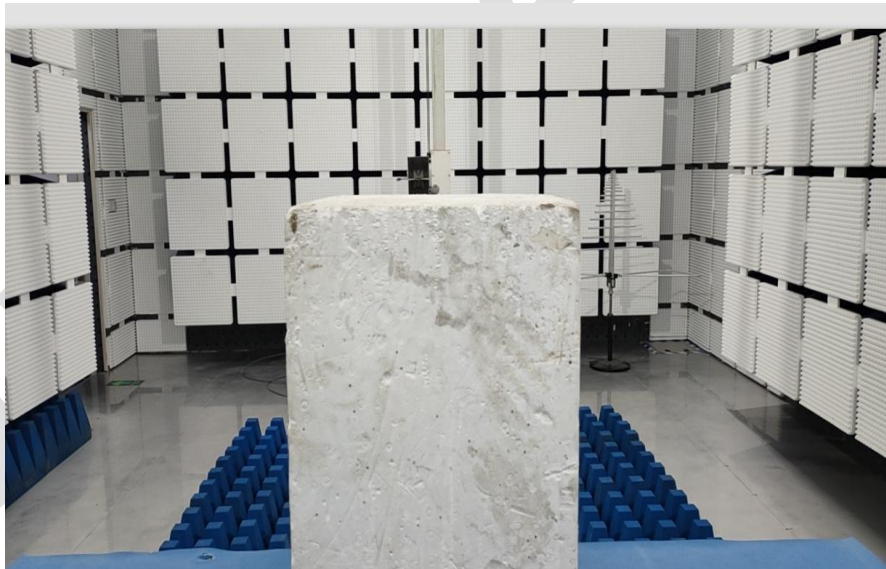
### Radiated Spurious Emissions
