## 6 Photographs of the Test Setup

## 7 Photographs of the EUT

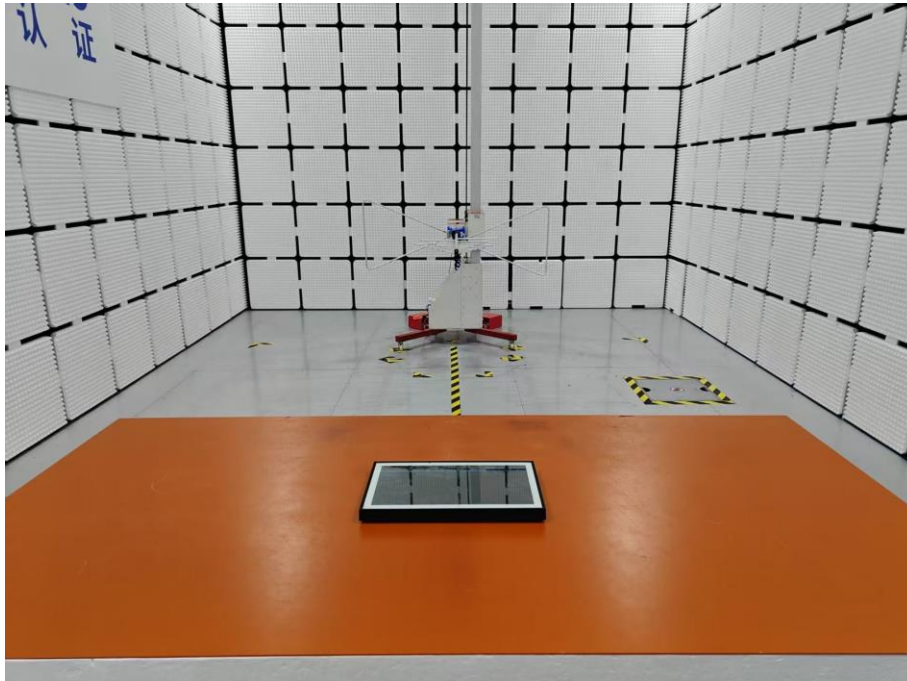
Radiated Emission Below 1GHz
