Radiated Emission Measurement

Condition : FCC\_part 15E RE\_Above 1GHz\_PK

EUT : W6M22409-23739

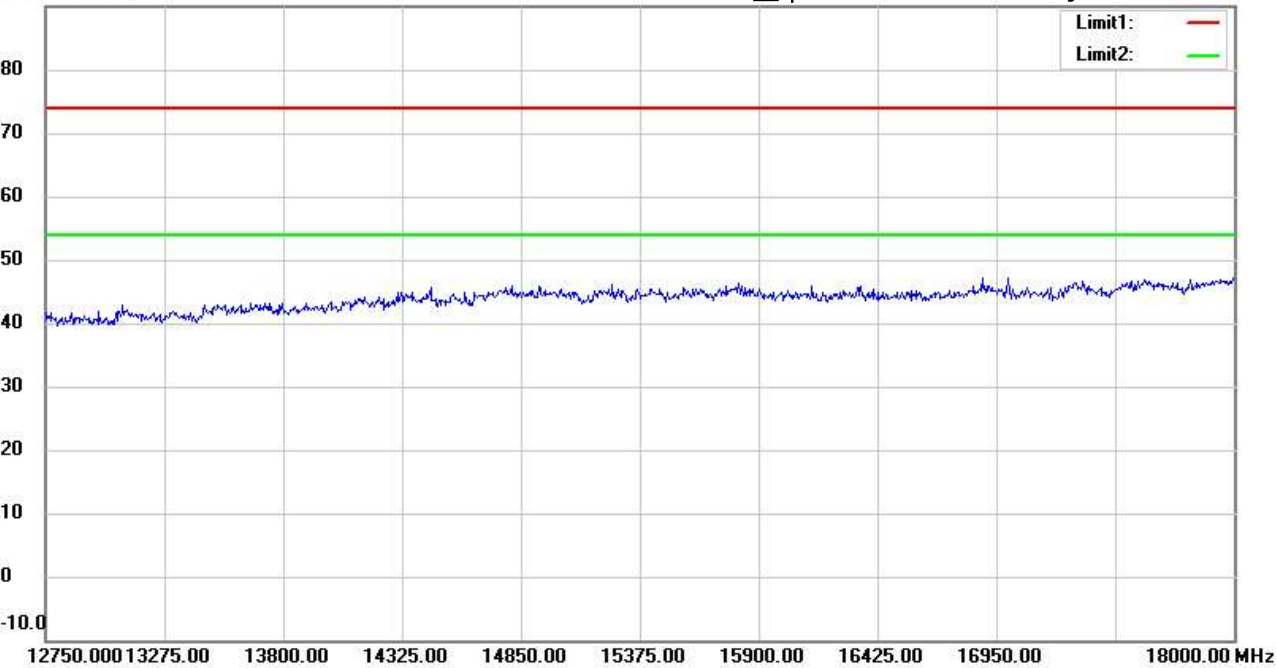
Data :#10

Test Mode : TX 802.11ax160 CH79

Polarization: Vertical

Distance: 3m

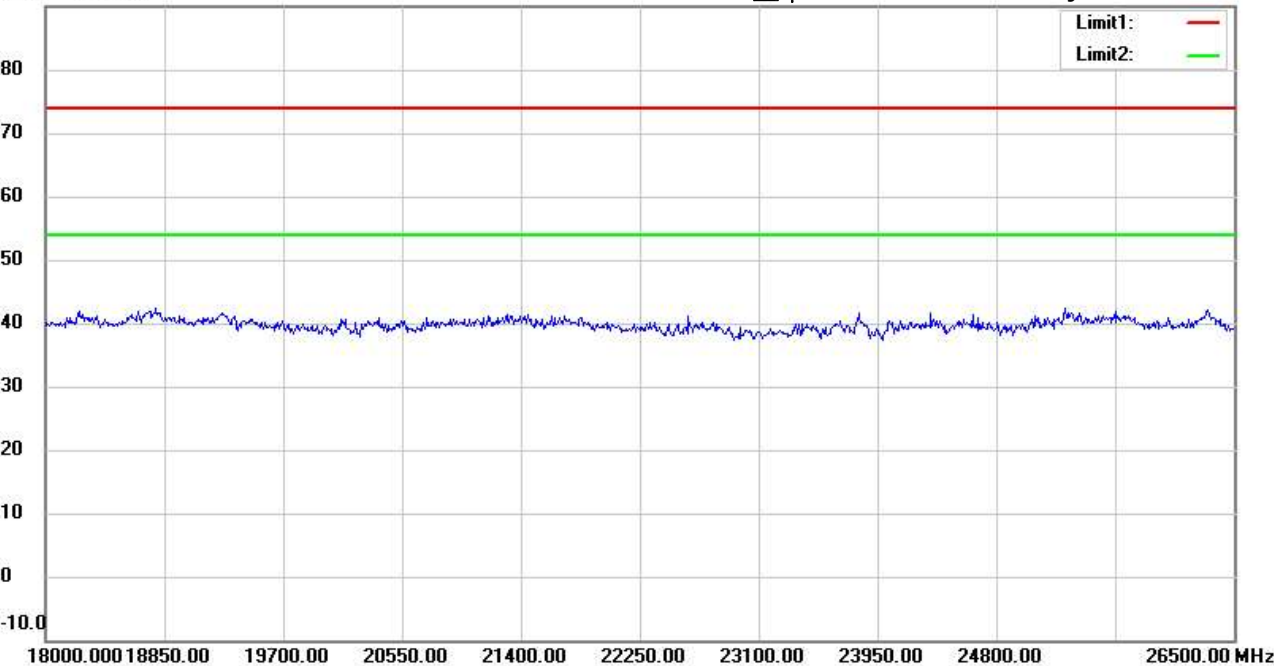
Data :#5

Condition : FCC\_part 15E RE\_Above 1GHz\_PK

Test Mode : TX 802.11ax160 CH79

Polarization: *Horizontal*

Distance: 3m

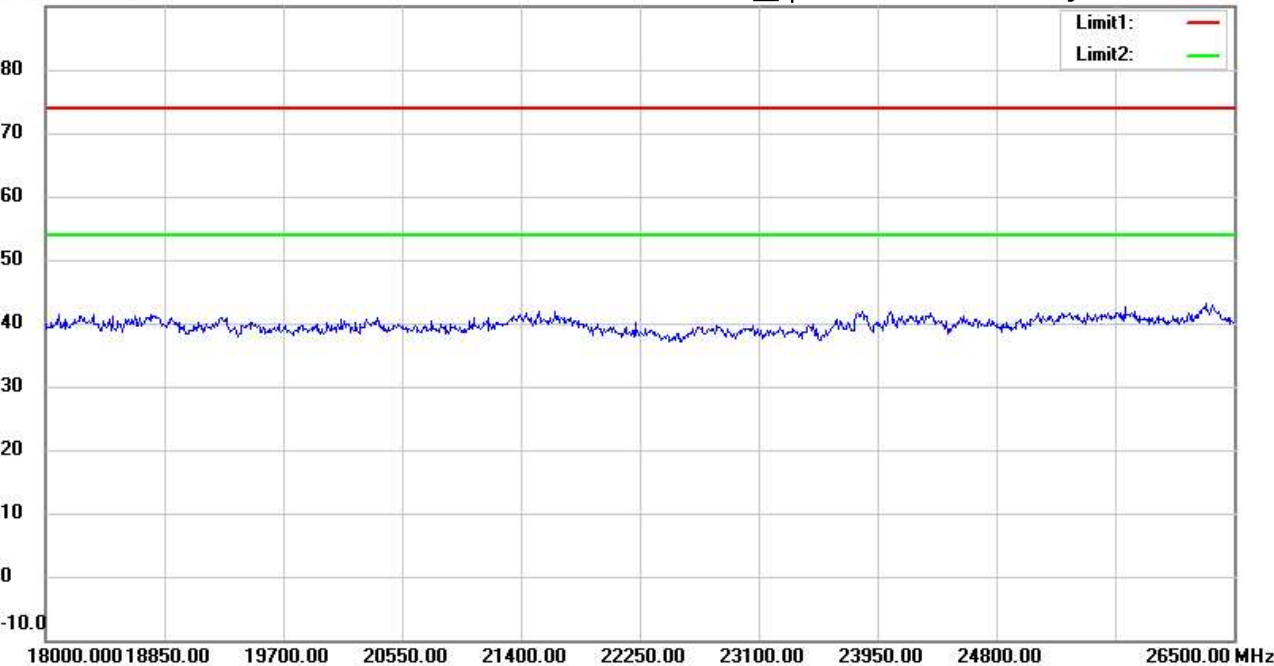
Data :#11

Condition : FCC\_part 15E RE\_Above 1GHz\_PK

Test Mode : TX 802.11ax160 CH79

Polarization: **Vertical**

Distance: 3m

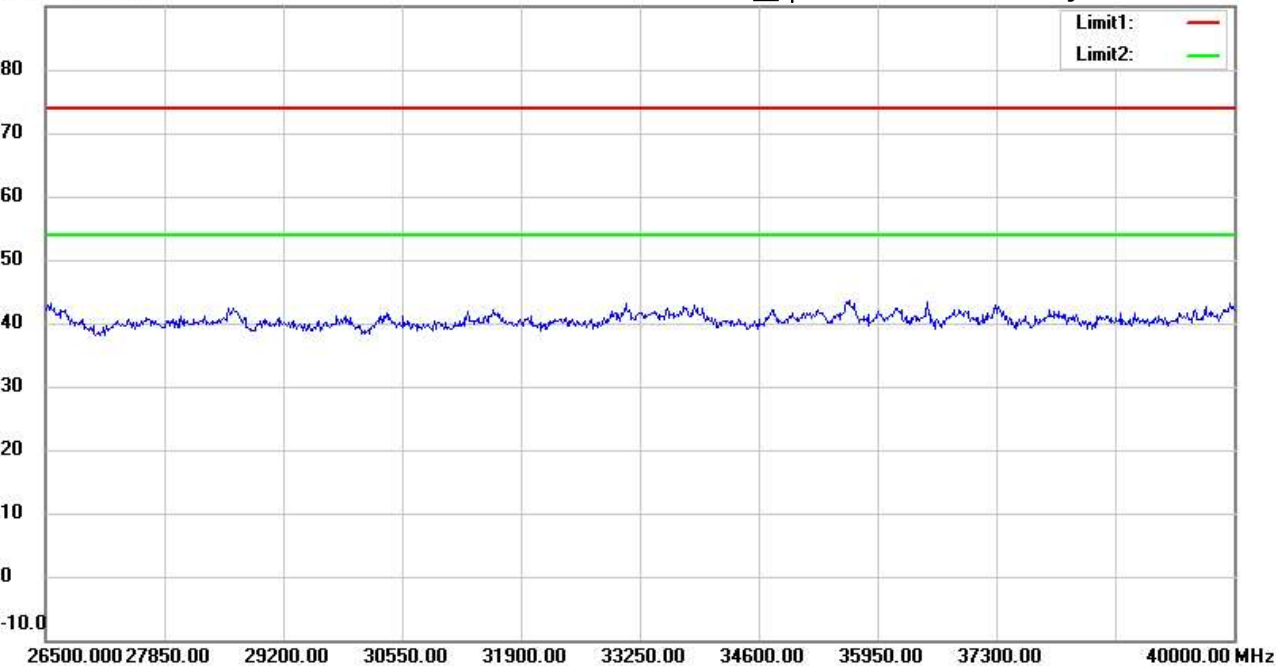
Data :#6

Condition : FCC\_part 15E RE\_Above 1GHz\_PK

Test Mode : TX 802.11ax160 CH79

Polarization: Horizontal

Distance: 3m

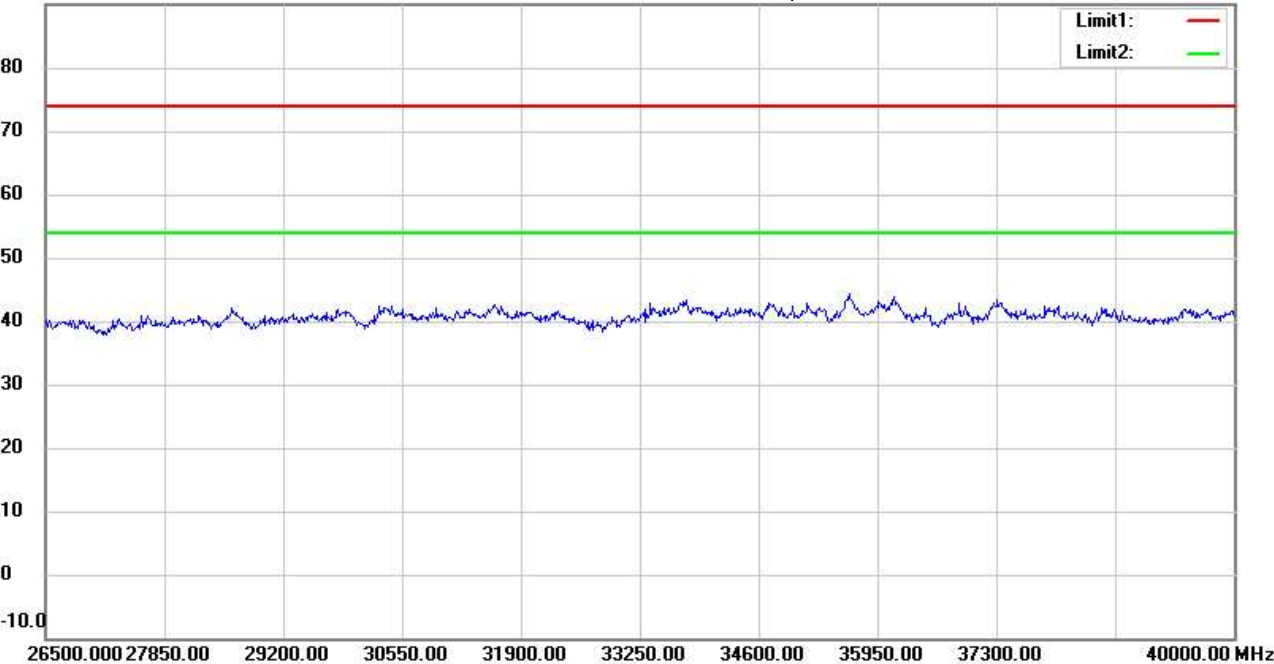
Data :#12

Condition : FCC\_part 15E RE\_Above 1GHz\_PK

Test Mode : TX 802.11ax160 CH79

Polarization: Vertical

Distance: 3m

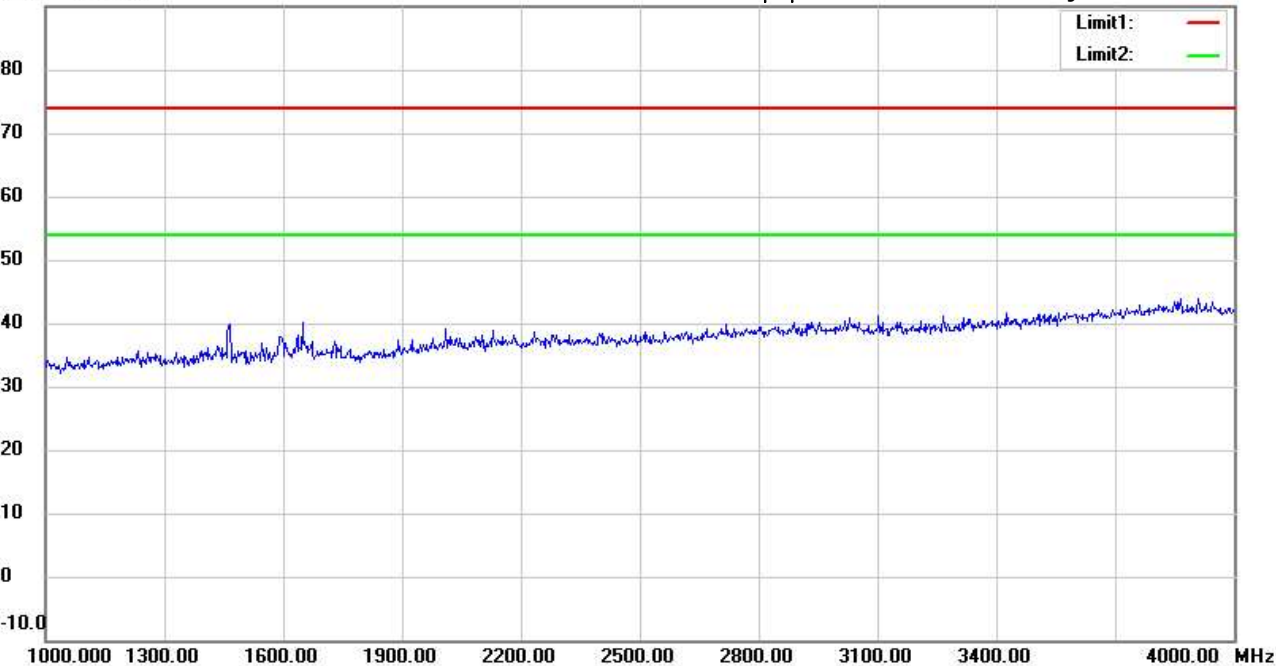
Data :#1

Condition : FCC\_part 15E RE\_Above 1GHz\_PK

Test Mode : TX 802.11a CH97

Polarization: *Horizontal*

Distance: 3m

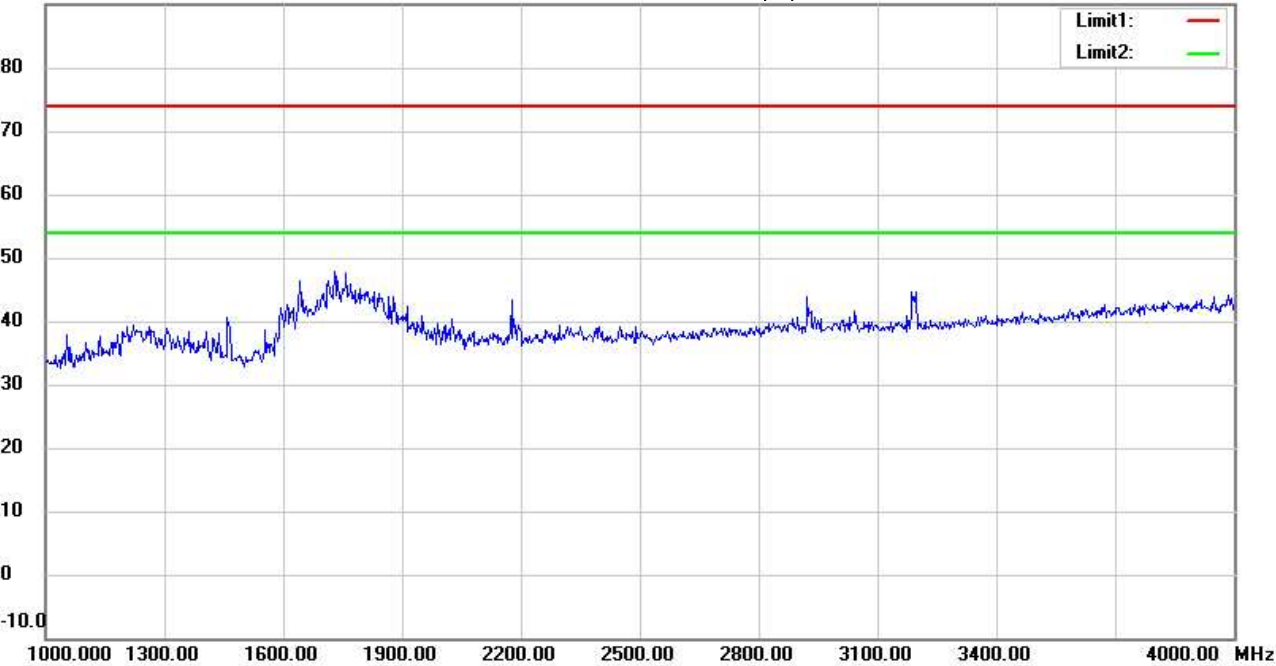
Data :#7

Site : 966A Chamber  
Condition : FCC\_part 15E RE\_Above 1GHz\_PK  
EUT : W6M22409-23739  
M/N:  
Test Mode : TX 802.11a CH97  
Note :

Polarization: Vertical  
Power : 120 Va.c.  
Distance: 3m

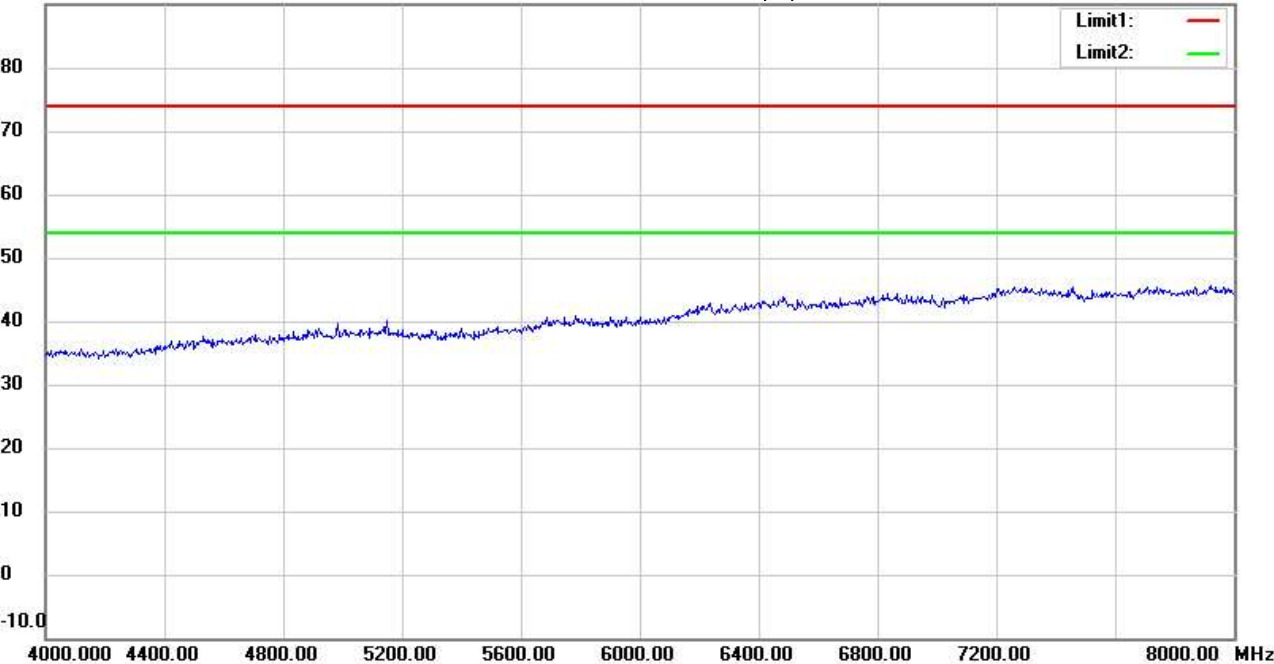
Data :#2

Site : 966A Chamber  
Condition : FCC\_part 15E RE\_Above 1GHz\_PK  
EUT : W6M22409-23739  
M/N:  
Test Mode : TX 802.11a CH97  
Note :

Polarization: Horizontal  
Power : 120 Va.c.  
Distance: 3m

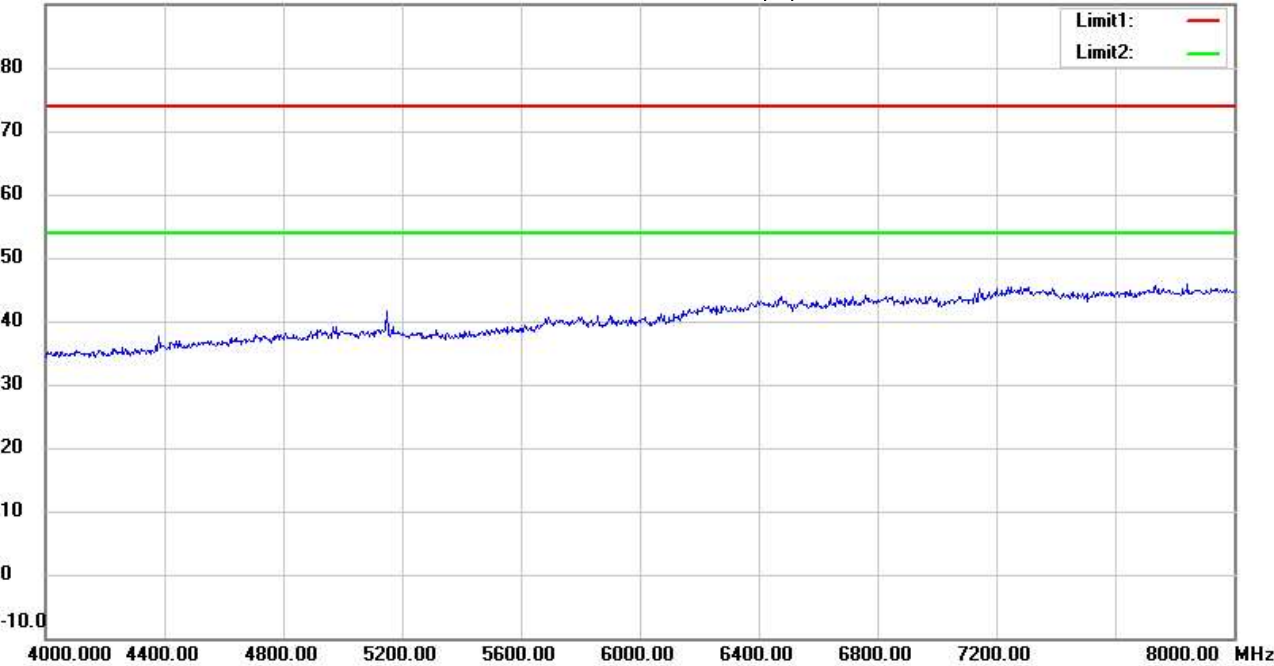
Data :#8

Site : 966A Chamber  
Condition : FCC\_part 15E RE\_Above 1GHz\_PK  
EUT : W6M22409-23739  
M/N:  
Test Mode : TX 802.11a CH97  
Note :

Polarization: Vertical  
Power : 120 Va.c.  
Distance: 3m

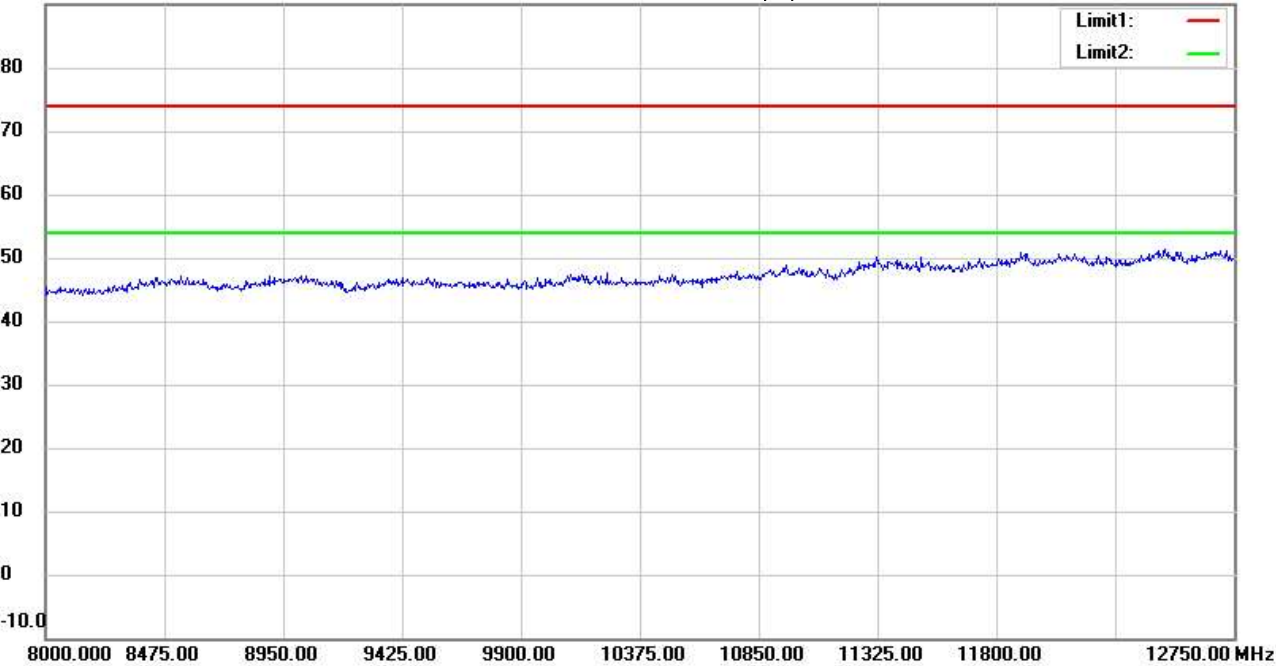
Data :#3

Site : 966A Chamber  
Condition : FCC\_part 15E RE\_Above 1GHz\_PK  
EUT : W6M22409-23739  
M/N:  
Test Mode : TX 802.11a CH97  
Note :

Polarization: *Horizontal*  
Power : 120 Va.c.  
Distance: 3m

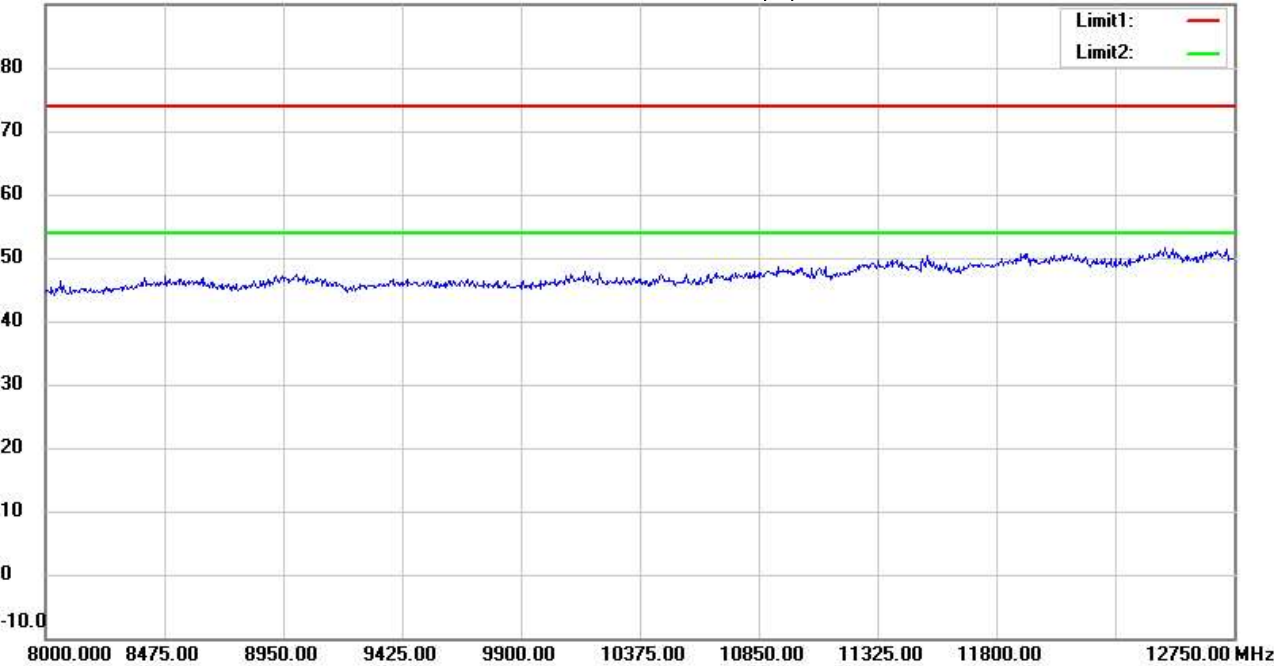
Data :#9

Site : 966A Chamber  
Condition : FCC\_part 15E RE\_Above 1GHz\_PK  
EUT : W6M22409-23739  
M/N:  
Test Mode : TX 802.11a CH97  
Note :

Polarization: Vertical  
Power : 120 V.a.c.  
Distance: 3m

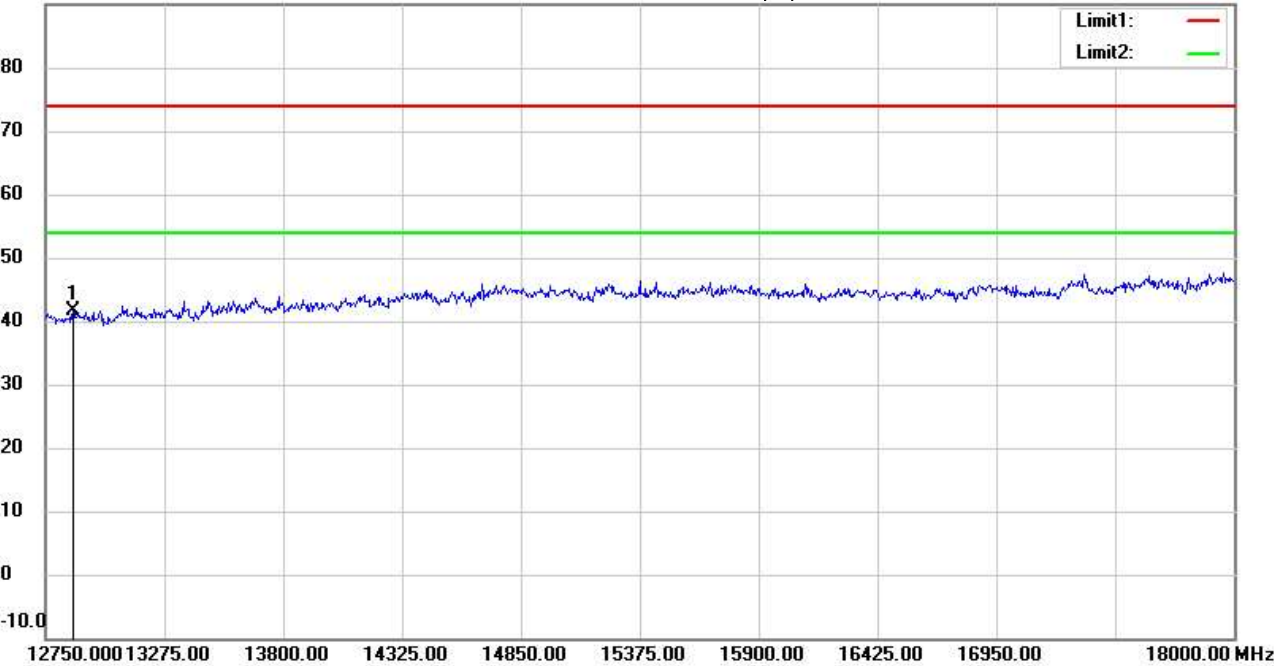
Data :#4

Site : 966A Chamber  
Condition : FCC\_part 15E RE\_Above 1GHz\_PK  
EUT : W6M22409-23739  
M/N:  
Test Mode : TX 802.11a CH97  
Note :

Polarization: *Horizontal*  
Power : 120 Va.c.  
Distance: 3m

| Mk. | Frequency (MHz) | Reading (dBuV) | Detector | Corr. factor (dB/m) | Result (dBuV/m) | Limit (dBuV/m) | Ant.Pos (cm) | Tab.Pos (deg.) | Margin (dB) | Comment |
|---|---|---|---|---|---|---|---|---|---|---|
| * | 12870.000 | 24.22 | peak | 17.37 | 41.59 | 74.00 | 150 | 111 | -32.41 | |

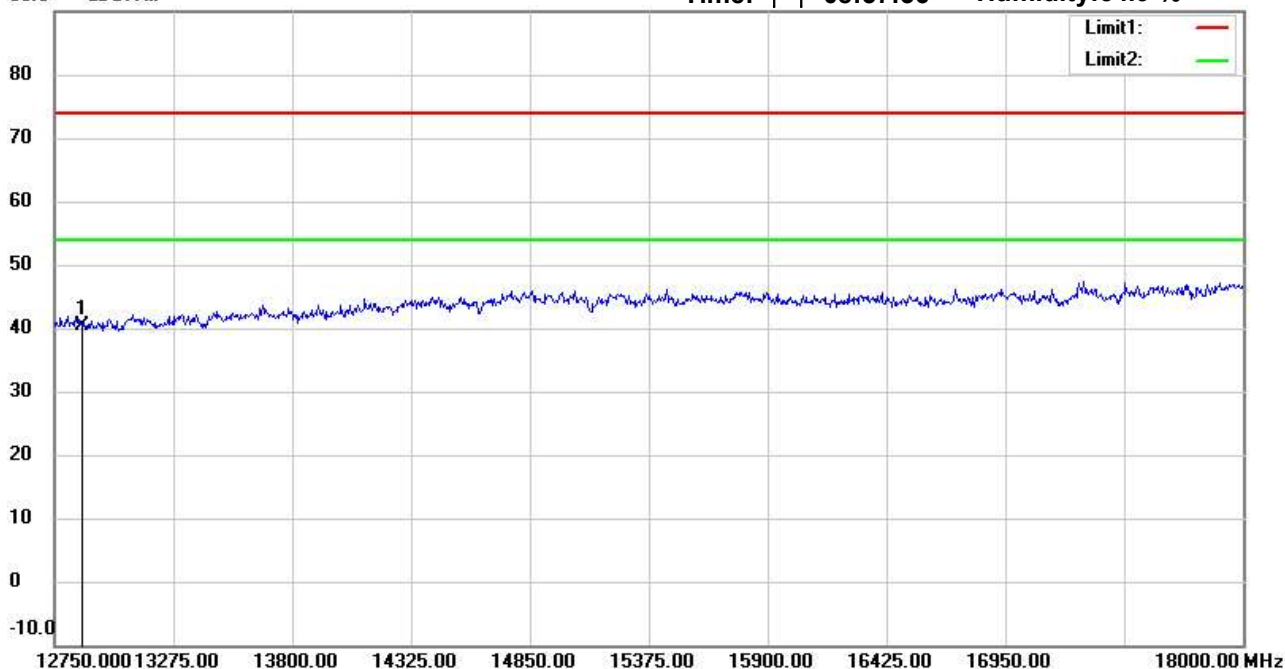
Data : #10

Condition : FCC\_part 15E RE\_Above 1GHz\_PK

Test Mode : TX 802.11a CH97

Polarization: **Vertical**

| Mk. | Frequency (MHz) | Reading (dBuV) | Detector | Corr. factor (dB/m) | Result (dBuV/m) | Limit (dBuV/m) | Ant.Pos (cm) | Tab.Pos (deg.) | Margin (dB) | Comment |
|---|---|---|---|---|---|---|---|---|---|---|
| * | 12870.000 | 22.91 | peak | 17.37 | 40.28 | 74.00 | 150 | 238 | -33.72 | |

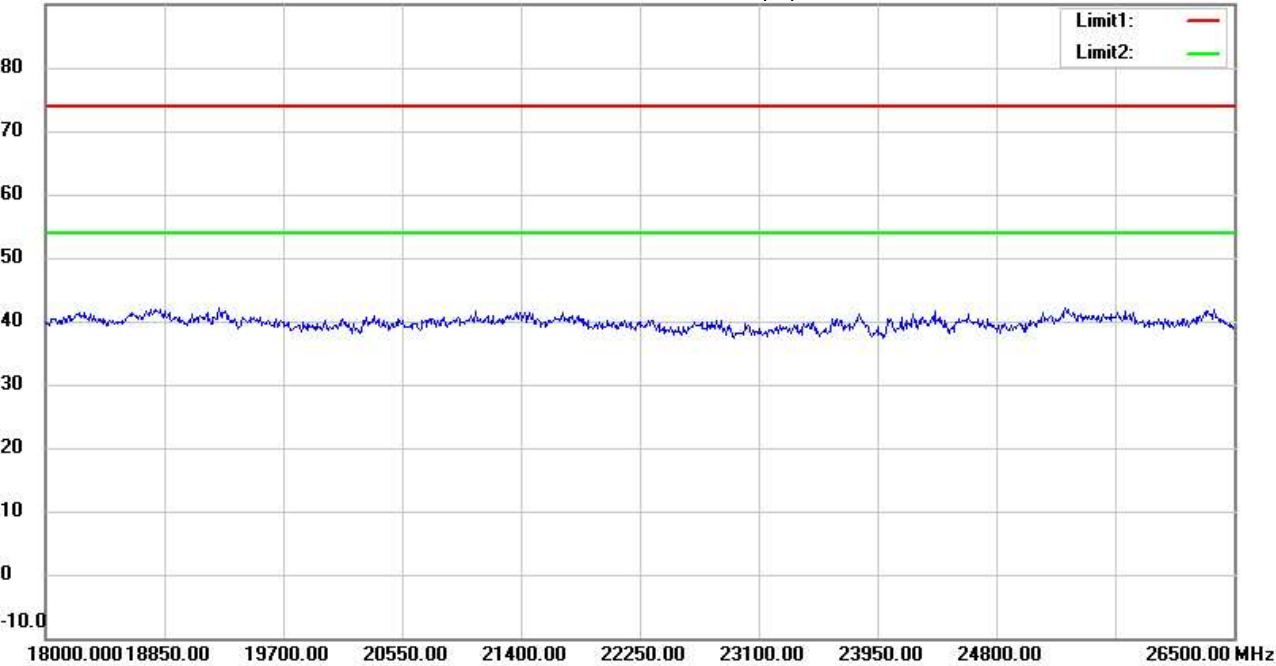
Data :#5

Site : 966A Chamber  
Condition : FCC\_part 15E RE\_Above 1GHz\_PK  
EUT : W6M22409-23739  
M/N:  
Test Mode : TX 802.11a CH97  
Note :

Polarization: *Horizontal*  
Power : 120 Va.c.  
Distance: 3m

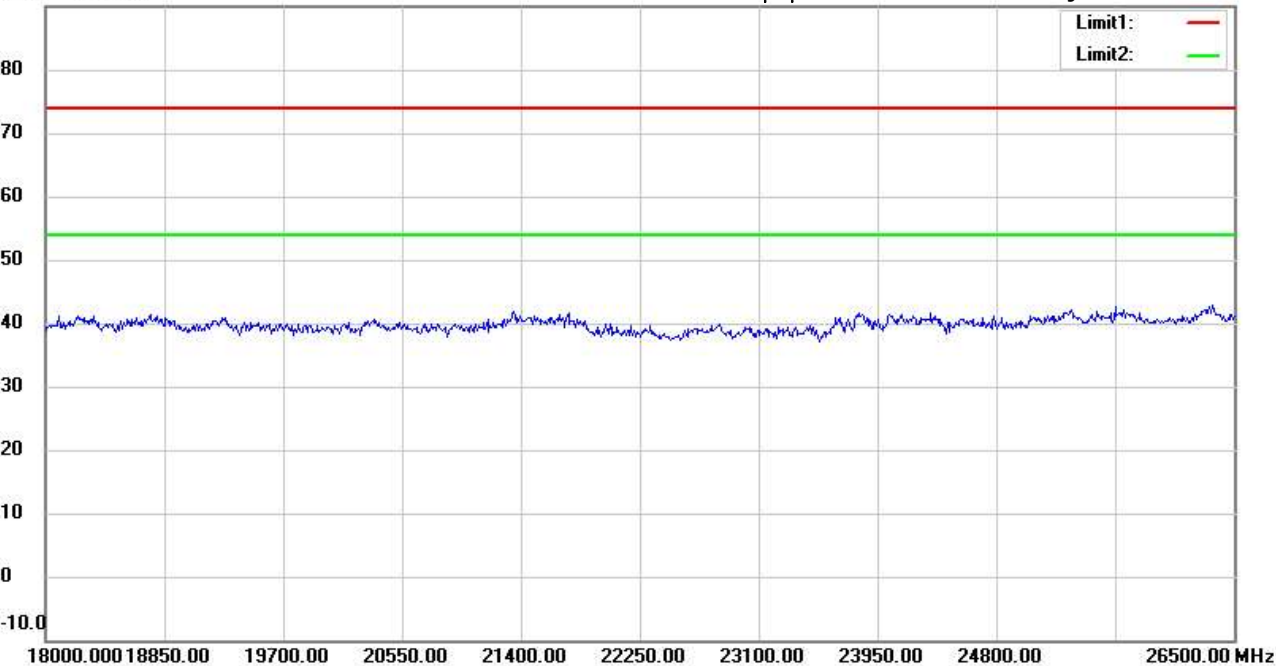
Data :#11

Condition : FCC\_part 15E RE\_Above 1GHz\_PK

Test Mode : TX 802.11a CH97

Polarization: Vertical

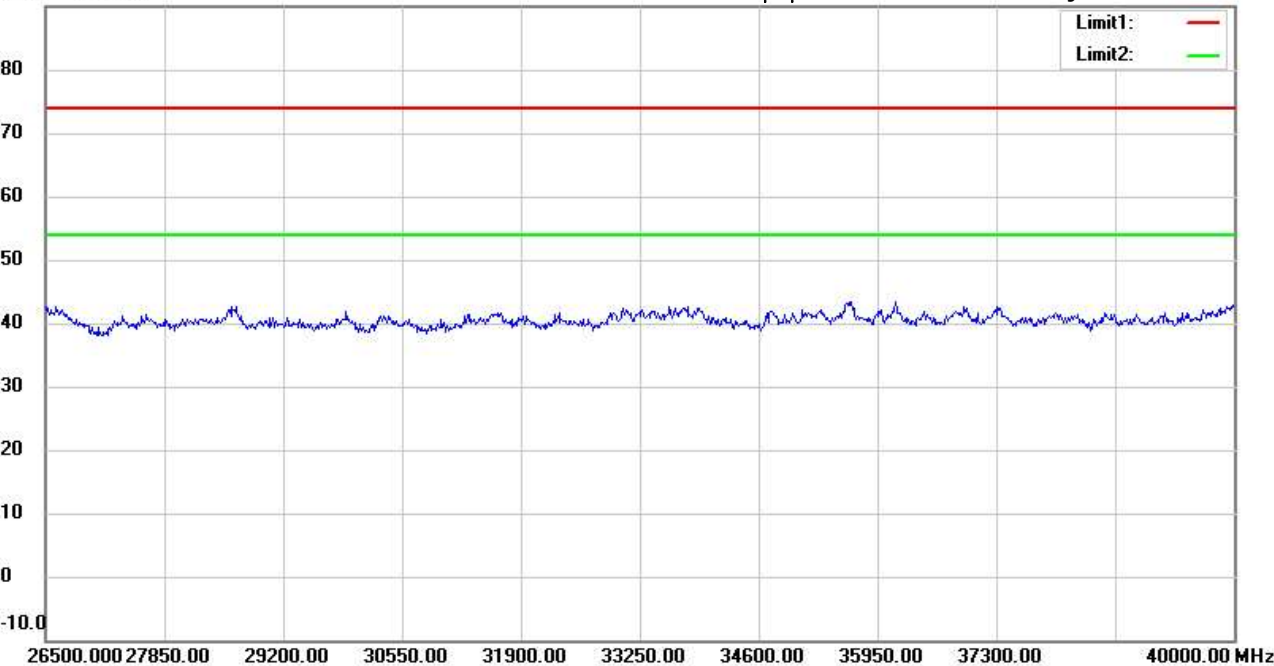
Data :#6

Condition : FCC\_part 15E RE\_Above 1GHz\_PK

Test Mode : TX 802.11a CH97

Polarization: **Horizontal**

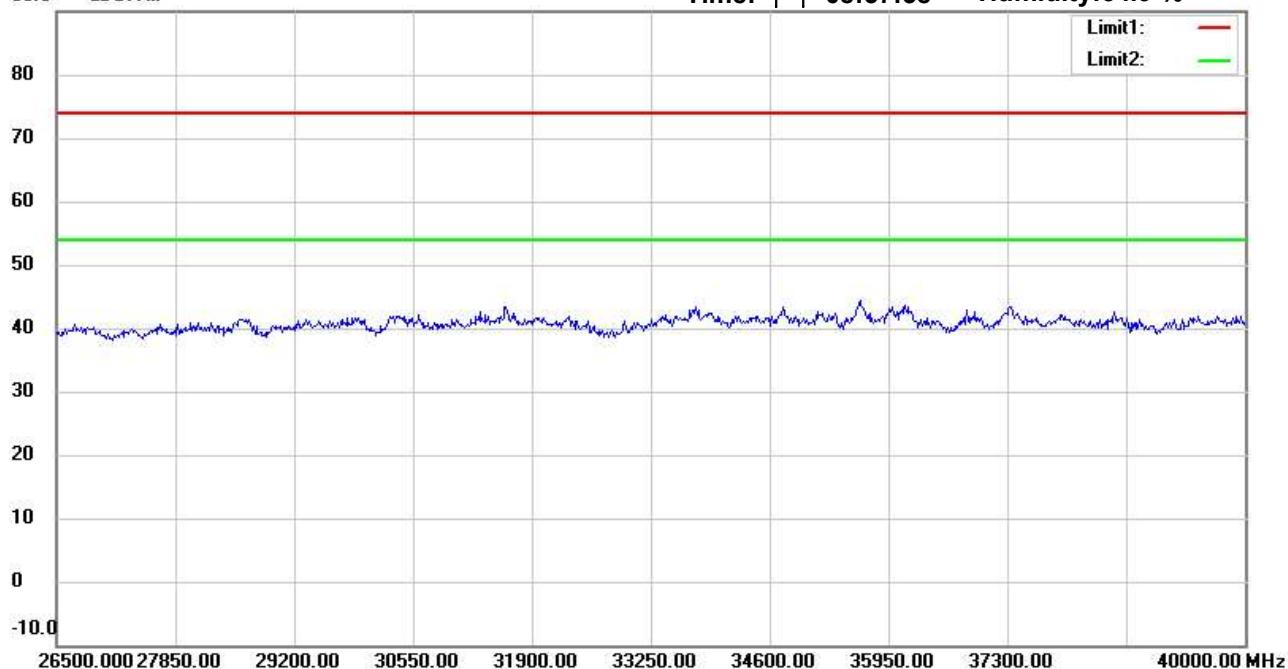
Data : #12

Condition : FCC\_part 15E RE\_Above 1GHz\_PK

Test Mode : TX 802.11a CH97

Polarization: **Vertical**

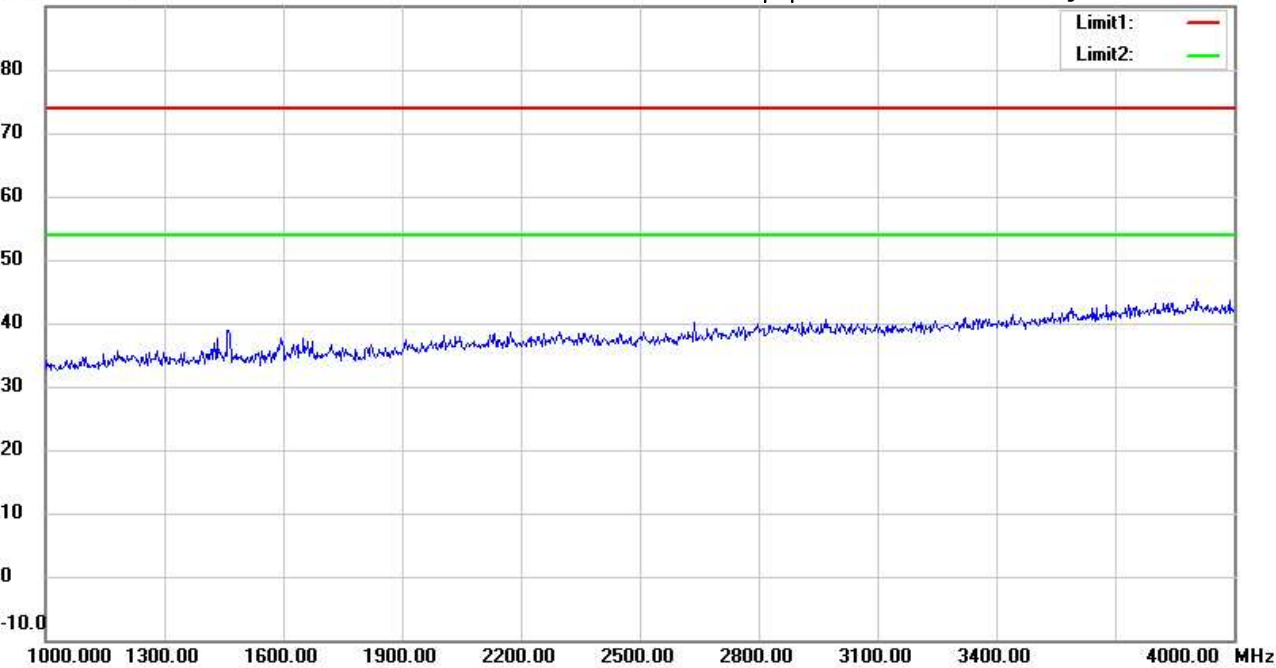
Data :#1

Condition : FCC\_part 15E RE\_Above 1GHz\_PK

Test Mode : TX 802.11a CH105

Polarization: Horizontal

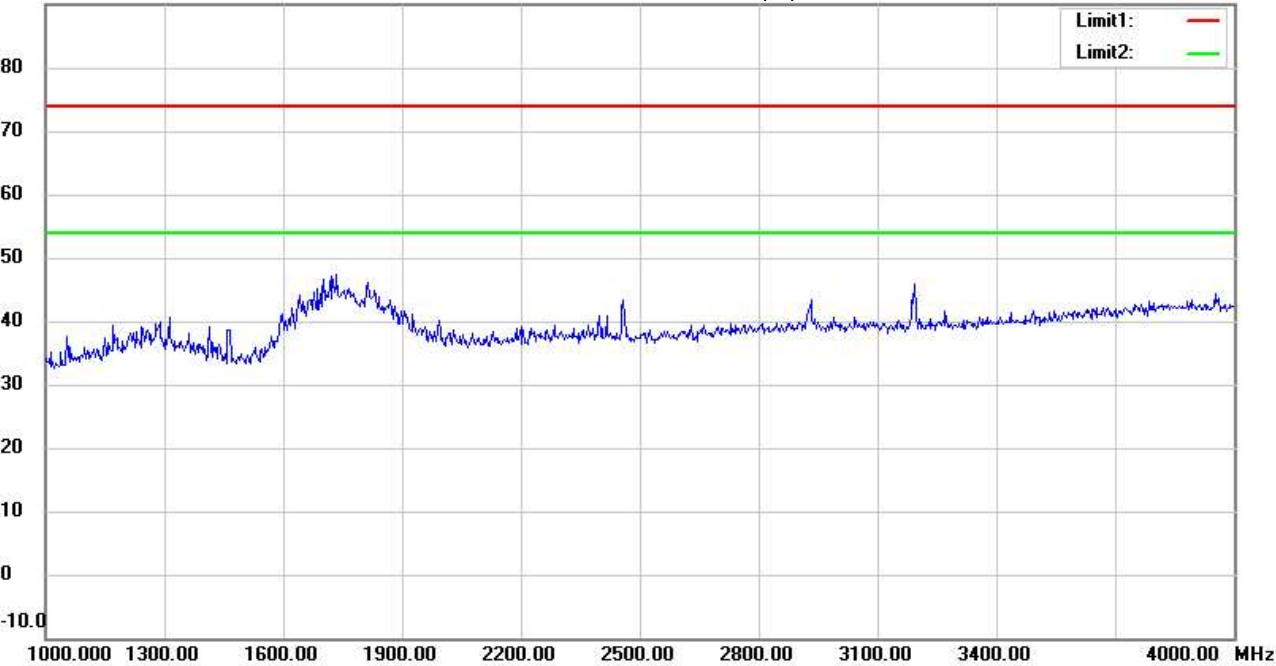
Data :#7

Site : 966A Chamber  
Condition : FCC\_part 15E RE\_Above 1GHz\_PK  
EUT : W6M22409-23739  
M/N:  
Test Mode : TX 802.11a CH105  
Note :

Polarization: Vertical  
Power : 120 Va.c.  
Distance: 3m

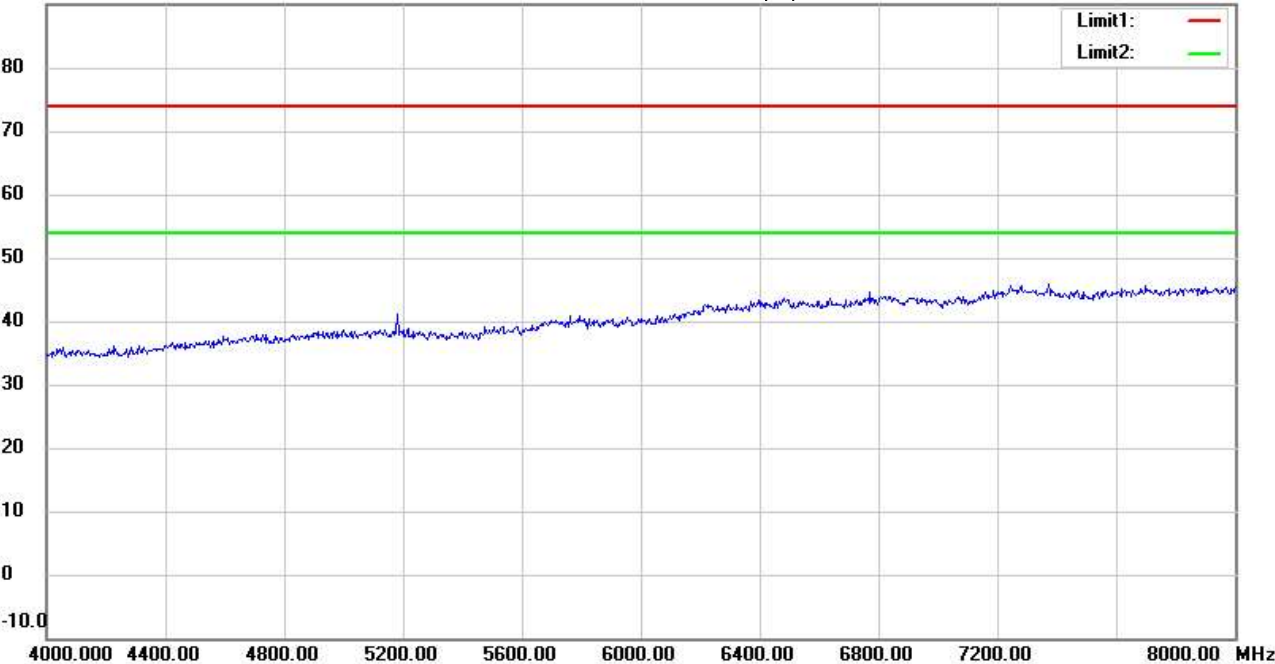
Data :#2

Site : 966A Chamber  
Condition : FCC\_part 15E RE\_Above 1GHz\_PK  
EUT : W6M22409-23739  
M/N:  
Test Mode : TX 802.11a CH105  
Note :

Polarization: *Horizontal*  
Power : 120 Va.c.  
Distance: 3m

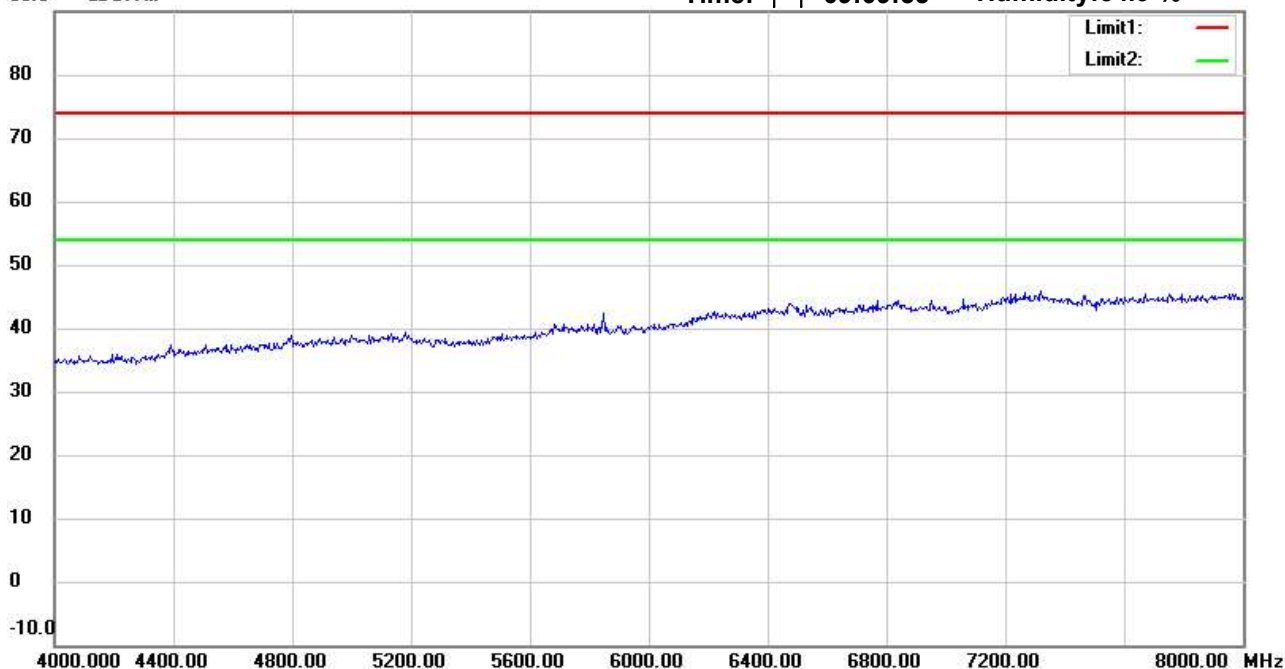
Data : #8

Condition : FCC\_part 15E RE\_Above 1GHz\_PK

Test Mode : TX 802.11a CH105

Polarization: **Vertical**

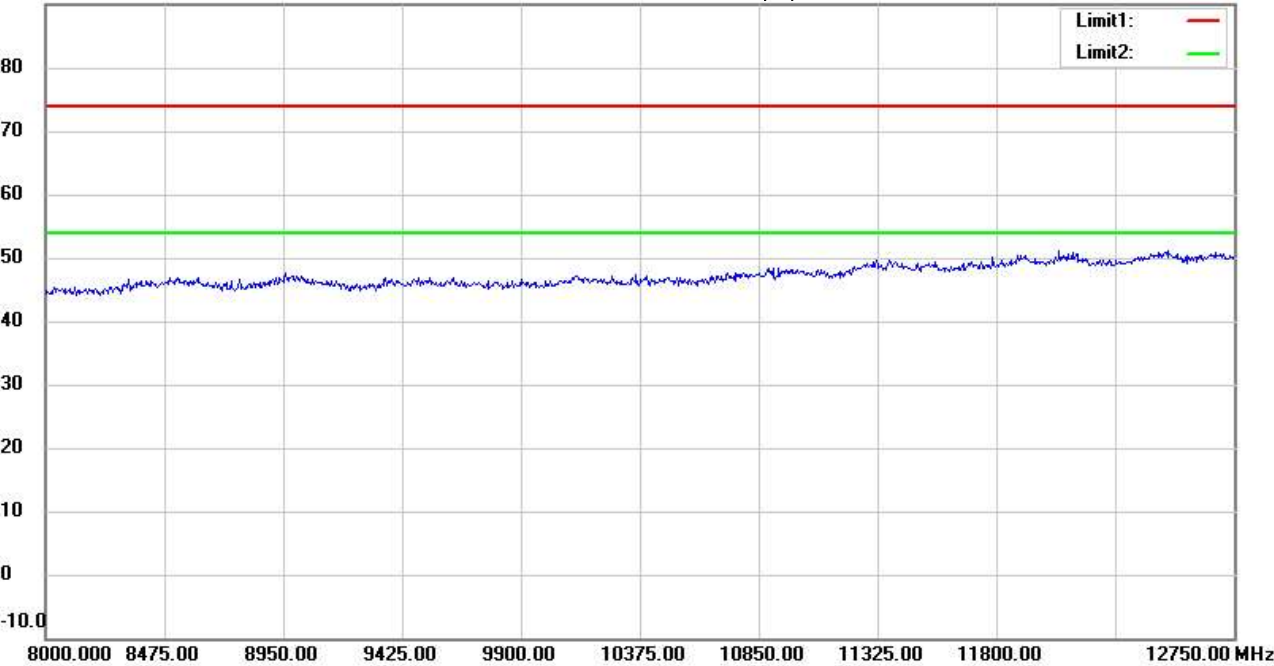
Data :#3

Condition : FCC\_part 15E RE\_Above 1GHz\_PK

Test Mode : TX 802.11a CH105

Polarization: *Horizontal*

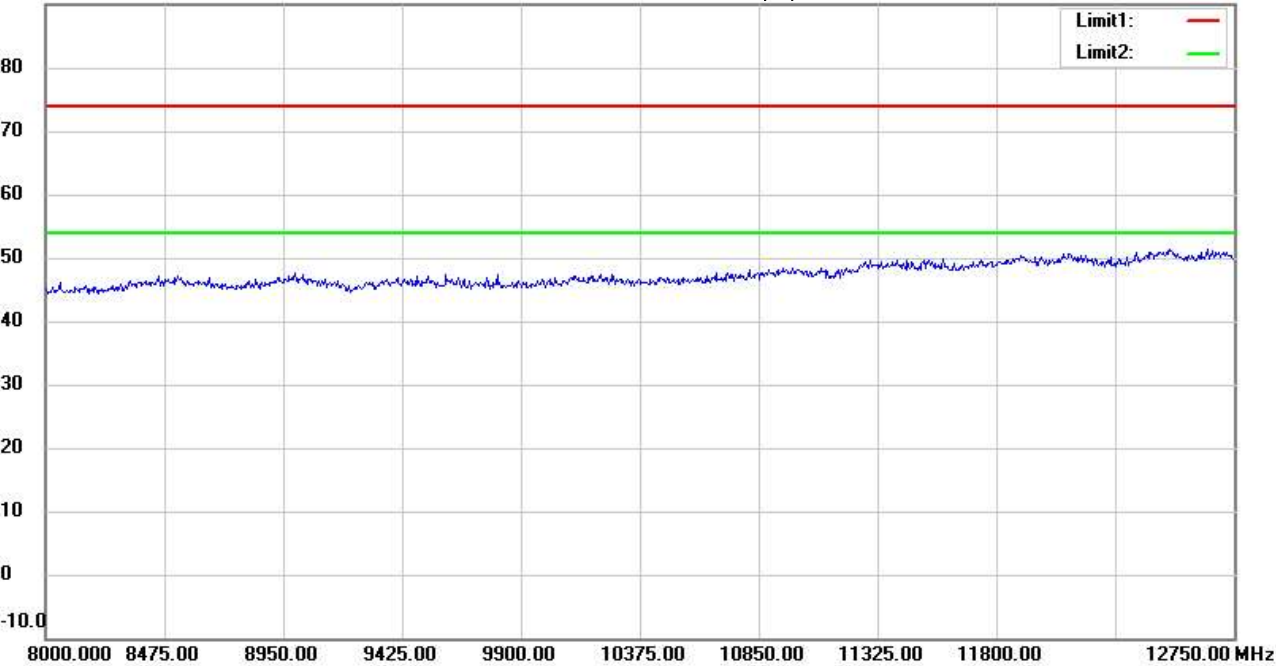
Data :#9

Site : 966A Chamber  
Condition : FCC\_part 15E RE\_Above 1GHz\_PK  
EUT : W6M22409-23739  
M/N:  
Test Mode : TX 802.11a CH105  
Note :

Polarization: Vertical  
Power : 120 V.a.c.  
Distance: 3m

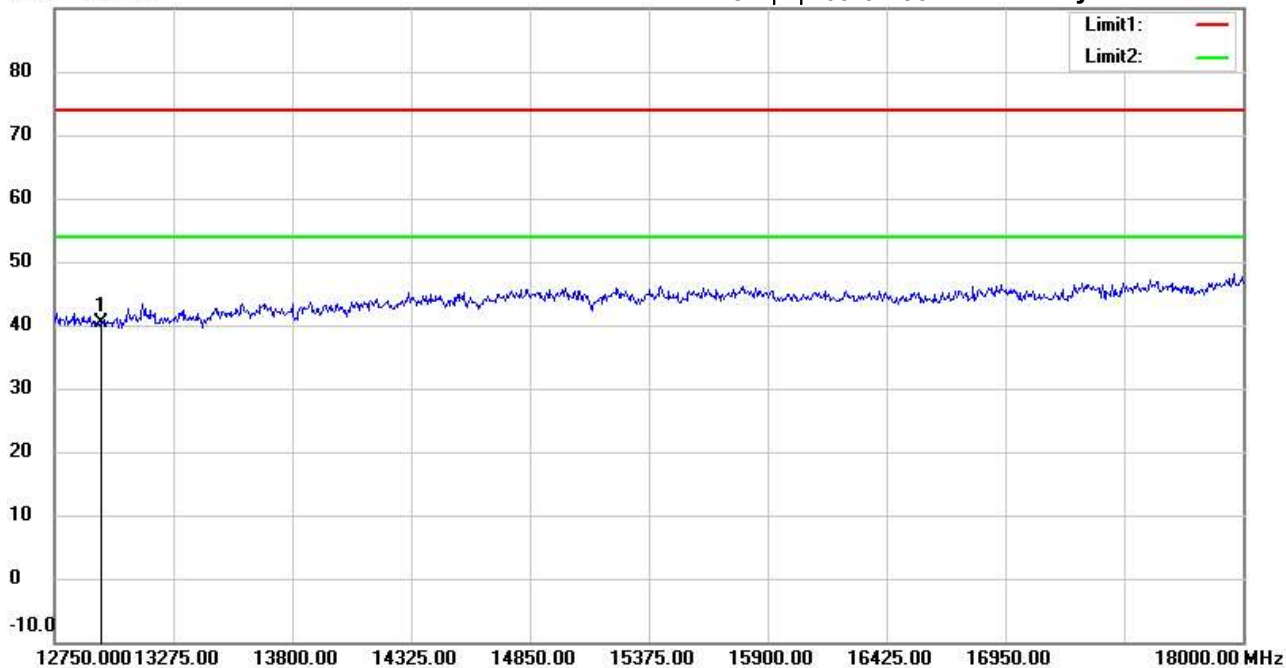
Data : #4

Condition : FCC\_part 15E RE\_Above 1GHz\_PK

Test Mode : TX 802.11a CH105

Polarization: **Horizontal**

| Mk. | Frequency (MHz) | Reading (dBuV) | Detector | Corr. factor (dB/m) | Result (dBuV/m) | Limit (dBuV/m) | Ant.Pos (cm) | Tab.Pos (deg.) | Margin (dB) | Comment |
|---|---|---|---|---|---|---|---|---|---|---|
| * | 12950.000 | 23.02 | peak | 17.30 | 40.32 | 74.00 | 150 | 355 | -33.68 | |

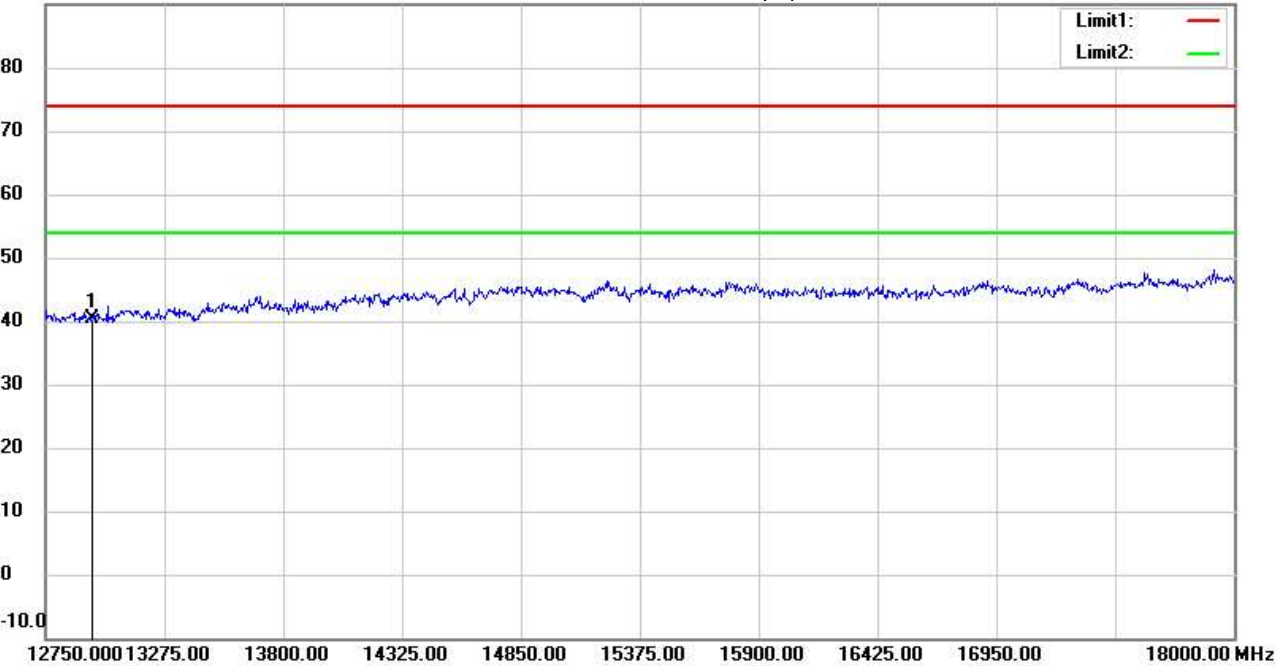
Data :#10

Site : 966A Chamber  
Condition : FCC\_part 15E RE\_Above 1GHz\_PK  
EUT : W6M22409-23739  
M/N:  
Test Mode : TX 802.11a CH105  
Note :

Polarization: Vertical  
Power : 120 Va.c.  
Distance: 3m

| Mk. | Frequency (MHz) | Reading (dBuV) | Detector | Corr. factor (dB/m) | Result (dBuV/m) | Limit (dBuV/m) | Ant.Pos (cm) | Tab.Pos (deg.) | Margin (dB) | Comment |
|---|---|---|---|---|---|---|---|---|---|---|
| * | 12950.000 | 23.09 | peak | 17.30 | 40.39 | 74.00 | 150 | 359 | -33.61 | |
