Radiated Emission Measurement

Condition : FCC\_part 15E RE\_Above 1GHz\_PK

EUT : W6M22409-23739

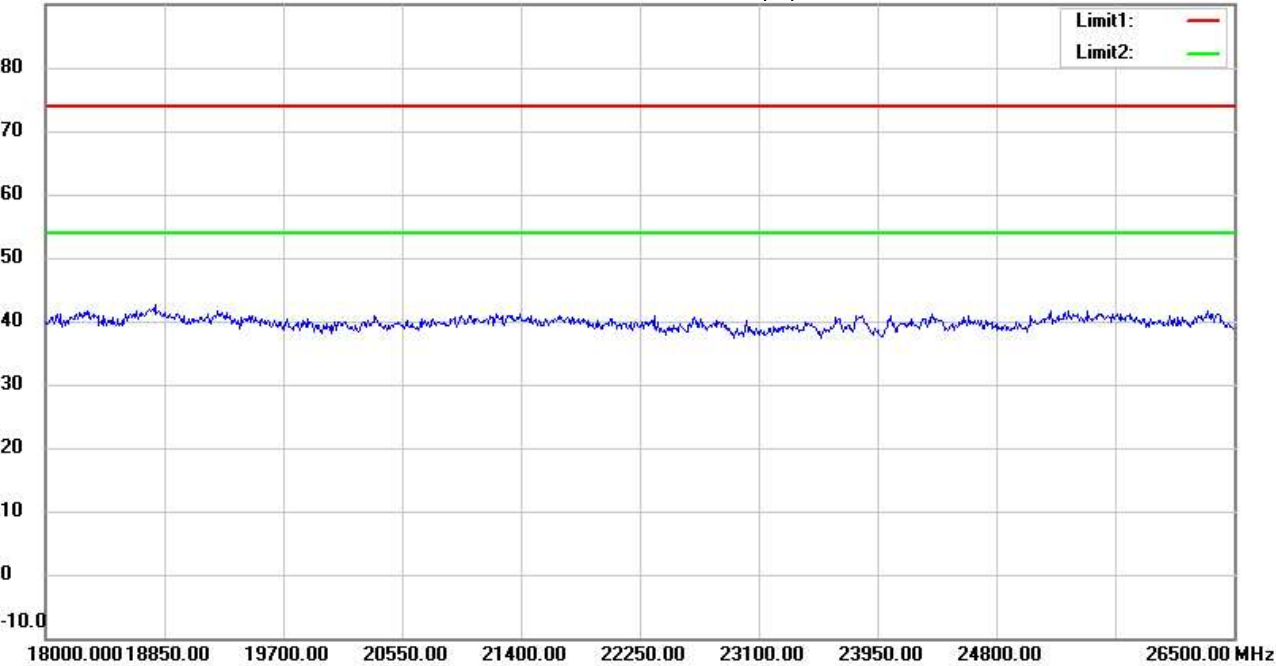
Data :#5

Site : 966A Chamber  
Condition : FCC\_part 15E RE\_Above 1GHz\_PK  
EUT : W6M22409-23739  
M/N:  
Test Mode : TX 802.11a CH105  
Note :

Polarization: Horizontal  
Power : 120 Va.c.  
Distance: 3m

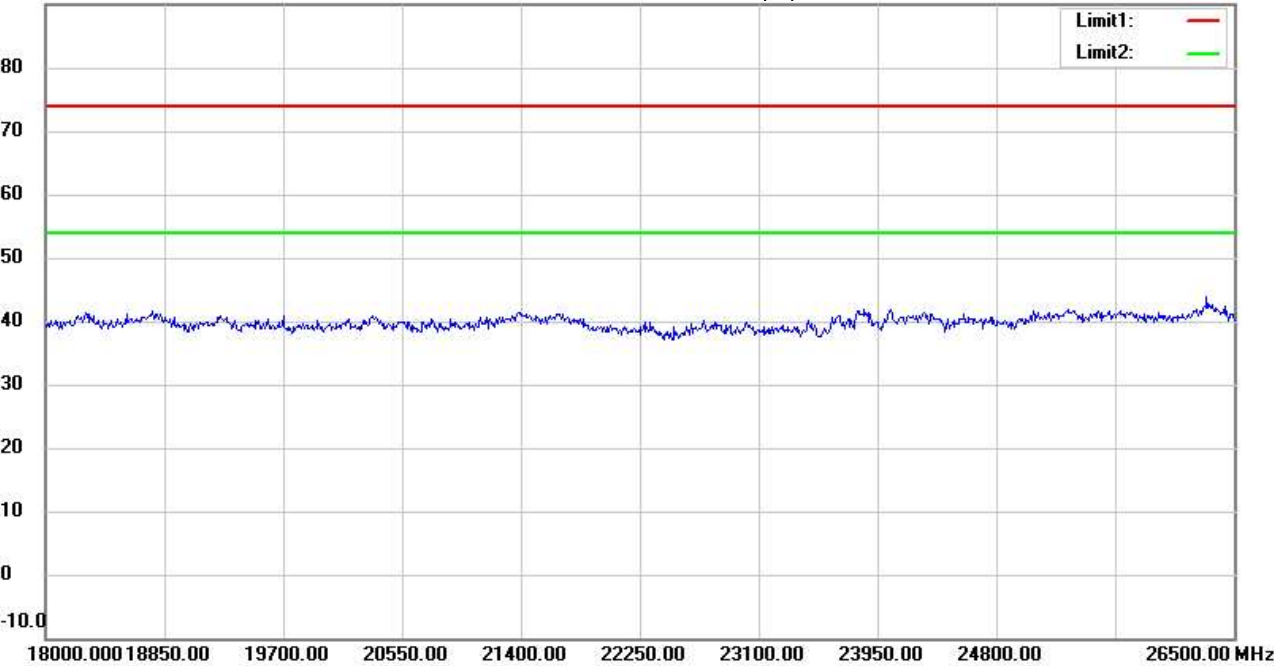
Data :#11

Site : 966A Chamber  
Condition : FCC\_part 15E RE\_Above 1GHz\_PK  
EUT : W6M22409-23739  
M/N:  
Test Mode : TX 802.11a CH105  
Note :

Polarization: Vertical  
Power : 120 Va.c.  
Distance: 3m
