**FCC PART 15 SUBPART E TEST REPORT**  
**for**  
**Notebook Computer**  
**Model No.: RB14**  
**FCC ID: IR5RB14**

**Worldwide Testing Services (Taiwan) Co., Ltd.**

**Report No.: W6M22005-19938-C-54**

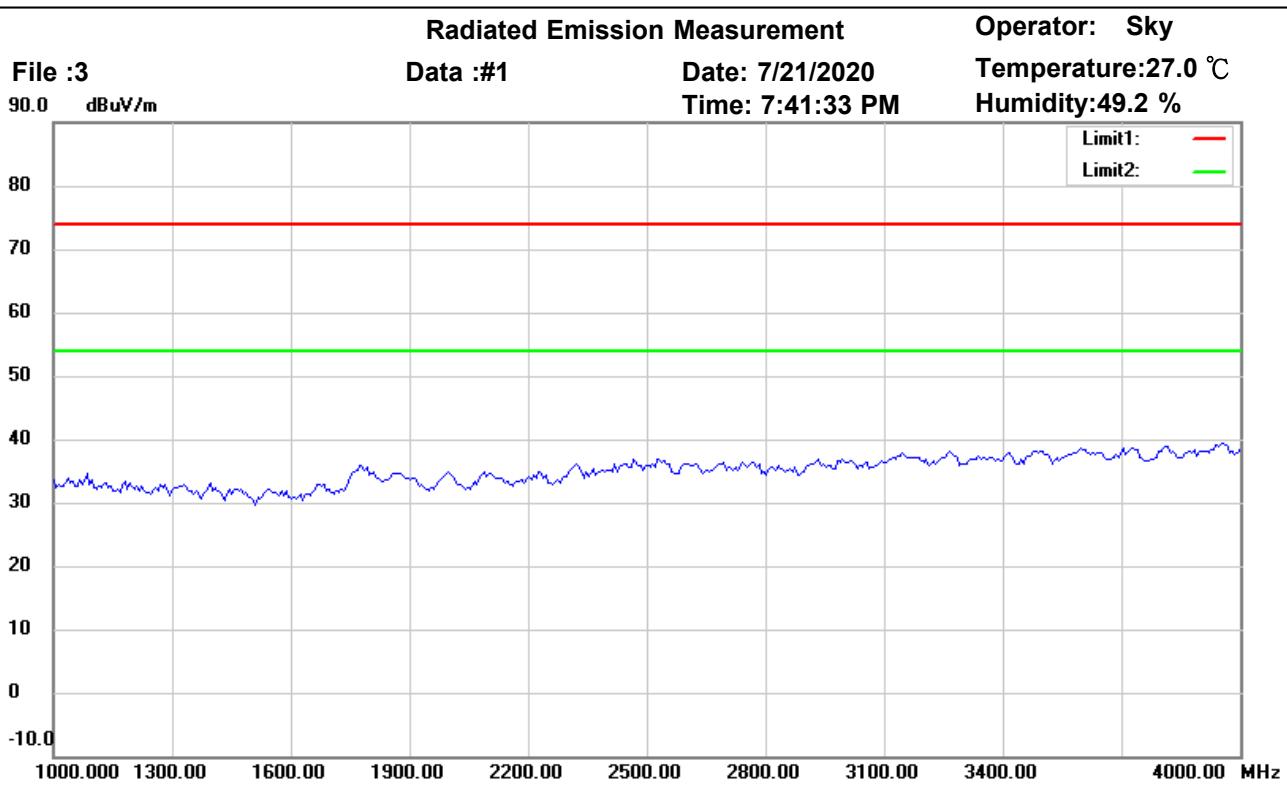
Site : Chamber

Condition : FCC\_part 15E RE\_Above 1GHz\_PK

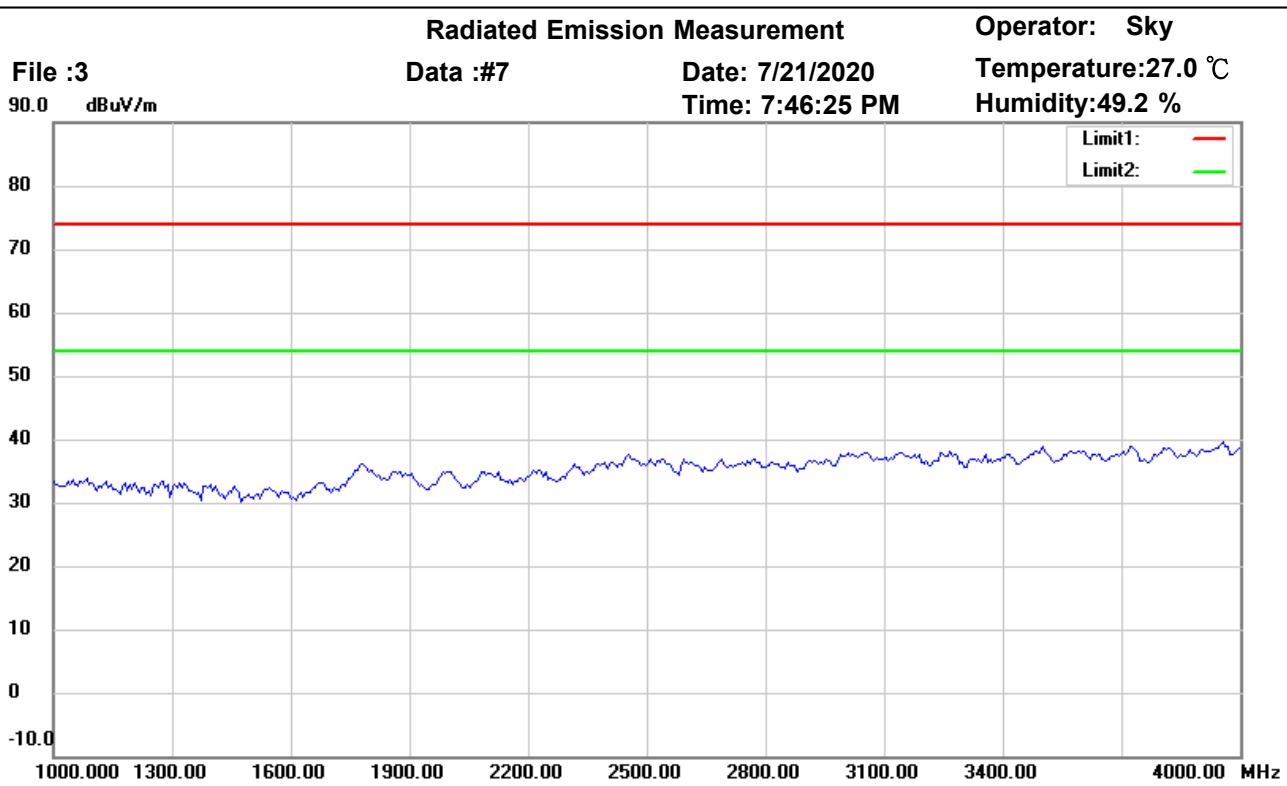
Site : Chamber

Condition : FCC\_part 15E RE\_Above 1GHz\_PK

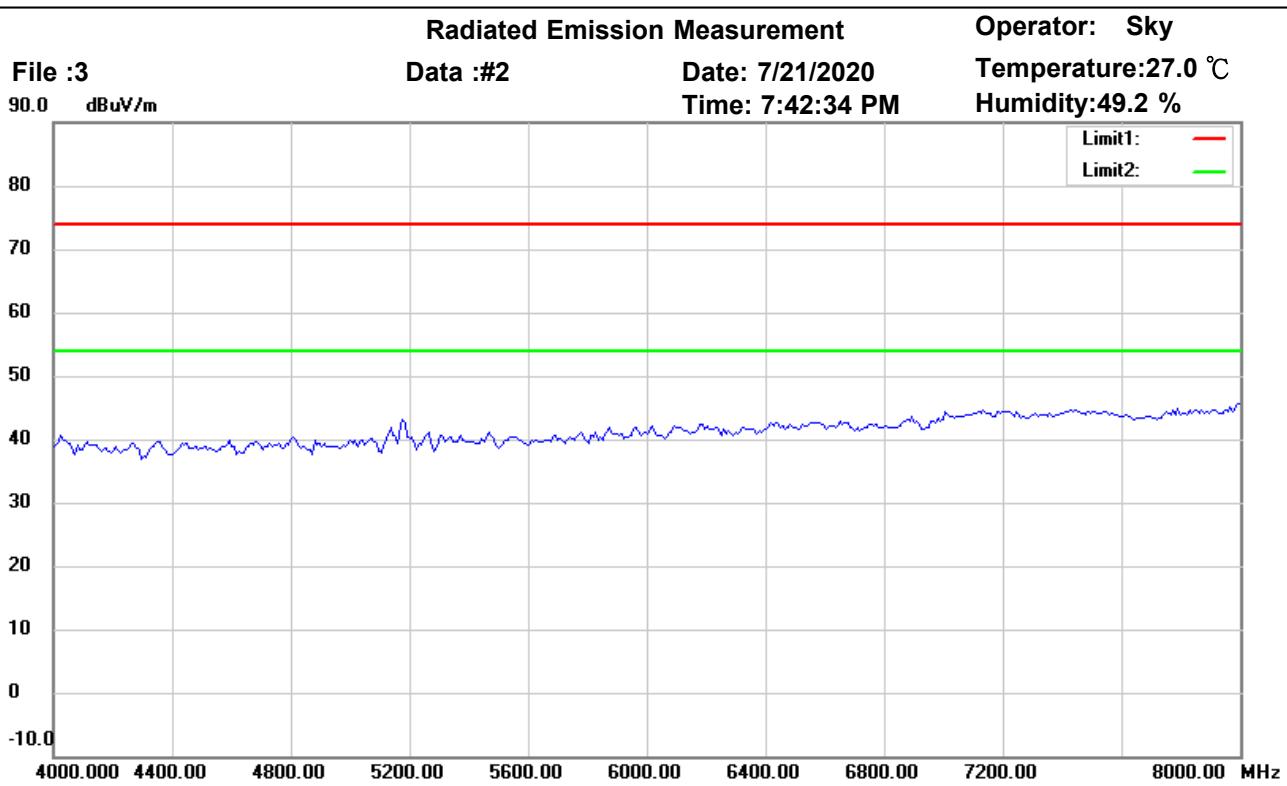
Site : Chamber

Condition : FCC\_part 15E RE\_Above 1GHz\_PK

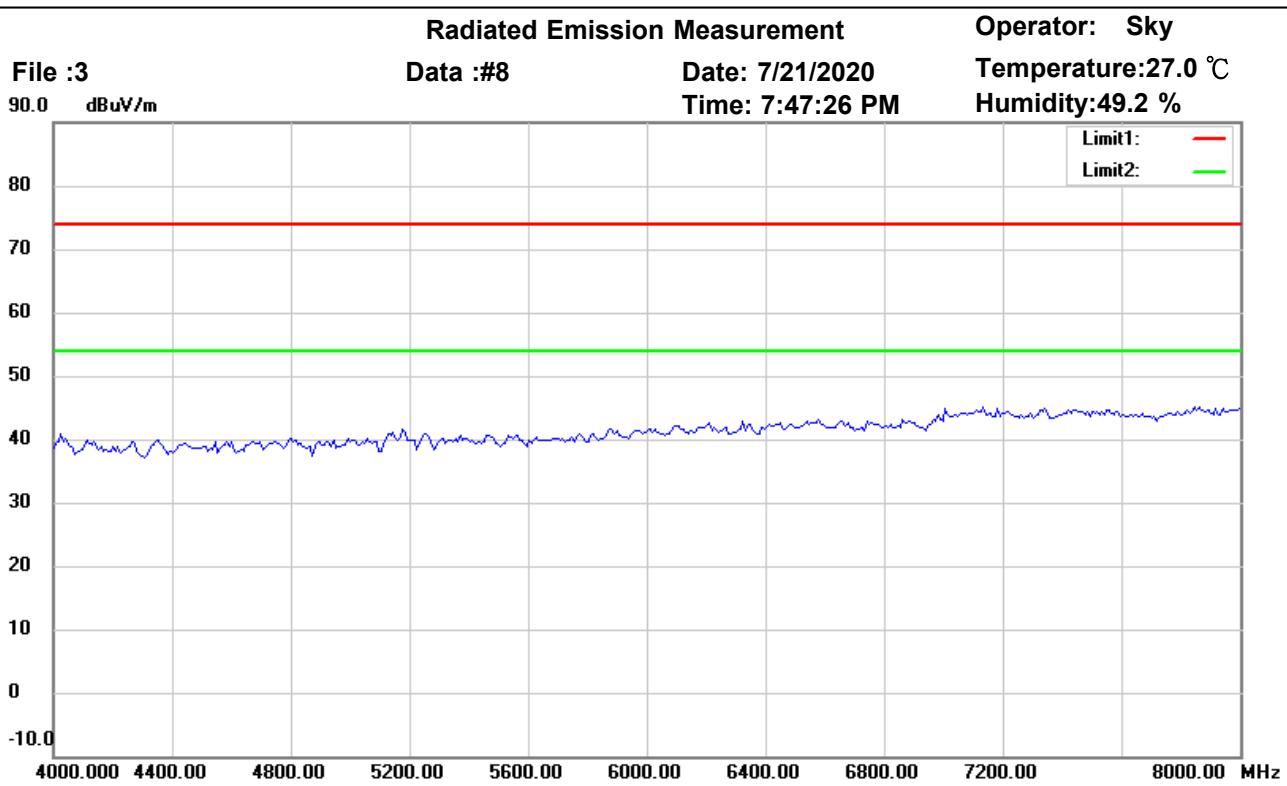
Site : Chamber

Condition : FCC\_part 15E RE\_Above 1GHz\_PK
