### **APPENDIX 3: Photographs of test setup**

#### **Radiated Spurious Emission** (Below 1GHz)

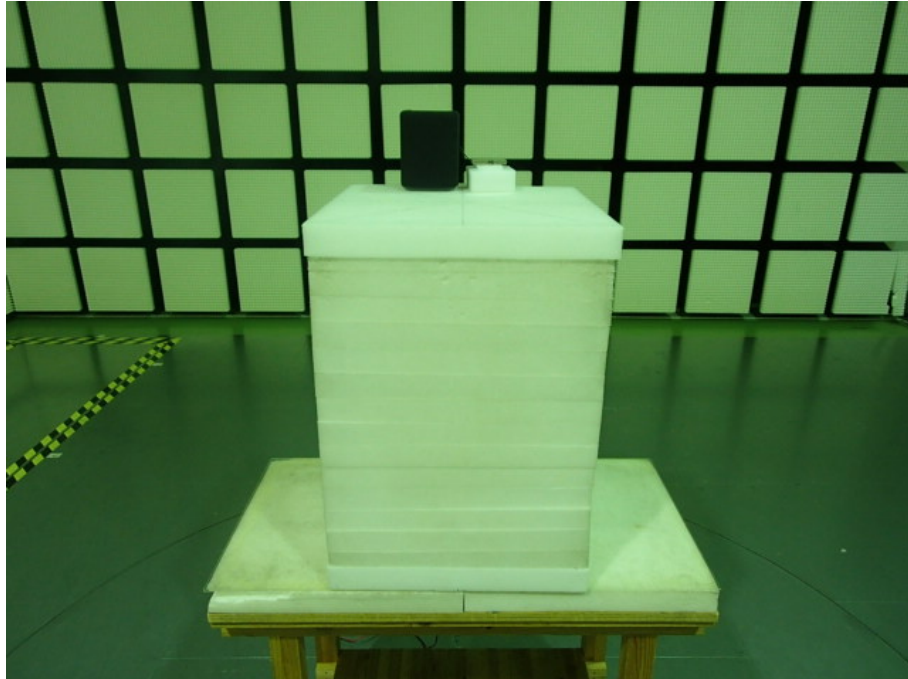
**Photo 1**

**Radiated Spurious Emission**  
(Above 1GHz)

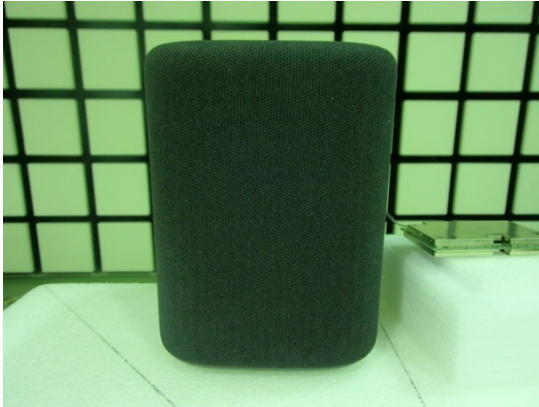
**Antenna  
Nomal**

Antenna (Nomal Position)

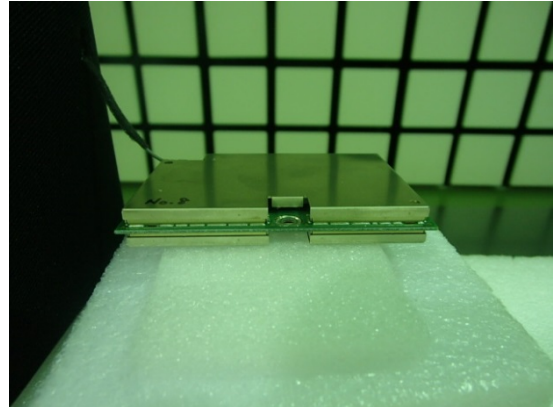
**Module  
X-axis**

Module (Above 1GHz (Horizontal:X-axis/ Vertical:X-axis)

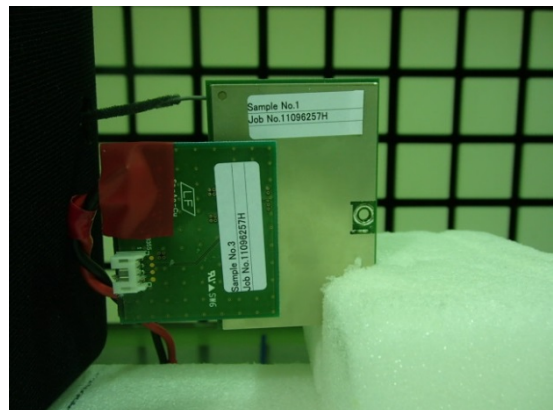
**Z-axis**

Module (Below 1GHz (Horizontal:Z-axis/ Vertical:Z-axis)
