Radiated Emission Measurement

Condition : FCC\_part 15E RE\_Above 1GHz\_PK

EUT : W6M22409-23739

Test Mode : TX 802.11ax20 CH93

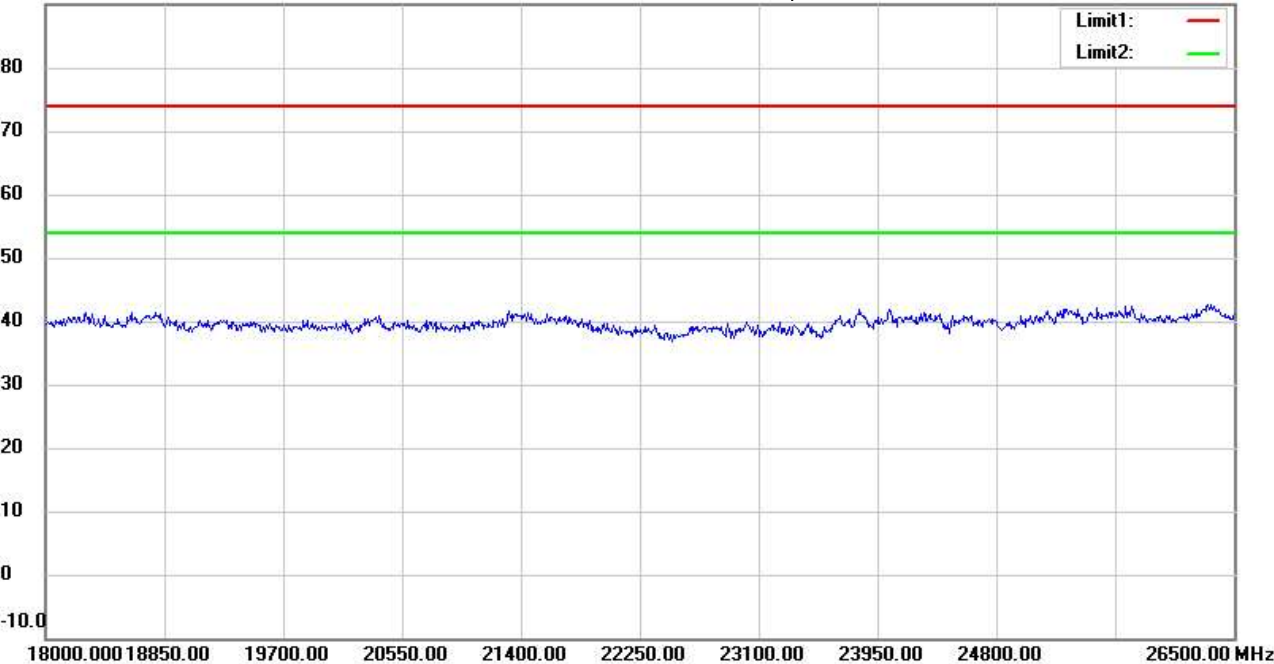
Data :#11

Test Mode : TX 802.11ax20 CH93

Polarization: Vertical

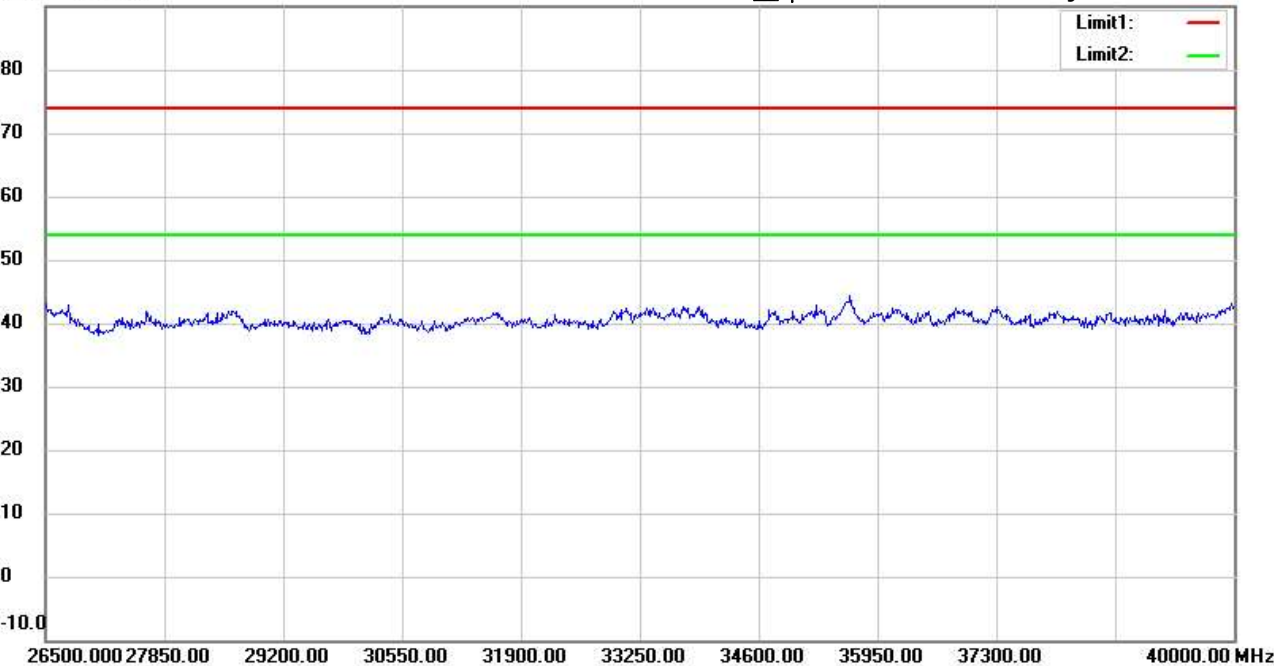
Data :#6

Test Mode : TX 802.11ax20 CH93

Polarization: Horizontal

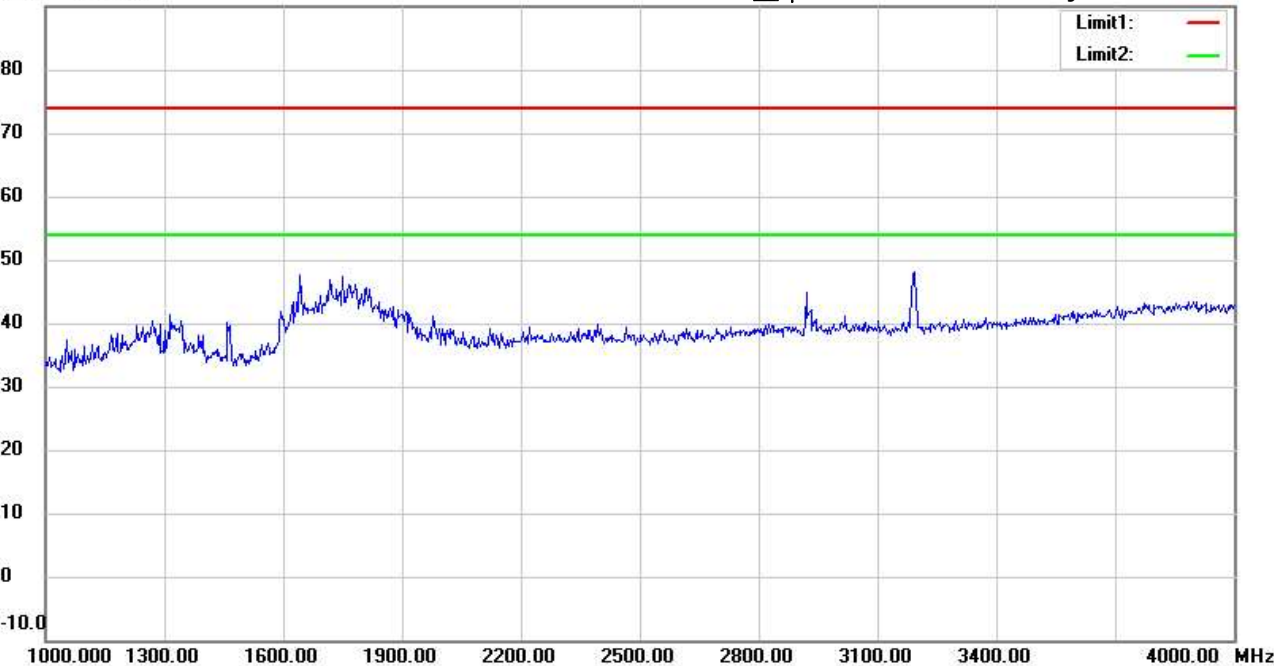
Data :#7

Test Mode : TX 802.11ax40 CH3

Polarization: Vertical

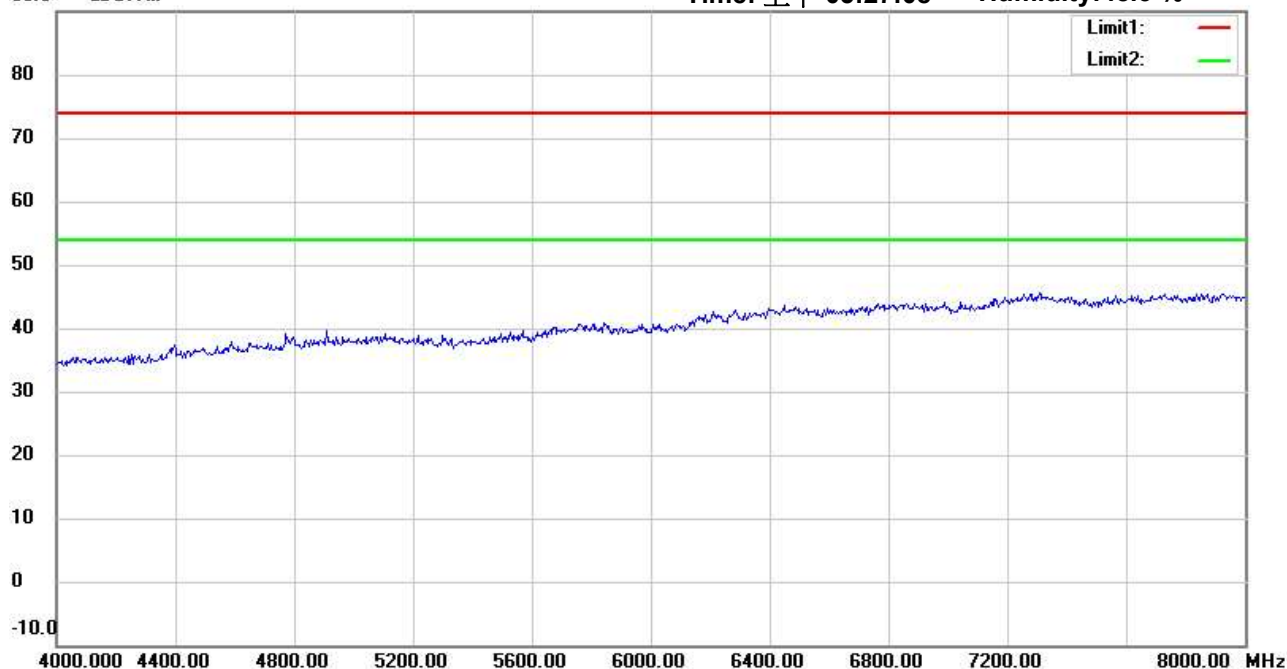
Data : #8

Test Mode : TX 802.11ax40 CH3

Polarization: Vertical

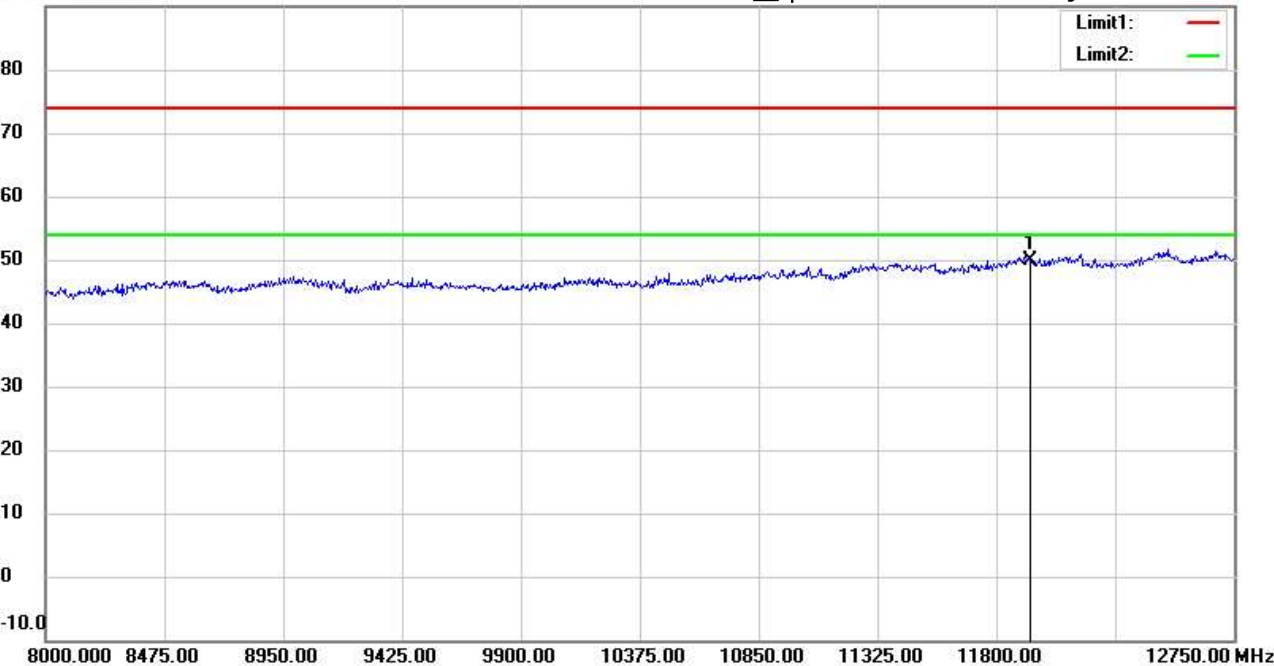
Data :#3

Test Mode : TX 802.11ax40 CH3

Polarization: *Horizontal*

| Mk. | Frequency (MHz) | Reading (dBuV) | Detector | Corr. factor (dB/m) | Result (dBuV/m) | Limit (dBuV/m) | Ant.Pos (cm) | Tab.Pos (deg.) | Margin (dB) | Comment |
|---|---|---|---|---|---|---|---|---|---|---|
| * | 11930.000 | 33.75 | peak | 16.10 | 49.85 | 74.00 | 150 | 73 | -24.15 | |

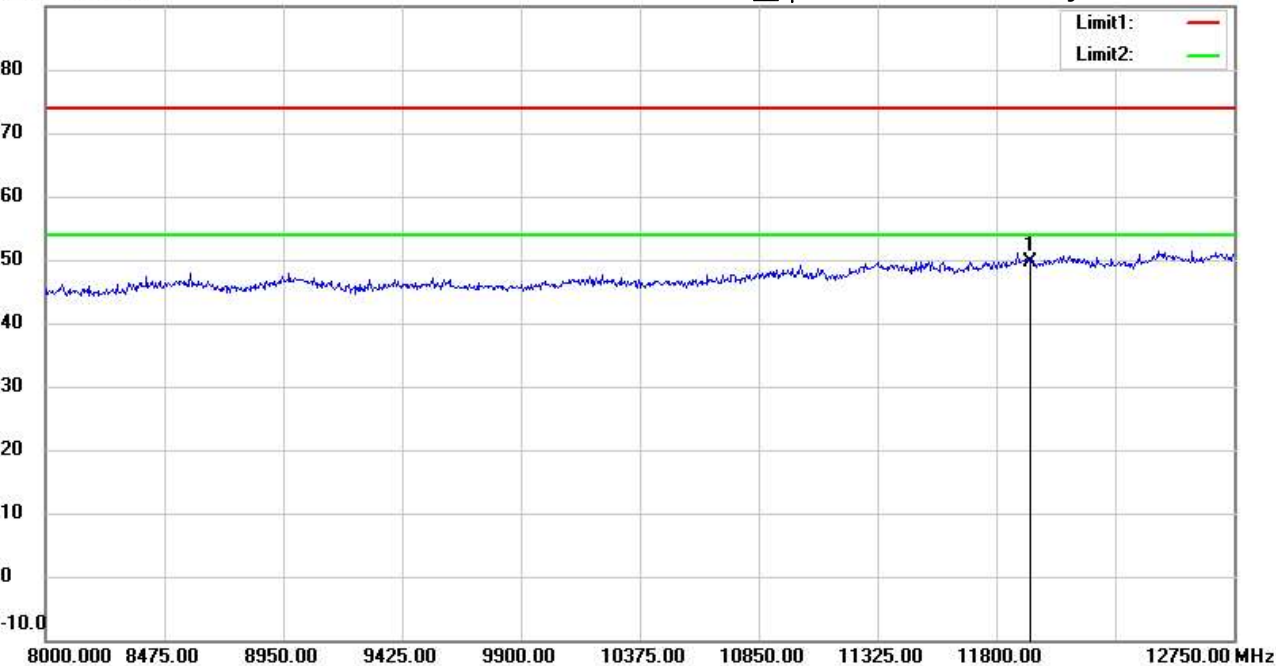
Data :#9

Test Mode : TX 802.11ax40 CH3

Polarization: Vertical

| Mk. | Frequency (MHz) | Reading (dBuV) | Detector | Corr. factor (dB/m) | Result (dBuV/m) | Limit (dBuV/m) | Ant.Pos (cm) | Tab.Pos (deg.) | Margin (dB) | Comment |
|---|---|---|---|---|---|---|---|---|---|---|
| * | 11930.000 | 33.51 | peak | 16.10 | 49.61 | 74.00 | 150 | 254 | -24.39 | |

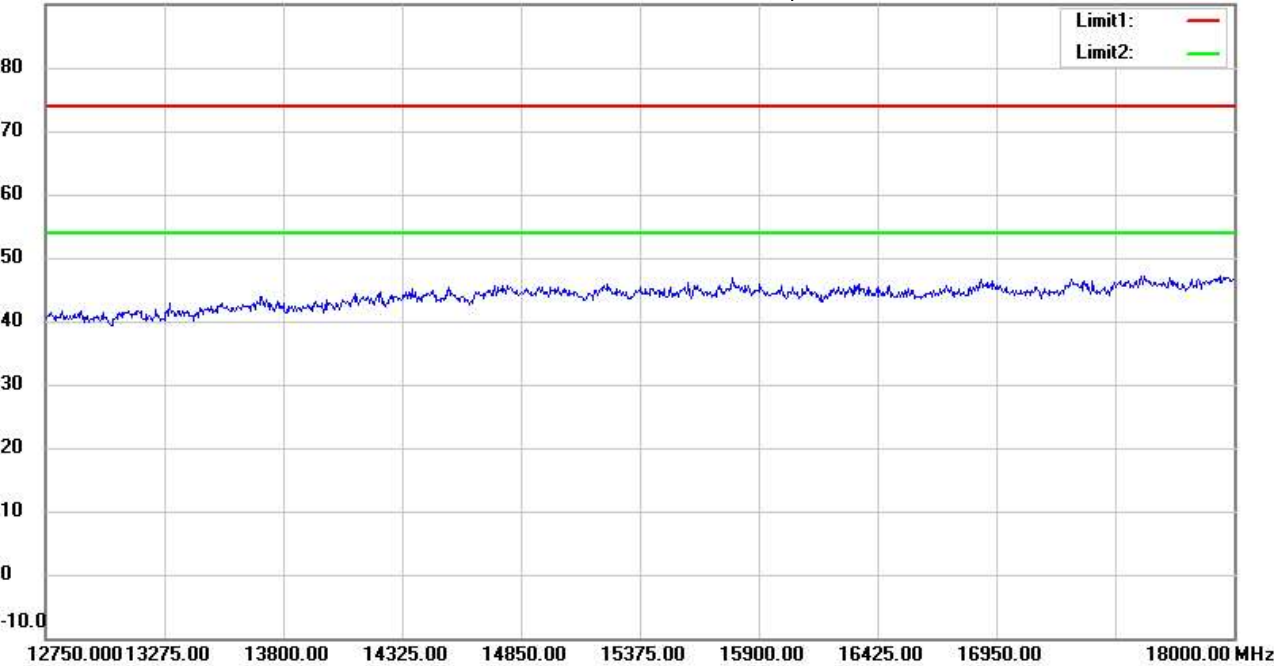
Data :#10

Test Mode : TX 802.11ax40 CH3

Polarization: Vertical

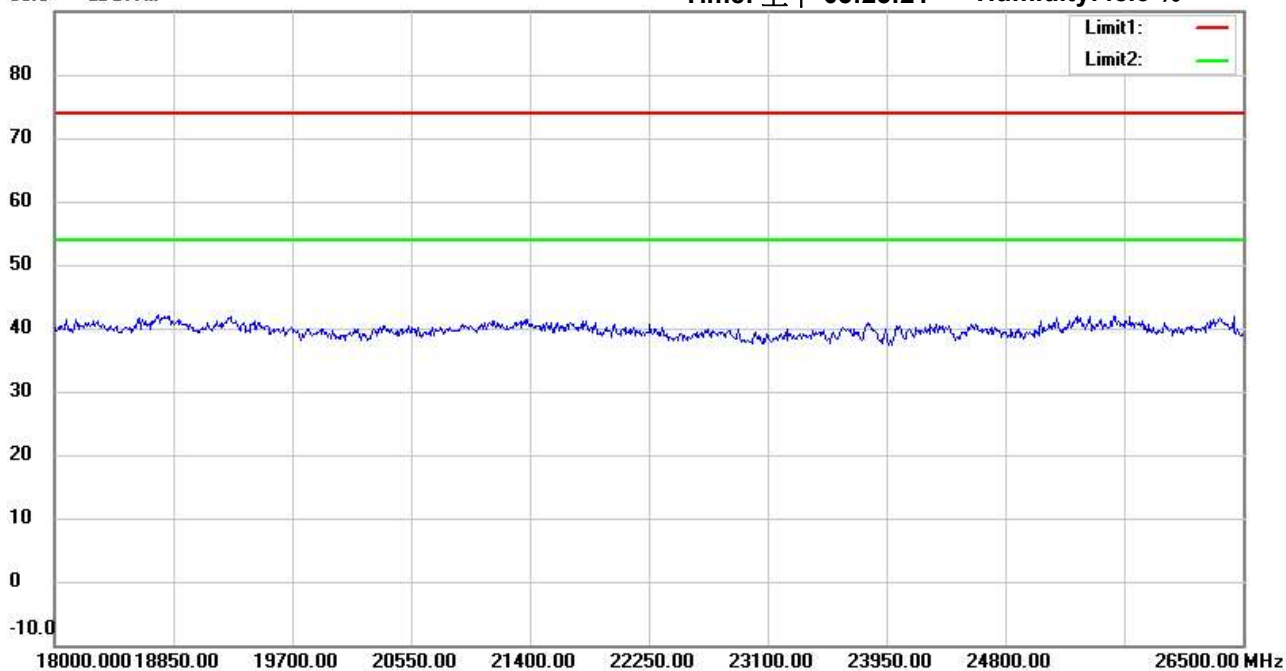
Data : #5

Test Mode : TX 802.11ax40 CH3

Polarization: **Horizontal**

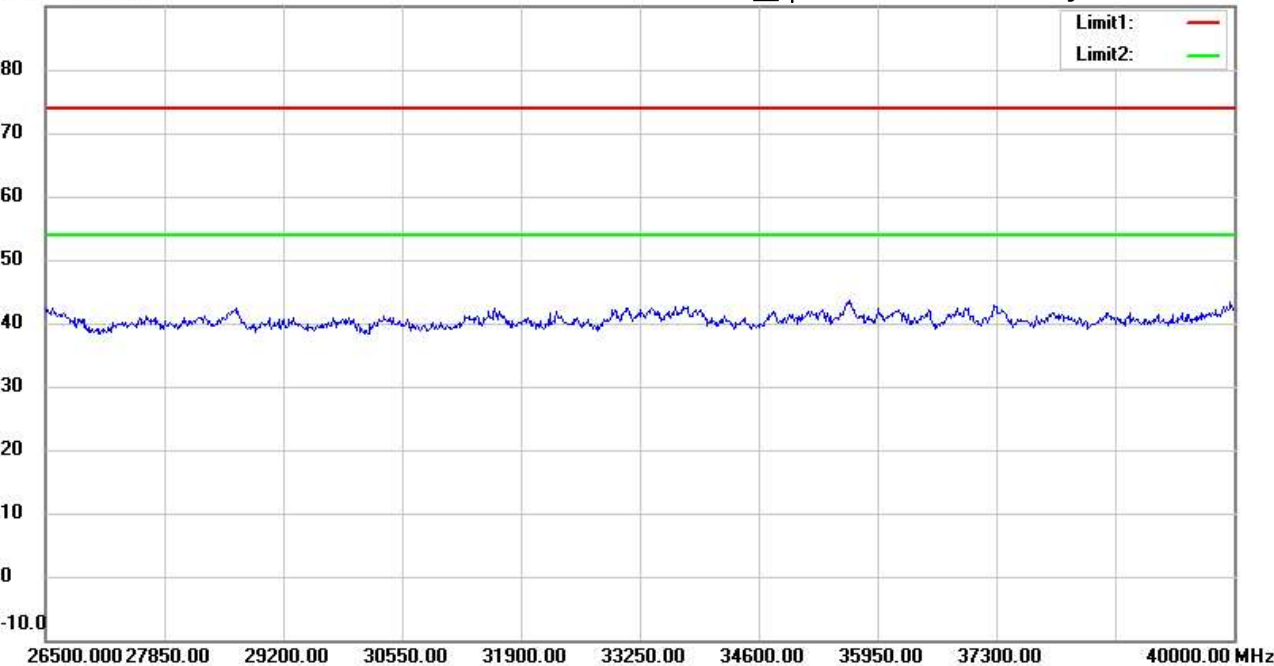
Data :#6

Test Mode : TX 802.11ax40 CH3

Polarization: **Horizontal**

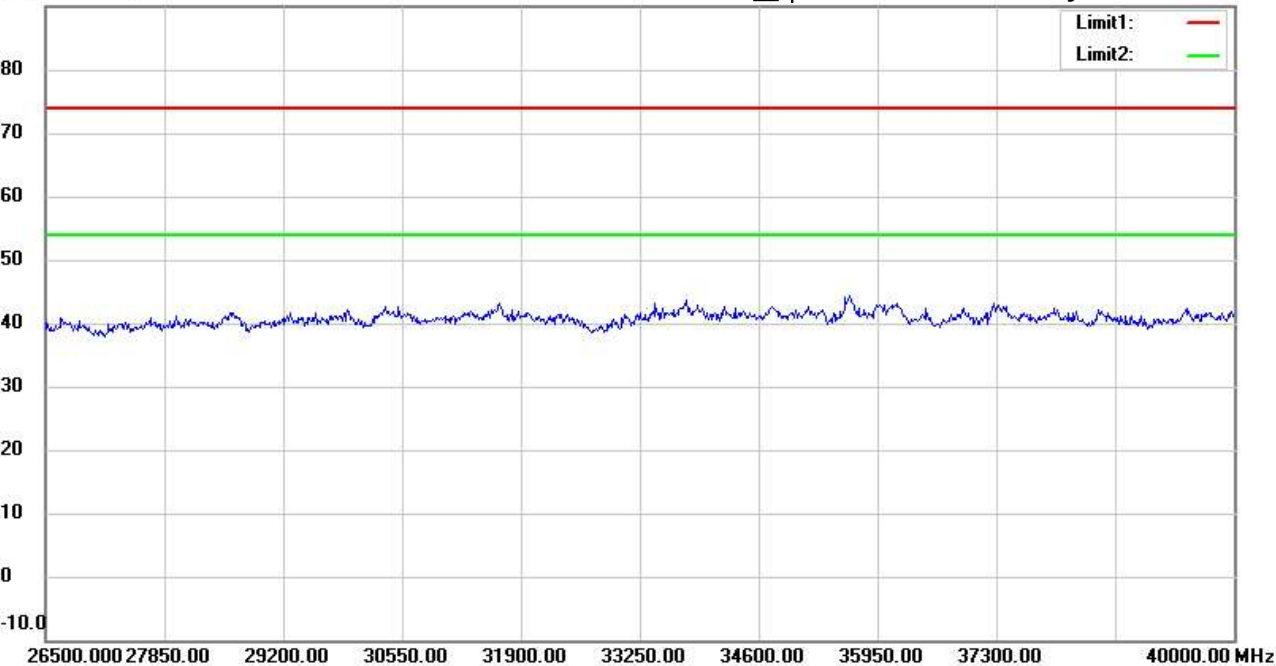
Data :#12

Test Mode : TX 802.11ax40 CH3

Polarization: Vertical

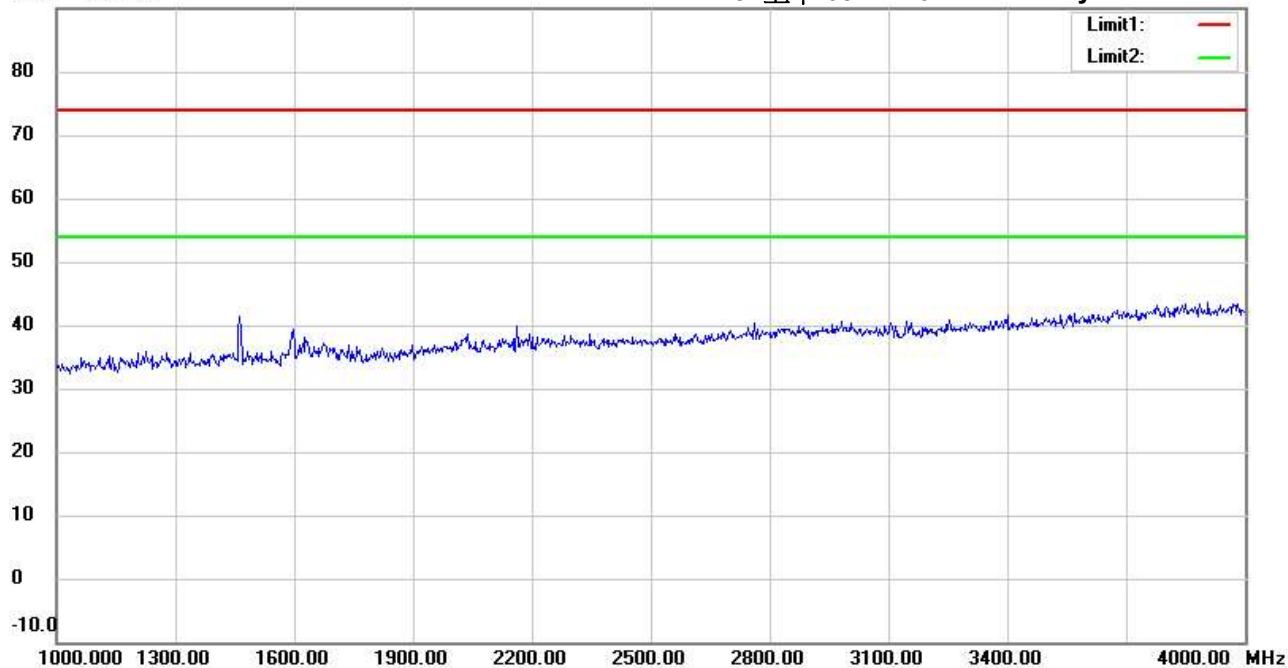
Data : #1

Test Mode : TX 802.11ax40 CH43

Polarization: **Horizontal**

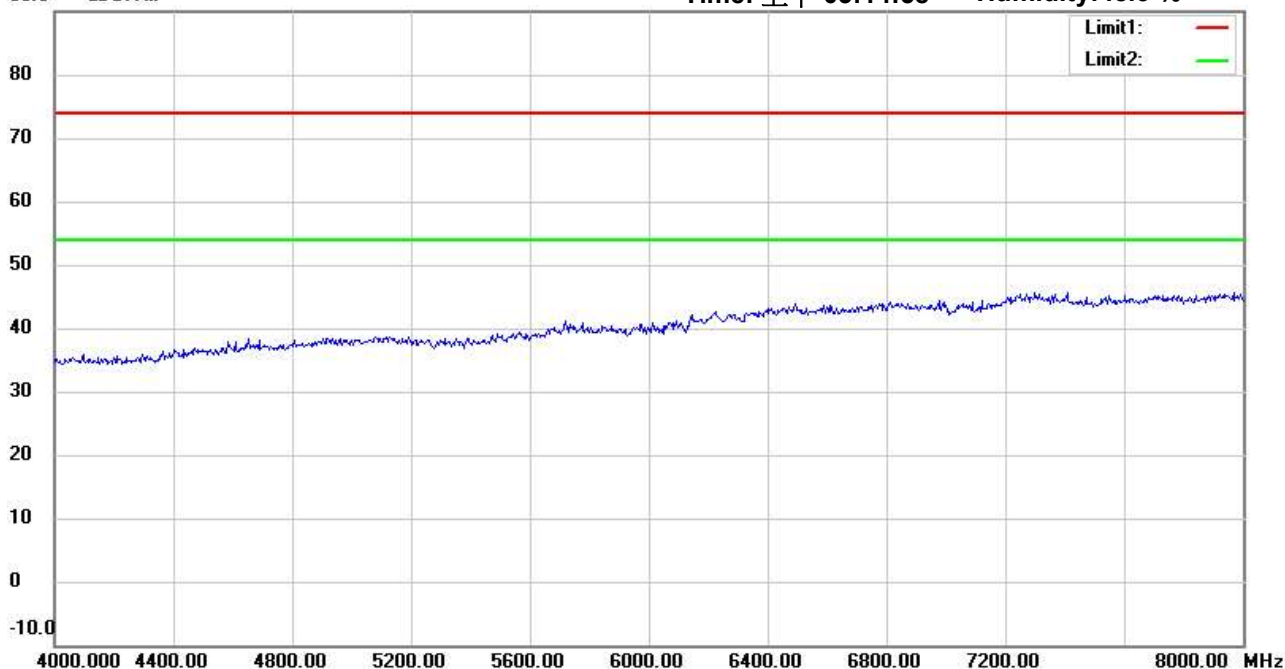
Data : #2

Test Mode : TX 802.11ax40 CH43

Polarization: **Horizontal**

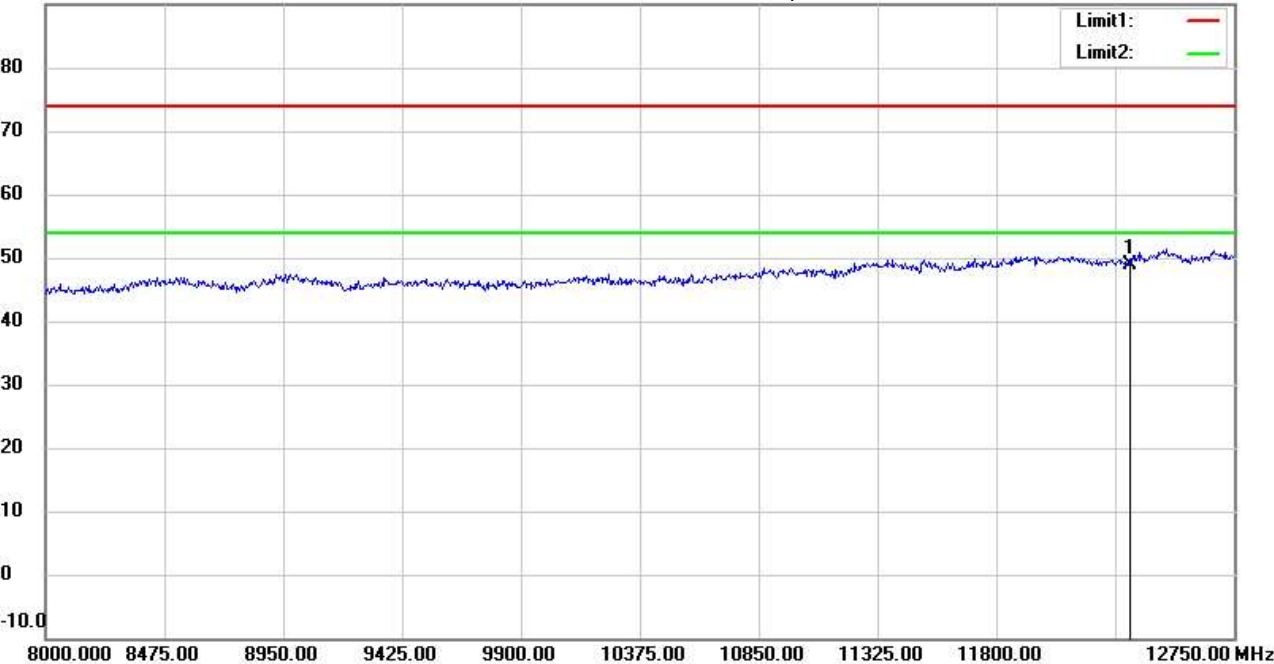
Data :#9

Test Mode : TX 802.11ax40 CH43

Polarization: Vertical

| Mk. | Frequency (MHz) | Reading (dBuV) | Detector | Corr. factor (dB/m) | Result (dBuV/m) | Limit (dBuV/m) | Ant.Pos (cm) | Tab.Pos (deg.) | Margin (dB) | Comment |
|---|---|---|---|---|---|---|---|---|---|---|
| * | 12330.000 | 32.59 | peak | 16.28 | 48.87 | 74.00 | 150 | 285 | -25.13 | |

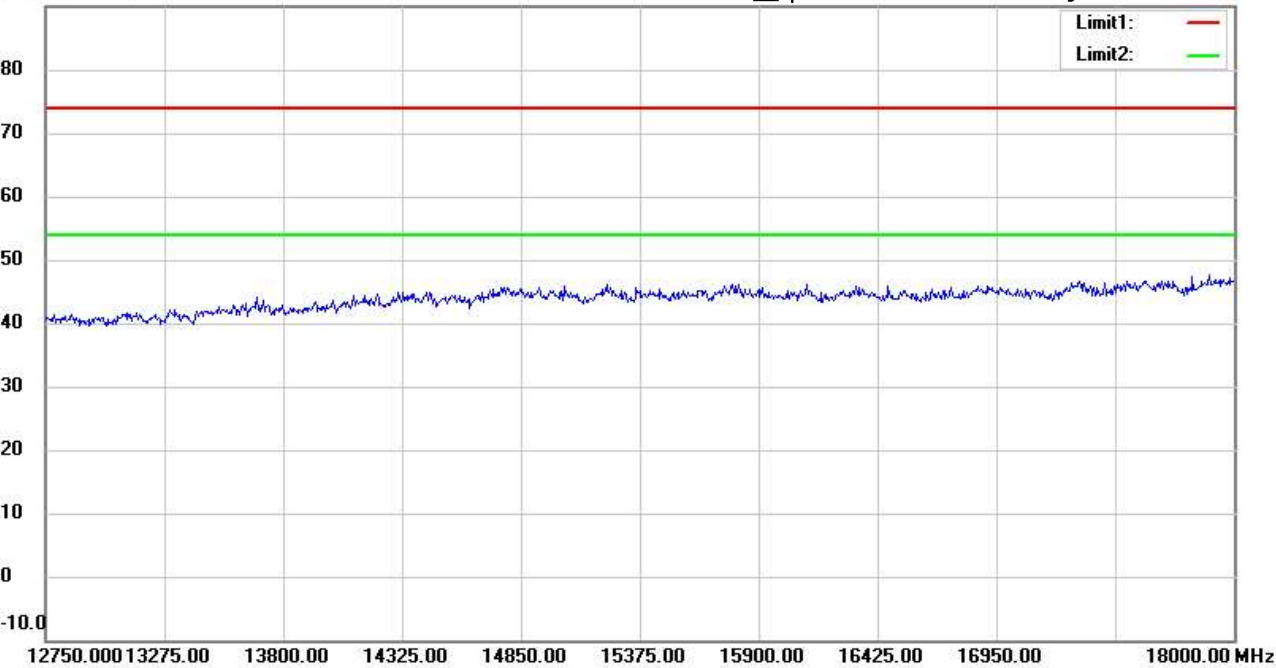
Data :#4

Test Mode : TX 802.11ax40 CH43

Polarization: *Horizontal*

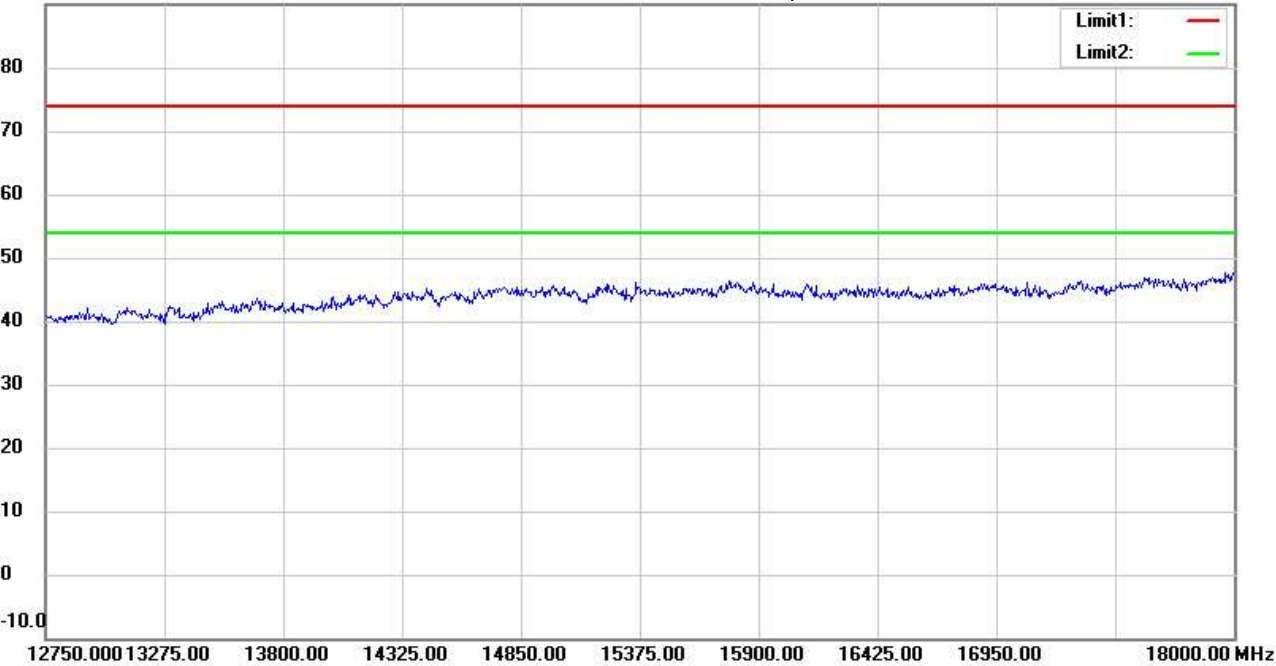
Data :#10

Test Mode : TX 802.11ax40 CH43

Polarization: Vertical

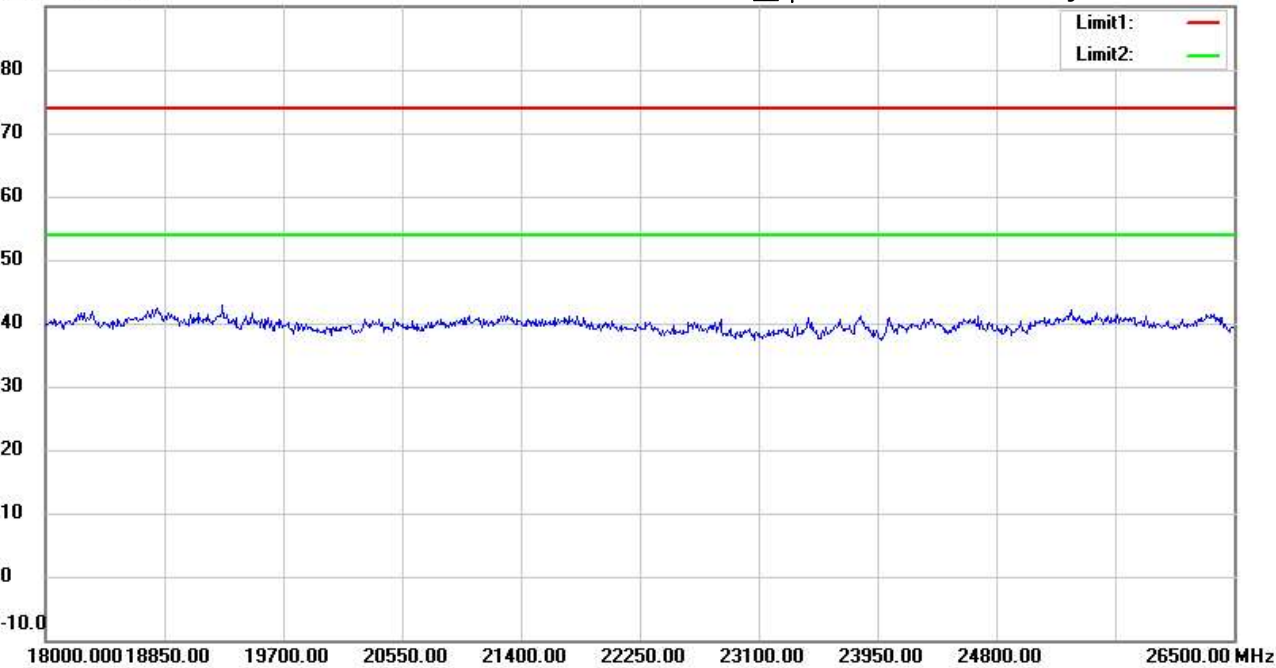
Data :#5

Test Mode : TX 802.11ax40 CH43

Polarization: **Horizontal**

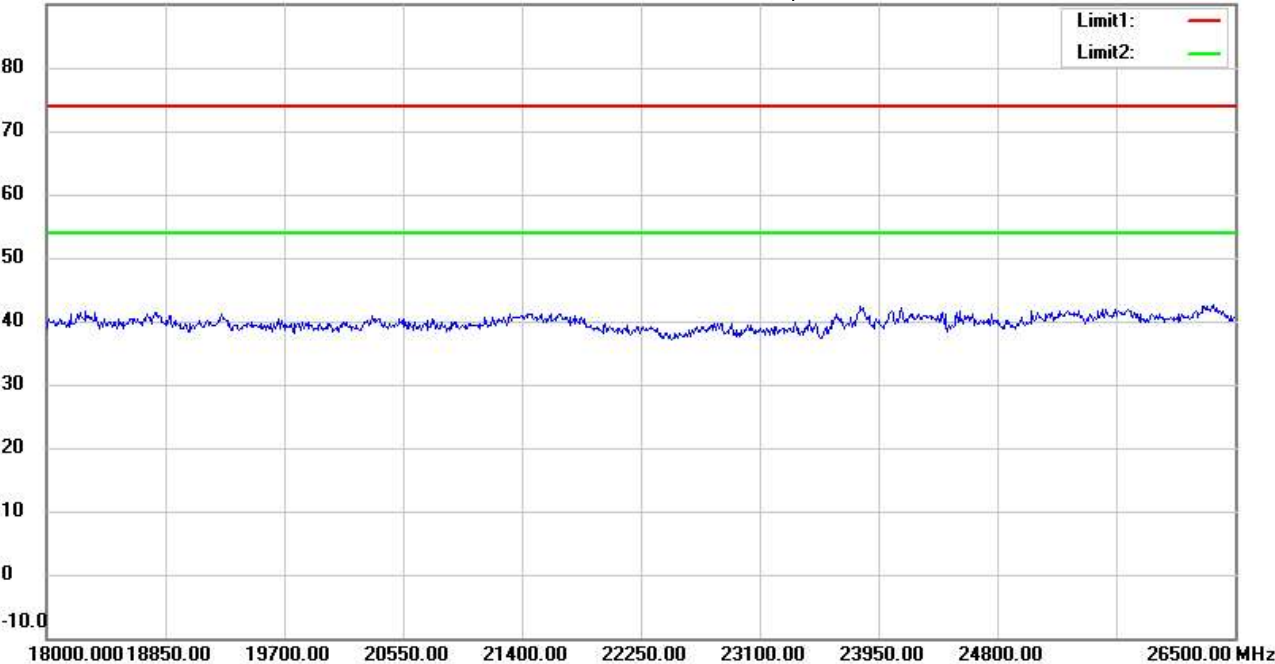
Data :#11

Test Mode : TX 802.11ax40 CH43

Polarization: Vertical
