### **APPENDIX 3: Photographs of test setup**

#### **Radiated Emission**

## 4.2 Configuration and peripherals

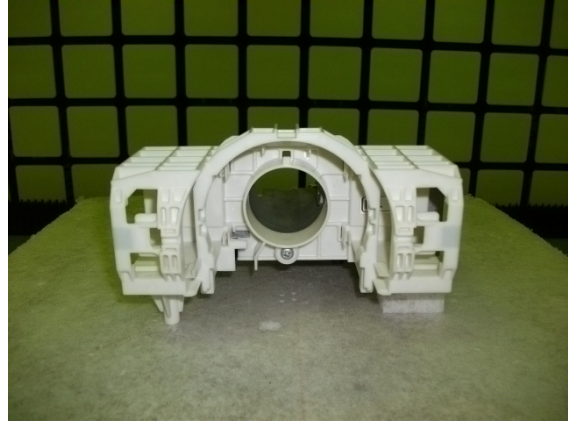
**ECU**  
Below30MHz: X-axis  
Above30MHz Hori:Z / Vert:X  
X-axis
