Radiated Emission Measurement

Condition : FCC\_part 15E RE\_Above 1GHz\_PK

EUT : W6M22409-23739

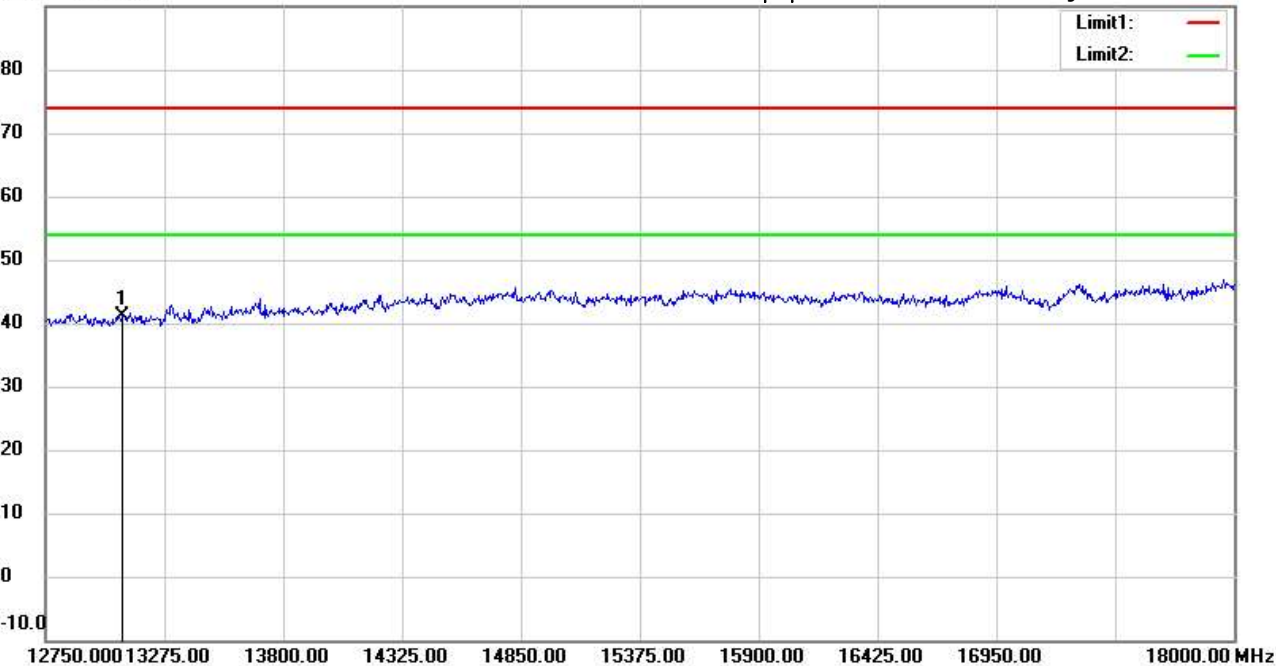
Data :#10

Site : 966A Chamber

Condition : FCC\_part 15E RE\_Above 1GHz\_PK

Polarization: Vertical

| Mk. | Frequency (MHz) | Reading (dBuV) | Detector | Corr. factor (dB/m) | Result (dBuV/m) | Limit (dBuV/m) | Ant.Pos (cm) | Tab.Pos (deg.) | Margin (dB) | Comment |
|---|---|---|---|---|---|---|---|---|---|---|
| * | 13090.000 | 23.98 | peak | 17.26 | 41.24 | 74.00 | 150 | 359 | -32.76 | |

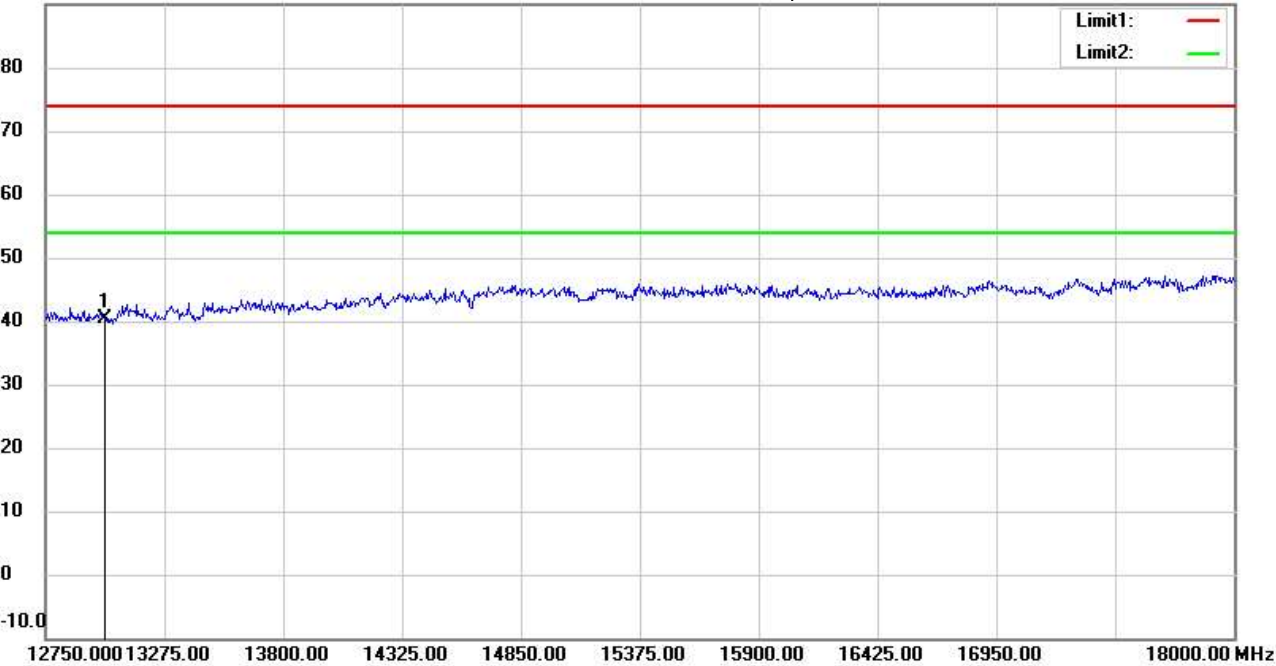
Data :#4

Site : 966A Chamber

Condition : FCC\_part 15E RE\_Above 1GHz\_PK

Polarization: *Horizontal*

| Mk. | Frequency (MHz) | Reading (dBuV) | Detector | Corr. factor (dB/m) | Result (dBuV/m) | Limit (dBuV/m) | Ant.Pos (cm) | Tab.Pos (deg.) | Margin (dB) | Comment |
|---|---|---|---|---|---|---|---|---|---|---|
| * | 13010.000 | 23.35 | peak | 17.05 | 40.40 | 74.00 | 150 | 111 | -33.60 | |

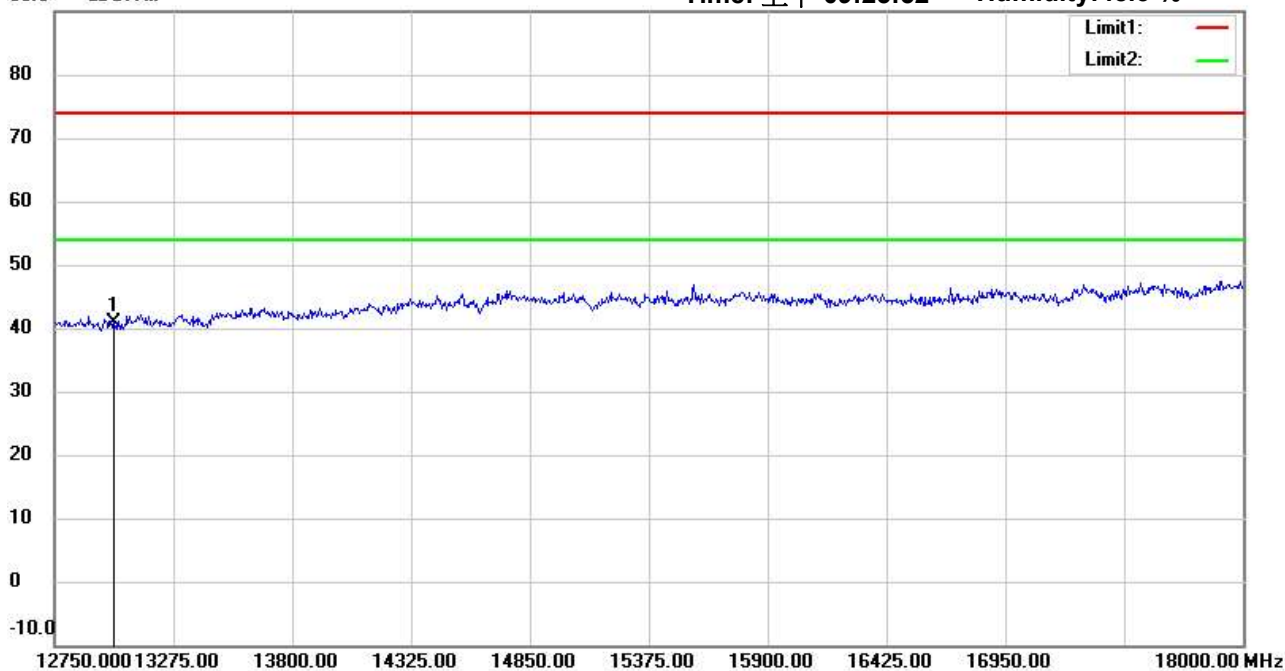
Data : #10

Site : 966A Chamber

Condition : FCC\_part 15E RE\_Above 1GHz\_PK

Polarization: **Vertical**

| Mk. | Frequency (MHz) | Reading (dBuV) | Detector | Corr. factor (dB/m) | Result (dBuV/m) | Limit (dBuV/m) | Ant.Pos (cm) | Tab.Pos (deg.) | Margin (dB) | Comment |
|---|---|---|---|---|---|---|---|---|---|---|
| * | 13010.000 | 23.91 | peak | 17.05 | 40.96 | 74.00 | 150 | 317 | -33.04 | |
