## Appendix G: Conducted Spurious Emission Test Result

## Appendix H: Reference level measurement Test Result

## 14. TEST SETUP PHOTO

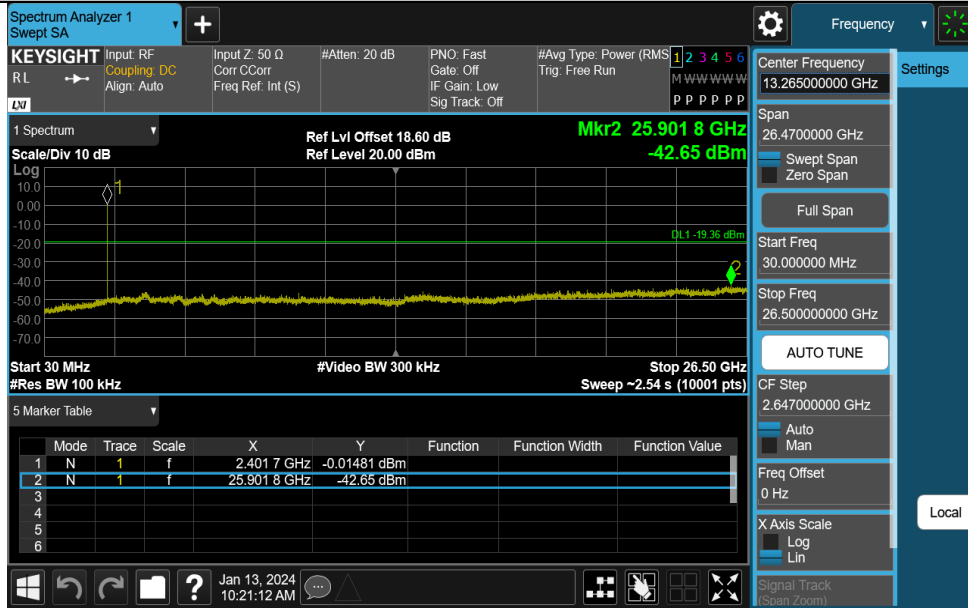
## DH5-Ant1-2402-30~26500-PASS

| TestMode | Antenna | Frequency[MHz] | FreqRange<br>[MHz] | RefLevel<br>[dBm] | Result<br>[dBm] | Limit<br>[dBm] | Verdict |
|---|---|---|---|---|---|---|---|
| DH5 | Ant1 | 2402 | 30~26500 | 0.64 | -42.65 | $\leq -19.36$ | PASS |

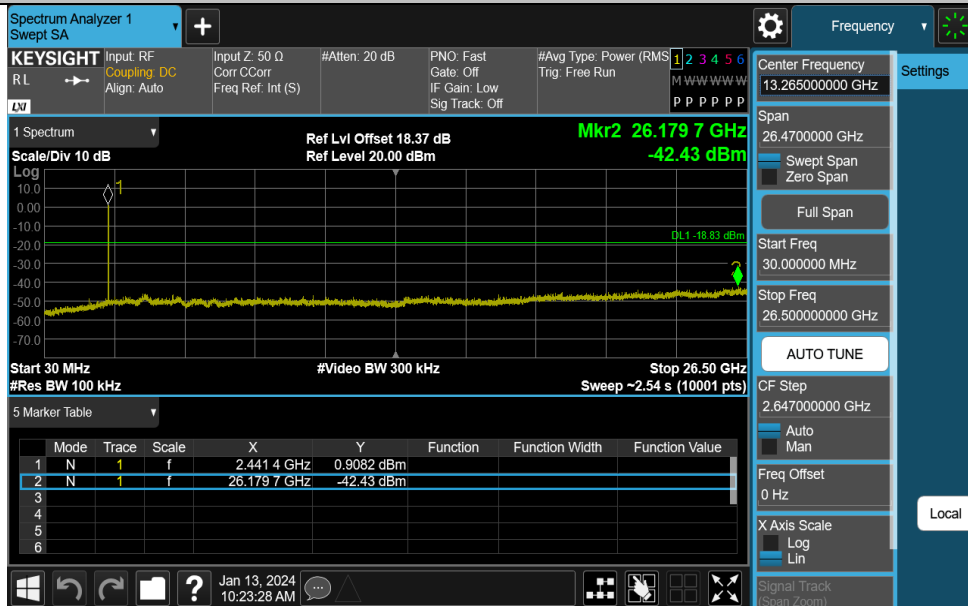
## DH5-Ant1-2441-30~26500-PASS

| TestMode | Antenna | Frequency[MHz] | FreqRange<br>[MHz] | RefLevel<br>[dBm] | Result<br>[dBm] | Limit<br>[dBm] | Verdict |
|---|---|---|---|---|---|---|---|
| DH5 | Ant1 | 2441 | 30~26500 | 1.17 | -42.43 | $\leq -18.83$ | PASS |

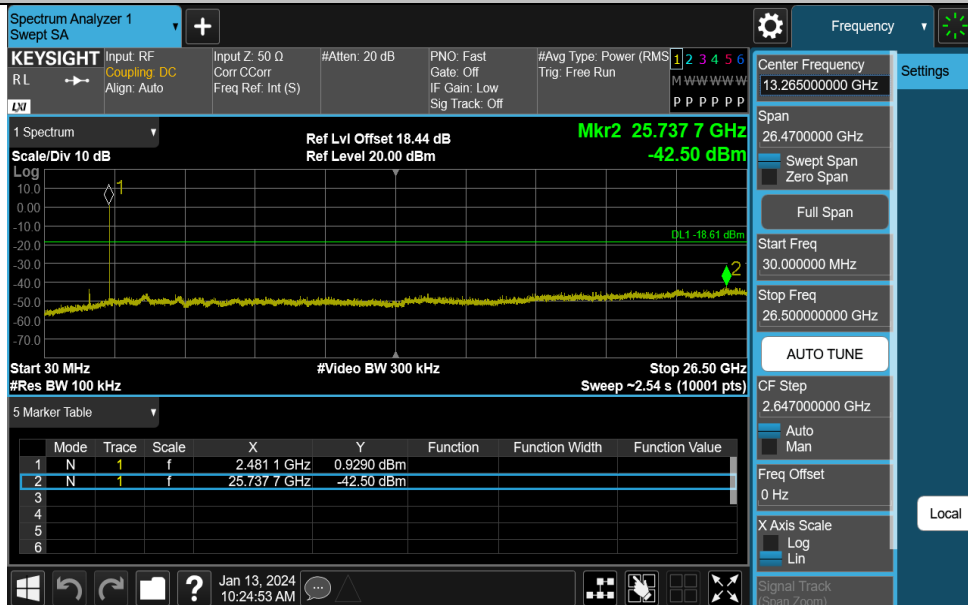
## DH5-Ant1-2480-30~26500-PASS

| TestMode | Antenna | Frequency[MHz] | FreqRange<br>[MHz] | RefLevel<br>[dBm] | Result<br>[dBm] | Limit<br>[dBm] | Verdict |
|---|---|---|---|---|---|---|---|
| DH5 | Ant1 | 2480 | 30~26500 | 1.39 | -42.5 | $\leq -18.61$ | PASS |

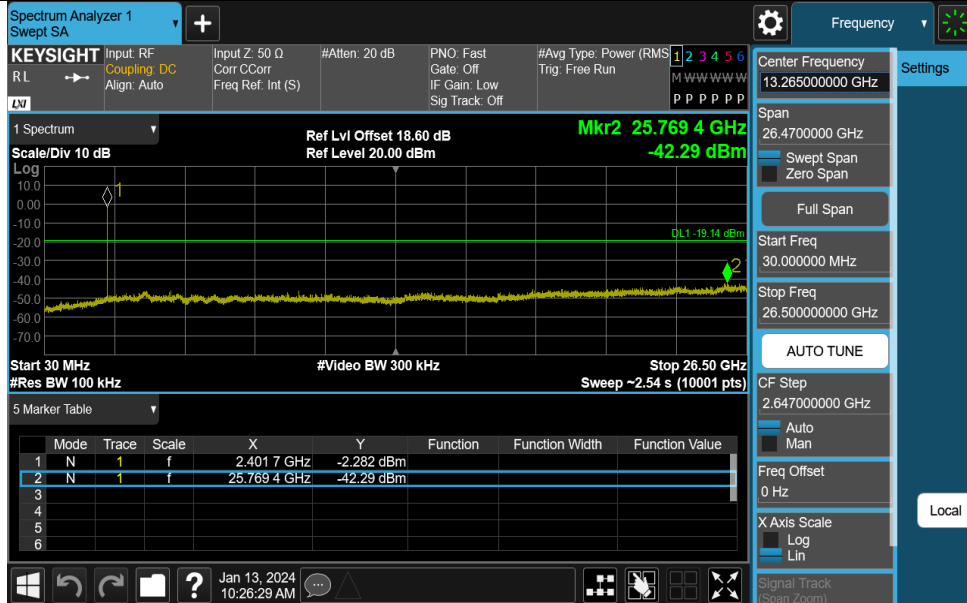
## 2DH5-Ant1-2402-30~26500-PASS

| TestMode | Antenna | Frequency[MHz] | FreqRange<br>[MHz] | RefLevel<br>[dBm] | Result<br>[dBm] | Limit<br>[dBm] | Verdict |
|---|---|---|---|---|---|---|---|
| 2DH5 | Ant1 | 2402 | 30~26500 | 0.86 | -42.29 | $\leq -19.14$ | PASS |

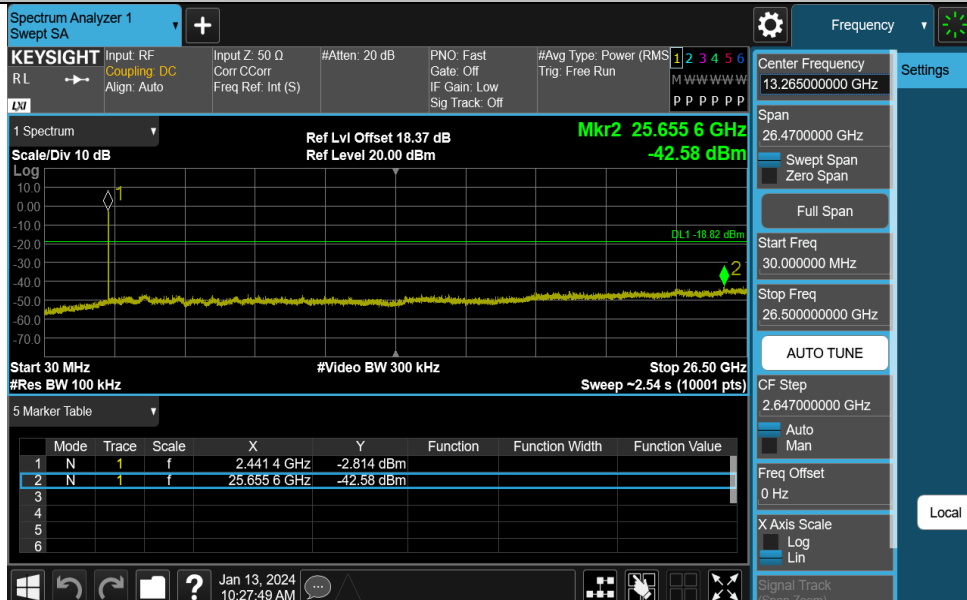
## 2DH5-Ant1-2441-30~26500-PASS

| TestMode | Antenna | Frequency[MHz] | FreqRange<br>[MHz] | RefLevel<br>[dBm] | Result<br>[dBm] | Limit<br>[dBm] | Verdict |
|---|---|---|---|---|---|---|---|
| 2DH5 | Ant1 | 2441 | 30~26500 | 1.18 | -42.58 | $\leq -18.82$ | PASS |

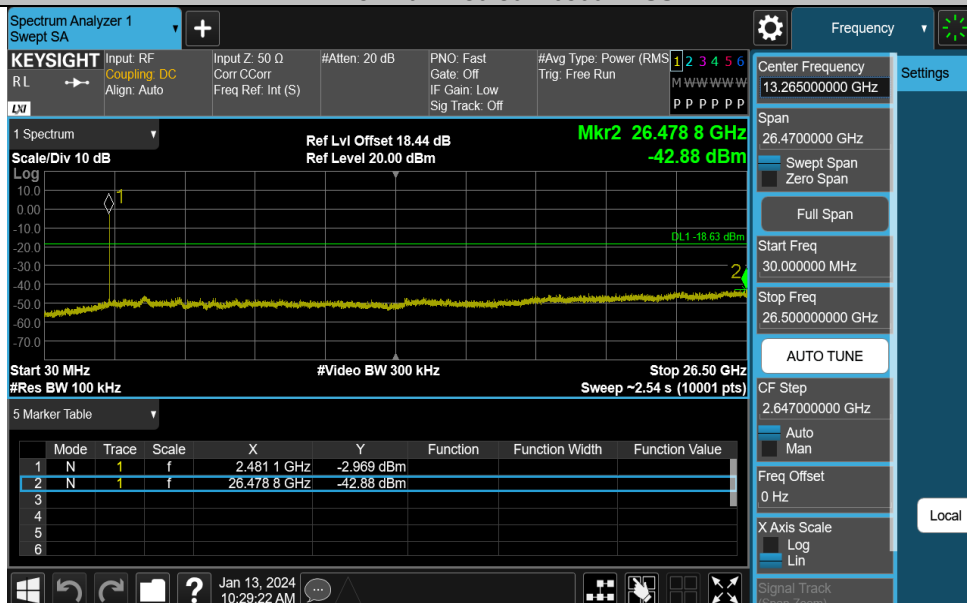
## 2DH5-Ant1-2480-30~26500-PASS

| TestMode | Antenna | Frequency[MHz] | FreqRange<br>[MHz] | RefLevel<br>[dBm] | Result<br>[dBm] | Limit<br>[dBm] | Verdict |
|---|---|---|---|---|---|---|---|
| 2DH5 | Ant1 | 2480 | 30~26500 | 1.37 | -42.88 | $\leq -18.63$ | PASS |

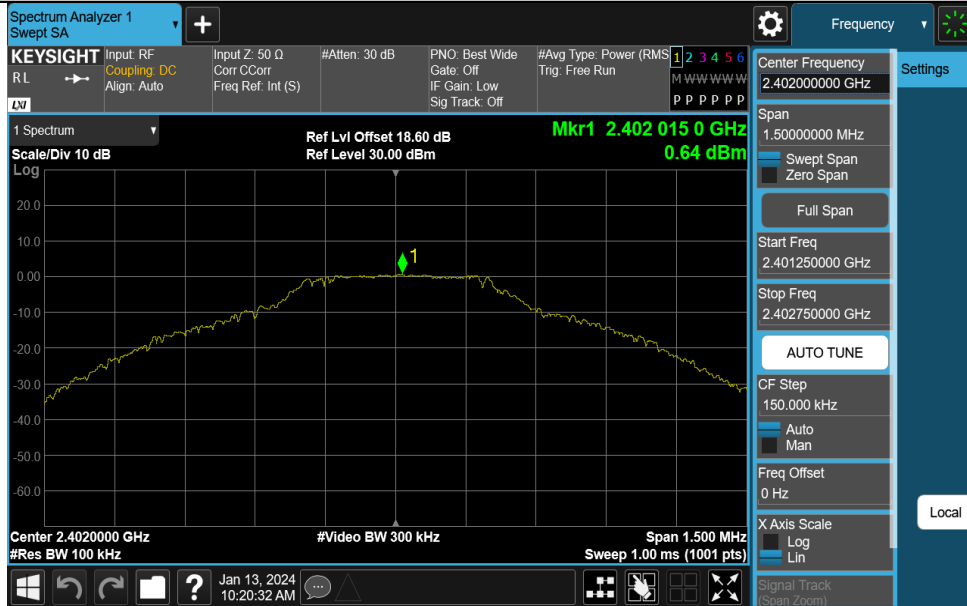
### DH5-Ant1-2402-PASS

| TestMode | Antenna | Freq(MHz) | Max.Point[MHz] | Result[dBm] |
|---|---|---|---|---|
| DH5 | Ant1 | 2402 | 2402.02 | 0.64 |

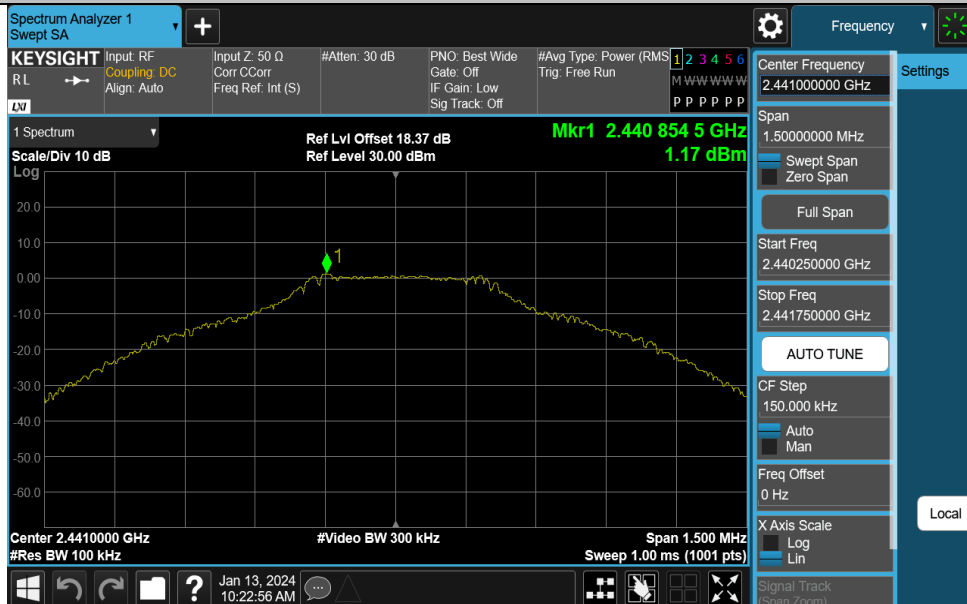
### DH5-Ant1-2441-PASS

| TestMode | Antenna | Freq(MHz) | Max.Point[MHz] | Result[dBm] |
|---|---|---|---|---|
| DH5 | Ant1 | 2441 | 2440.85 | 1.17 |

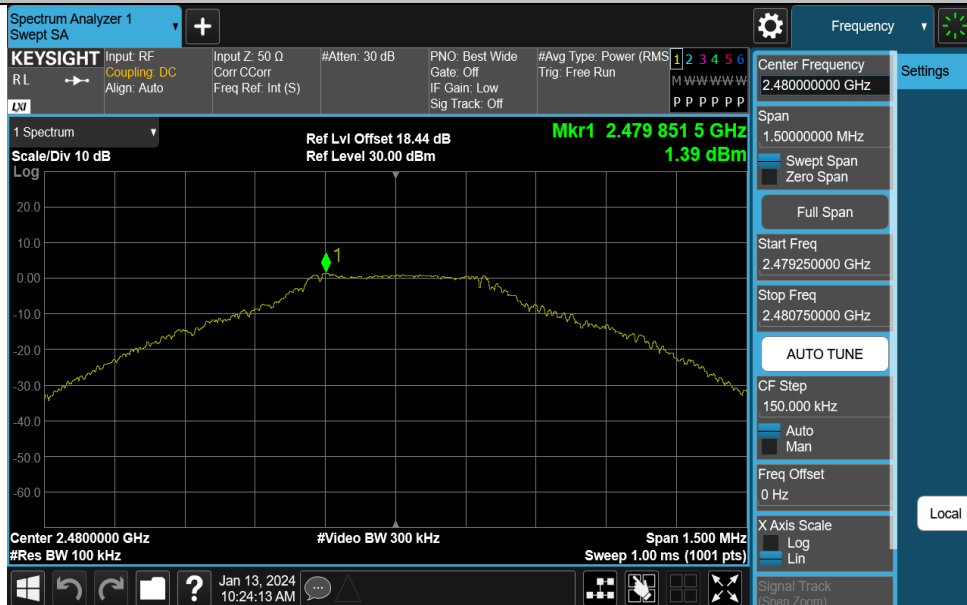
### DH5-Ant1-2480-PASS

| TestMode | Antenna | Freq(MHz) | Max.Point[MHz] | Result[dBm] |
|---|---|---|---|---|
| DH5 | Ant1 | 2480 | 2479.85 | 1.39 |

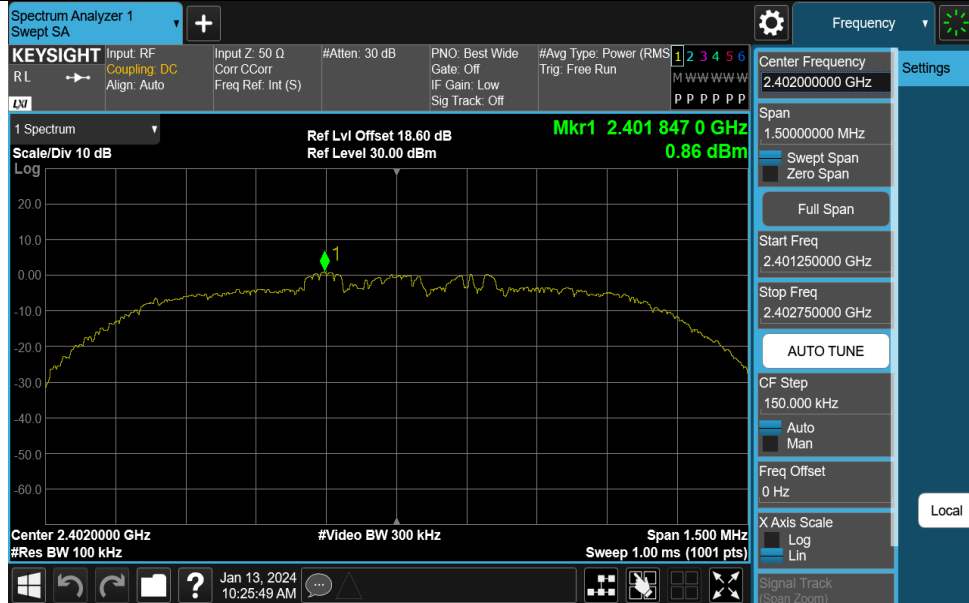
## 2DH5-Ant1-2402-PASS

| TestMode | Antenna | Freq(MHz) | Max.Point[MHz] | Result[dBm] |
|---|---|---|---|---|
| 2DH5 | Ant1 | 2402 | 2401.85 | 0.86 |

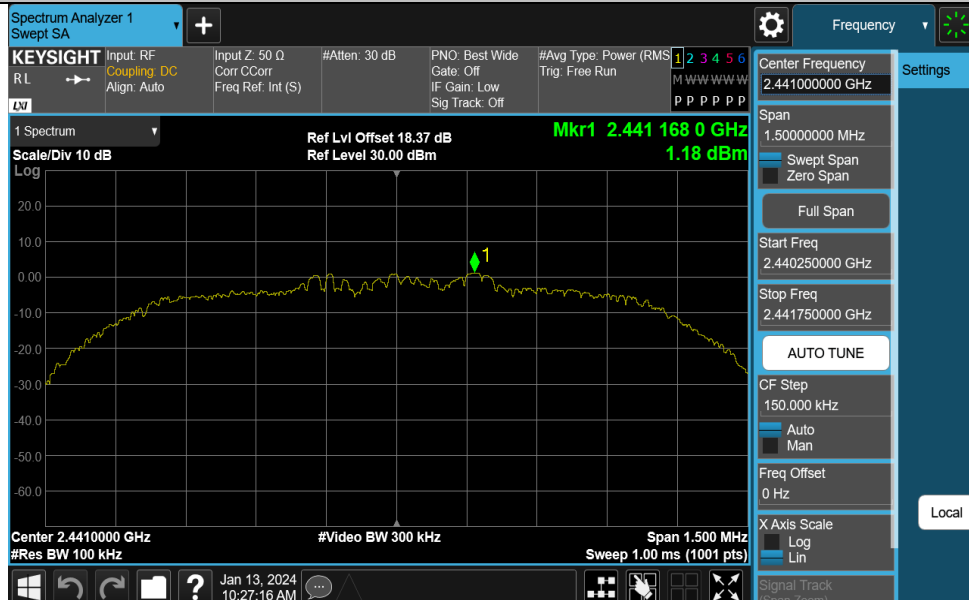
## 2DH5-Ant1-2441-PASS

| TestMode | Antenna | Freq(MHz) | Max.Point[MHz] | Result[dBm] |
|---|---|---|---|---|
| 2DH5 | Ant1 | 2441 | 2441.17 | 1.18 |

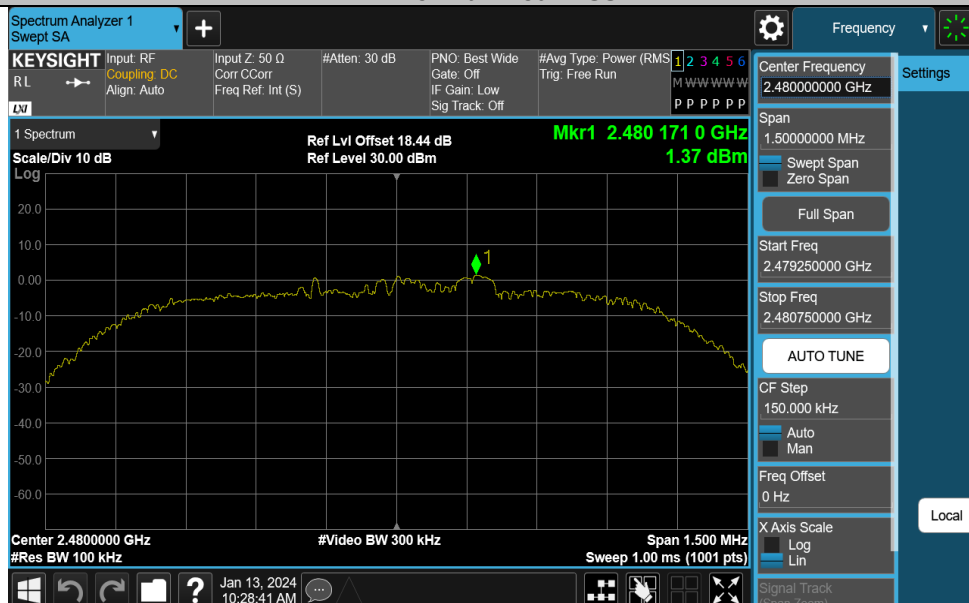
## 2DH5-Ant1-2480-PASS

| TestMode | Antenna | Freq(MHz) | Max.Point[MHz] | Result[dBm] |
|---|---|---|---|---|
| 2DH5 | Ant1 | 2480 | 2480.17 | 1.37 |

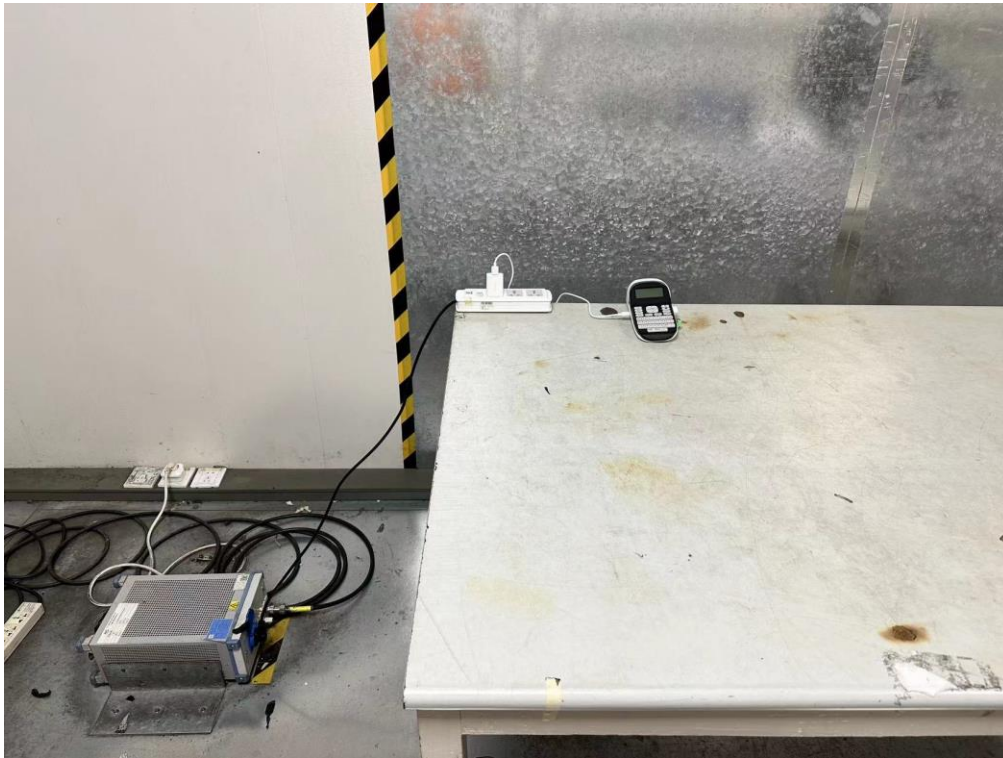
Conducted Test

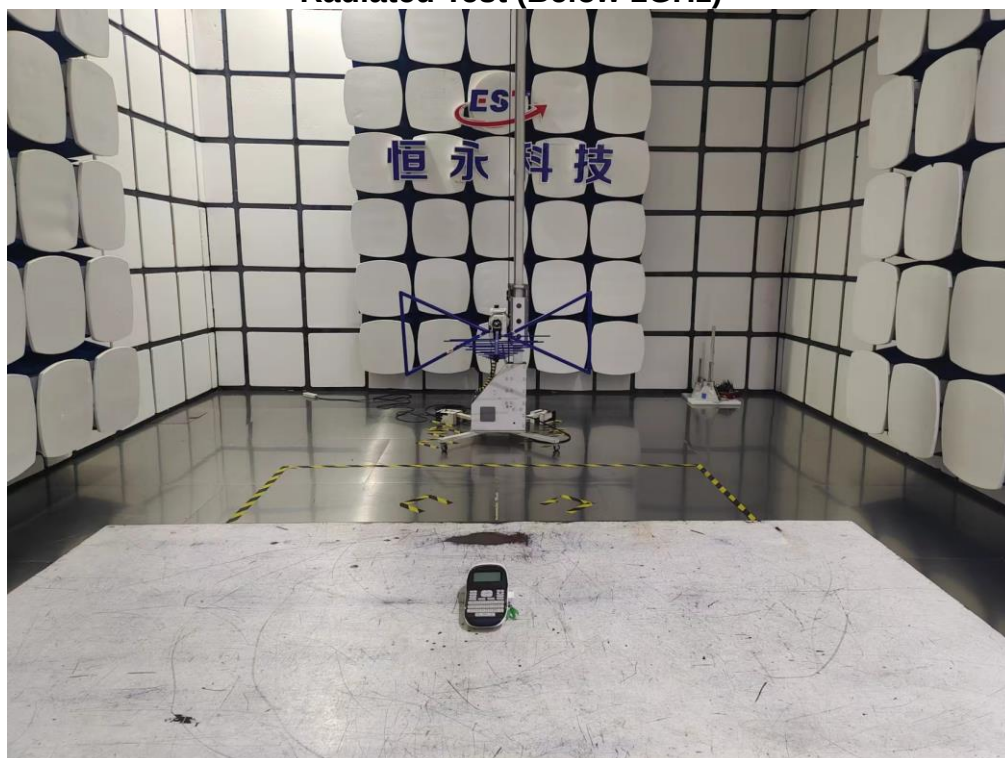
**Radiated Test (Below 1GHz)**

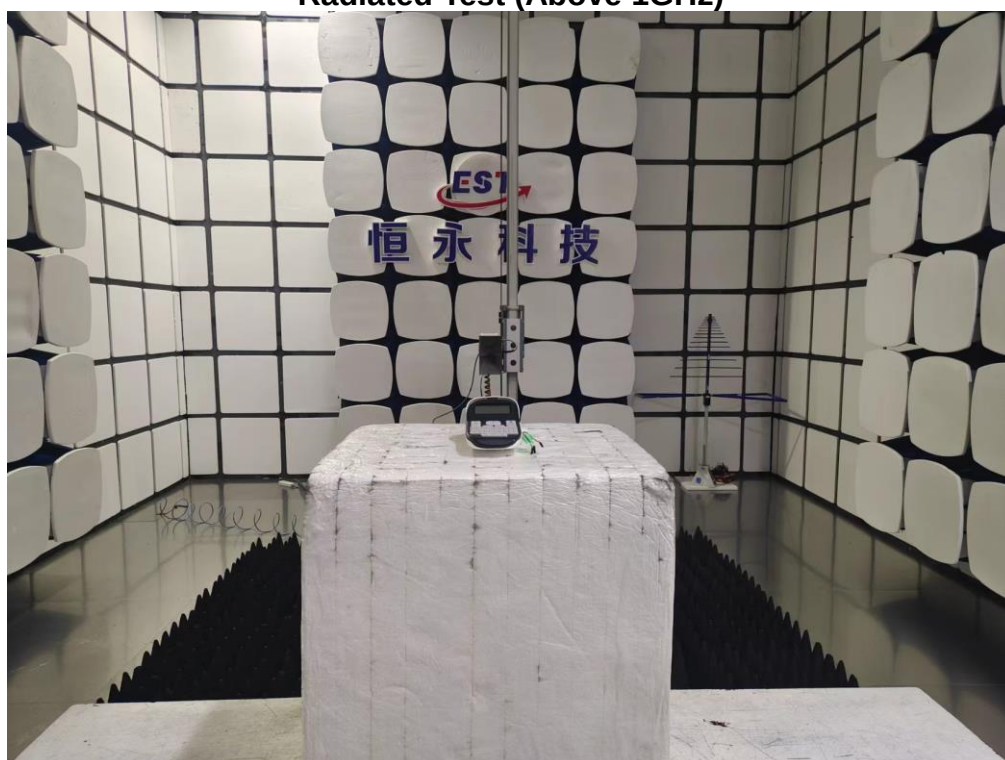
**Radiated Test (Above 1GHz)**

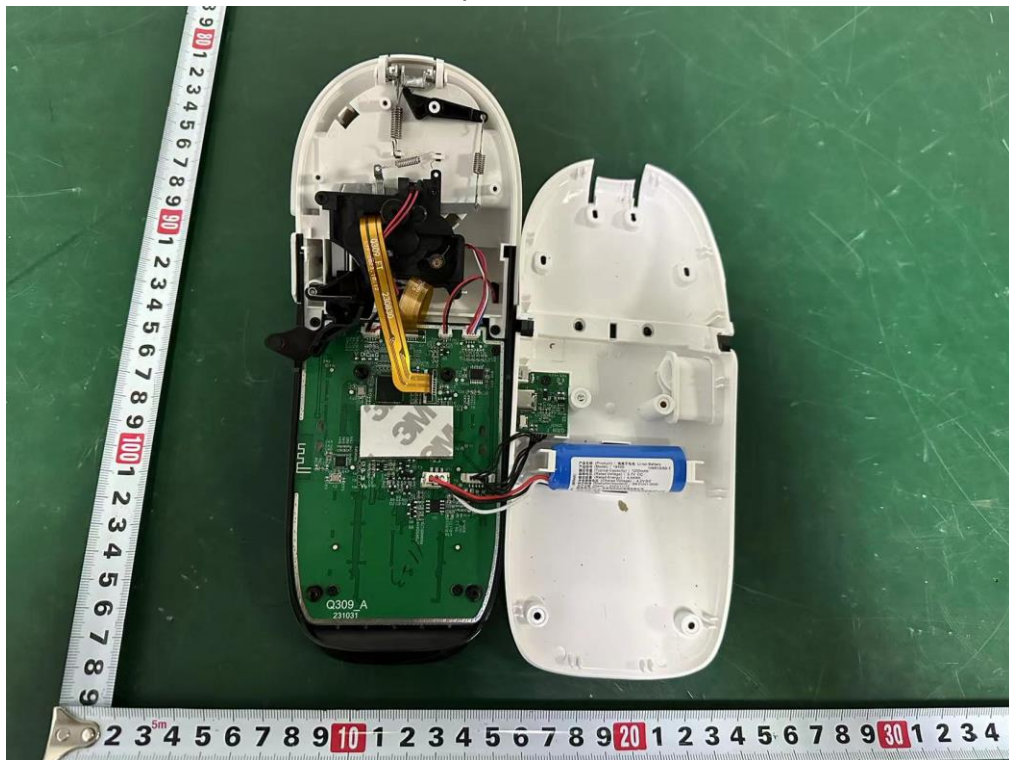
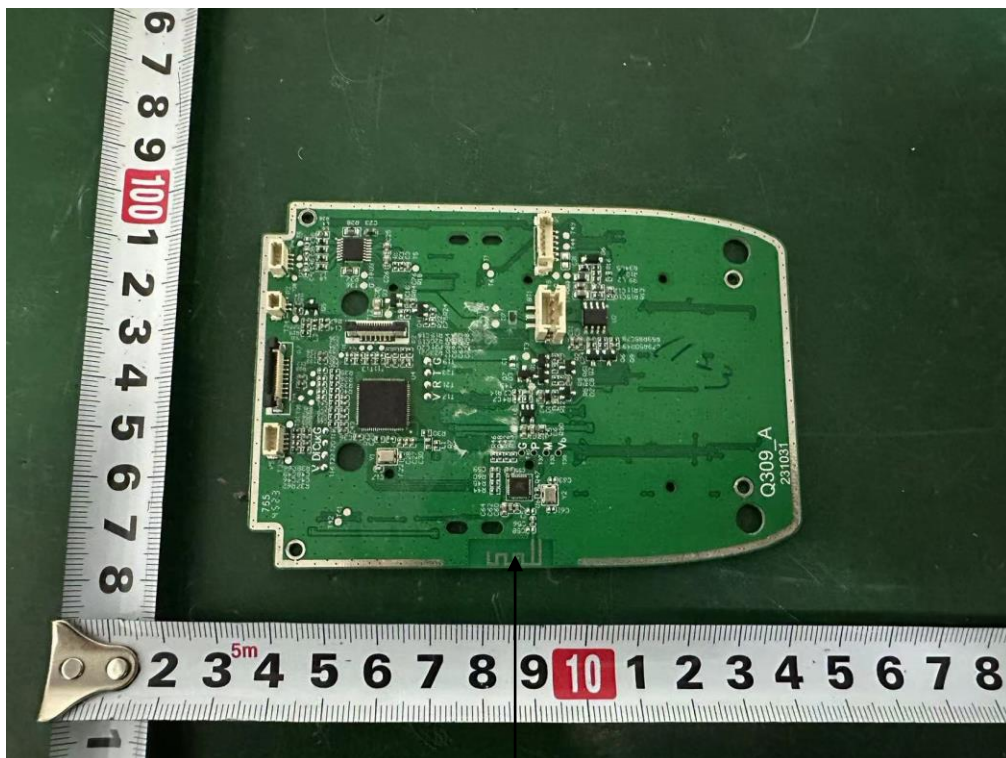
Bluetooth  
Antenna
