Radiated Emission Measurement

Condition : FCC\_part 15E RE\_Above 1GHz\_PK

EUT : W6M22409-23739

Test Mode : TX 802.11ax80 CH39

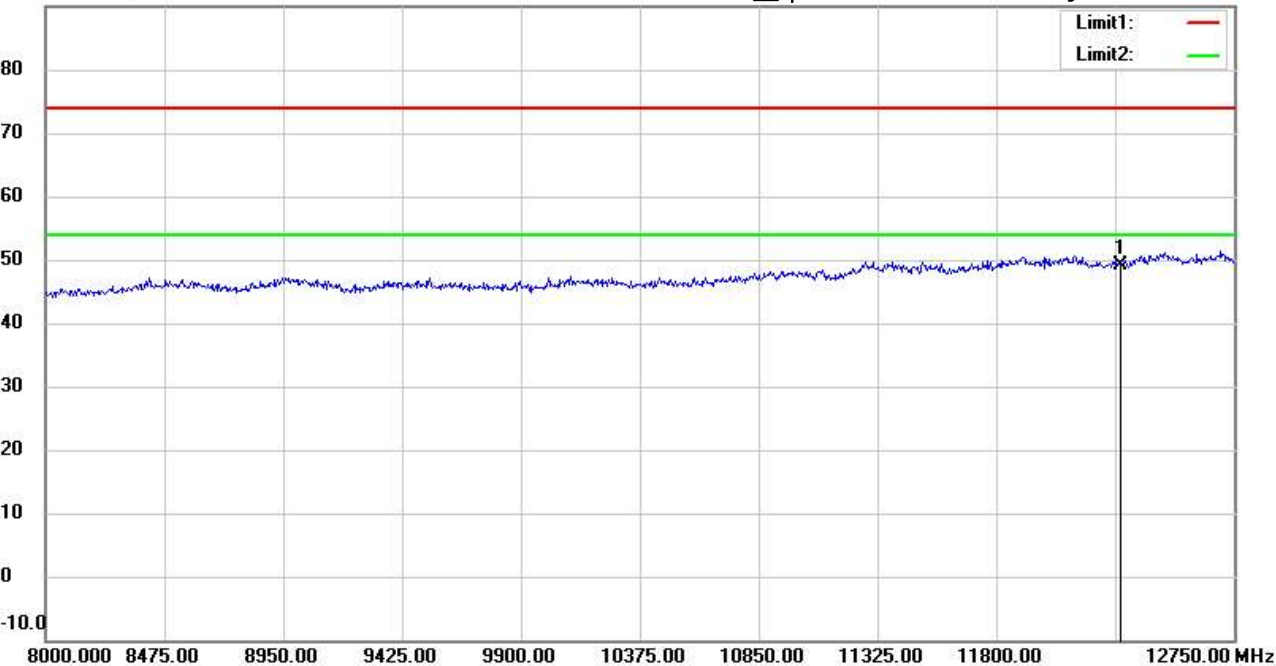
Data :#3

Test Mode : TX 802.11ax80 CH39

Polarization: **Horizontal**

| Mk. | Frequency (MHz) | Reading (dBuV) | Detector | Corr. factor (dB/m) | Result (dBuV/m) | Limit (dBuV/m) | Ant.Pos (cm) | Tab.Pos (deg.) | Margin (dB) | Comment |
|---|---|---|---|---|---|---|---|---|---|---|
| * | 12290.000 | 32.89 | peak | 16.12 | 49.01 | 74.00 | 150 | 59 | -24.99 | |

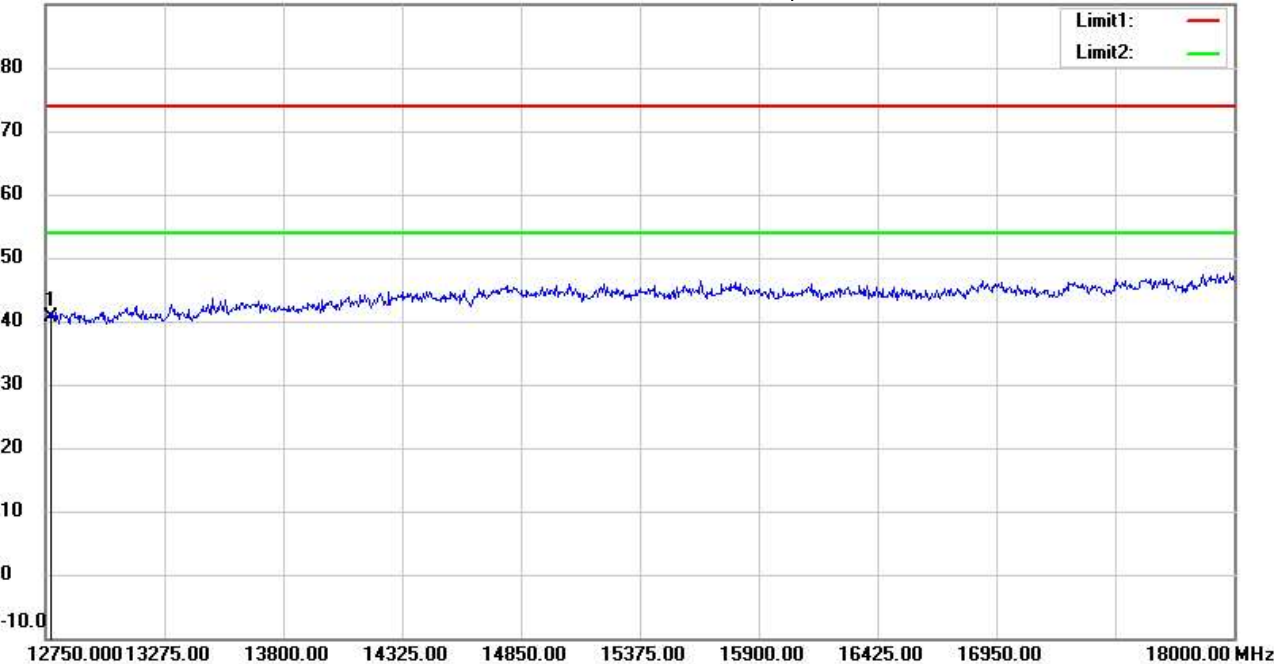
Data :#4

Test Mode : TX 802.11ax80 CH87

Polarization: **Horizontal**

| Mk. | Frequency (MHz) | Reading (dBuV) | Detector | Corr. factor (dB/m) | Result (dBuV/m) | Limit (dBuV/m) | Ant.Pos (cm) | Tab.Pos (deg.) | Margin (dB) | Comment |
|---|---|---|---|---|---|---|---|---|---|---|
| * | 12770.000 | 23.82 | peak | 16.91 | 40.73 | 74.00 | 150 | 280 | -33.27 | |

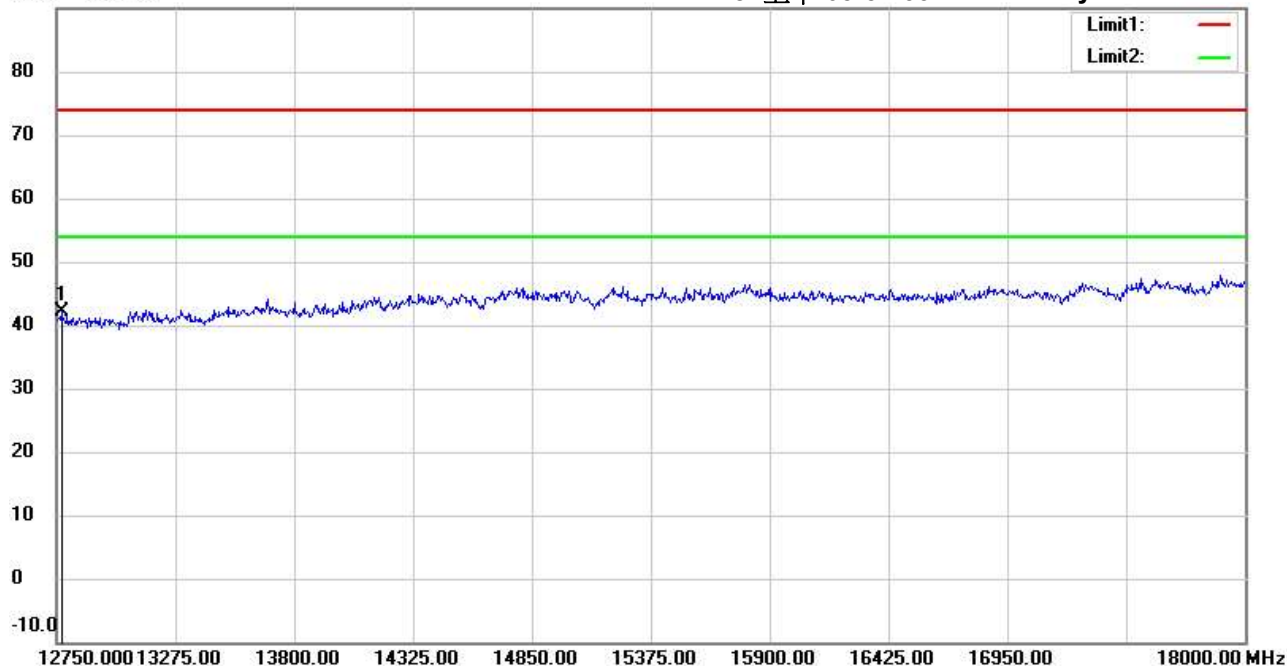
Data : #10

Test Mode : TX 802.11ax80 CH87

Polarization: Vertical

| Mk. | Frequency (MHz) | Reading (dBuV) | Detector | Corr. factor (dB/m) | Result (dBuV/m) | Limit (dBuV/m) | Ant.Pos (cm) | Tab.Pos (deg.) | Margin (dB) | Comment |
|---|---|---|---|---|---|---|---|---|---|---|
| * | 12770.000 | 25.16 | peak | 16.91 | 42.07 | 74.00 | 150 | 152 | -31.93 | |
