## Receiving Pattern ( $\Phi$ ), $\theta=0^\circ$

## DASY/EASY – Parameters of Probe: EX3DV4 – SN: 7346

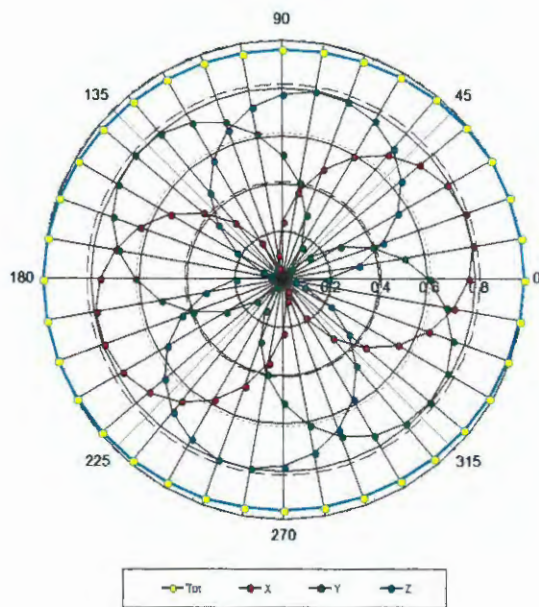
**f=600 MHz, TEM**

Uncertainty of Axial Isotropy Assessment:  $\pm 1.2\%$  ( $k=2$ )

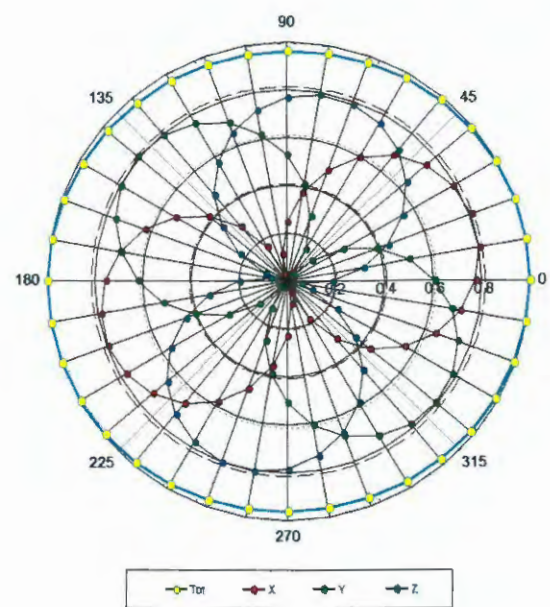
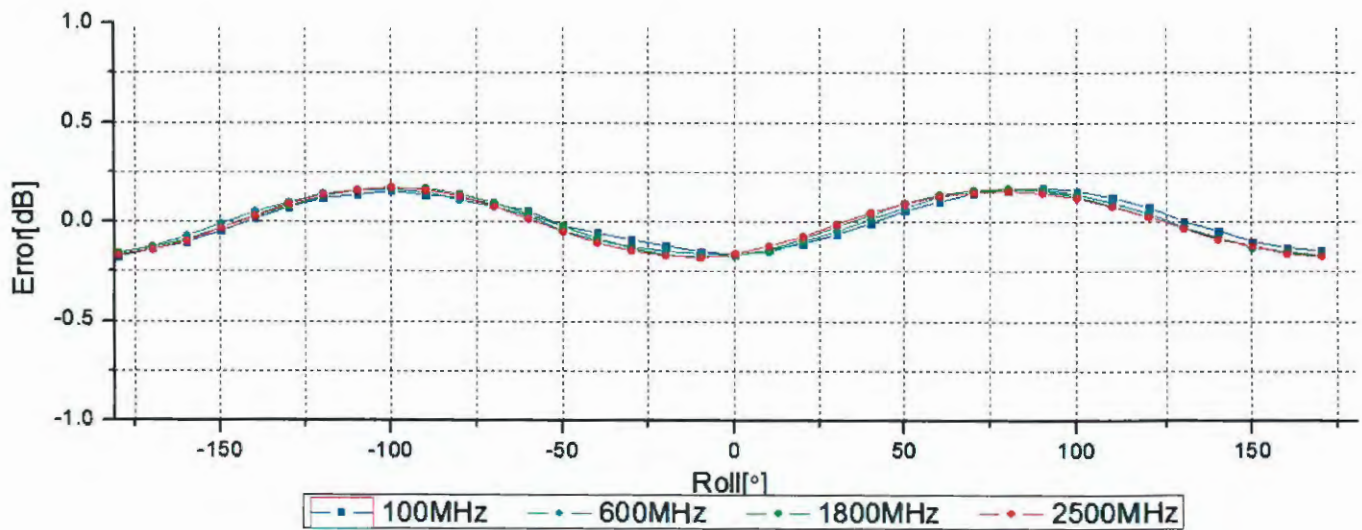
**f=1800 MHz, R22**

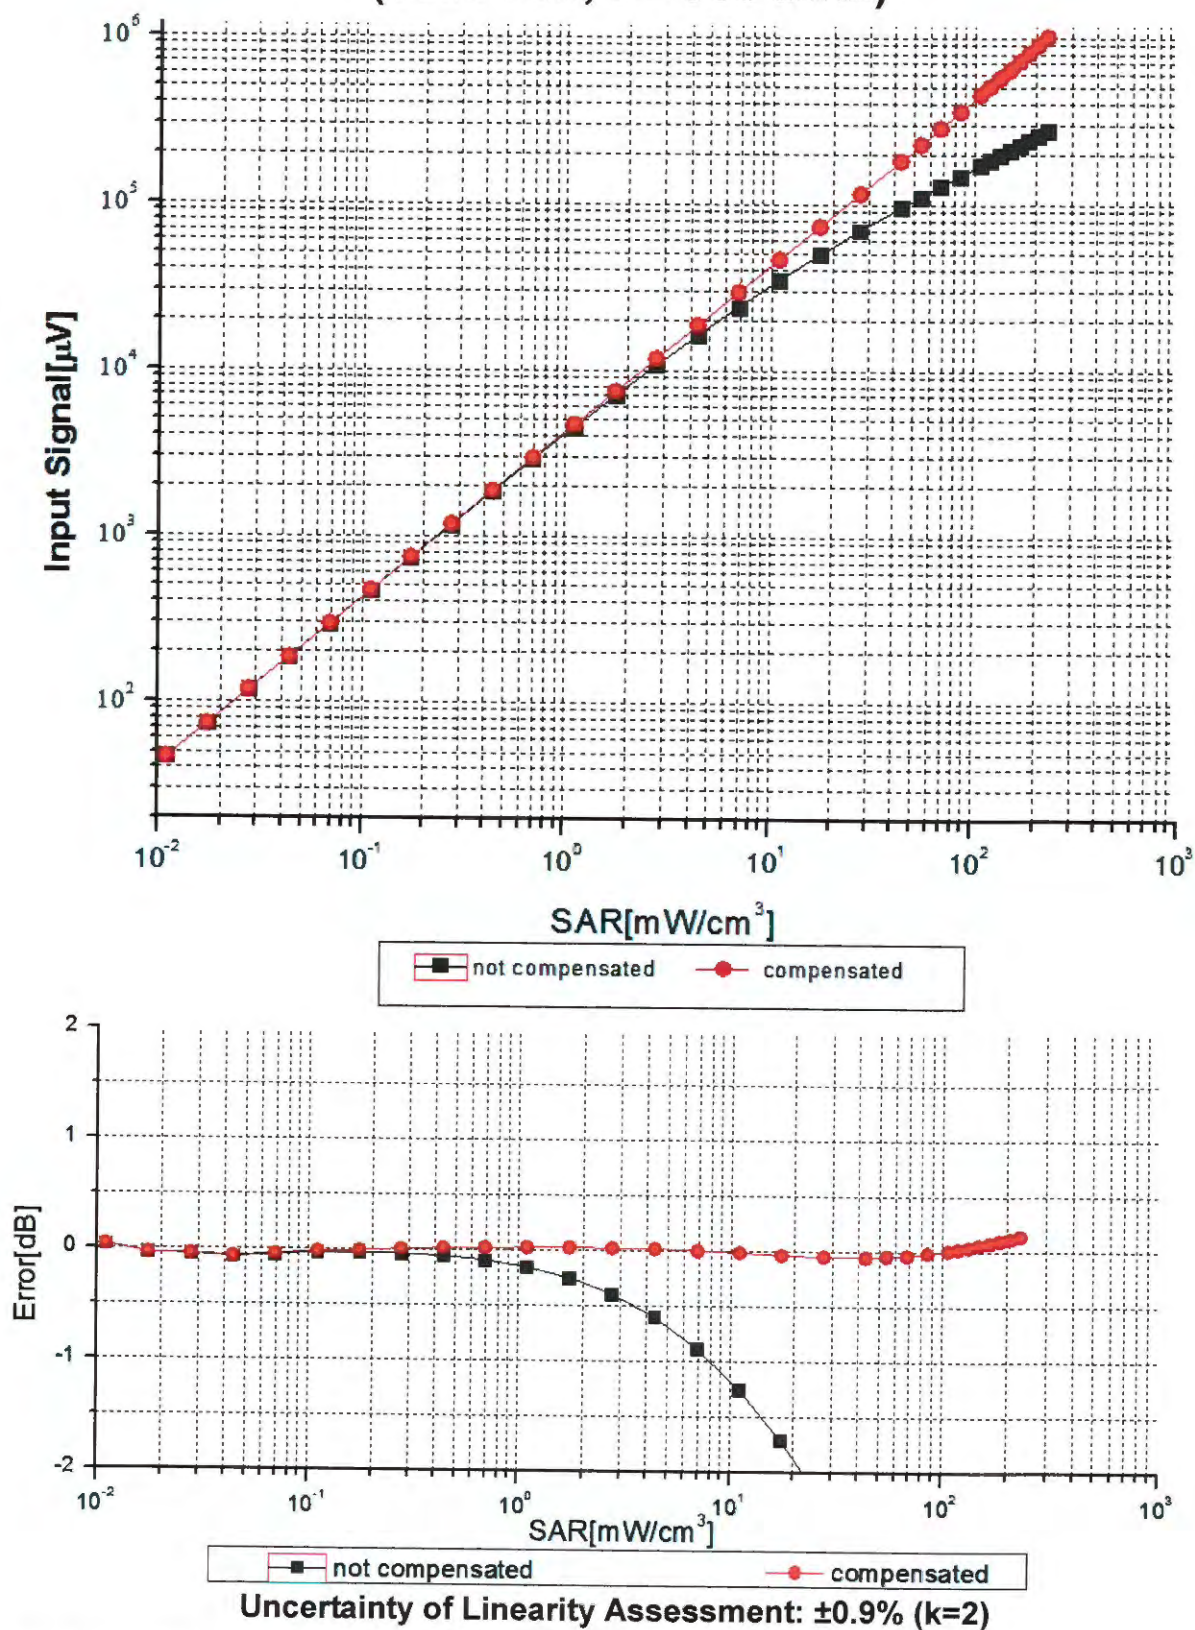
## Dynamic Range f(SAR<sub>head</sub>) (TEM cell, f = 900 MHz)

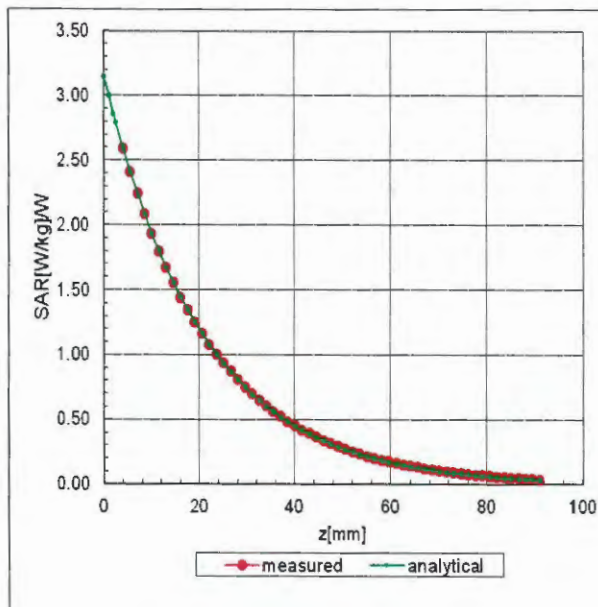
## Conversion Factor Assessment

$f=750$  MHz, WGLS R9(H\_convF)

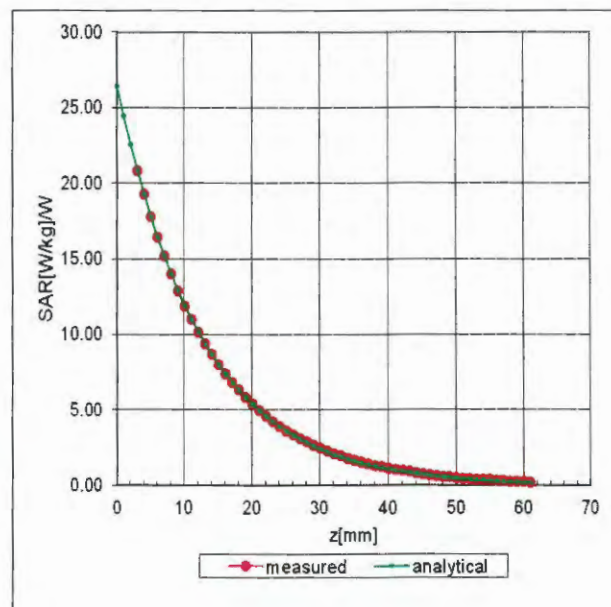
$f=1750$  MHz, WGLS R22(H\_convF)

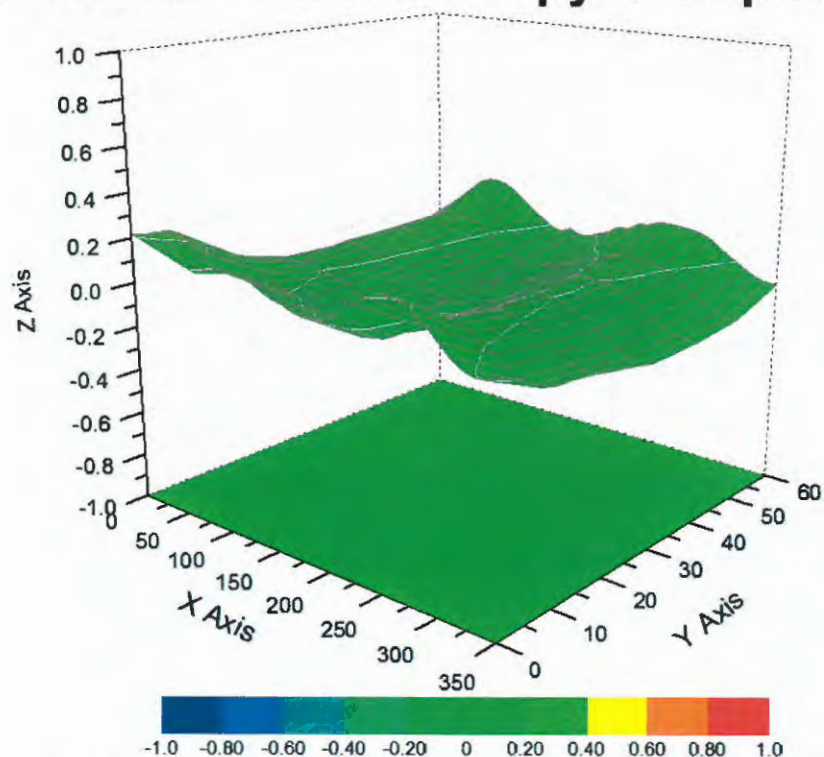
## Deviation from Isotropy in Liquid

Uncertainty of Spherical Isotropy Assessment:  $\pm 3.2\%$  (K=2)
