Appendix B  
CN24K76Q 003

Prüfbericht - Produkte  
Test Report - Products

### 1.3 Test Datas 99% Bandwidth (U-NII-3:)

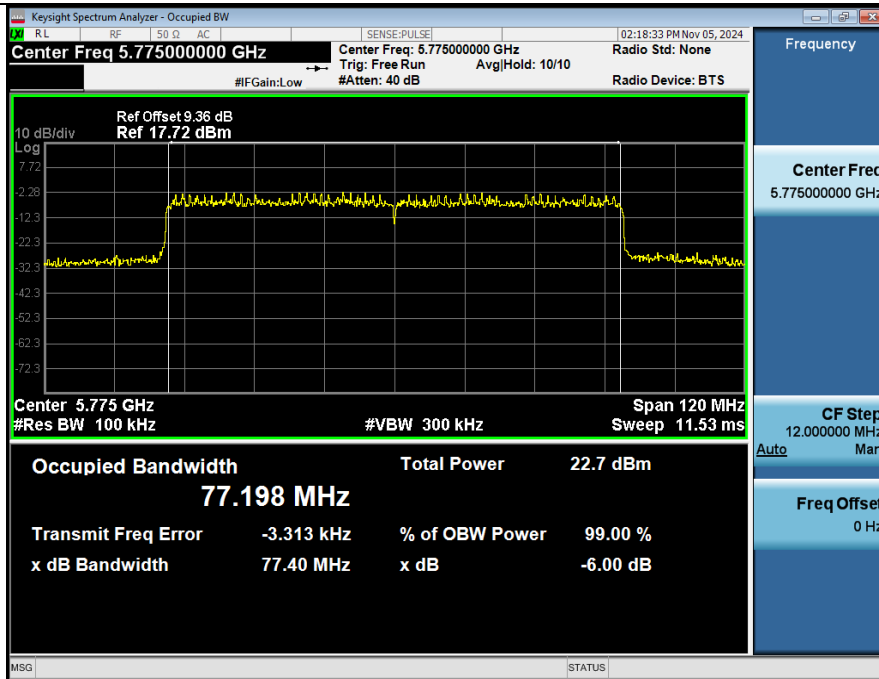
-6dB Emission Bandwidth\_NVNT\_ANT2\_802\_11ax(HE80)\_5775\_80M

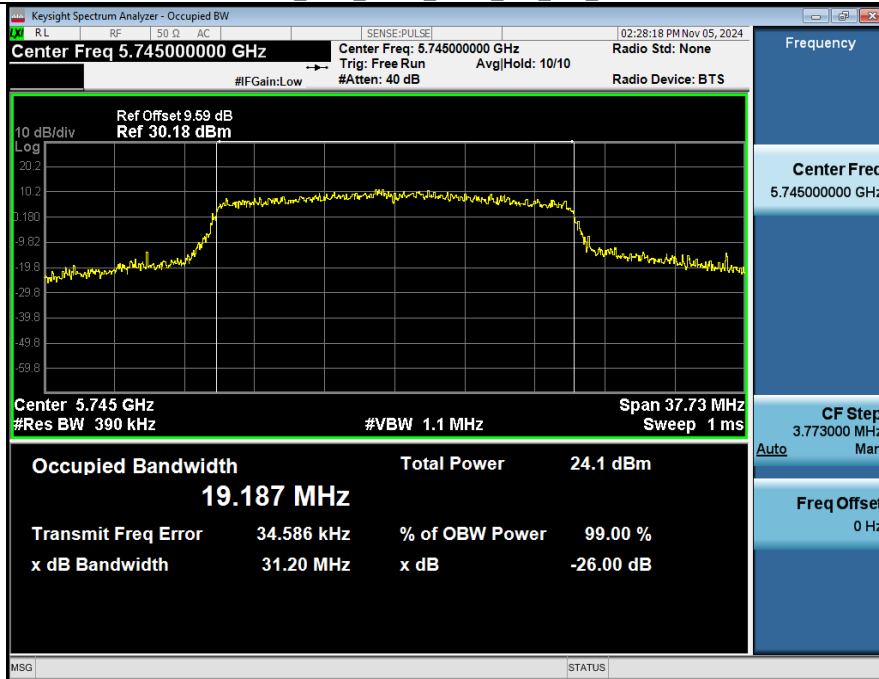
99%\_OCB\_NVNT\_ANT1\_802\_11a\_5745

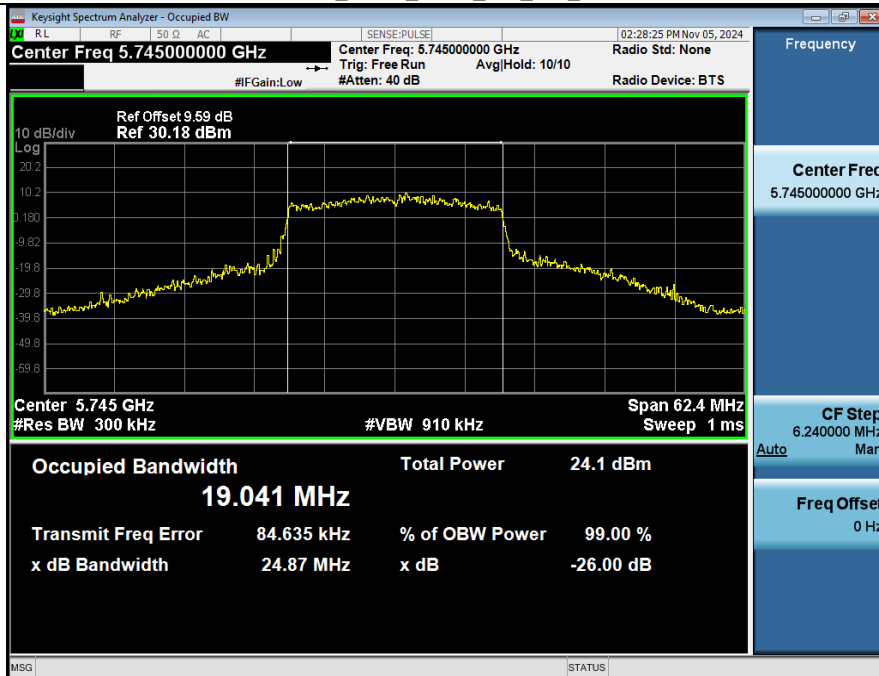
-26BW\_NVNT\_ANT1\_802\_11a\_5745

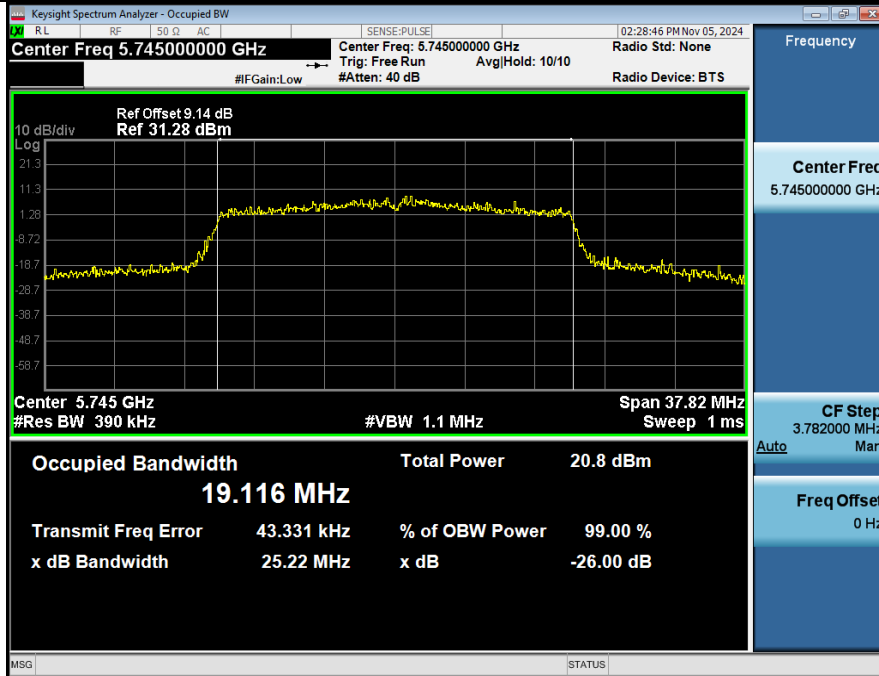
99%\_OCB\_NVNT\_ANT2\_802\_11a\_5745

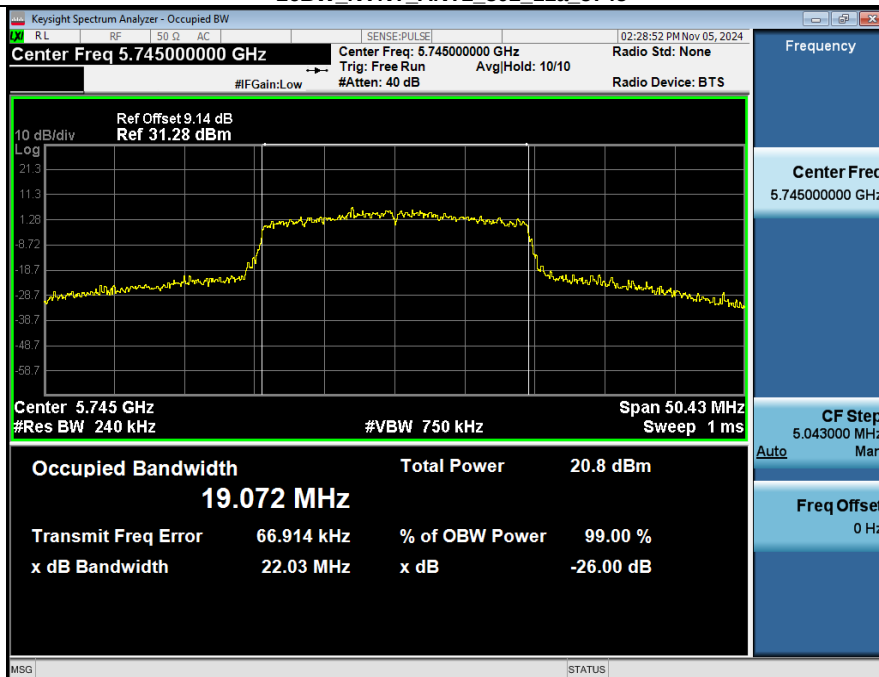
-26BW\_NVNT\_ANT2\_802\_11a\_5745

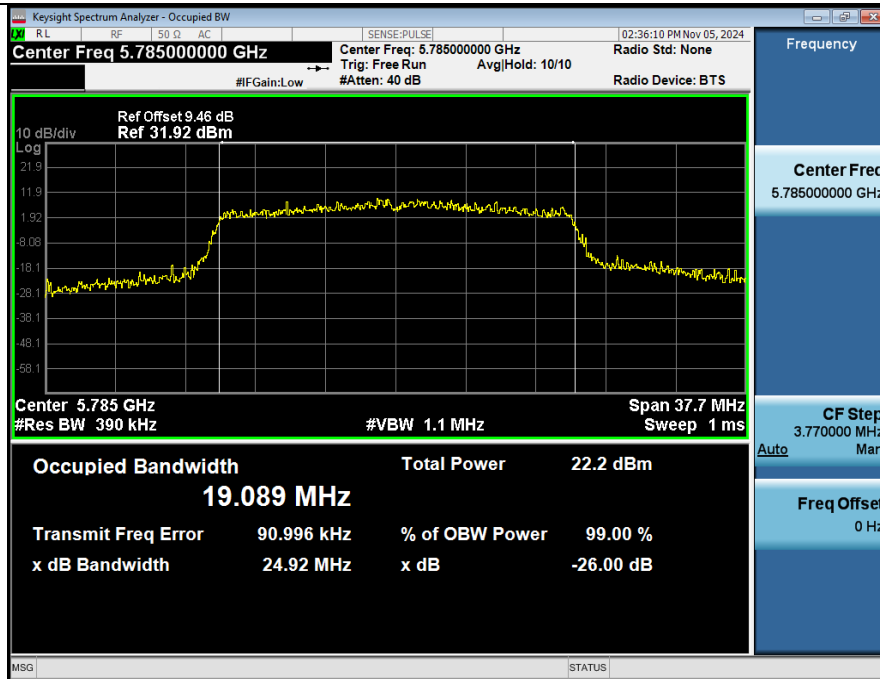
99%\_OCB\_NVNT\_ANT1\_802\_11a\_5785

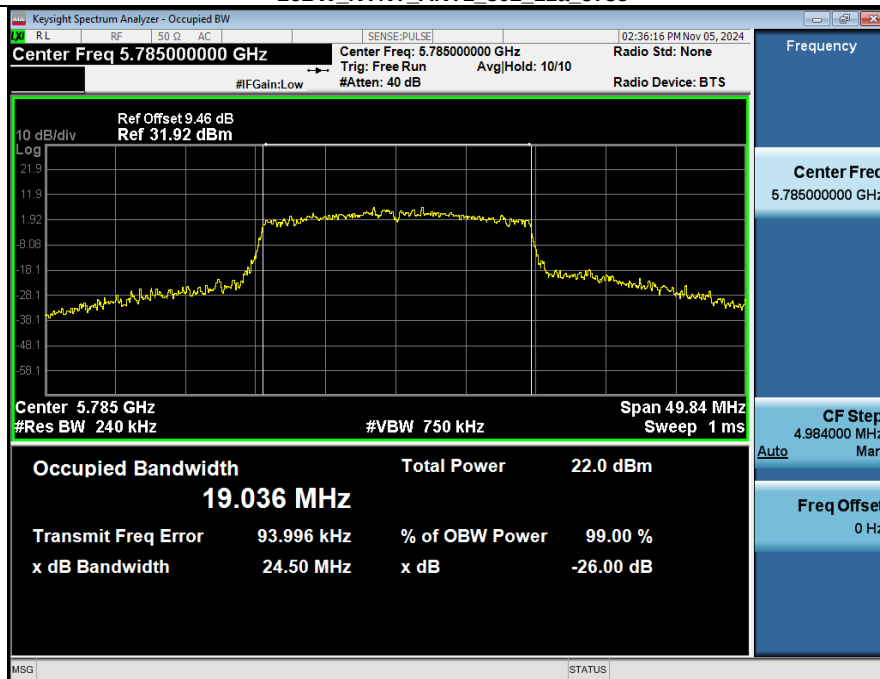
-26BW\_NVNT\_ANT1\_802\_11a\_5785

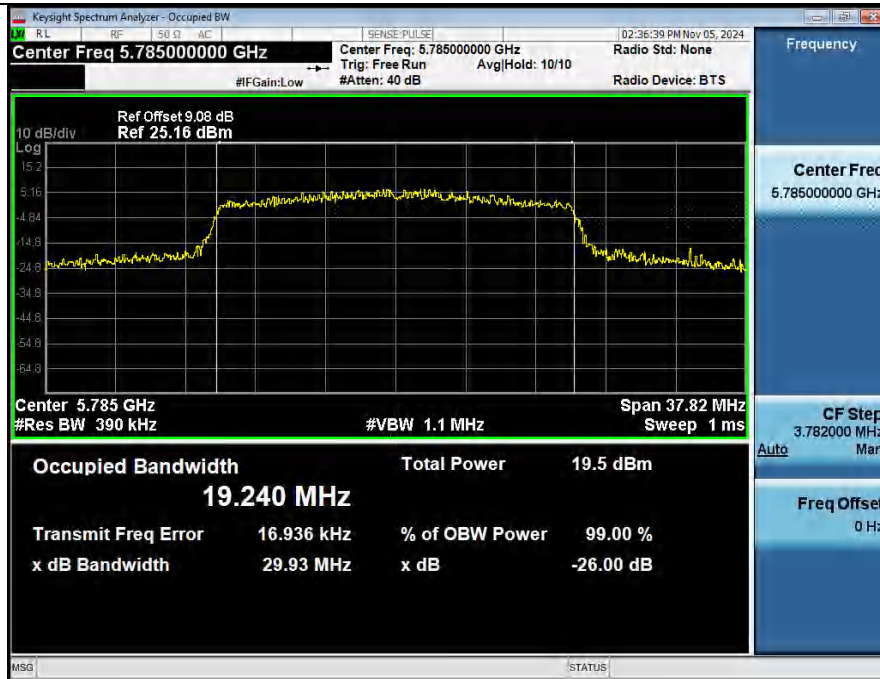
99%\_OCB\_NVNT\_ANT2\_802\_11a\_5785

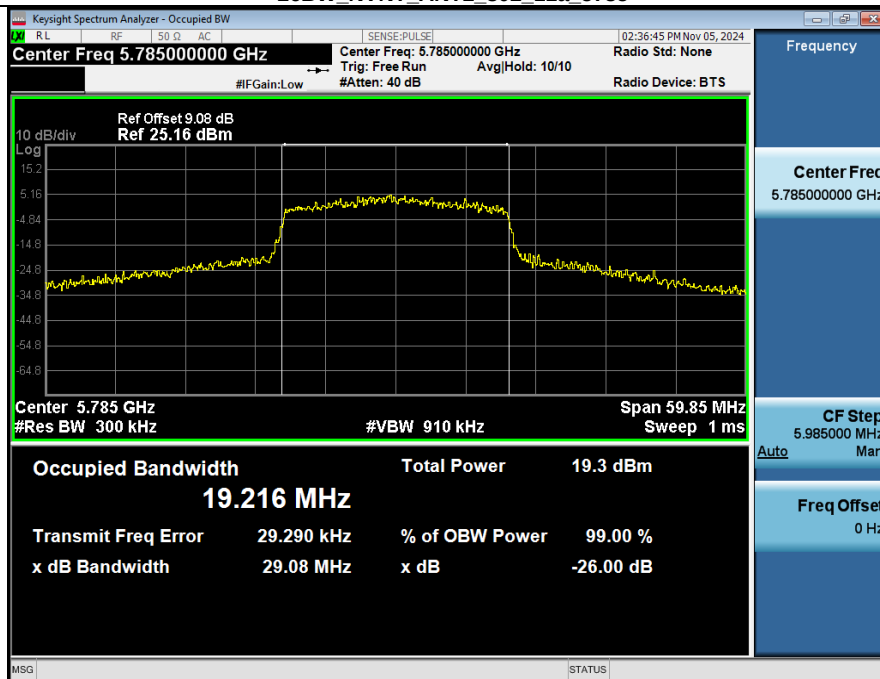
-26BW\_NVNT\_ANT2\_802\_11a\_5785

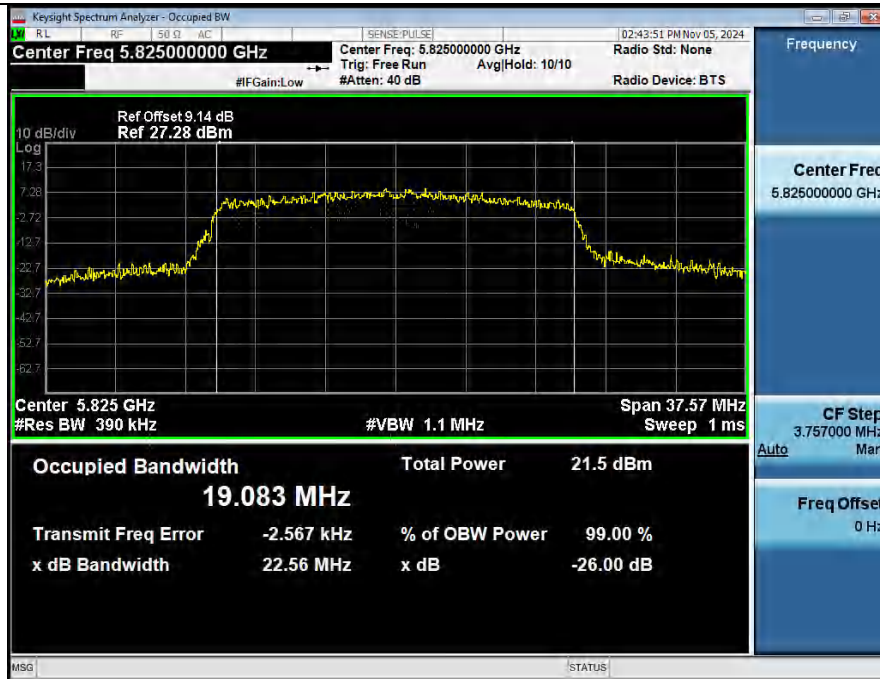
99%\_OCB\_NVNT\_ANT1\_802\_11a\_5825

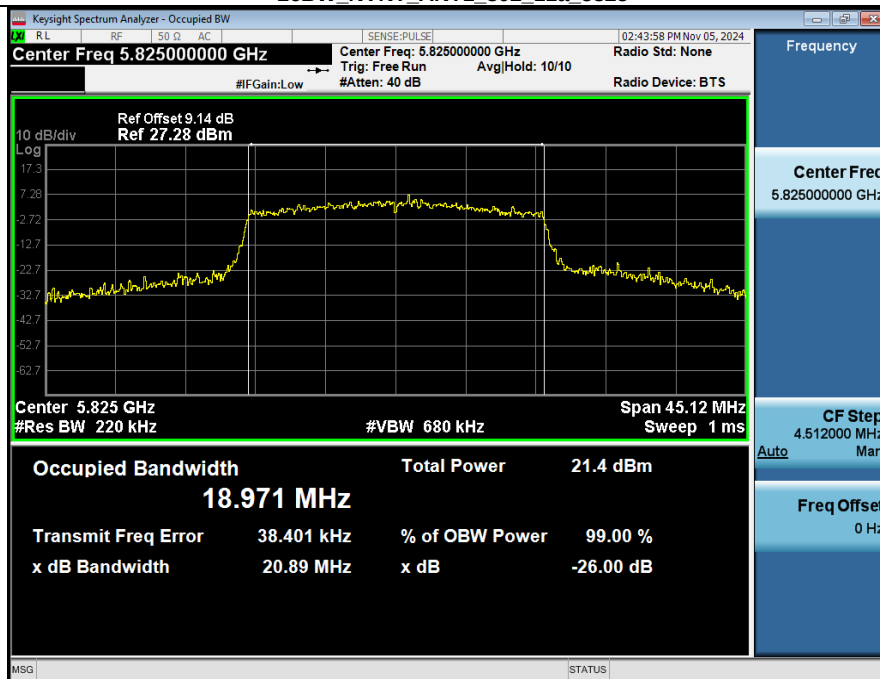
-26BW\_NVNT\_ANT1\_802\_11a\_5825

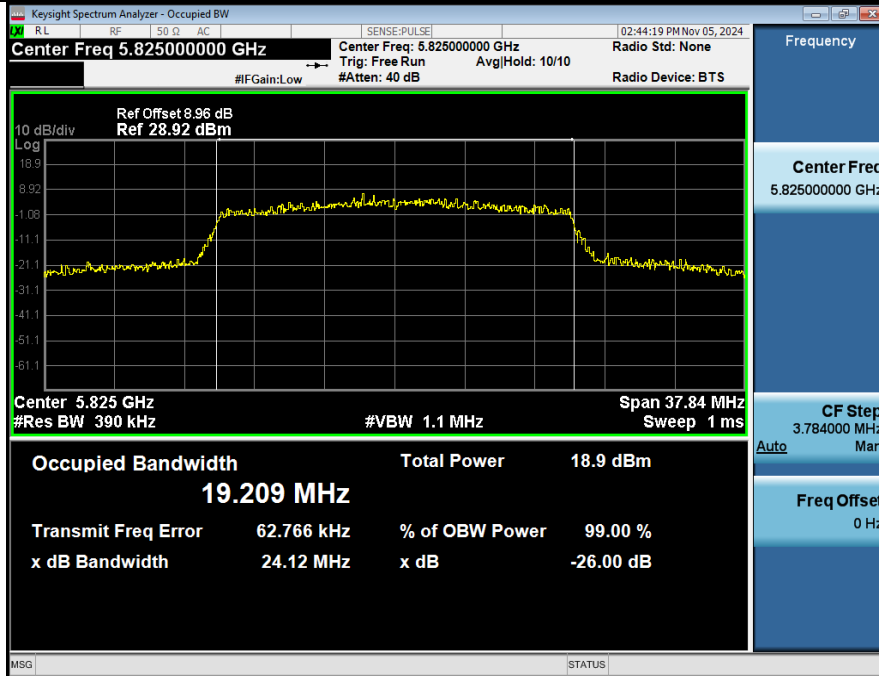
99%\_OCB\_NVNT\_ANT2\_802\_11a\_5825

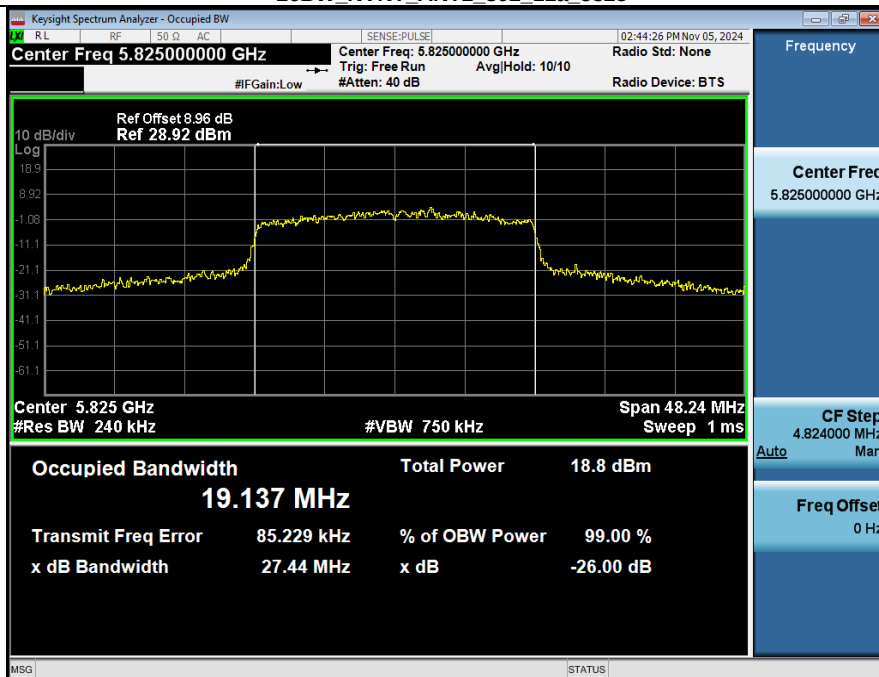
-26BW\_NVNT\_ANT2\_802\_11a\_5825
