Radiated Emission Measurement

Condition : FCC\_part 15E RE\_Above 1GHz\_PK

EUT : W6M22409-23739

Test Mode : TX 802.11ax80 CH199

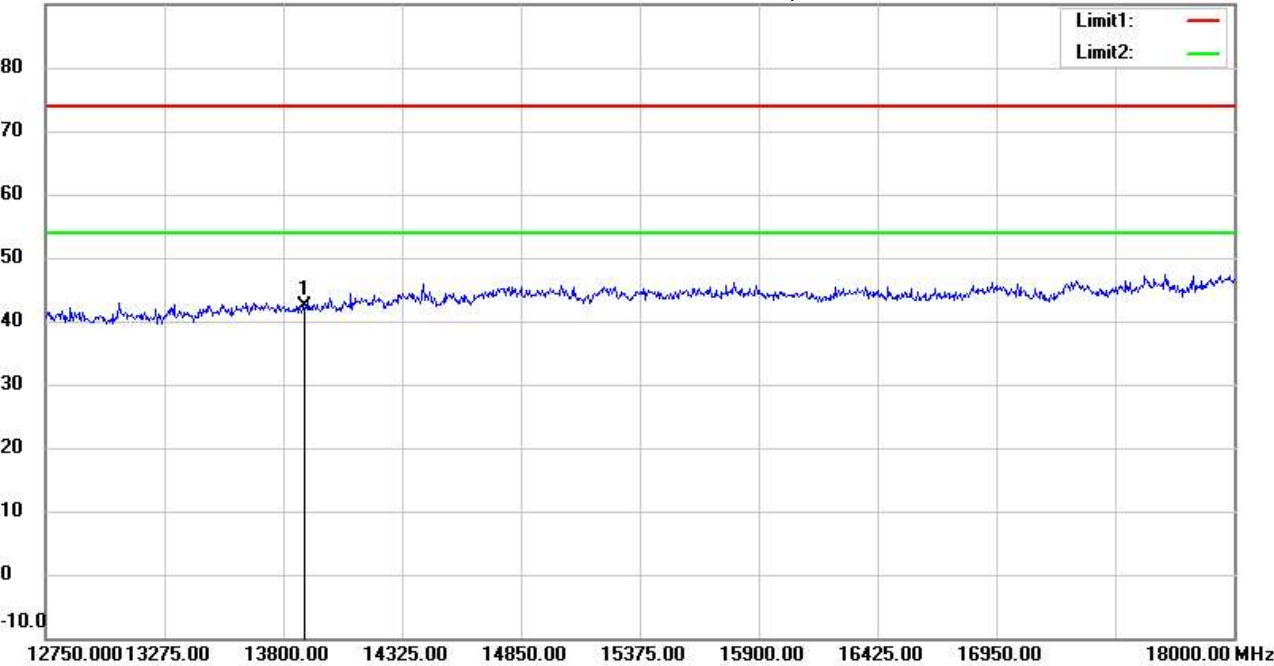
Data :#4

Test Mode : TX 802.11ax80 CH199

Polarization: **Horizontal**

| Mk. | Frequency (MHz) | Reading (dBuV) | Detector | Corr. factor (dB/m) | Result (dBuV/m) | Limit (dBuV/m) | Ant.Pos (cm) | Tab.Pos (deg.) | Margin (dB) | Comment |
|---|---|---|---|---|---|---|---|---|---|---|
| * | 13890.000 | 22.22 | peak | 20.09 | 42.31 | 74.00 | 150 | 266 | -31.69 | |

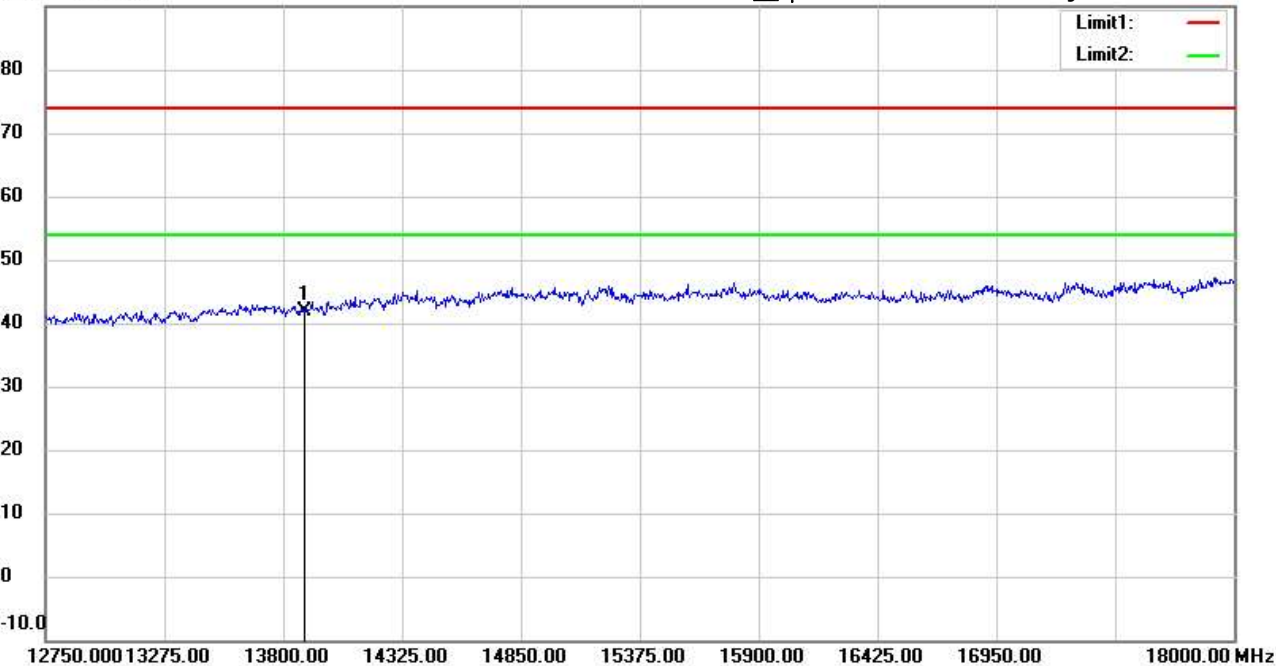
Data :#10

Test Mode : TX 802.11ax80 CH199

Polarization: Vertical

| Mk. | Frequency (MHz) | Reading (dBuV) | Detector | Corr. factor (dB/m) | Result (dBuV/m) | Limit (dBuV/m) | Ant.Pos (cm) | Tab.Pos (deg.) | Margin (dB) | Comment |
|---|---|---|---|---|---|---|---|---|---|---|
| * | 13890.000 | 21.81 | peak | 20.09 | 41.90 | 74.00 | 150 | 186 | -32.10 | |

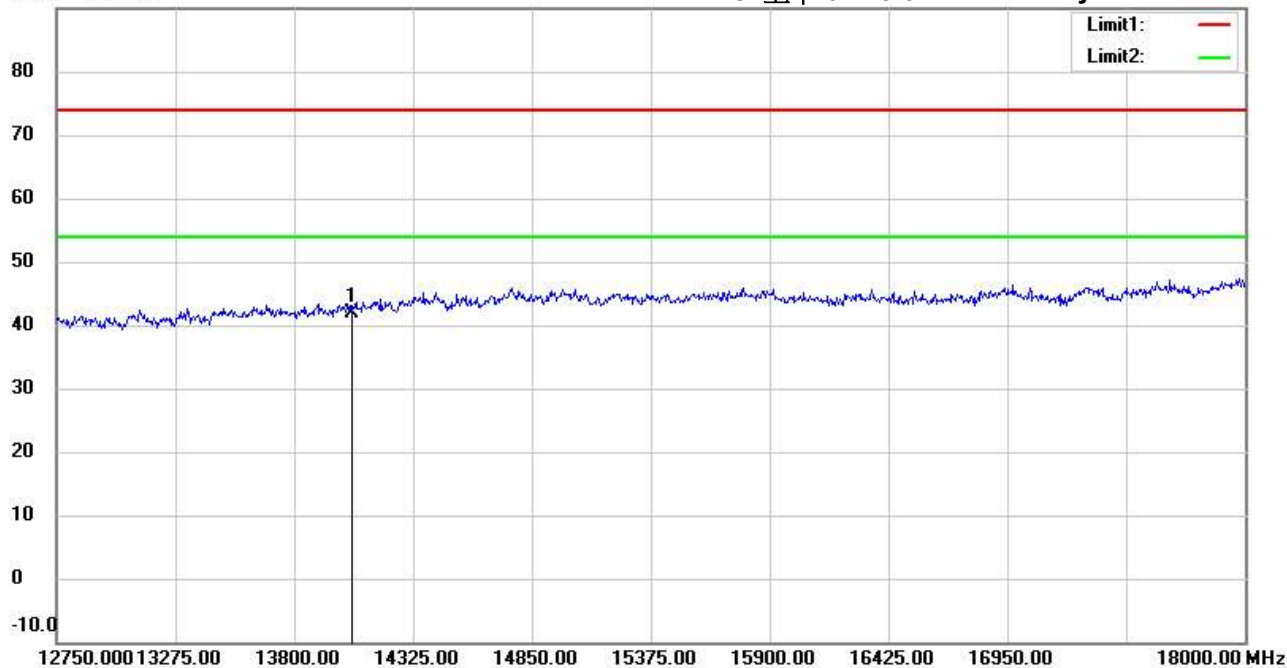
Data : #4

Test Mode : TX 802.11ax80 CH215

Polarization: **Horizontal**

| Mk. | Frequency (MHz) | Reading (dBuV) | Detector | Corr. factor (dB/m) | Result (dBuV/m) | Limit (dBuV/m) | Ant.Pos (cm) | Tab.Pos (deg.) | Margin (dB) | Comment |
|---|---|---|---|---|---|---|---|---|---|---|
| * | 14050.000 | 20.91 | peak | 21.05 | 41.96 | 74.00 | 150 | 185 | -32.04 | |

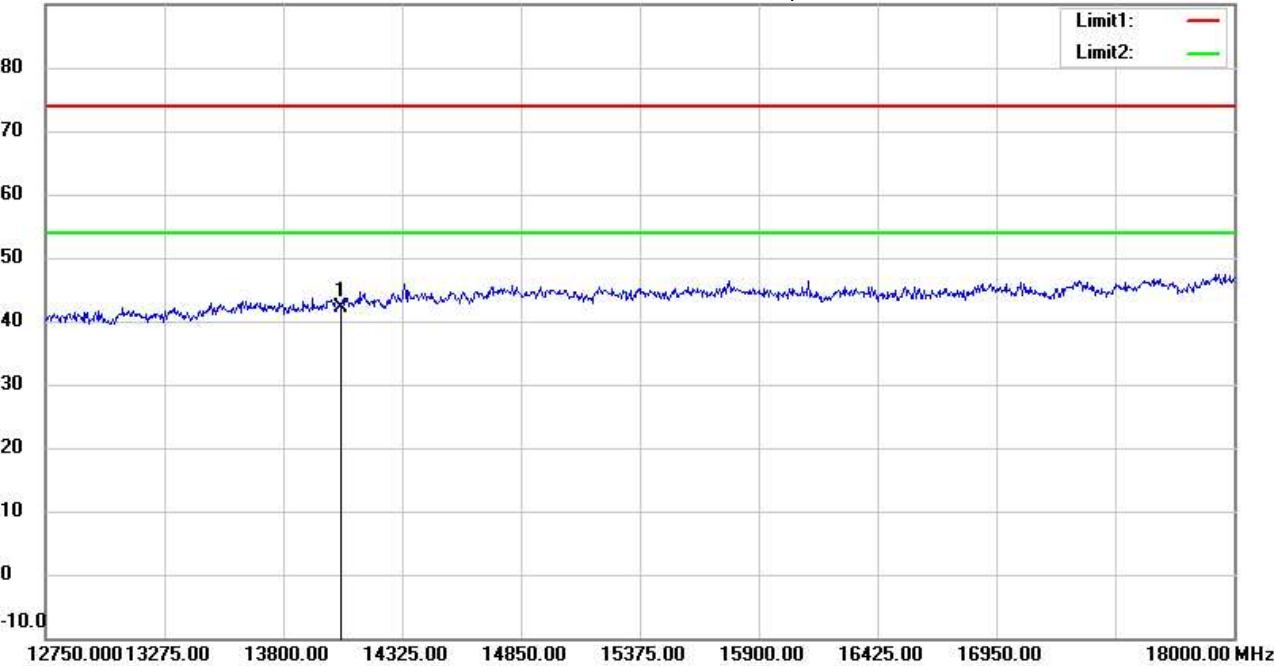
Data :#10

Test Mode : TX 802.11ax80 CH215

Polarization: Vertical

| Mk. | Frequency (MHz) | Reading (dBuV) | Detector | Corr. factor (dB/m) | Result (dBuV/m) | Limit (dBuV/m) | Ant.Pos (cm) | Tab.Pos (deg.) | Margin (dB) | Comment |
|---|---|---|---|---|---|---|---|---|---|---|
| * | 14050.000 | 20.99 | peak | 21.05 | 42.04 | 74.00 | 150 | 271 | -31.96 | |
