# InterLab<sup>®</sup> Photo Report on Test Setups

**Report Reference:** MDE\_GNNET\_1311\_FCCb\_Photo\_Setups

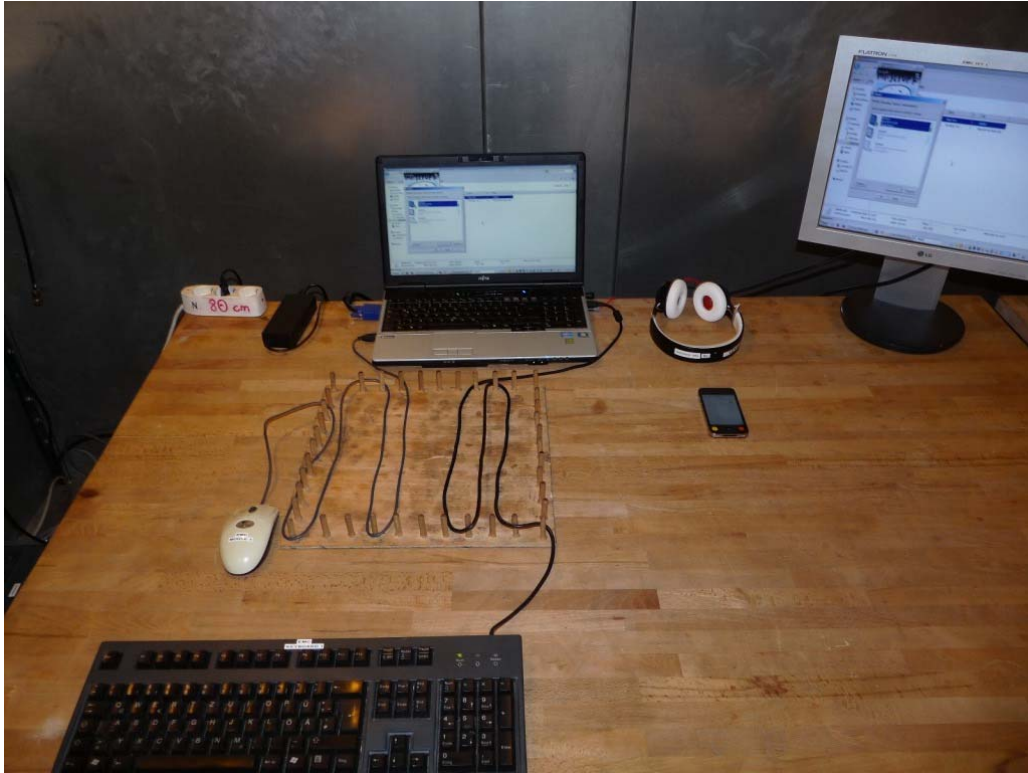
**Photo 1:** Test setup for conducted measurements (AC Port (power line), computer peripheral setup, EUT supplied by USB-cable from computer, intentional / unintentional radiator §15) Computer supplied by 110v 60Hz AC.
