### **APPENDIX 3: Photographs of Test Setup**

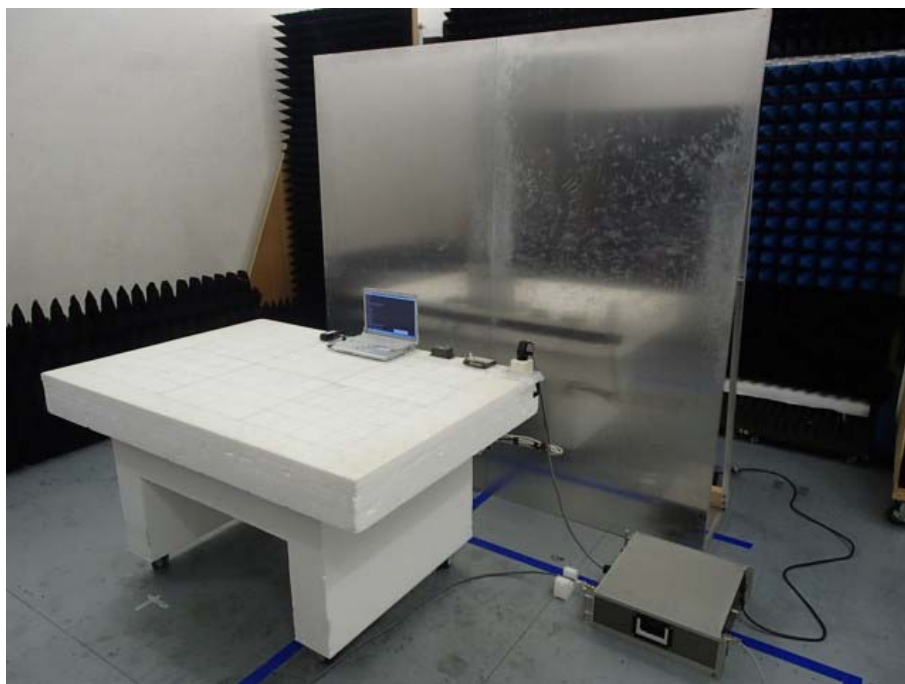
**Photo 1**

#### **Conducted Emission**

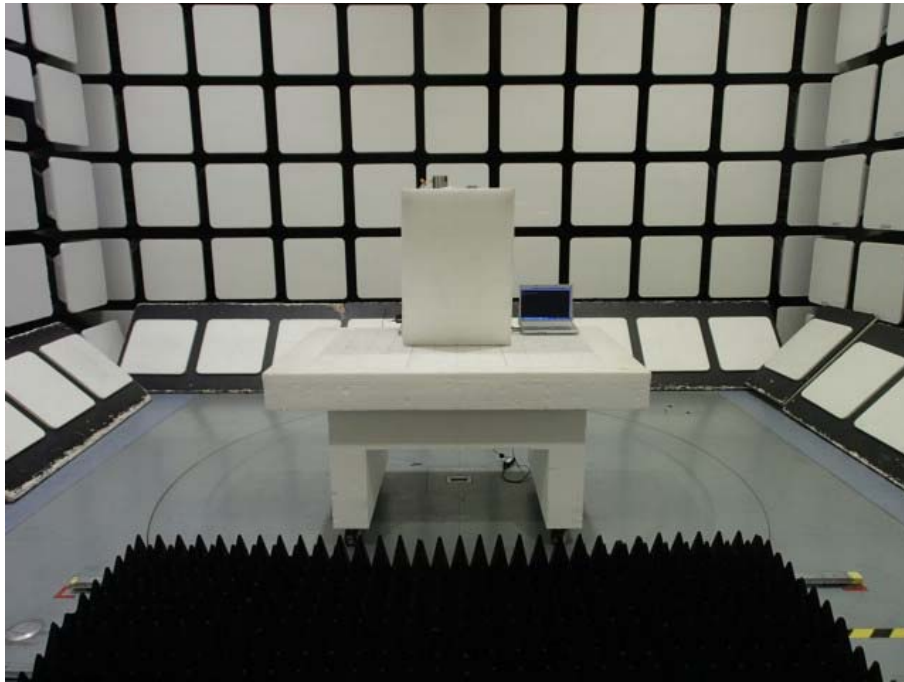
Photo 1

## Radiated Spurious Emission

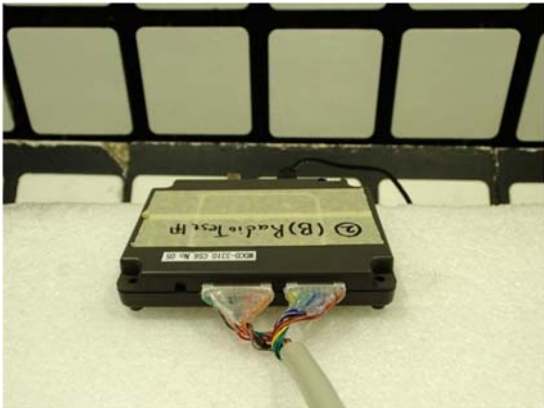
**Module  
X-axis**

**Worst Case Position**

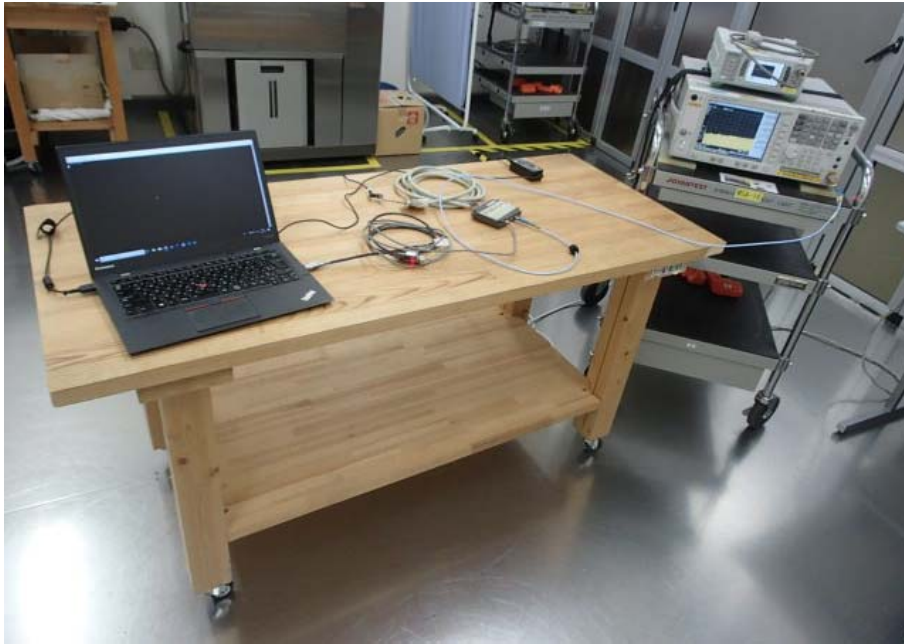
Photo 1

## Antenna Terminal Conducted Tests
