## Appendix B: Photographs of Test Setup

Product: Automotive Diagnostic Tool

Model: FOX200

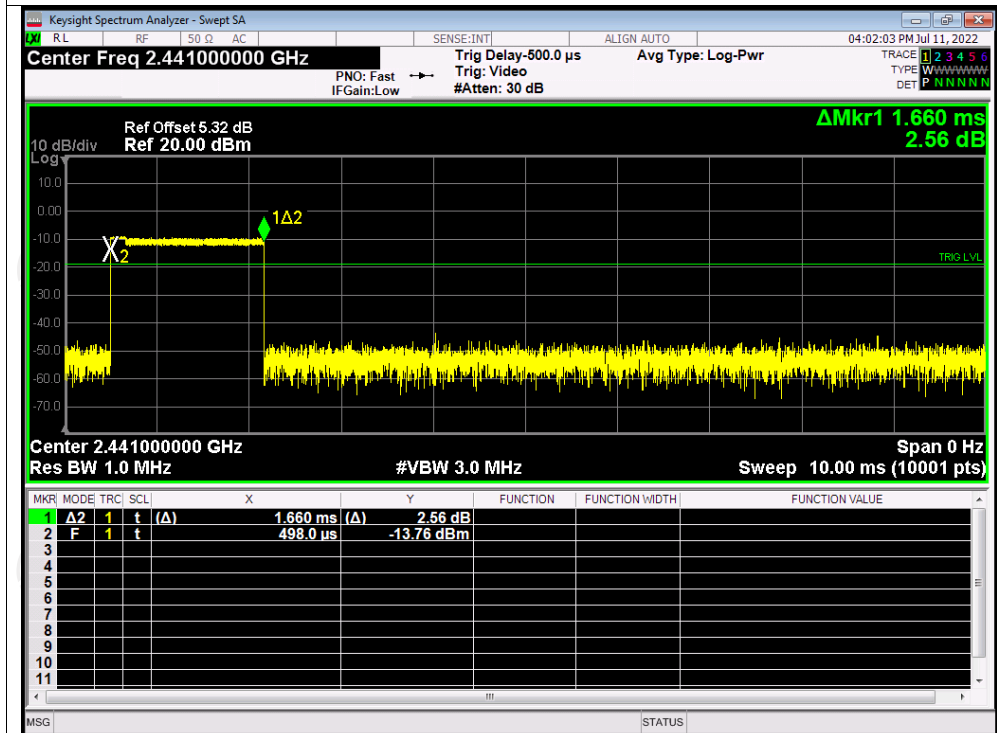
## Dwell NVNT 2-DH3 2441MHz One Burst

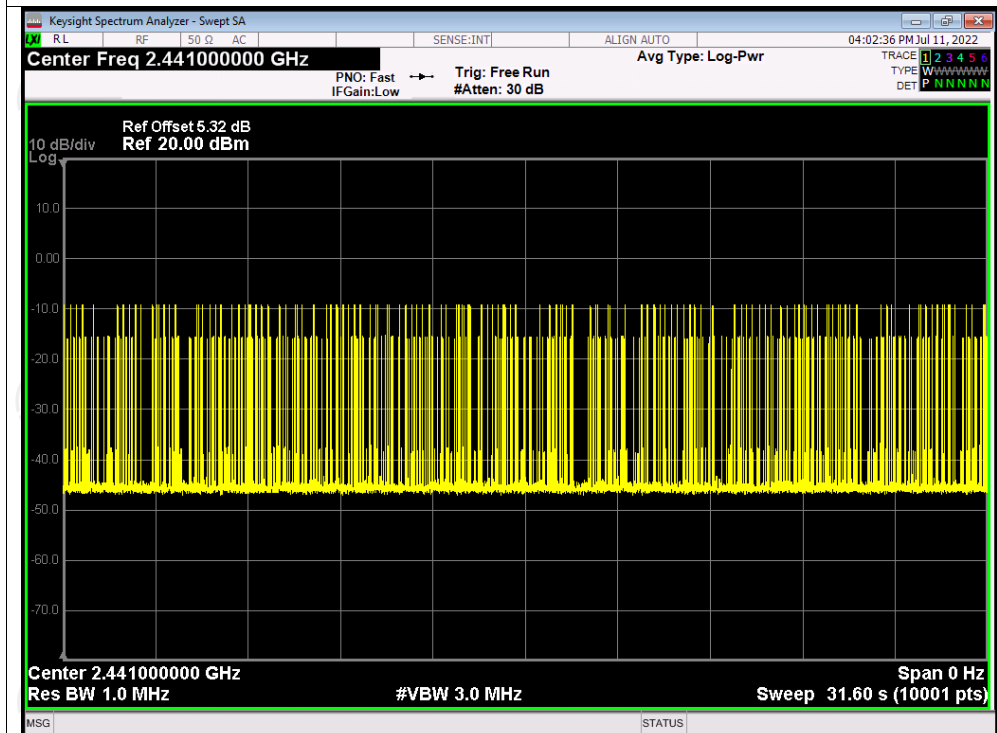
## Dwell NVNT 2-DH3 2441MHz Accumulated

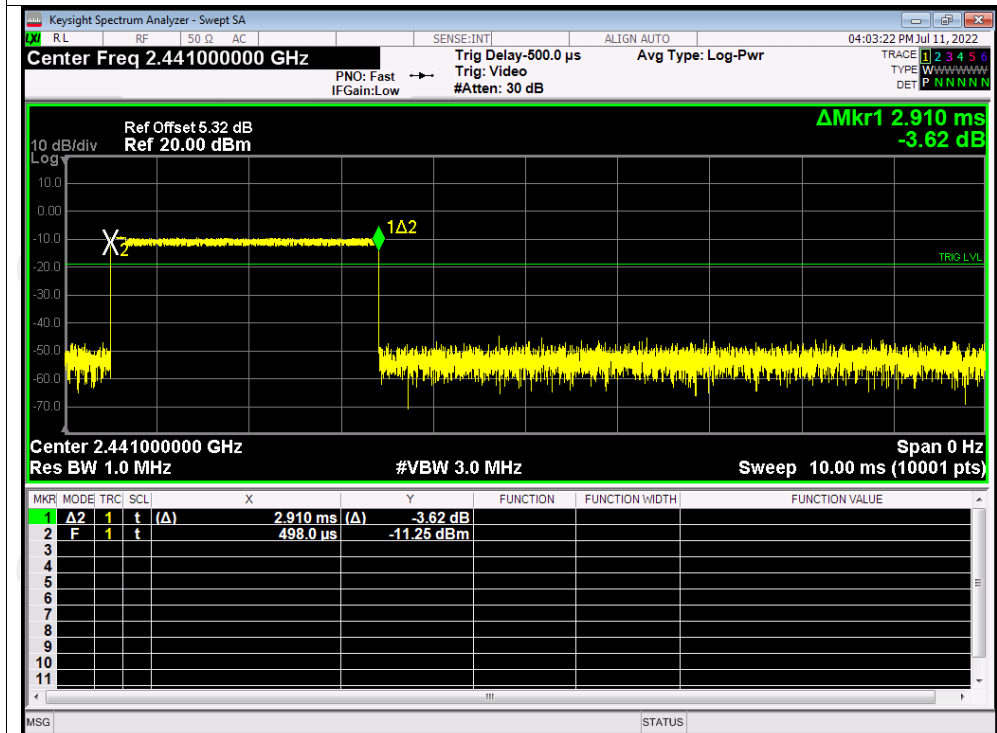
## Dwell NVNT 2-DH5 2441MHz One Burst

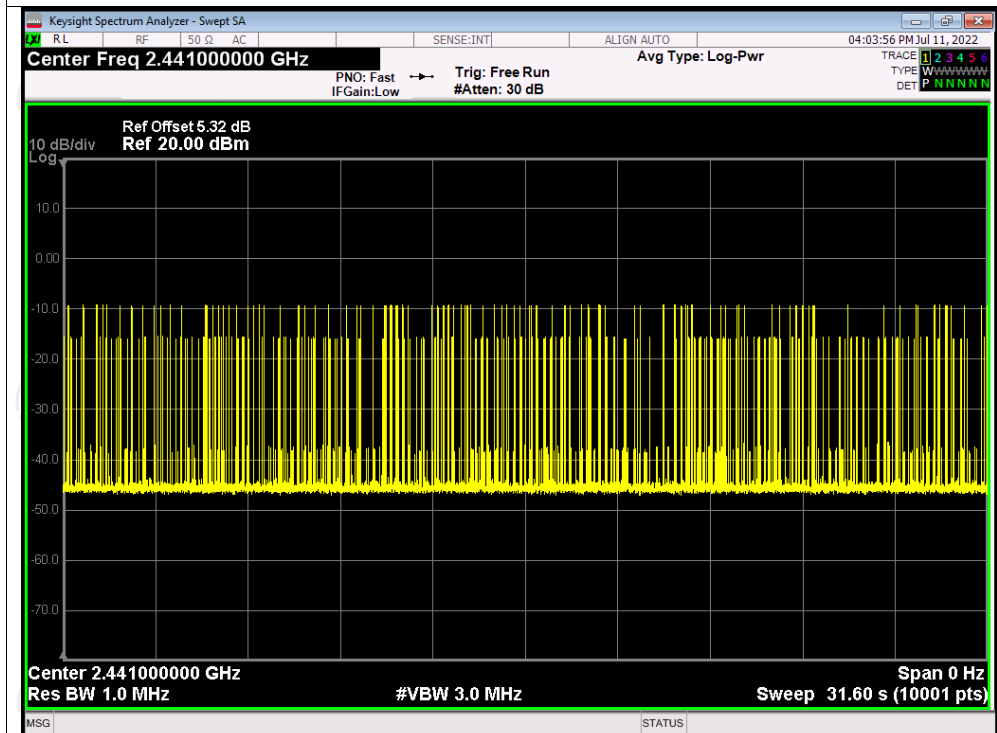
## Dwell NVNT 2-DH5 2441MHz Accumulated

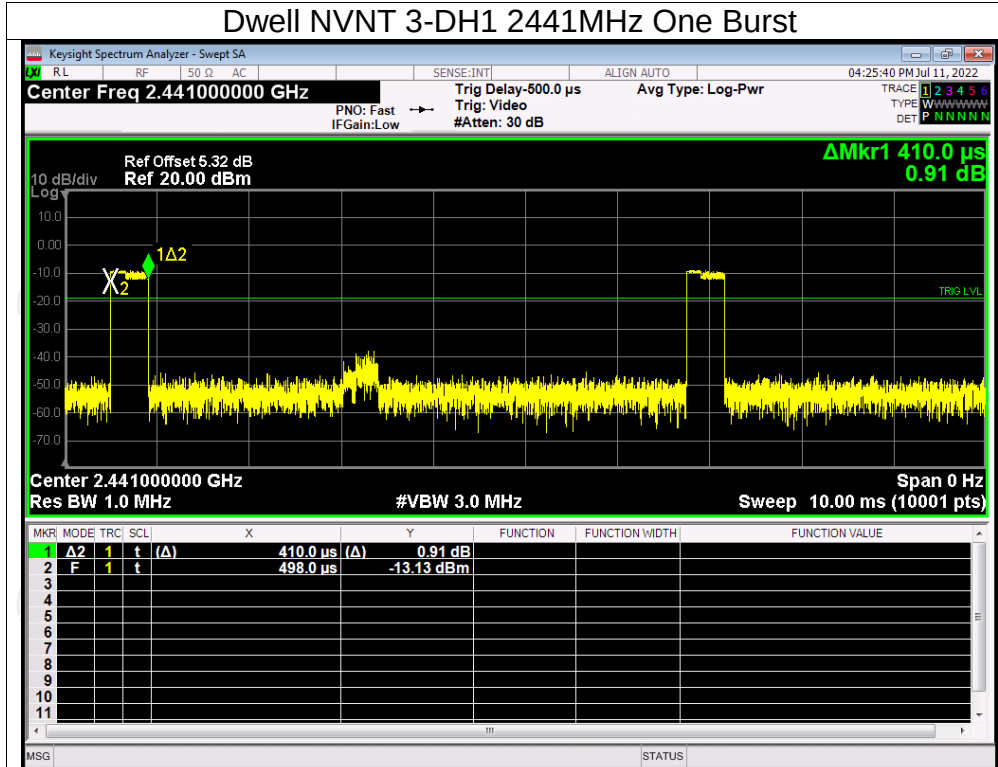
## Dwell NVNT 3-DH1 2441MHz One Burst

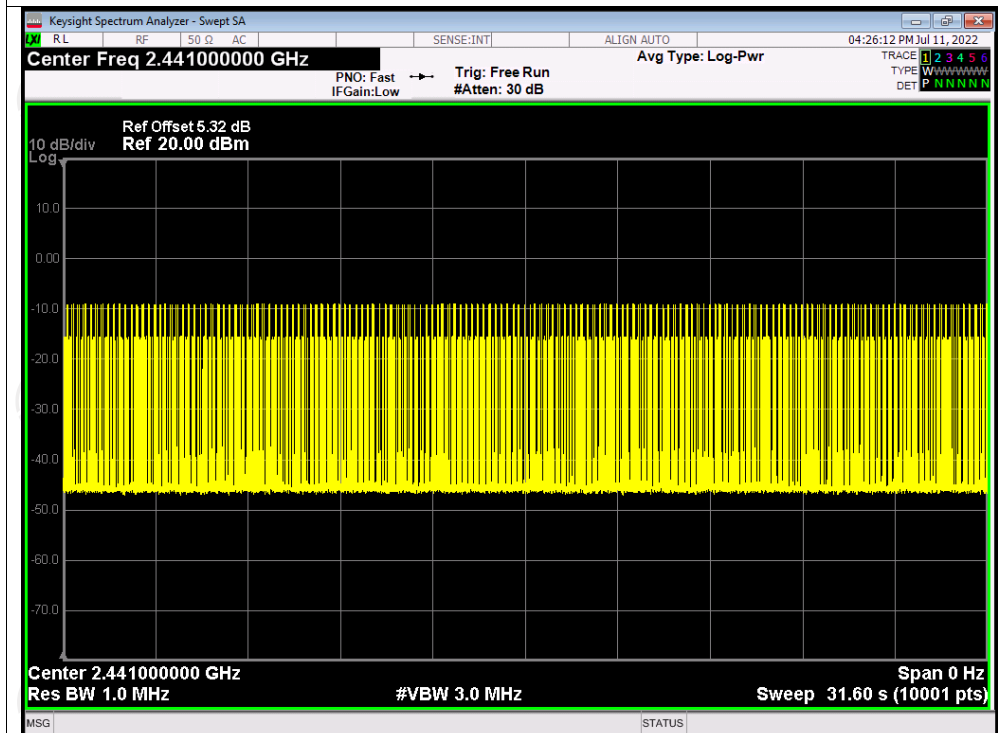
## Dwell NVNT 3-DH1 2441MHz Accumulated

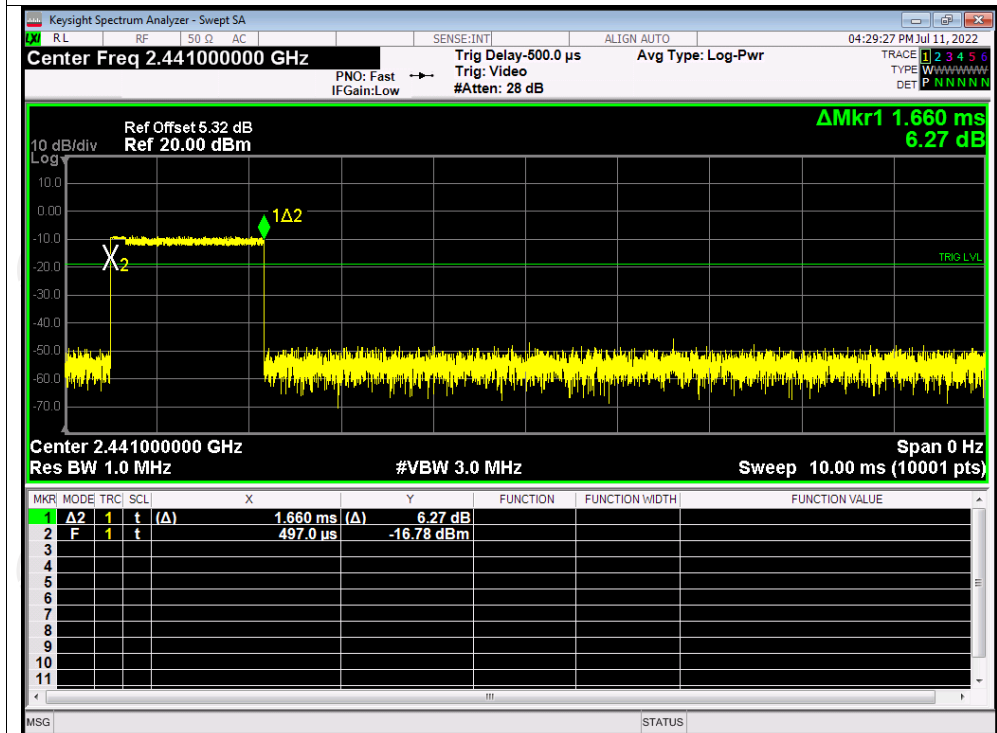
## Dwell NVNT 3-DH3 2441MHz One Burst

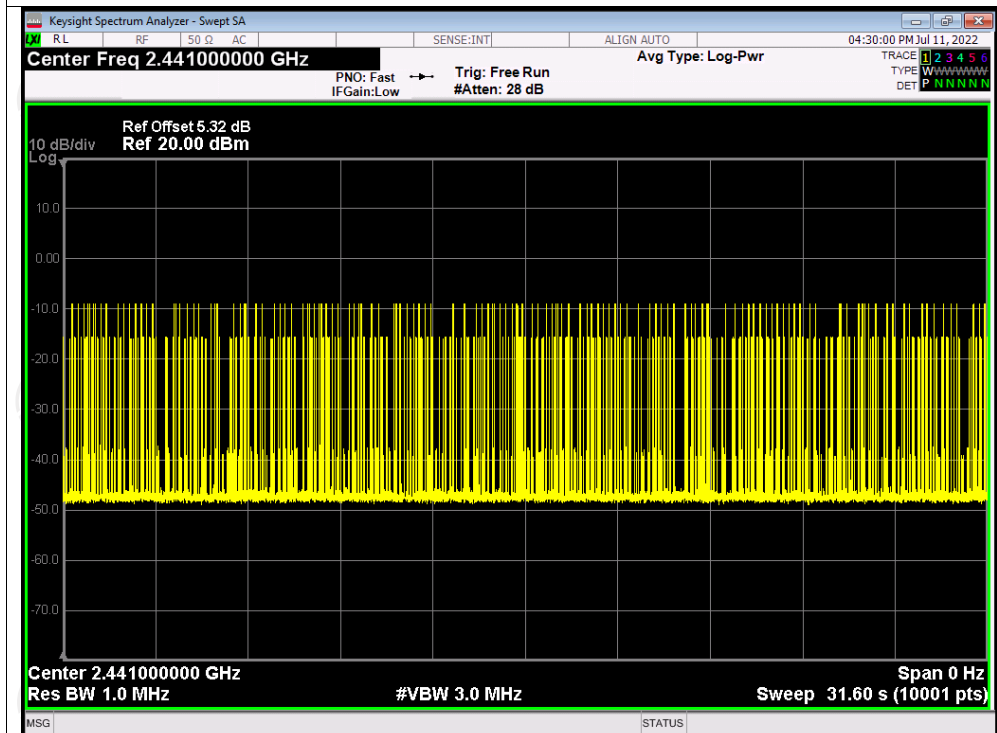
## Dwell NVNT 3-DH3 2441MHz Accumulated

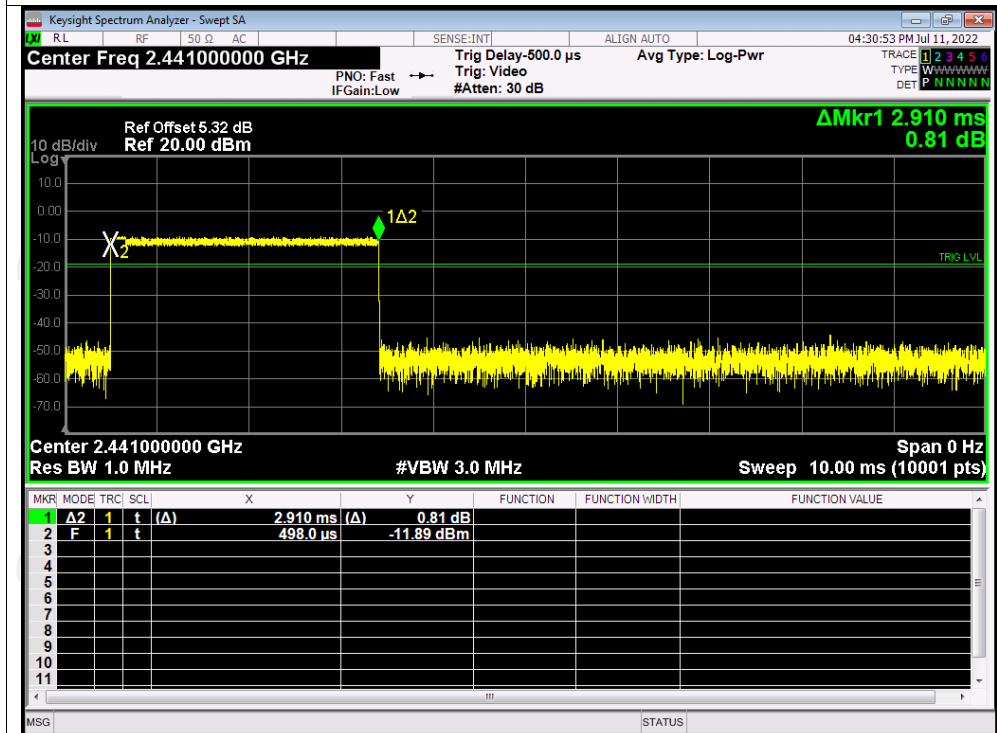
## Dwell NVNT 3-DH5 2441MHz One Burst

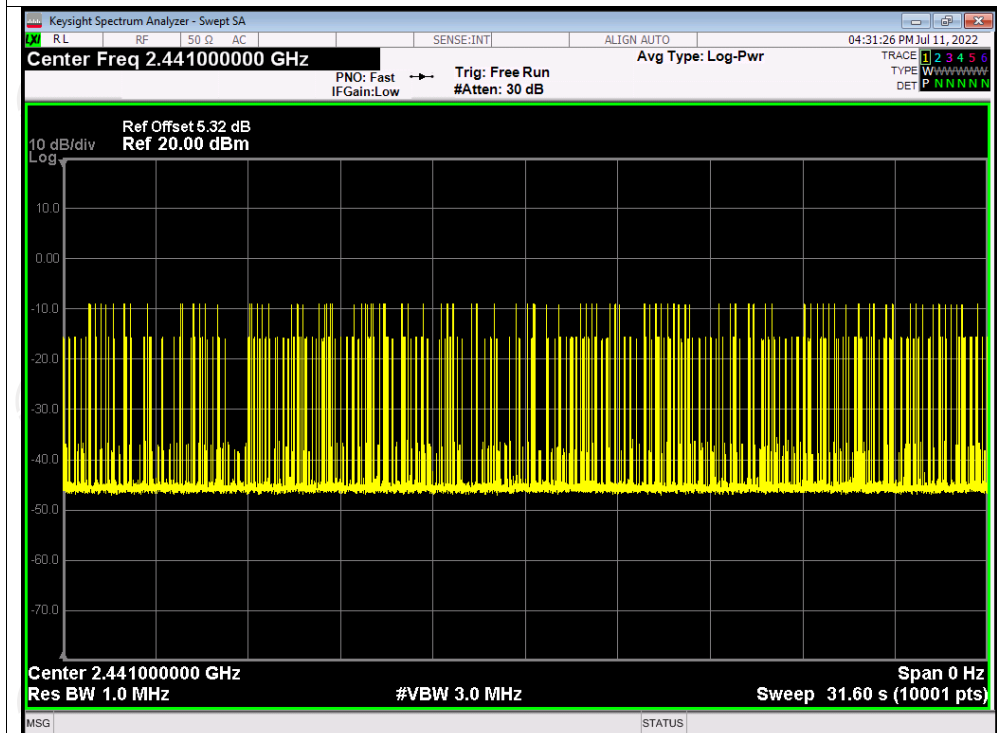
## Dwell NVNT 3-DH5 2441MHz Accumulated
