## Appendix G: Conducted Spurious Emission Test Result

## Appendix H: Reference level measurement

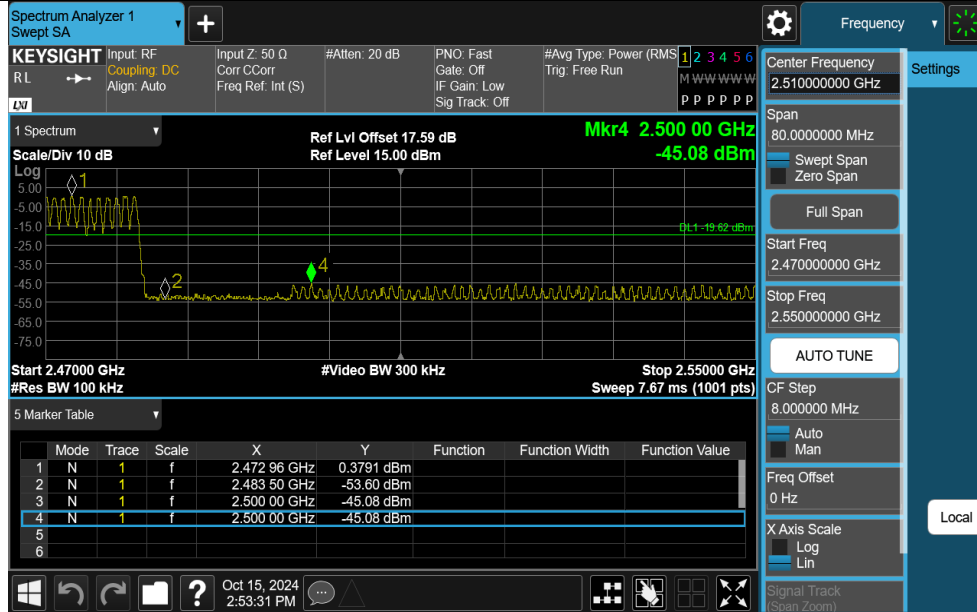
## DH5-Ant1-Hop 2480-PASS

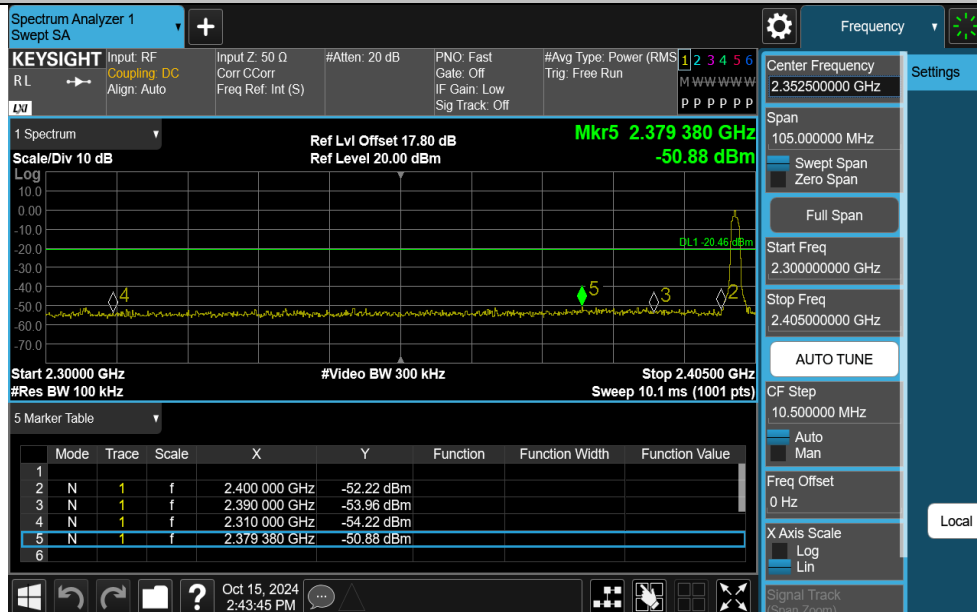
## 2DH5-Ant1-2402-PASS

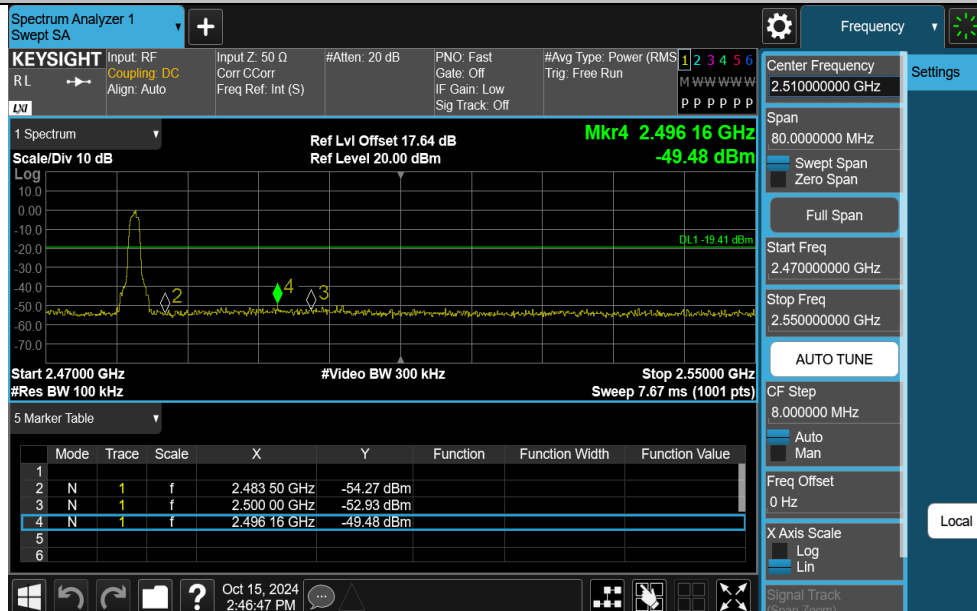
## 2DH5-Ant1-2480-PASS

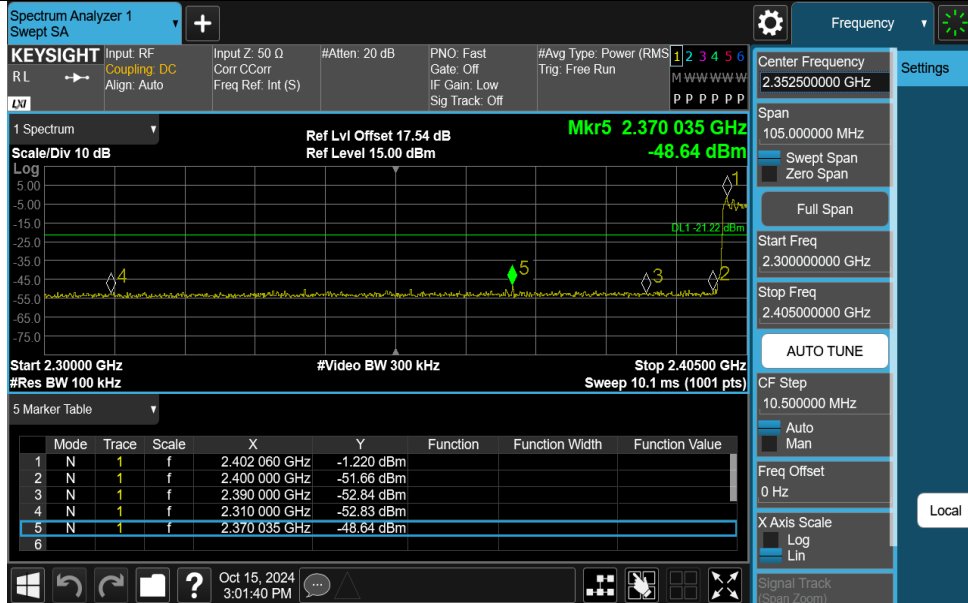
## 2DH5-Ant1-Hop 2402-PASS

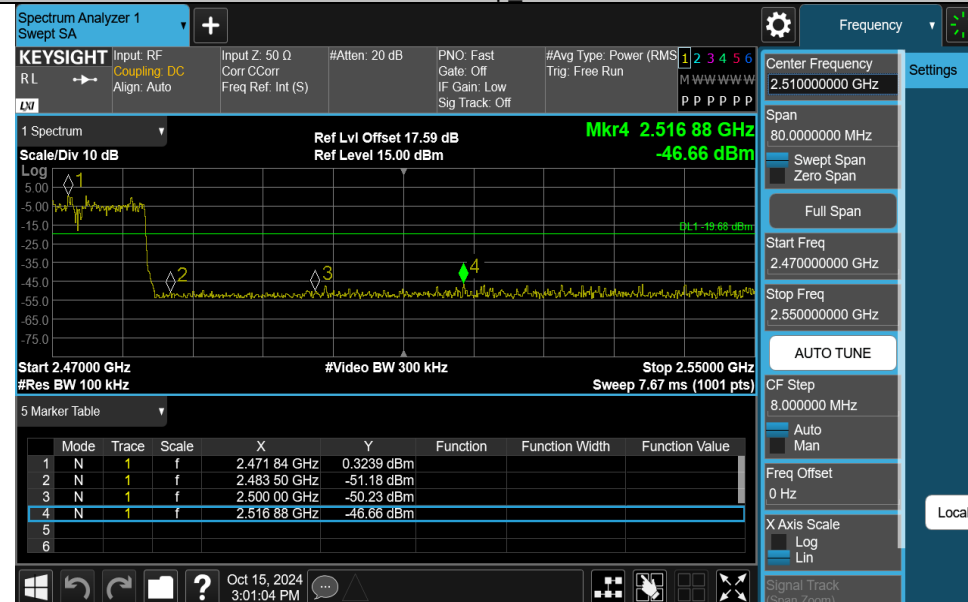
## 2DH5-Ant1-Hop 2480-PASS

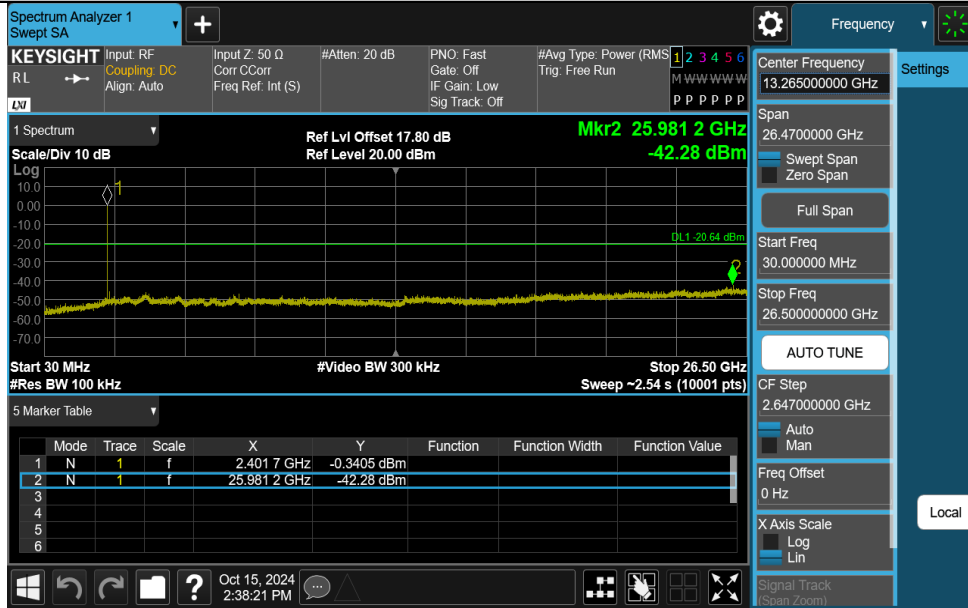
## DH5-Ant1-2402-30~26500-PASS

| TestMode | Antenna | Frequency[MHz] | FreqRange<br>[MHz] | RefLevel<br>[dBm] | Result<br>[dBm] | Limit<br>[dBm] | Verdict |
|---|---|---|---|---|---|---|---|
| DH5 | Ant1 | 2402 | 30~26500 | -0.64 | -42.28 | $\leq -20.64$ | PASS |

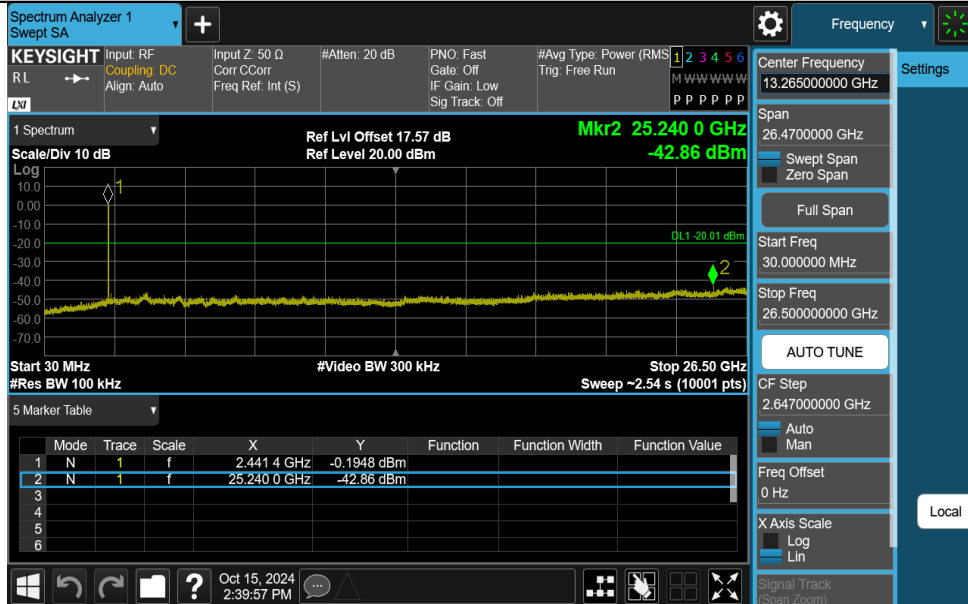
## DH5-Ant1-2441-30~26500-PASS

| TestMode | Antenna | Frequency[MHz] | FreqRange<br>[MHz] | RefLevel<br>[dBm] | Result<br>[dBm] | Limit<br>[dBm] | Verdict |
|---|---|---|---|---|---|---|---|
| DH5 | Ant1 | 2441 | 30~26500 | -0.01 | -42.86 | $\leq -20.01$ | PASS |

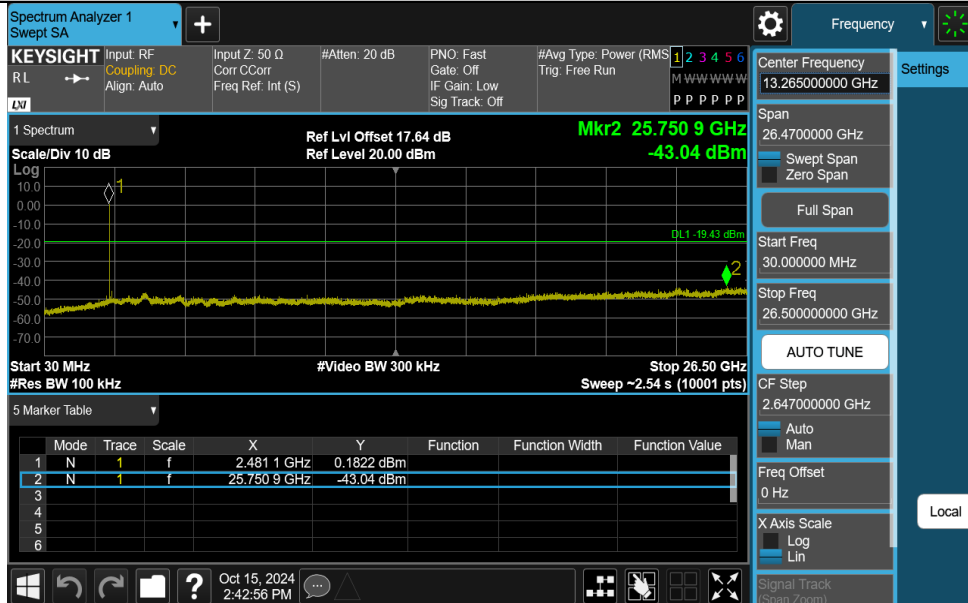
## DH5-Ant1-2480-30~26500-PASS

| TestMode | Antenna | Frequency[MHz] | FreqRange<br>[MHz] | RefLevel<br>[dBm] | Result<br>[dBm] | Limit<br>[dBm] | Verdict |
|---|---|---|---|---|---|---|---|
| DH5 | Ant1 | 2480 | 30~26500 | 0.57 | -43.04 | $\leq -19.43$ | PASS |

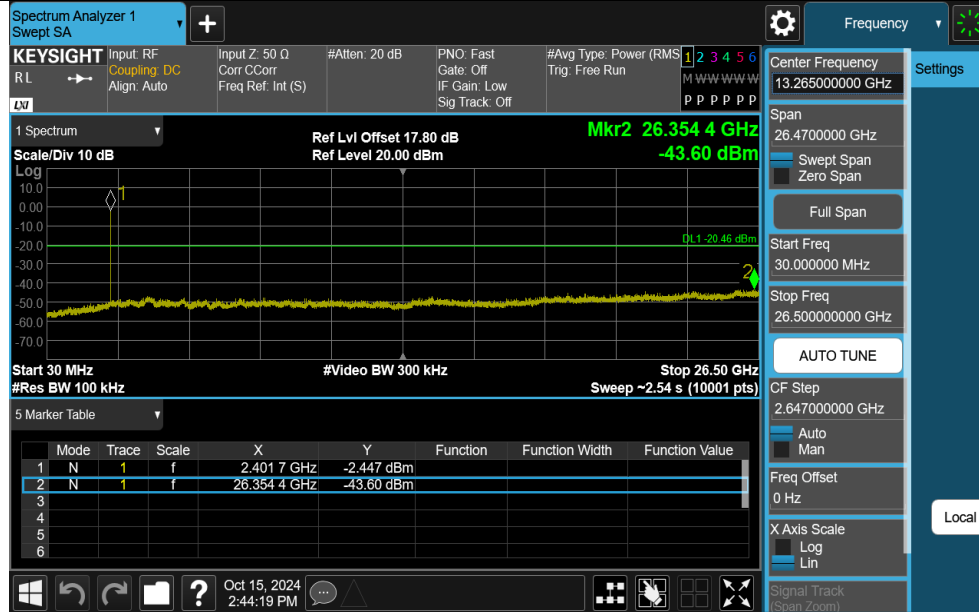
## 2DH5-Ant1-2402-30~26500-PASS

| TestMode | Antenna | Frequency[MHz] | FreqRange<br>[MHz] | RefLevel<br>[dBm] | Result<br>[dBm] | Limit<br>[dBm] | Verdict |
|---|---|---|---|---|---|---|---|
| 2DH5 | Ant1 | 2402 | 30~26500 | -0.46 | -43.6 | $\leq -20.46$ | PASS |

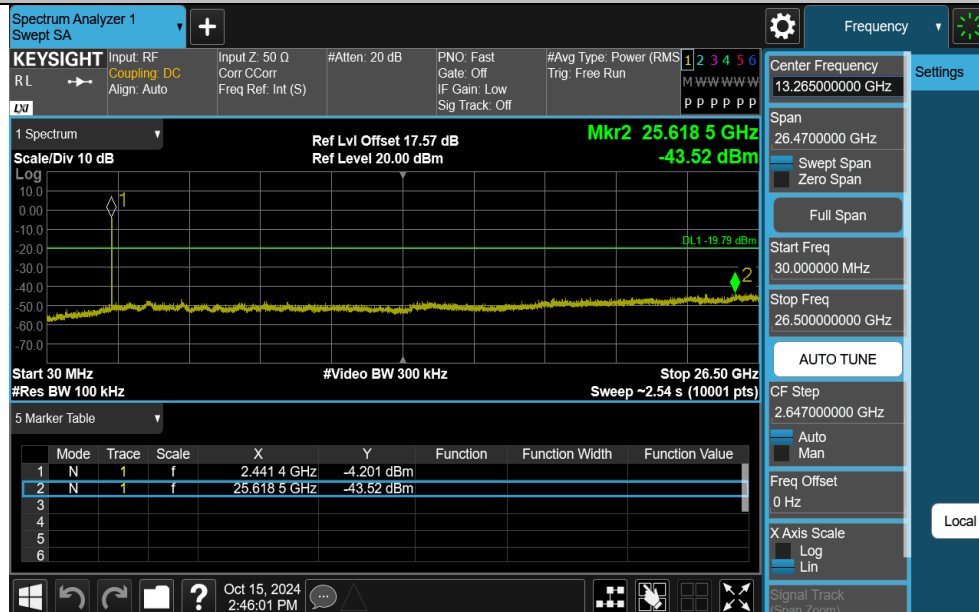
## 2DH5-Ant1-2441-30~26500-PASS

| TestMode | Antenna | Frequency[MHz] | FreqRange<br>[MHz] | RefLevel<br>[dBm] | Result<br>[dBm] | Limit<br>[dBm] | Verdict |
|---|---|---|---|---|---|---|---|
| 2DH5 | Ant1 | 2441 | 30~26500 | 0.21 | -43.52 | $\leq -19.79$ | PASS |

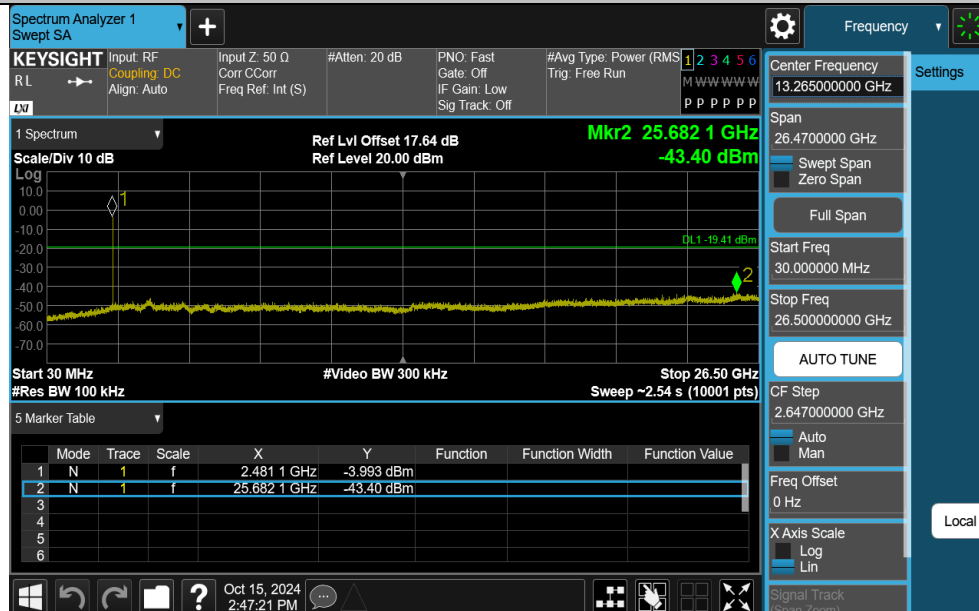
## 2DH5-Ant1-2480-30~26500-PASS

| TestMode | Antenna | Frequency[MHz] | FreqRange<br>[MHz] | RefLevel<br>[dBm] | Result<br>[dBm] | Limit<br>[dBm] | Verdict |
|---|---|---|---|---|---|---|---|
| 2DH5 | Ant1 | 2480 | 30~26500 | 0.59 | -43.4 | $\leq -19.41$ | PASS |

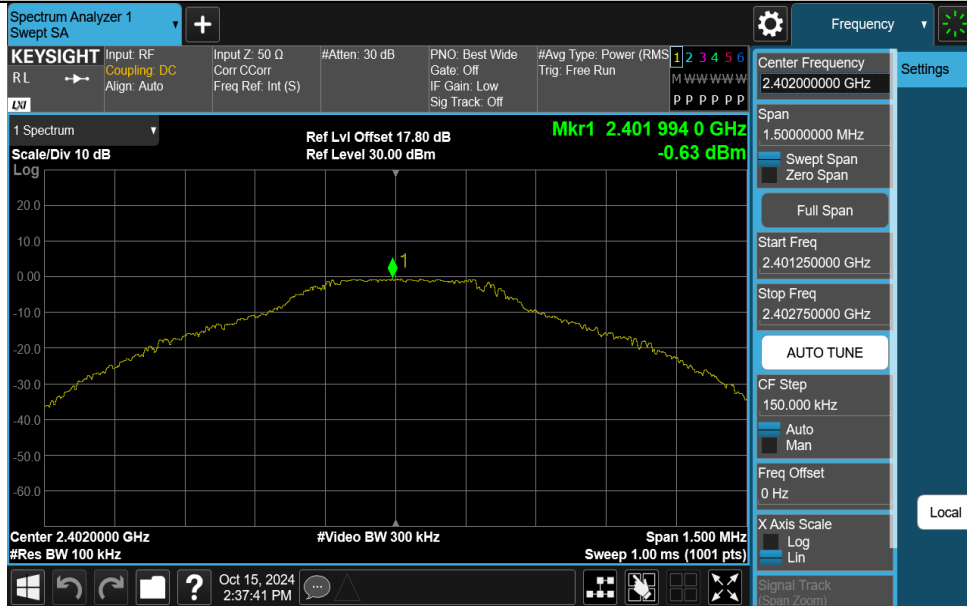
## DH5-Ant1-2402-PASS

| TestMode | Antenna | Freq(MHz) | Max.Point[MHz] | Result[dBm] |
|---|---|---|---|---|
| DH5 | Ant1 | 2402 | 2401.99 | -0.64 |

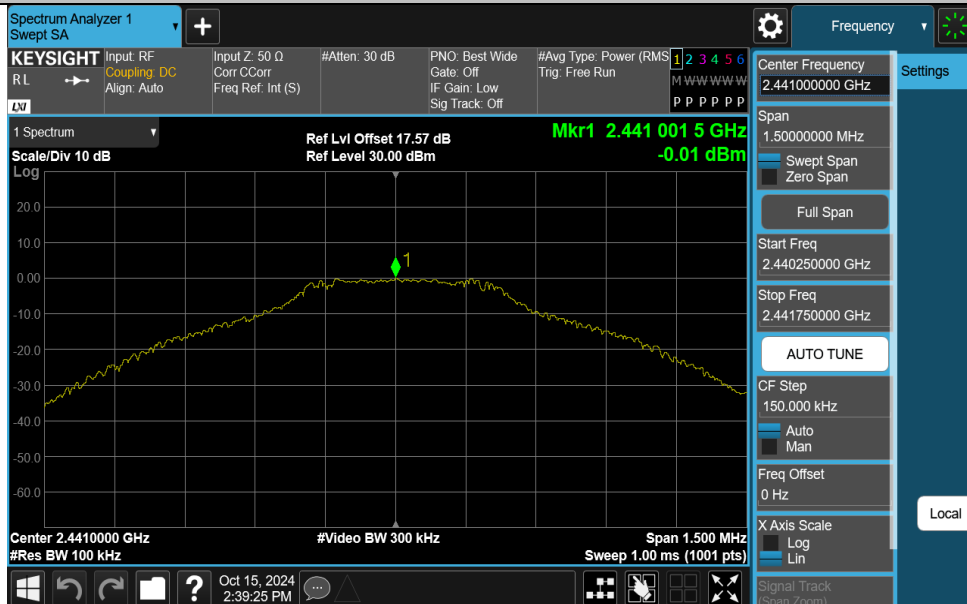
## DH5-Ant1-2441-PASS

| TestMode | Antenna | Freq(MHz) | Max.Point[MHz] | Result[dBm] |
|---|---|---|---|---|
| DH5 | Ant1 | 2441 | 2441.00 | -0.01 |

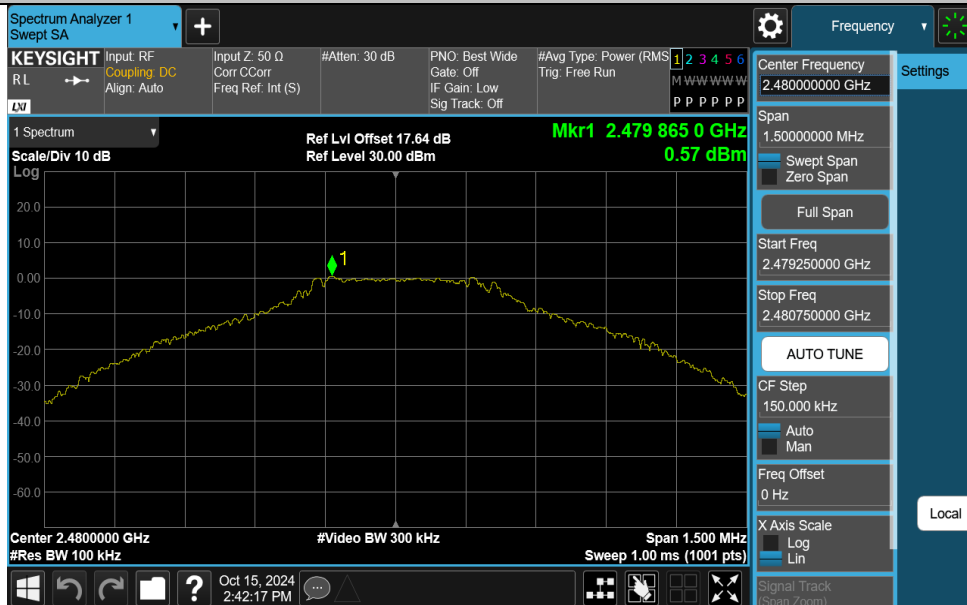
## DH5-Ant1-2480-PASS

| TestMode | Antenna | Freq(MHz) | Max.Point[MHz] | Result[dBm] |
|---|---|---|---|---|
| DH5 | Ant1 | 2480 | 2479.87 | 0.57 |

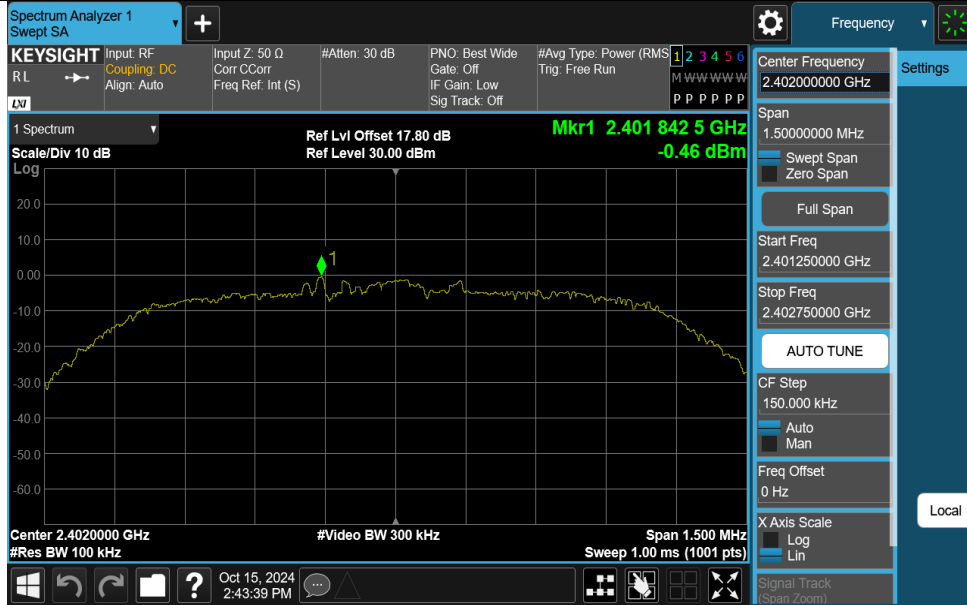
## 2DH5-Ant1-2402-PASS

| TestMode | Antenna | Freq(MHz) | Max.Point[MHz] | Result[dBm] |
|---|---|---|---|---|
| 2DH5 | Ant1 | 2402 | 2401.84 | -0.46 |

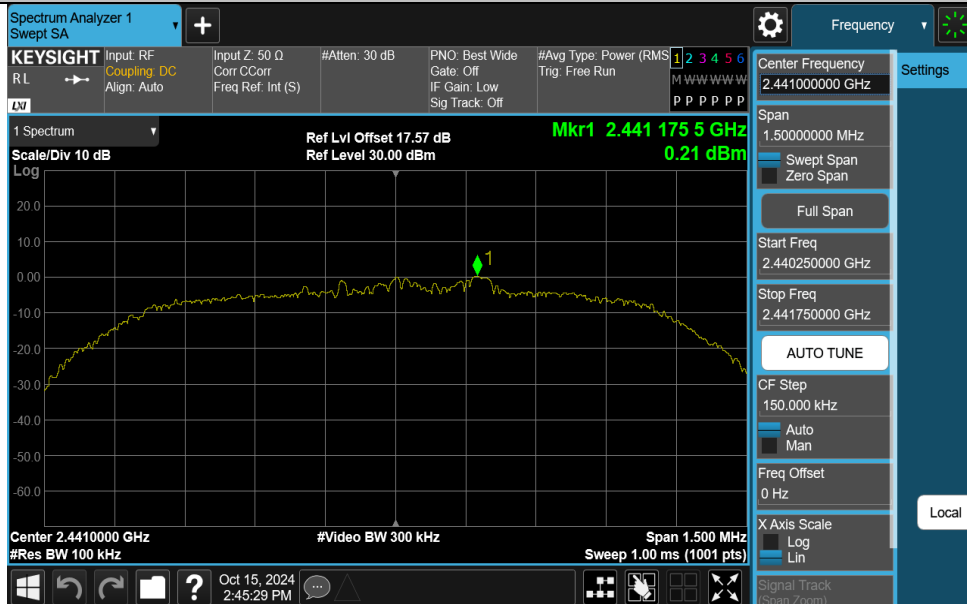
## 2DH5-Ant1-2441-PASS

| TestMode | Antenna | Freq(MHz) | Max.Point[MHz] | Result[dBm] |
|---|---|---|---|---|
| 2DH5 | Ant1 | 2441 | 2441.18 | 0.21 |

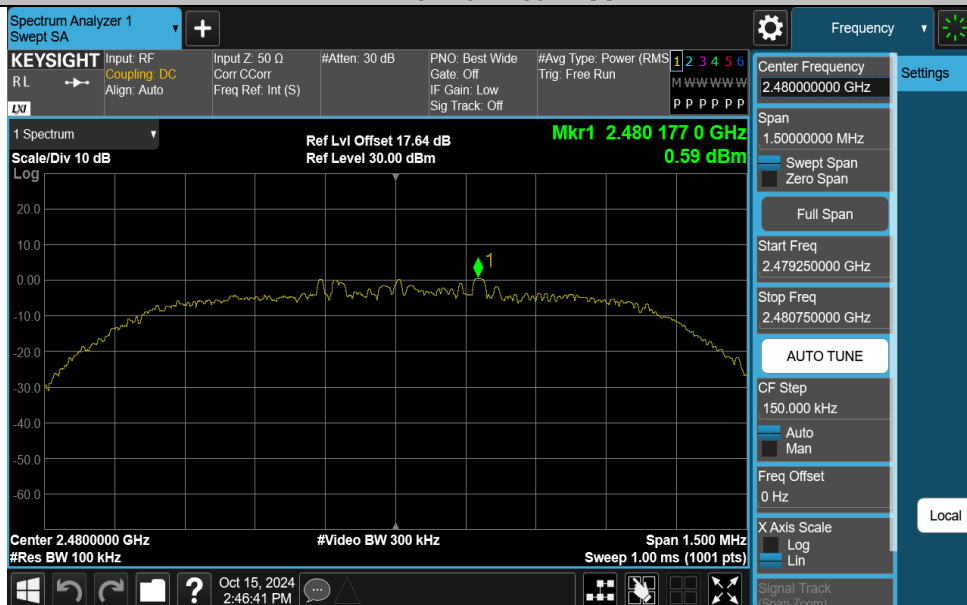
## 2DH5-Ant1-2480-PASS

| TestMode | Antenna | Freq(MHz) | Max.Point[MHz] | Result[dBm] |
|---|---|---|---|---|
| 2DH5 | Ant1 | 2480 | 2480.18 | 0.59 |

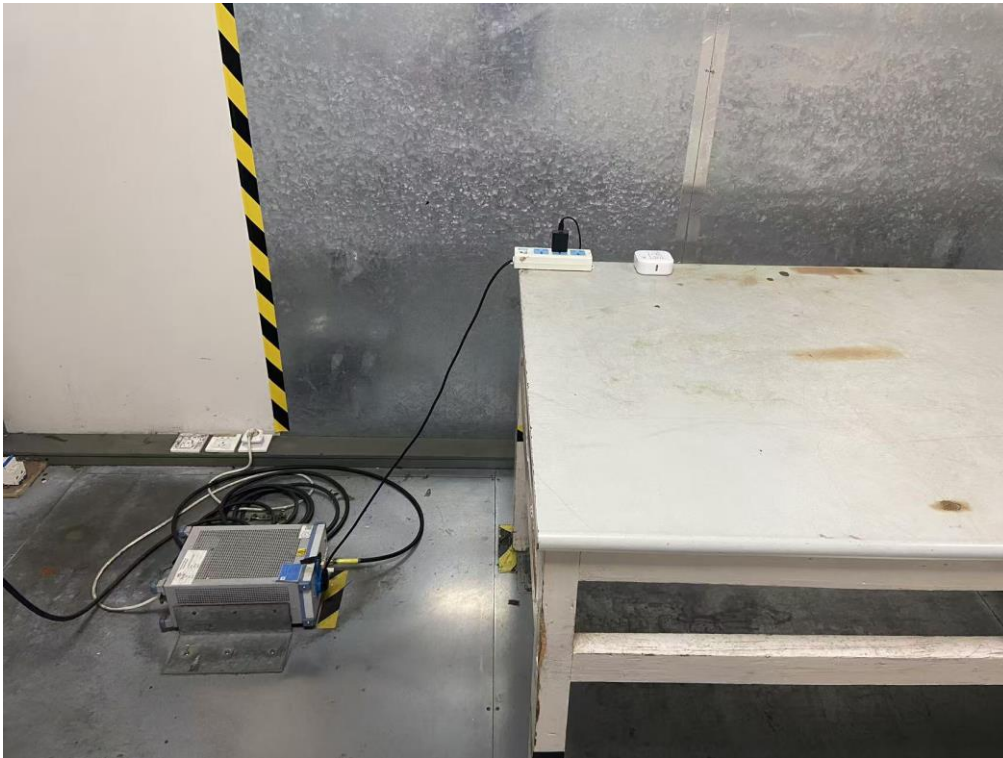
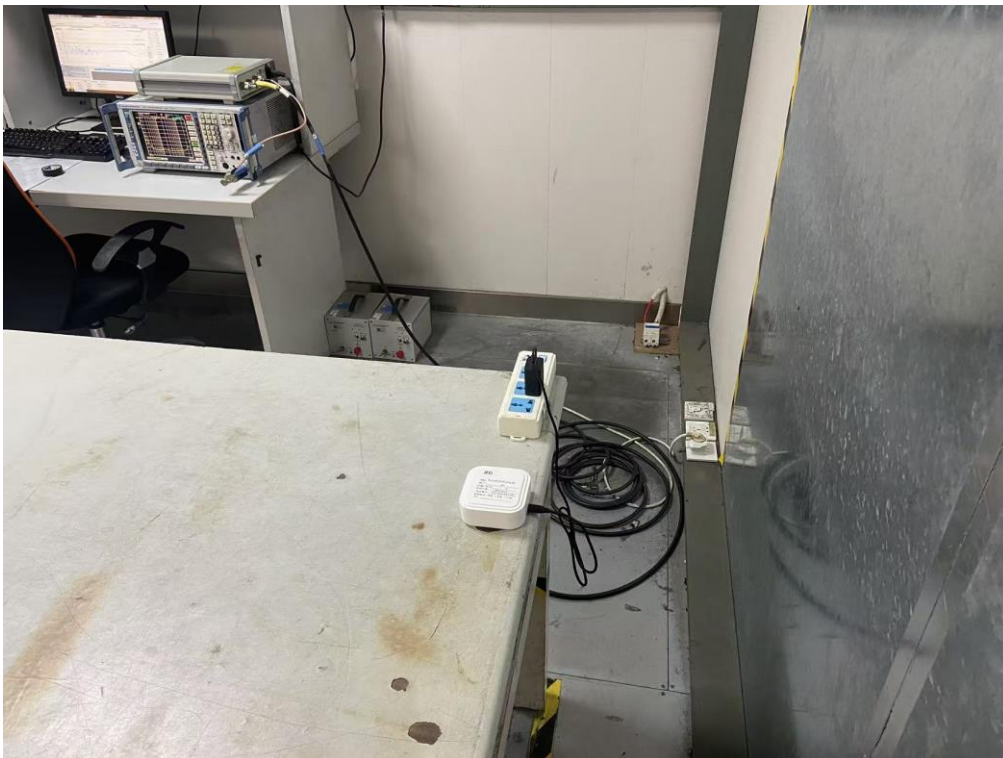
Conducted Test

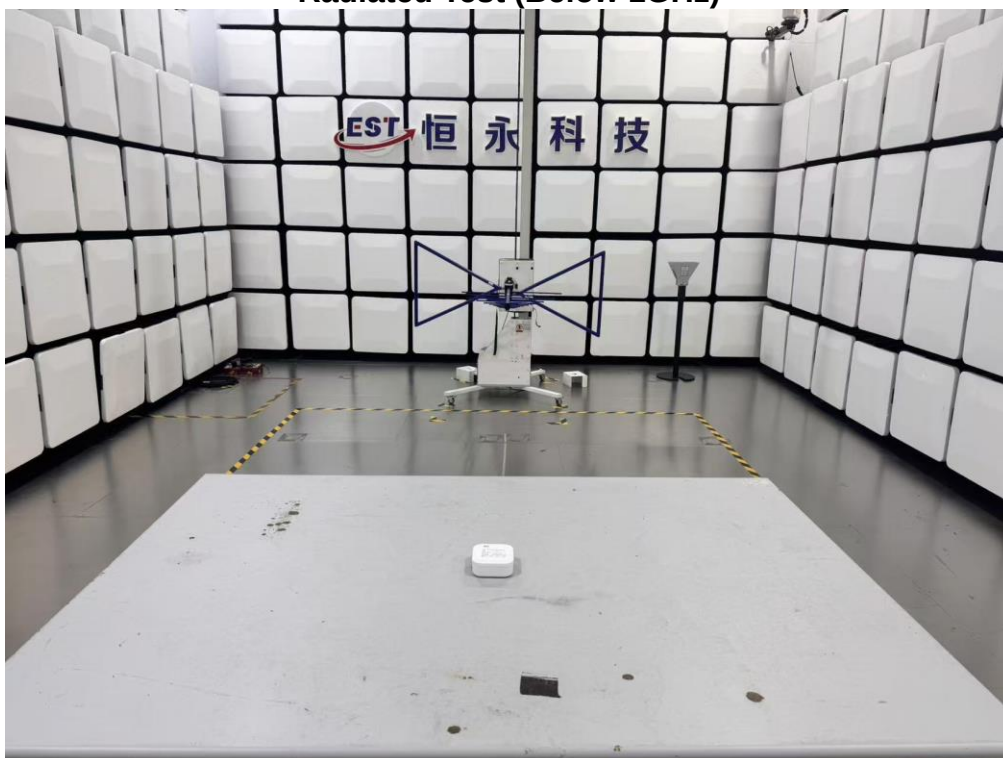
**Radiated Test (Below 1GHz)**

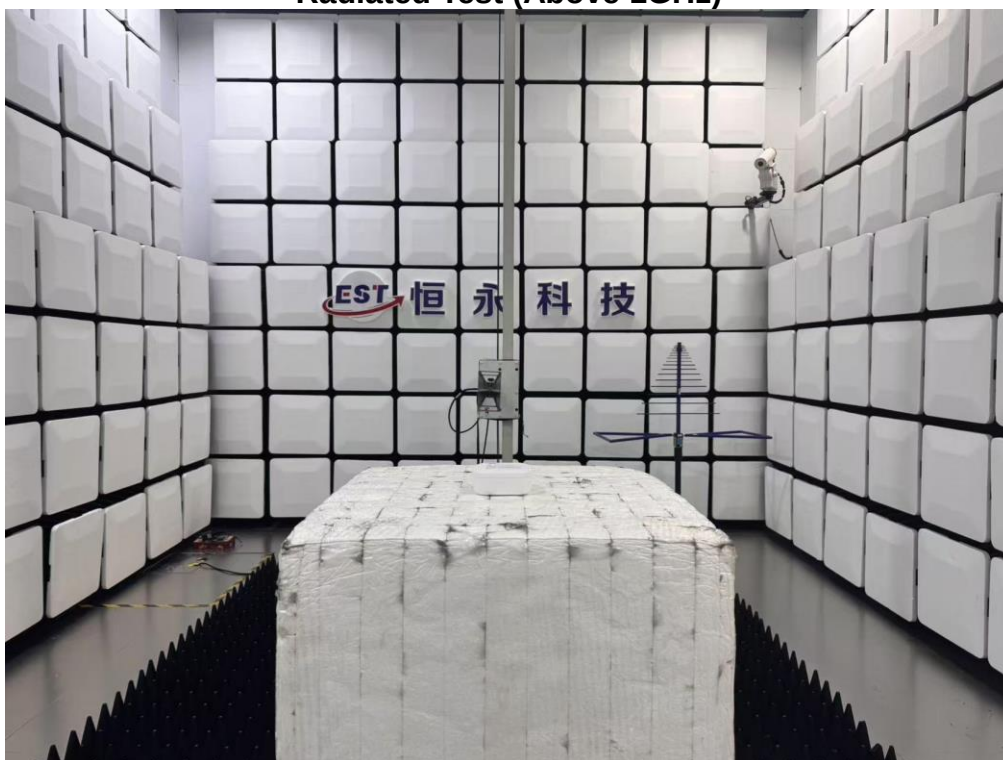
**Radiated Test (Above 1GHz)**
