## 10.7 APPENDIXH: CONDUCTED SPURIOUS EMISSION

## APPENDIX A: PHOTOGRAPHS OF TEST SETUP

## APPENDIX B: PHOTOGRAPHS OF EUT

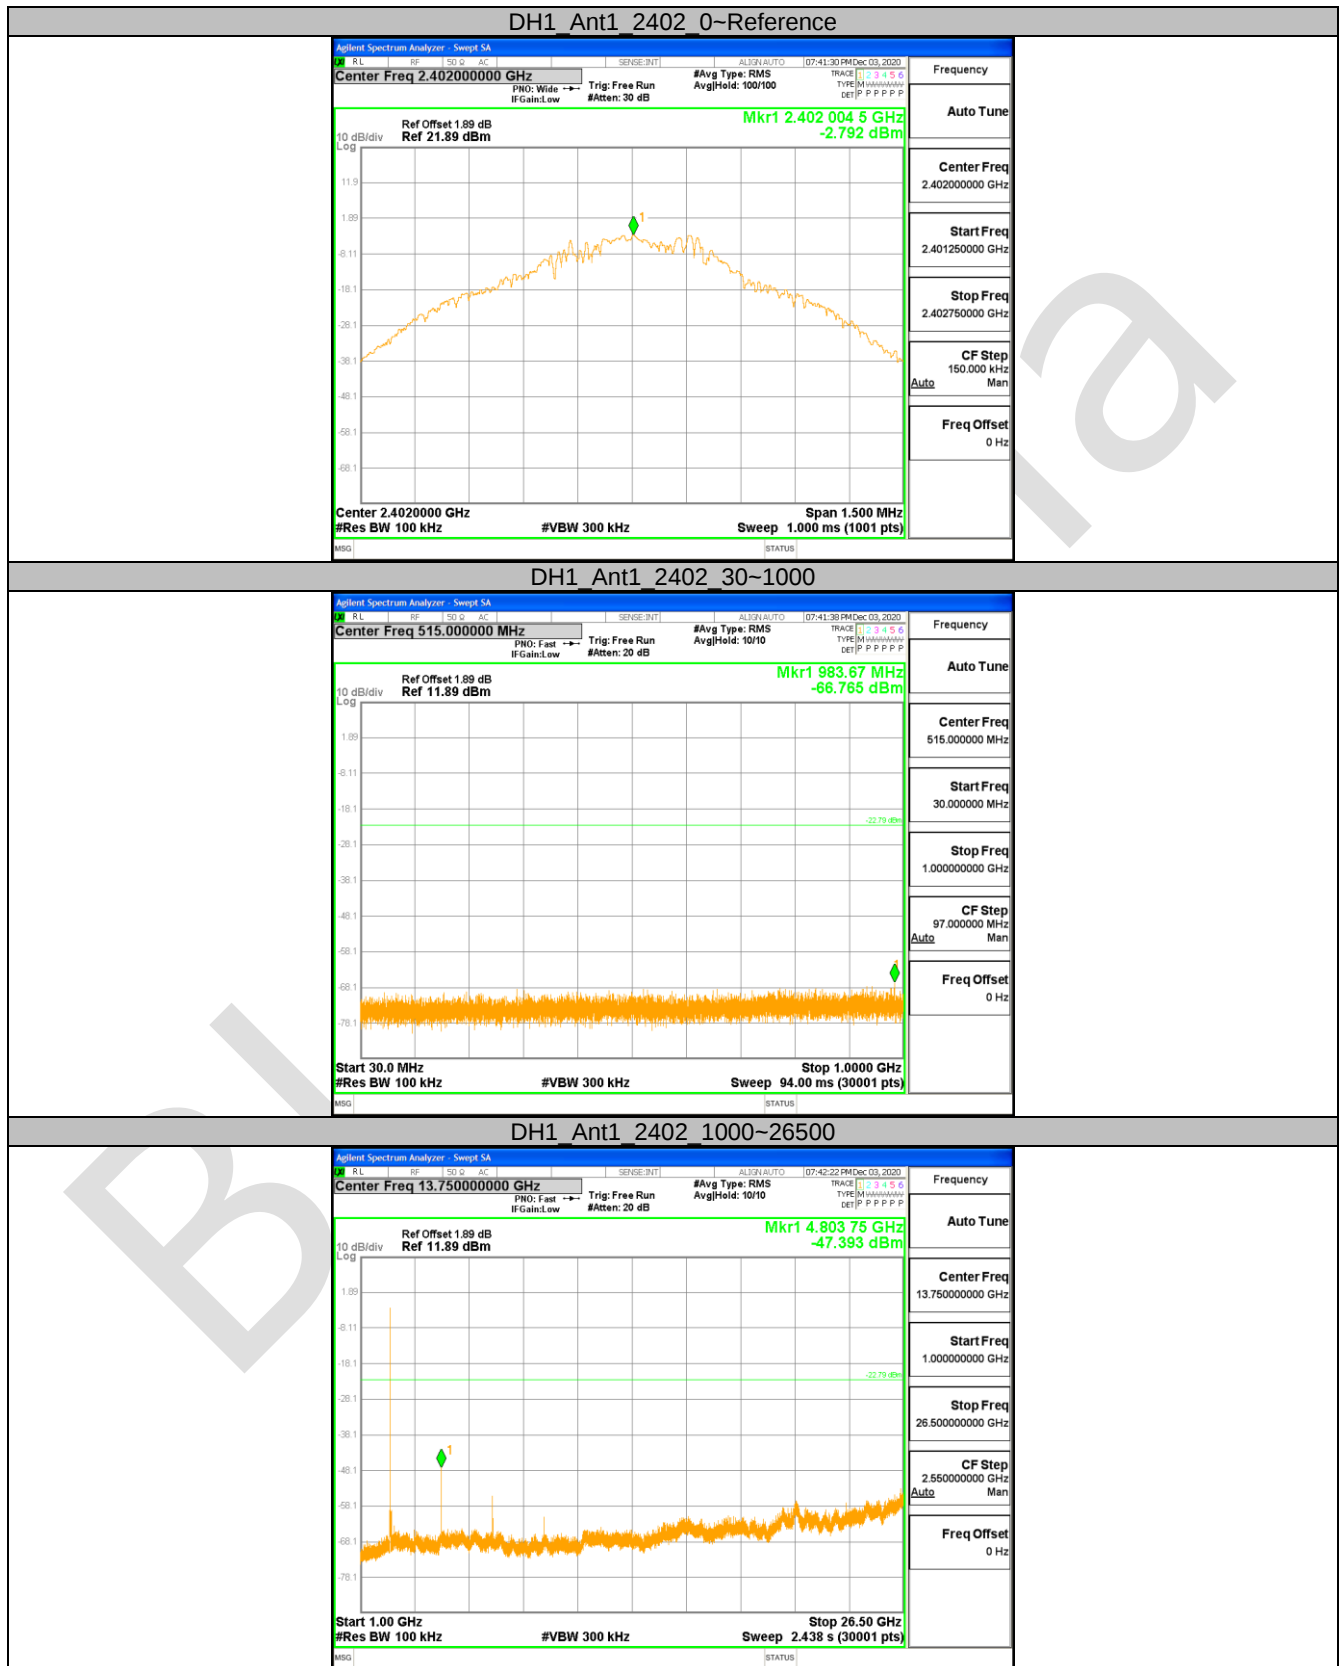
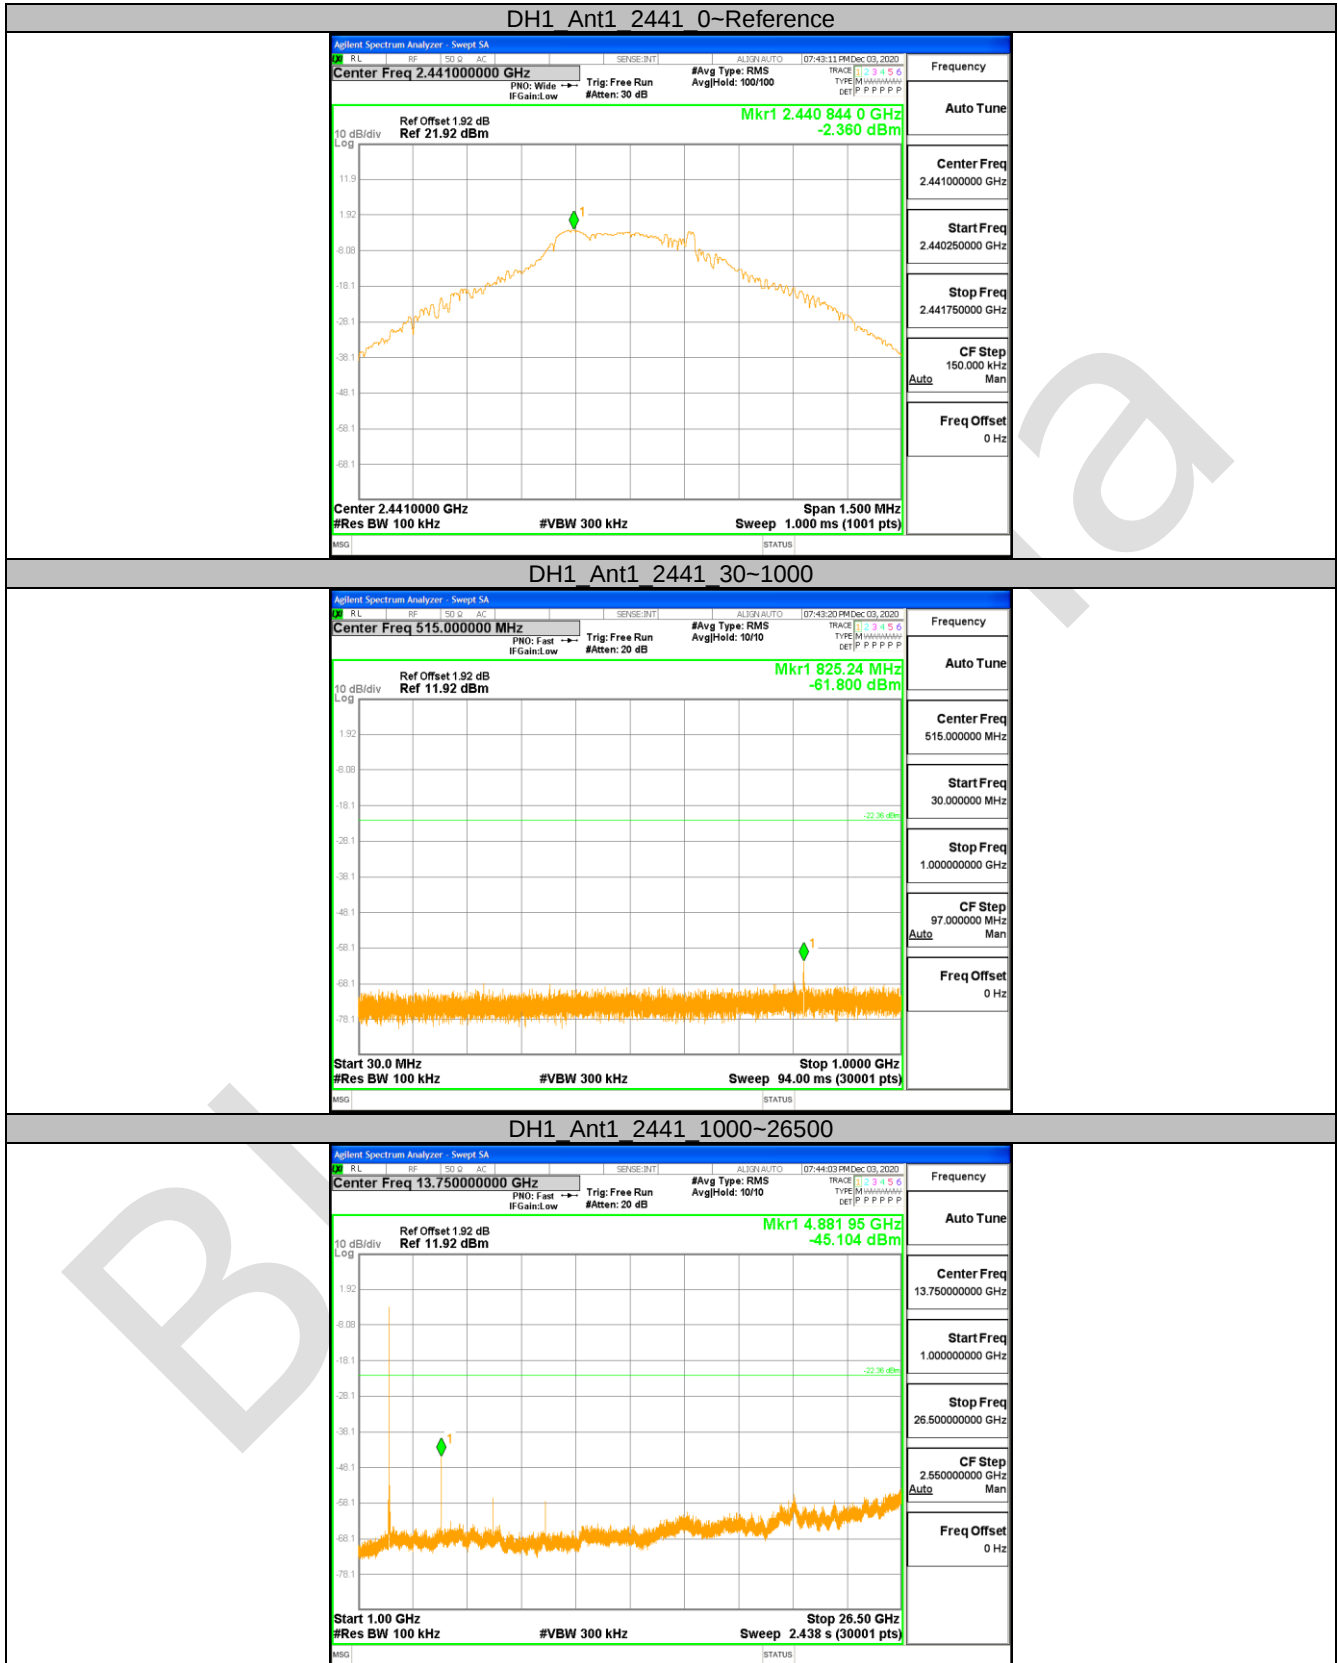
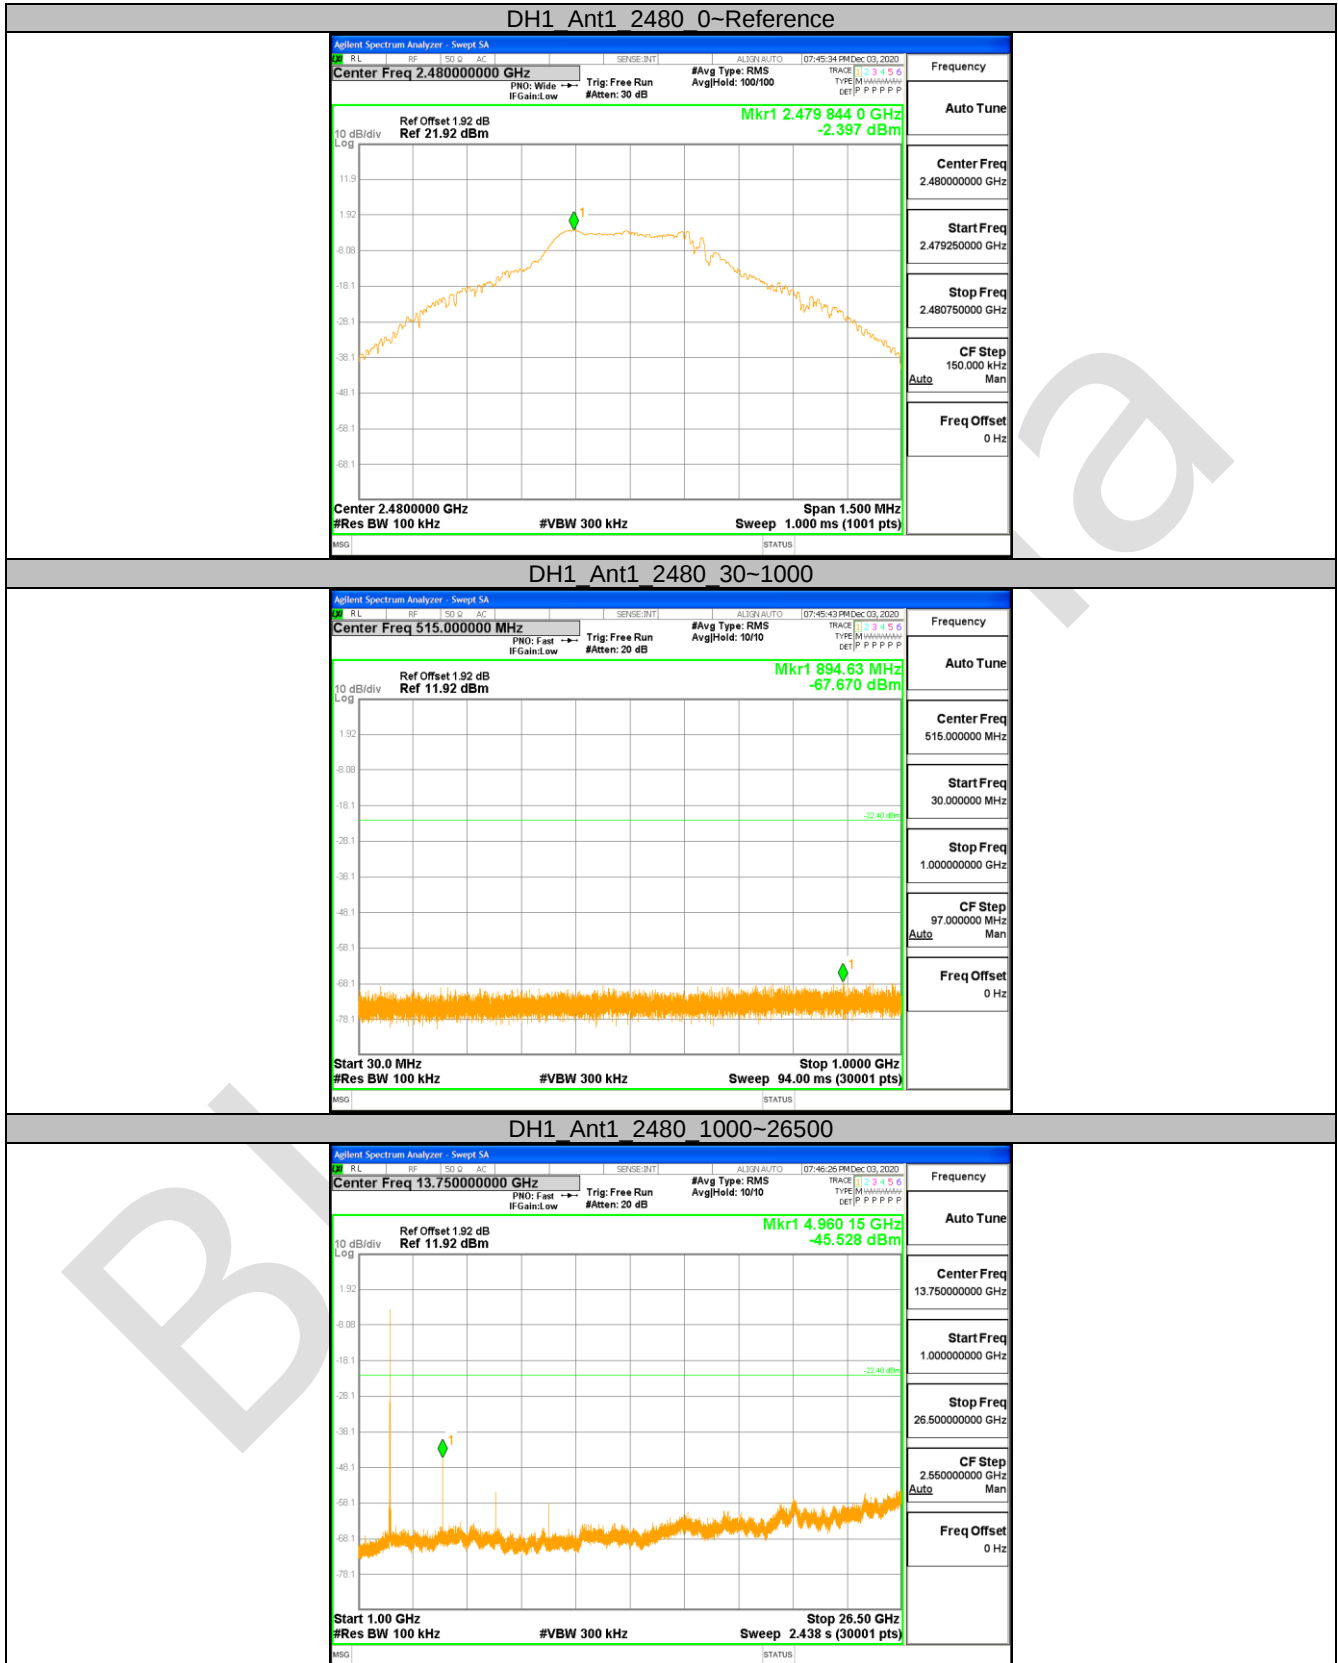
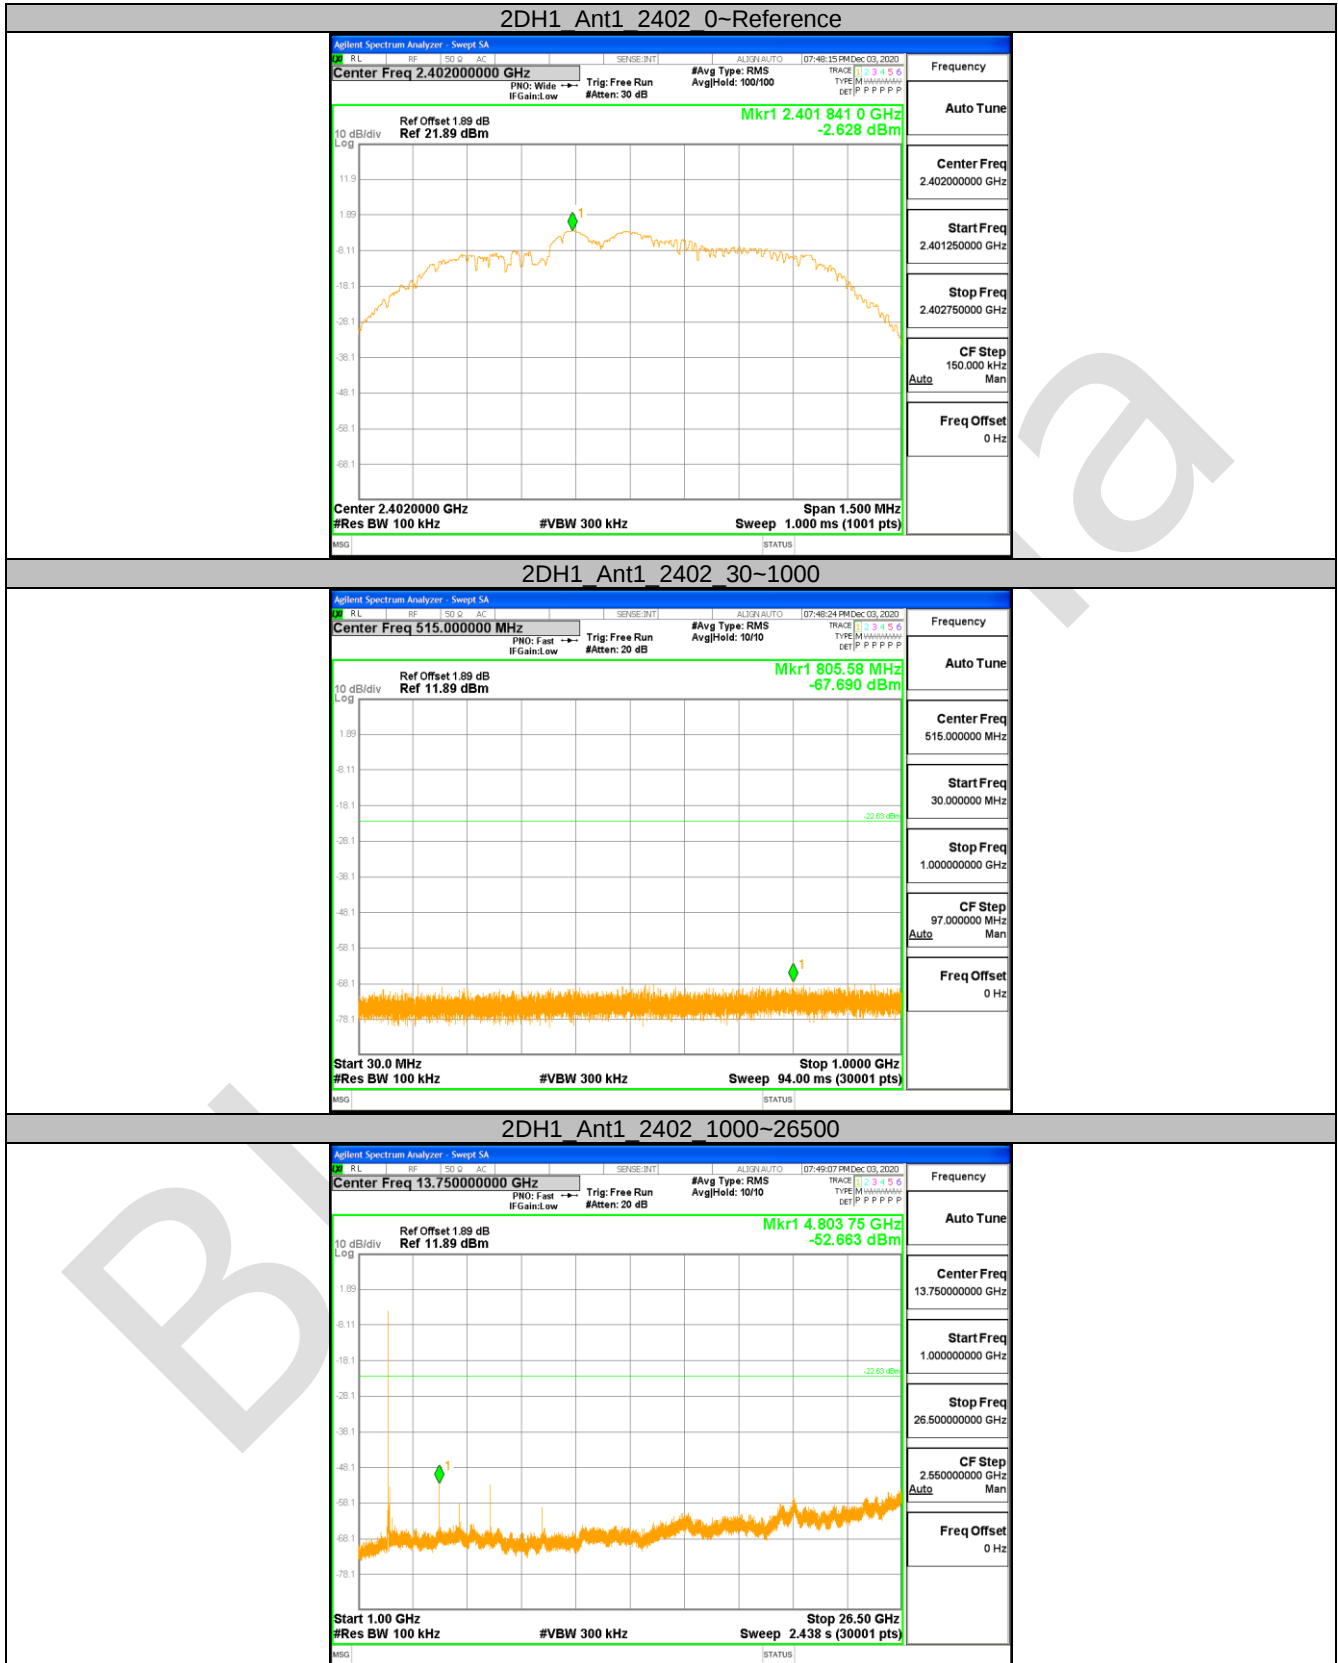
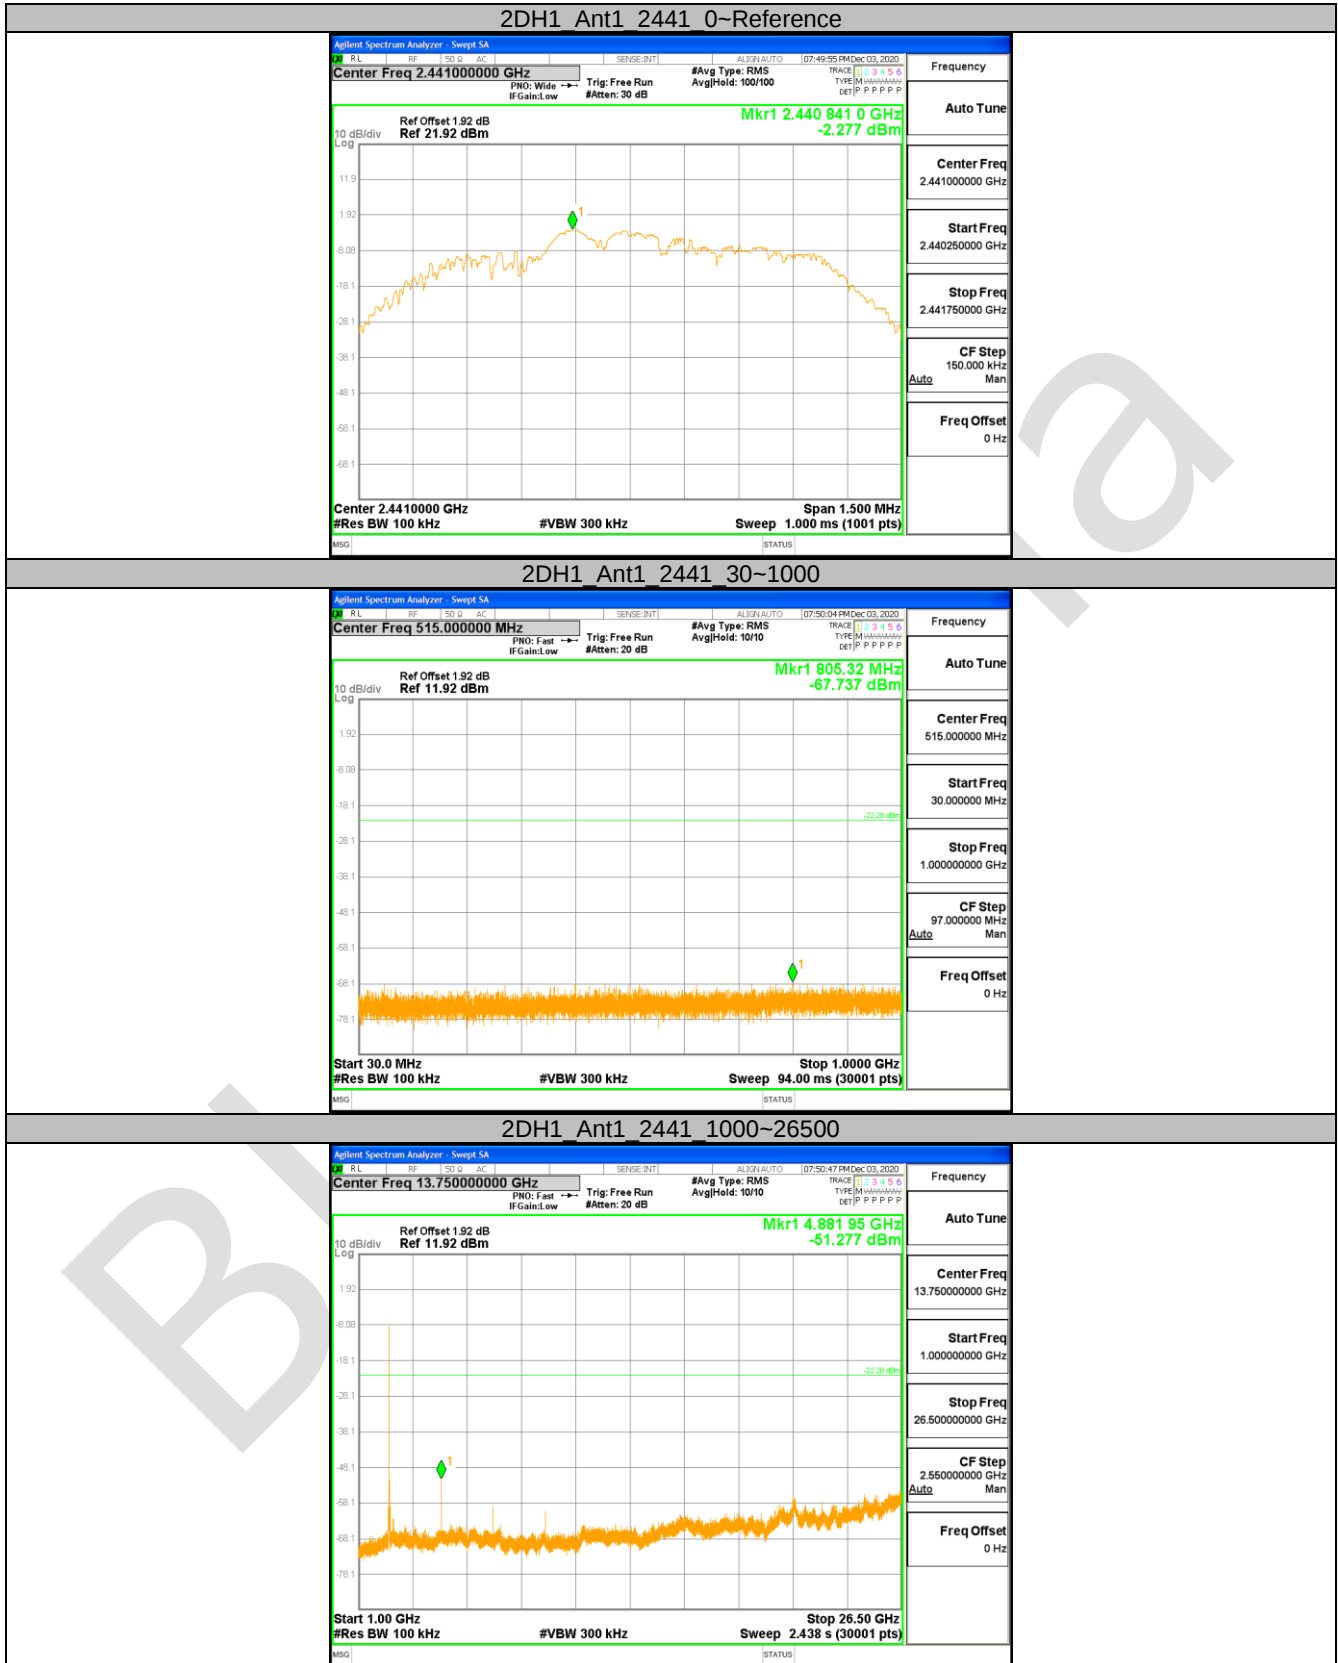
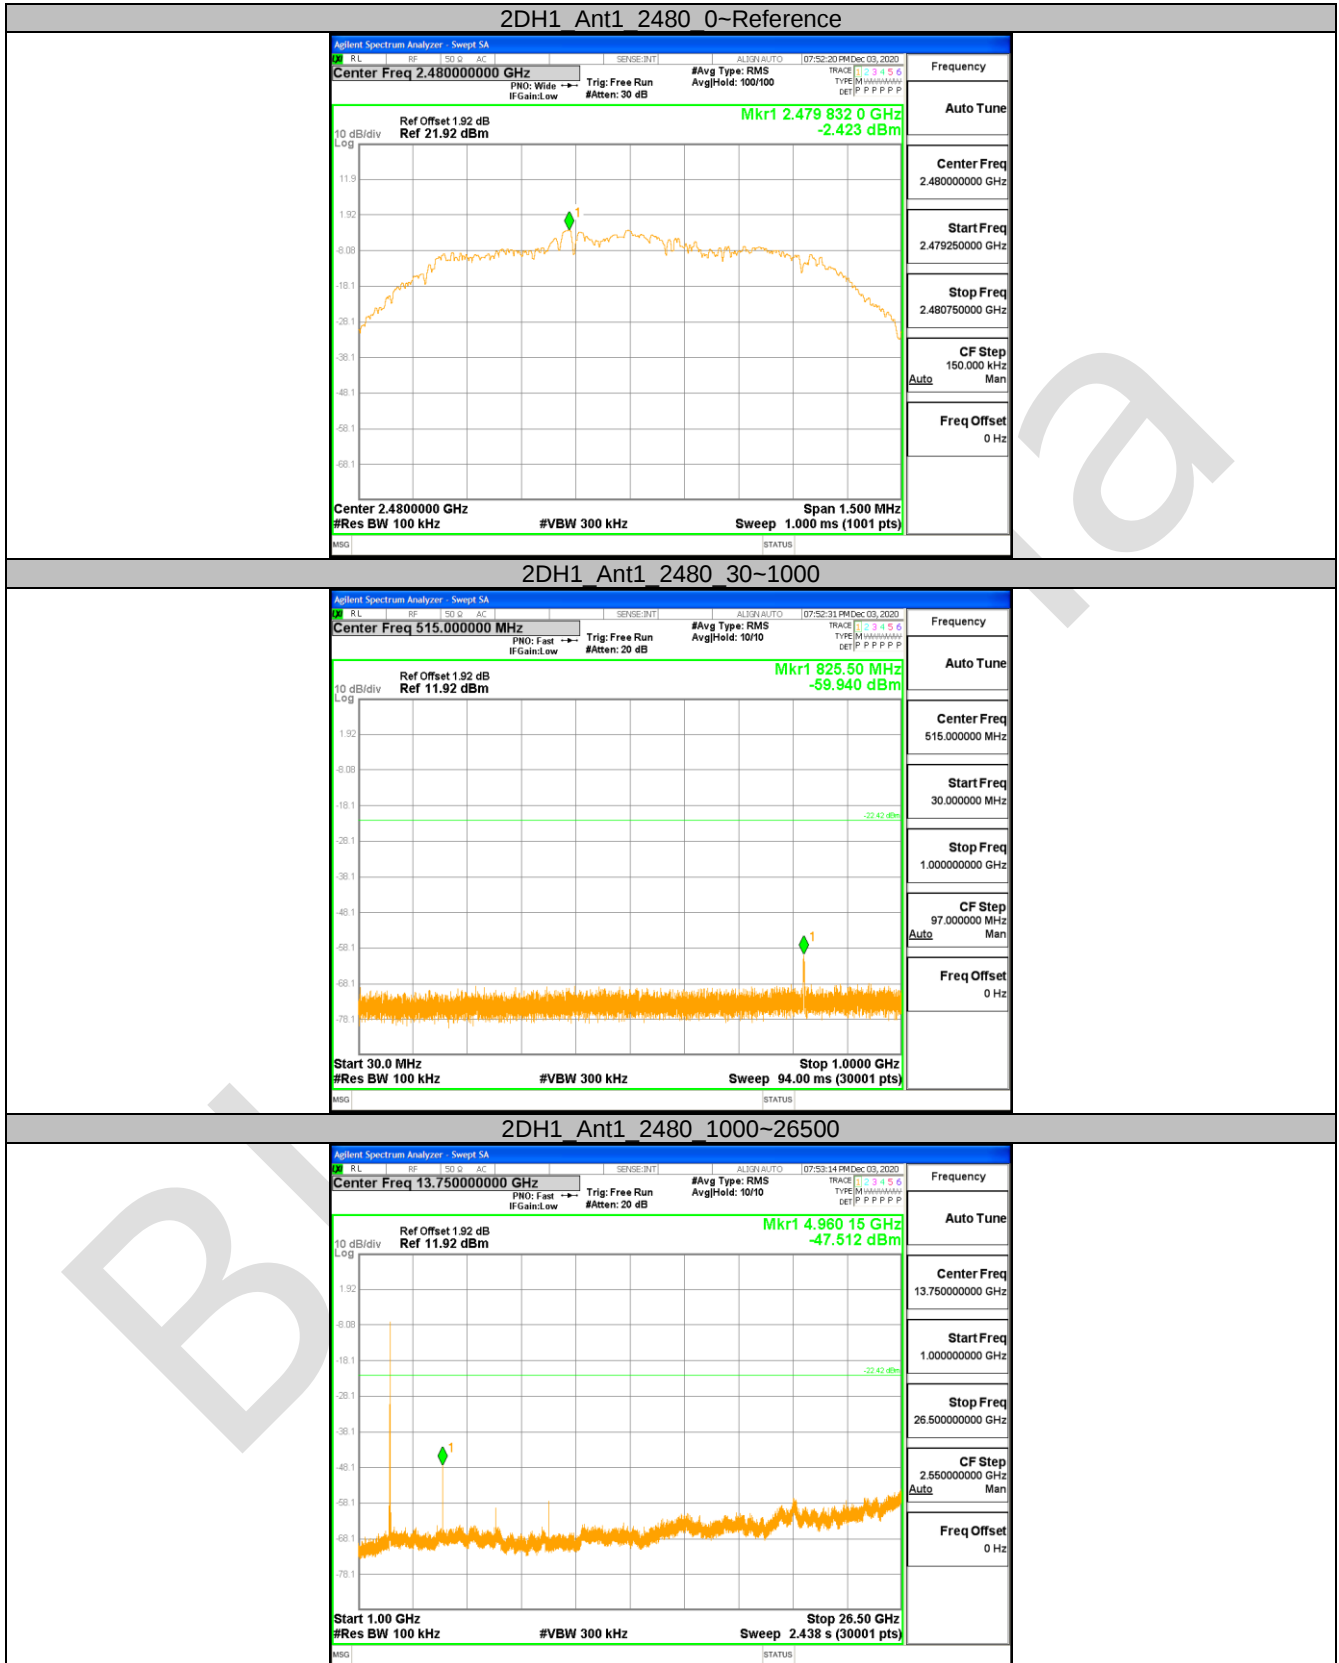
## Test Graphs

### Test Result
