Radiated Emission Measurement

Condition : FCC\_part 15E RE\_Above 1GHz\_PK

EUT : W6M22409-23739

Test Mode : TX 802.11ax80 CH151

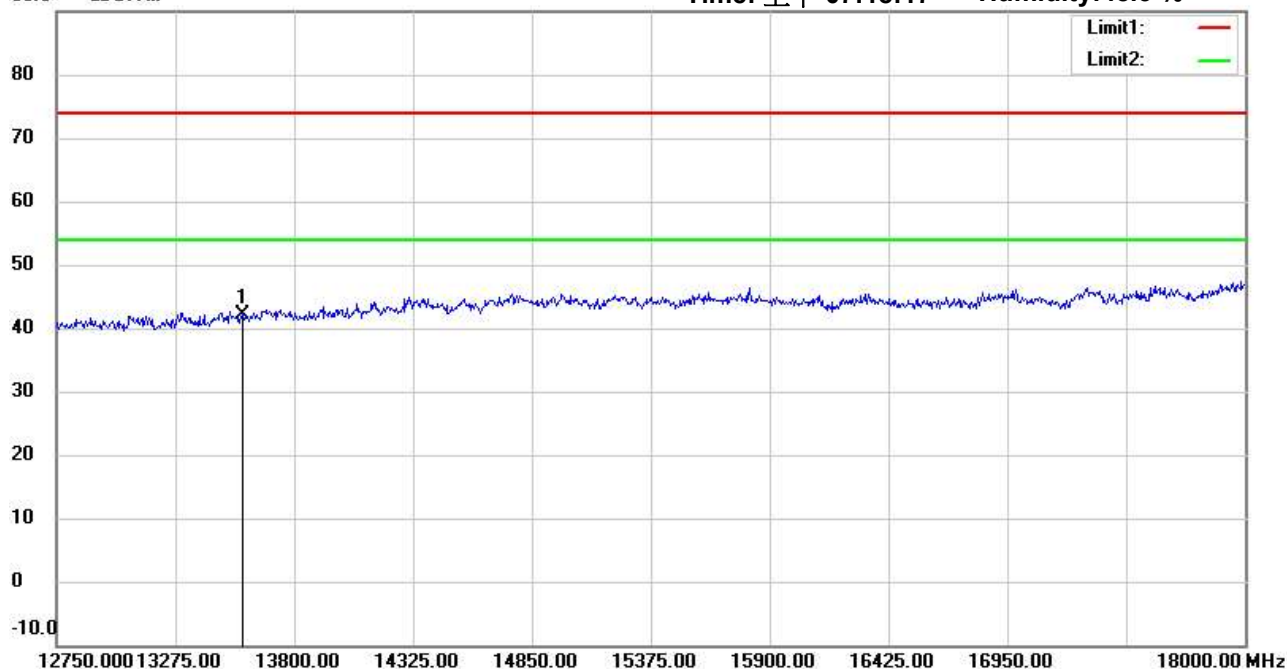
Test Mode : TX 802.11ax80 CH167

Polarization: **Horizontal**

| Mk. | Frequency (MHz) | Reading (dBuV) | Detector | Corr. factor (dB/m) | Result (dBuV/m) | Limit (dBuV/m) | Ant.Pos (cm) | Tab.Pos (deg.) | Margin (dB) | Comment |
|---|---|---|---|---|---|---|---|---|---|---|
| * | 13570.000 | 22.47 | peak | 19.56 | 42.03 | 74.00 | 150 | 143 | -31.97 | |

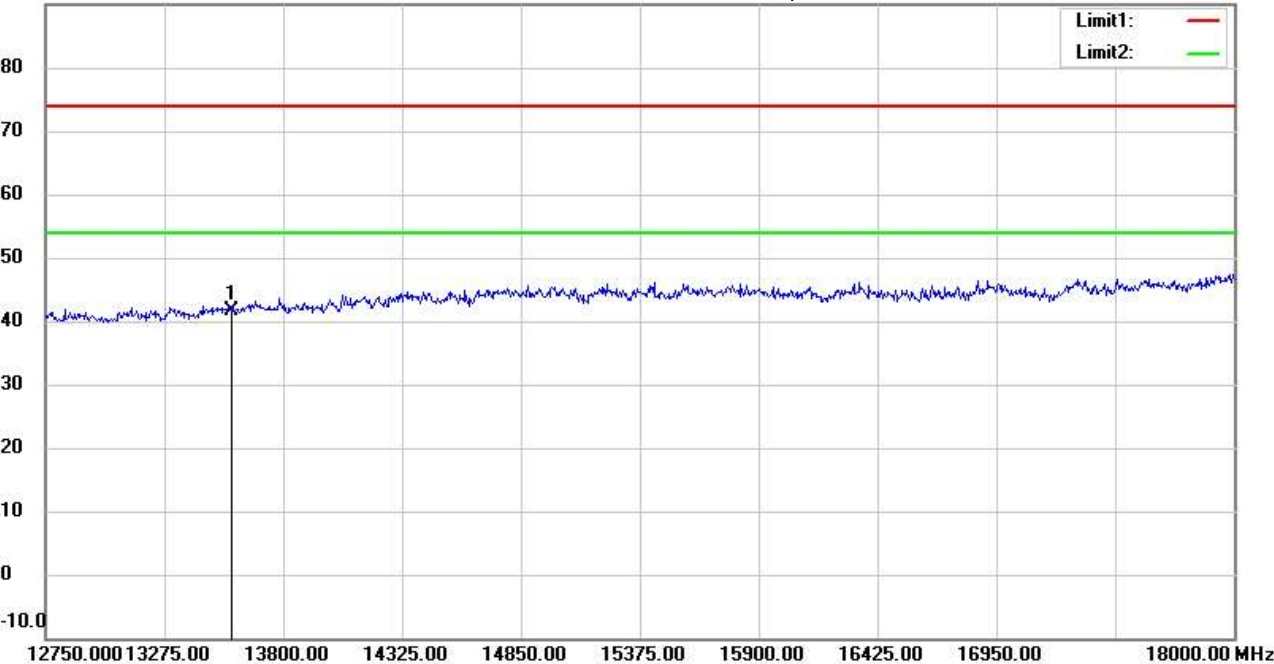
Test Mode : TX 802.11ax80 CH167

Polarization: Vertical

| Mk. | Frequency (MHz) | Reading (dBuV) | Detector | Corr. factor (dB/m) | Result (dBuV/m) | Limit (dBuV/m) | Ant.Pos (cm) | Tab.Pos (deg.) | Margin (dB) | Comment |
|---|---|---|---|---|---|---|---|---|---|---|
| * | 13570.000 | 22.03 | peak | 19.56 | 41.59 | 74.00 | 150 | 106 | -32.41 | |

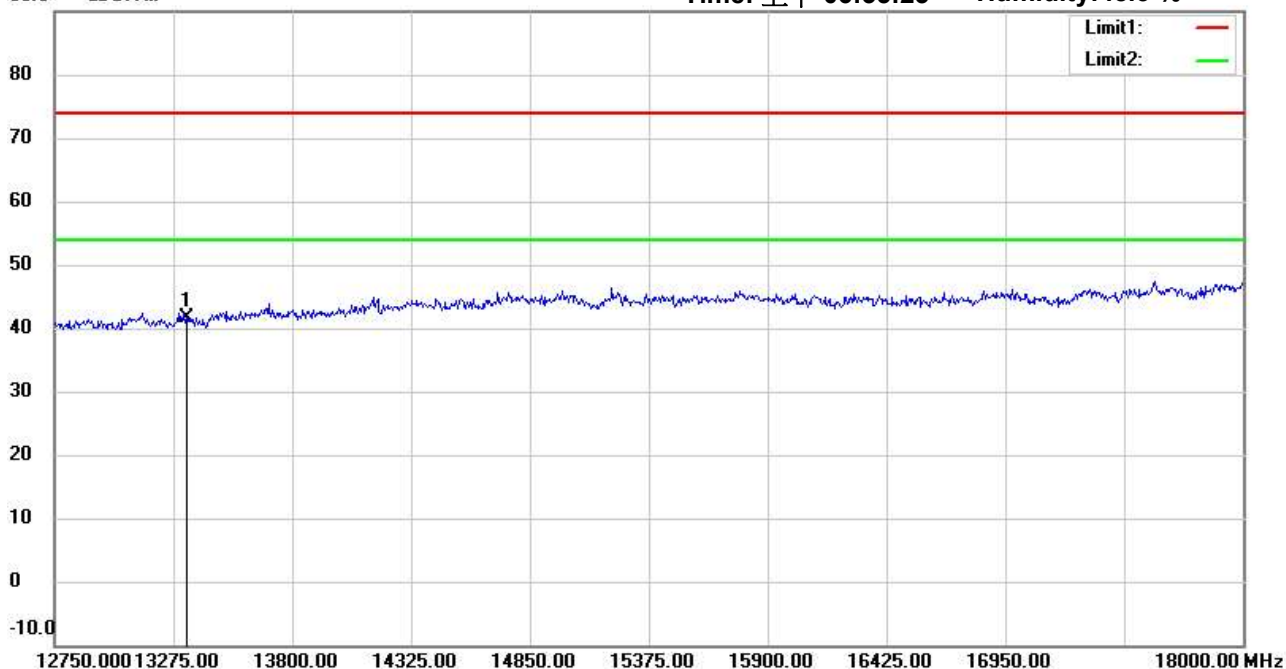
Test Mode : TX 802.11ax160 CH143

Polarization: **Horizontal**

| Mk. | Frequency (MHz) | Reading (dBuV) | Detector | Corr. factor (dB/m) | Result (dBuV/m) | Limit (dBuV/m) | Ant.Pos (cm) | Tab.Pos (deg.) | Margin (dB) | Comment |
|---|---|---|---|---|---|---|---|---|---|---|
| * | 13330.000 | 23.28 | peak | 18.29 | 41.57 | 74.00 | 150 | 359 | -32.43 | |

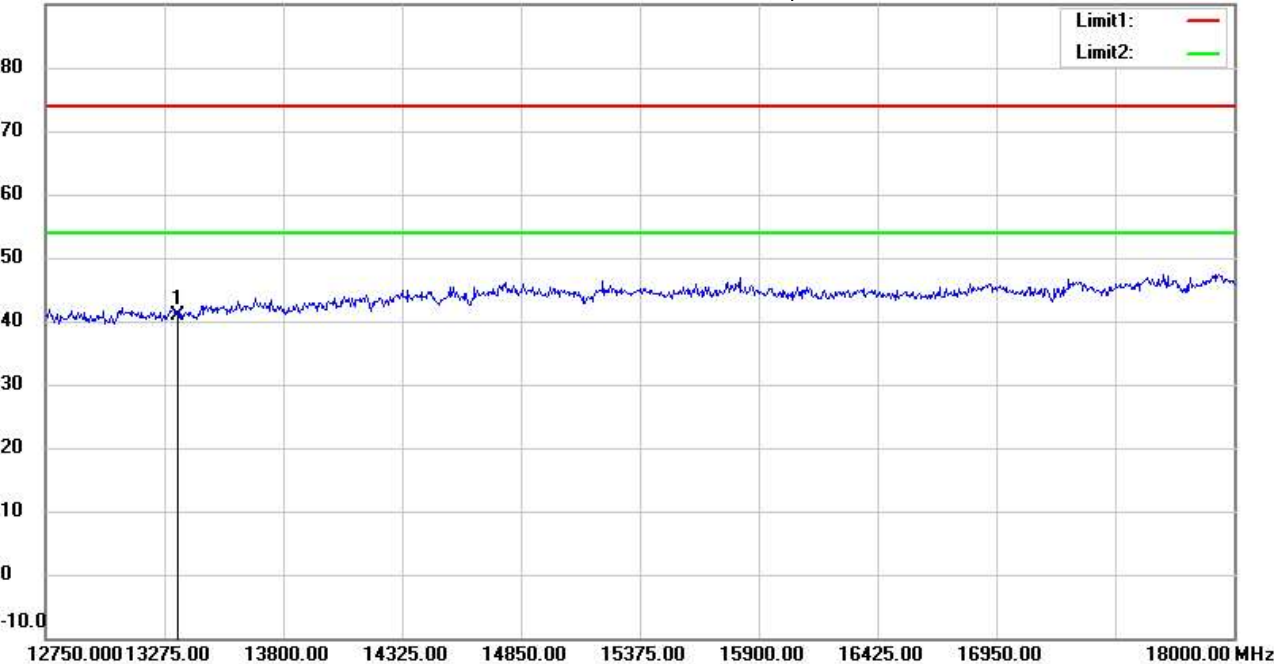
Test Mode : TX 802.11ax160 CH143

Polarization: Vertical

| Mk. | Frequency (MHz) | Reading (dBuV) | Detector | Corr. factor (dB/m) | Result (dBuV/m) | Limit (dBuV/m) | Ant.Pos (cm) | Tab.Pos (deg.) | Margin (dB) | Comment |
|---|---|---|---|---|---|---|---|---|---|---|
| * | 13330.000 | 22.71 | peak | 18.29 | 41.00 | 74.00 | 150 | 231 | -33.00 | |
