VM100 56/EN – User's Manual Rev P149-Creft 2004-11

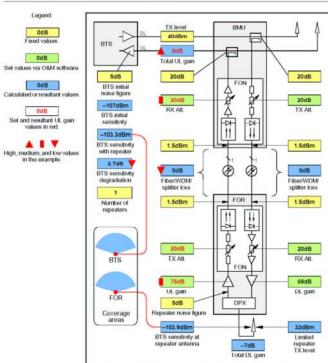
$Figure\ 6-5.\ One\ FOR,\ low\ optical\ loss,\ medium\ uplink\ gain\ and\ attenuation$

Figure 6-5 shows a FOR connected with low optical loss, medium uplink gain and medium uplink attenuation. The BTS sensitivity degradation is low.

High total uplink gain and a BTS sensitivty with repeater very close to the BTS sensitivity at the repeater antenna indicates a similar coverage area for the BTS and the FOR.
