Radiated Emission Measurement

Condition : FCC\_part 15E RE\_Above 1GHz\_PK

EUT : W6M22409-23739

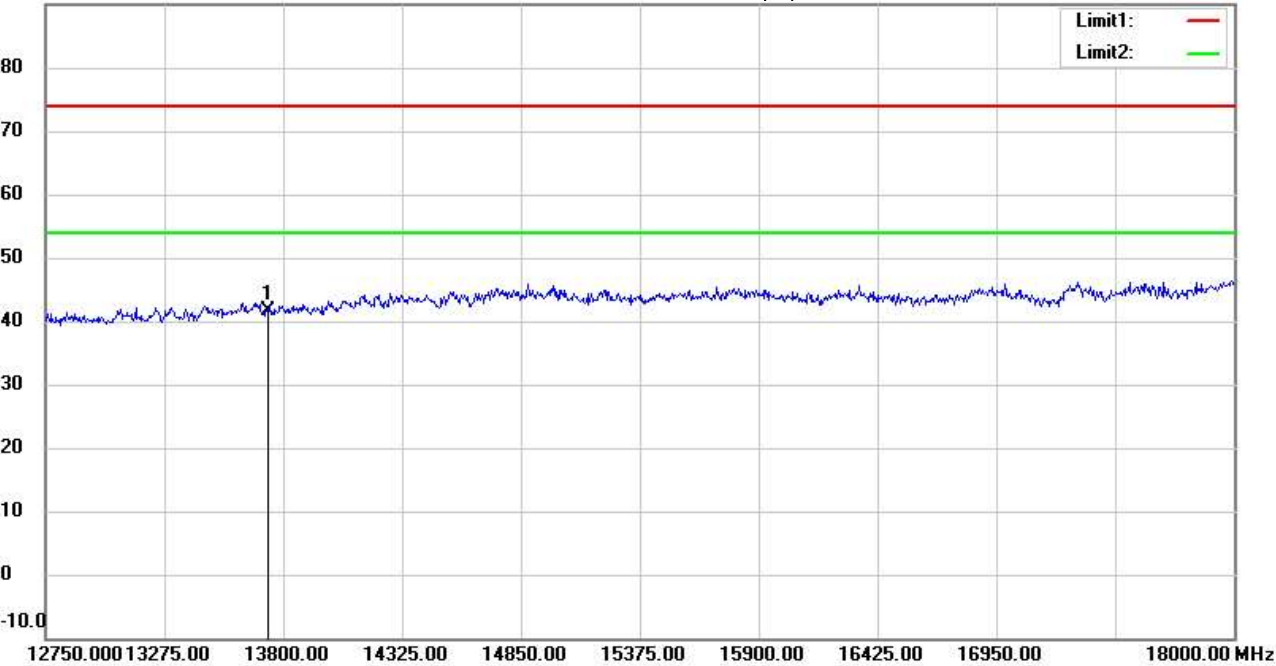
Data :#10

Test Mode : TX 802.11ax80 CH183

Polarization: Vertical

| Mk. | Frequency (MHz) | Reading (dBuV) | Detector | Corr. factor (dB/m) | Result (dBuV/m) | Limit (dBuV/m) | Ant.Pos (cm) | Tab.Pos (deg.) | Margin (dB) | Comment |
|---|---|---|---|---|---|---|---|---|---|---|
| * | 13730.000 | 21.73 | peak | 19.92 | 41.65 | 74.00 | 150 | 350 | -32.35 | |

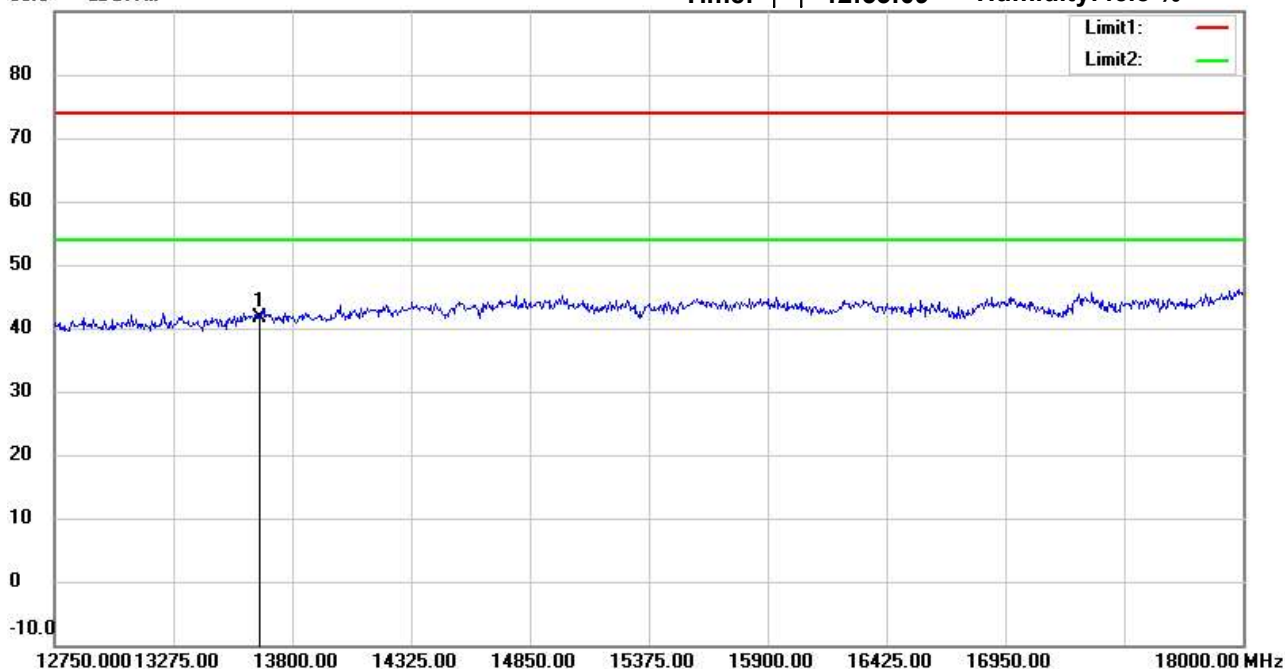
Data : #4

Condition : FCC\_part 15E RE\_Above 1GHz\_PK

Test Mode : TX 802.11ax160 CH175

Polarization: **Horizontal**

| Mk. | Frequency (MHz) | Reading (dBuV) | Detector | Corr. factor (dB/m) | Result (dBuV/m) | Limit (dBuV/m) | Ant.Pos (cm) | Tab.Pos (deg.) | Margin (dB) | Comment |
|---|---|---|---|---|---|---|---|---|---|---|
| * | 13650.000 | 21.81 | peak | 19.84 | 41.65 | 74.00 | 150 | 359 | -32.35 | |

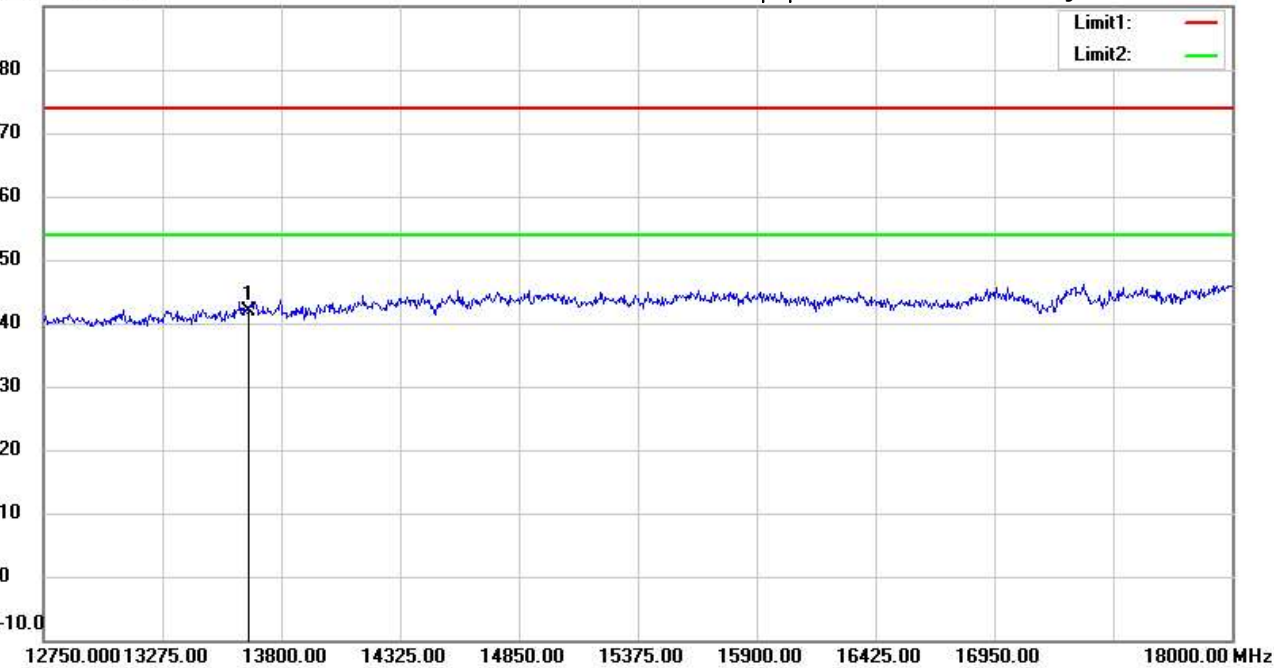
Data :#10

Condition : FCC\_part 15E RE\_Above 1GHz\_PK

Test Mode : TX 802.11ax160 CH175

Polarization: Vertical

| Mk. | Frequency (MHz) | Reading (dBuV) | Detector | Corr. factor (dB/m) | Result (dBuV/m) | Limit (dBuV/m) | Ant.Pos (cm) | Tab.Pos (deg.) | Margin (dB) | Comment |
|---|---|---|---|---|---|---|---|---|---|---|
| * | 13650.000 | 21.93 | peak | 19.84 | 41.77 | 74.00 | 150 | 144 | -32.23 | |

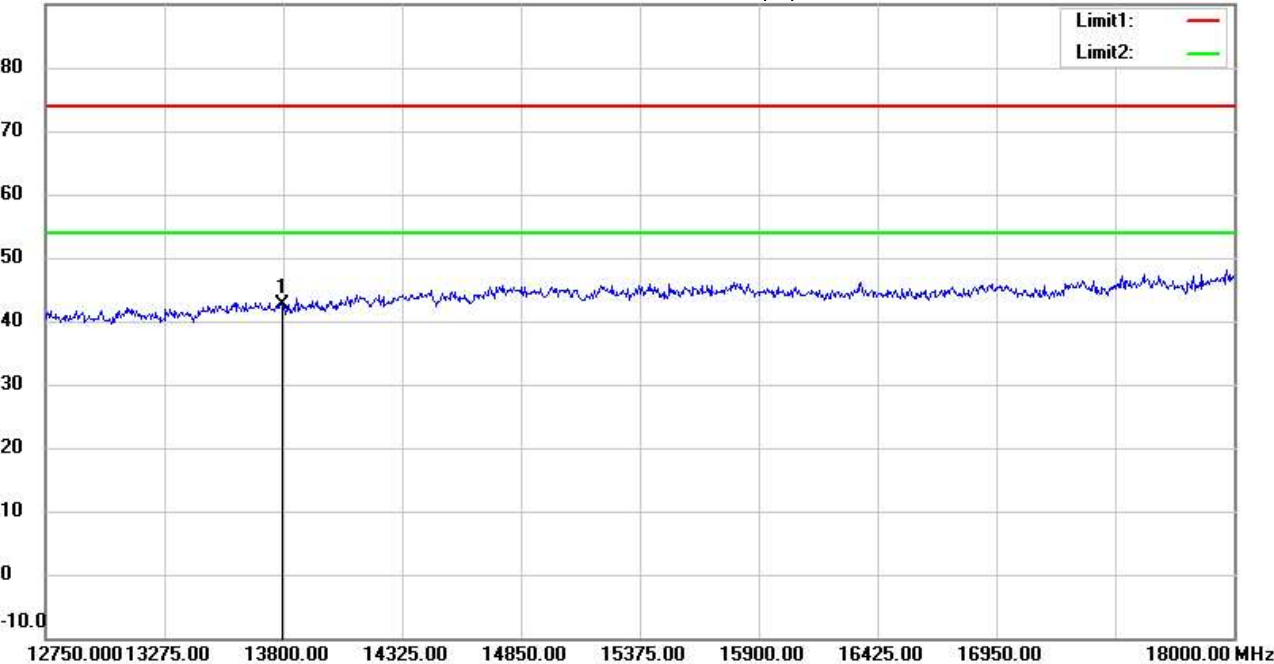
Data :#4

Condition : FCC\_part 15E RE\_Above 1GHz\_PK

Test Mode : TX 802.11a CH189

Polarization: **Horizontal**

| Mk. | Frequency (MHz) | Reading (dBuV) | Detector | Corr. factor (dB/m) | Result (dBuV/m) | Limit (dBuV/m) | Ant.Pos (cm) | Tab.Pos (deg.) | Margin (dB) | Comment |
|---|---|---|---|---|---|---|---|---|---|---|
| * | 13790.000 | 22.92 | peak | 19.59 | 42.51 | 74.00 | 150 | 311 | -31.49 | |
