Radiated Emission Measurement

Condition : FCC\_part 15 RE-Class B\_Above 1GHz\_PK

EUT : W6M21910-19416

Test Mode : RX 802.11b CH7

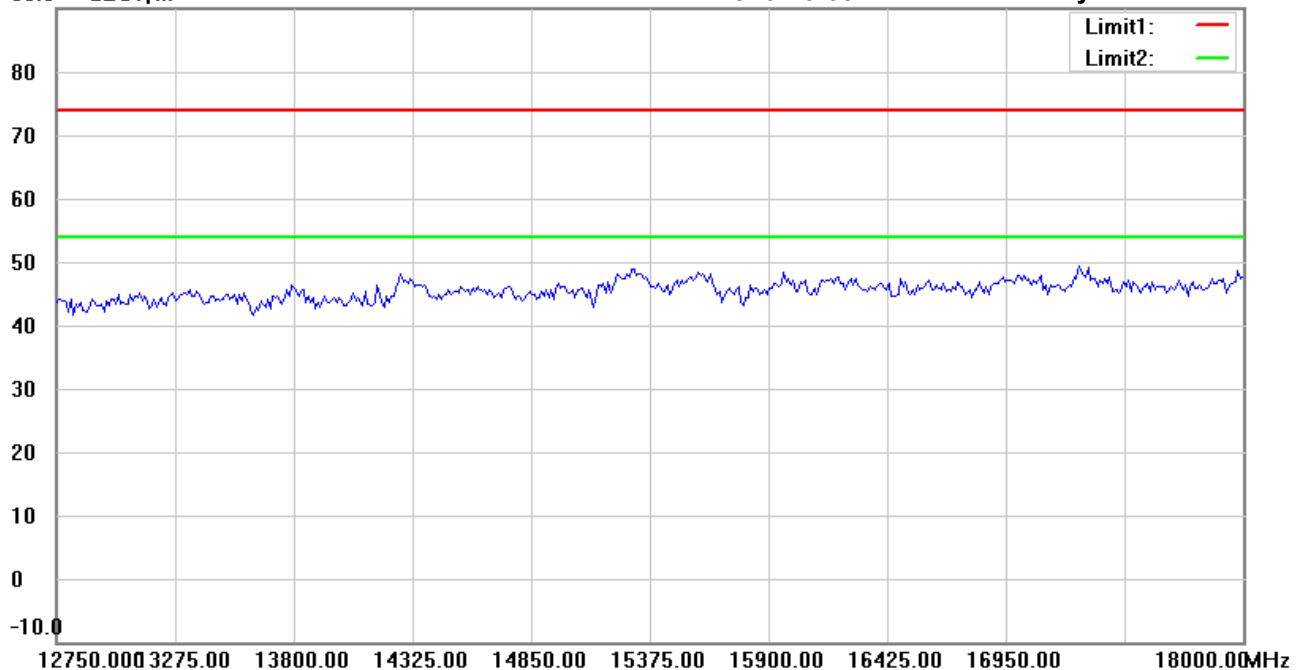
Polarization: Vertical

Distance: 3m
