## Conducted Band Edge

## Test Graphs

UTTR-RF-FCC4G-V1.1

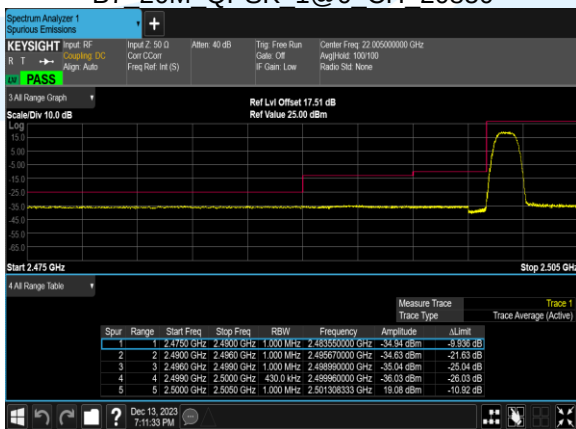
B7 20M QPSK 1@0 CH 20850

| Band | Bandwidth (MHz) | Channel | Freq (MHz) | Modulation | RB | Result | Verdict |
|---|---|---|---|---|---|---|---|
| 7 | 20.0 | 20850 | 2510.0 | QPSK | 1@0 | see graph | PASS |

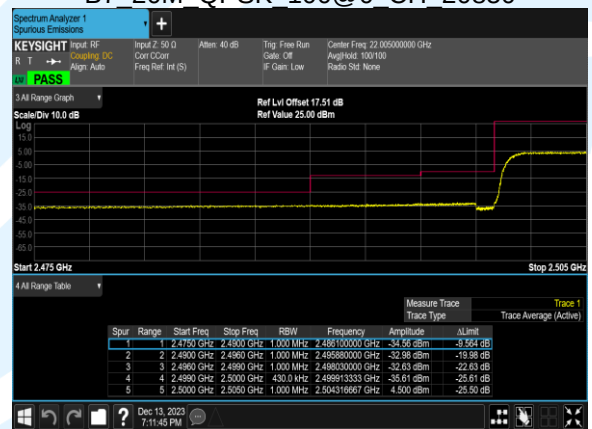
B7 20M QPSK 100@0 CH 20850

| Band | Bandwidth (MHz) | Channel | Freq (MHz) | Modulation | RB | Result | Verdict |
|---|---|---|---|---|---|---|---|
| 7 | 20.0 | 20850 | 2510.0 | QPSK | 100@0 | see graph | PASS |

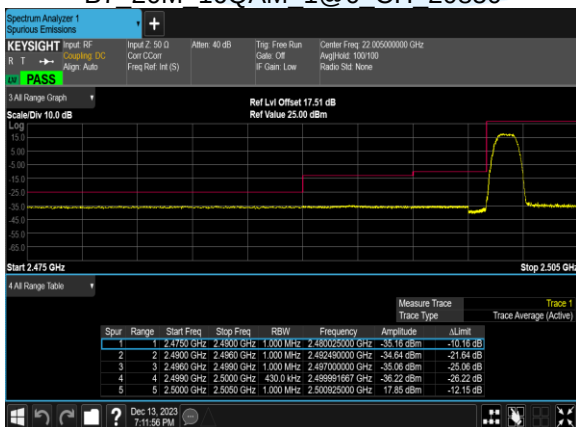
B7 20M 16QAM 1@0 CH 20850

| Band | Bandwidth (MHz) | Channel | Freq (MHz) | Modulation | RB | Result | Verdict |
|---|---|---|---|---|---|---|---|
| 7 | 20.0 | 20850 | 2510.0 | 16QAM | 1@0 | see graph | PASS |

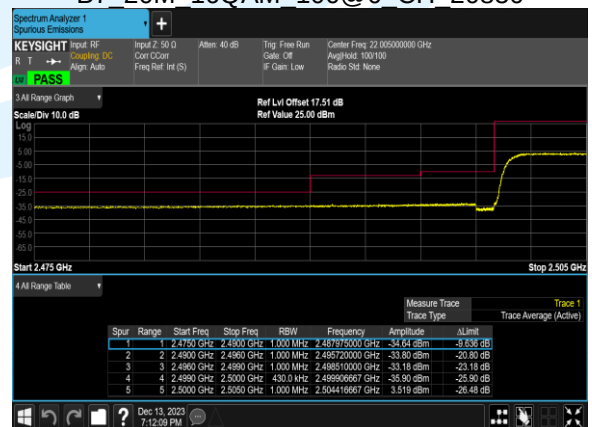
B7 20M 16QAM 100@0 CH 20850

| Band | Bandwidth (MHz) | Channel | Freq (MHz) | Modulation | RB | Result | Verdict |
|---|---|---|---|---|---|---|---|
| 7 | 20.0 | 20850 | 2510.0 | 16QAM | 100@0 | see graph | PASS |

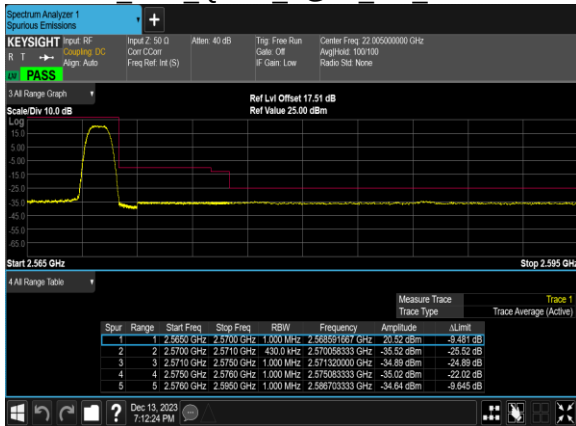
B7 20M QPSK 1@99 CH 21350

| Band | Bandwidth (MHz) | Channel | Freq (MHz) | Modulation | RB | Result | Verdict |
|---|---|---|---|---|---|---|---|
| 7 | 20.0 | 21350 | 2560.0 | QPSK | 1@99 | see graph | PASS |

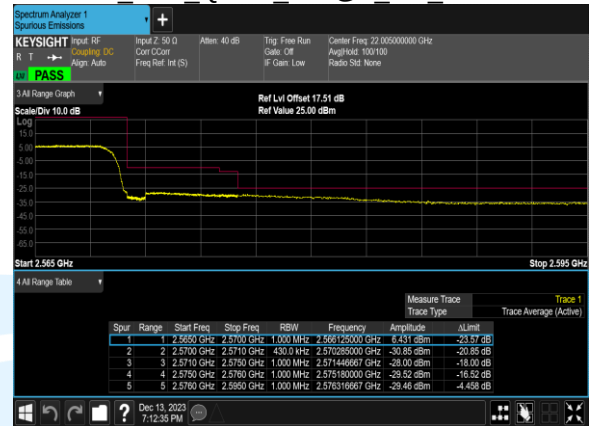
B7 20M QPSK 100@0 CH 21350

| Band | Bandwidth (MHz) | Channel | Freq (MHz) | Modulation | RB | Result | Verdict |
|---|---|---|---|---|---|---|---|
| 7 | 20.0 | 21350 | 2560.0 | QPSK | 100@0 | see graph | PASS |

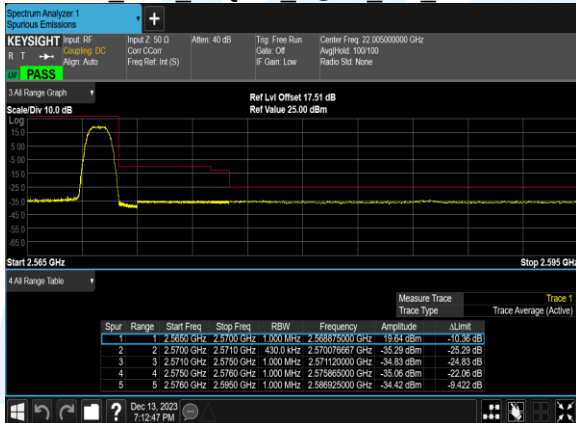
B7 20M 16QAM 1@99 CH 21350

| Band | Bandwidth (MHz) | Channel | Freq (MHz) | Modulation | RB | Result | Verdict |
|---|---|---|---|---|---|---|---|
| 7 | 20.0 | 21350 | 2560.0 | 16QAM | 1@99 | see graph | PASS |

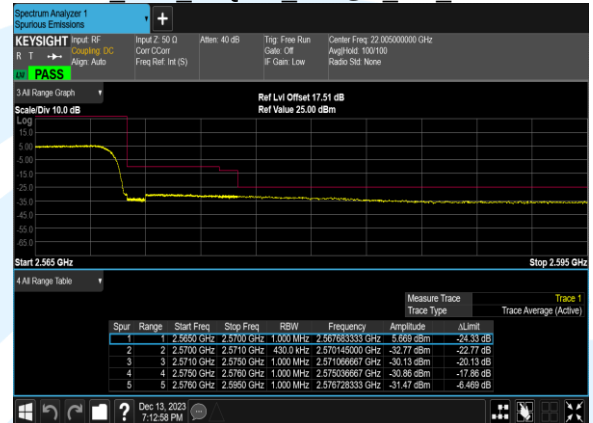
B7 20M 16QAM 100@0 CH 21350

| Band | Bandwidth (MHz) | Channel | Freq (MHz) | Modulation | RB | Result | Verdict |
|---|---|---|---|---|---|---|---|
| 7 | 20.0 | 21350 | 2560.0 | 16QAM | 100@0 | see graph | PASS |

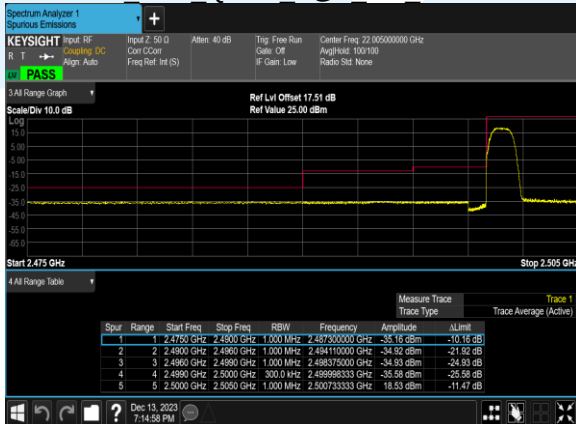
B7 15M QPSK 1@0 CH 20825

| Band | Bandwidth (MHz) | Channel | Freq (MHz) | Modulation | RB | Result | Verdict |
|---|---|---|---|---|---|---|---|
| 7 | 15.0 | 20825 | 2507.5 | QPSK | 1@0 | see graph | PASS |

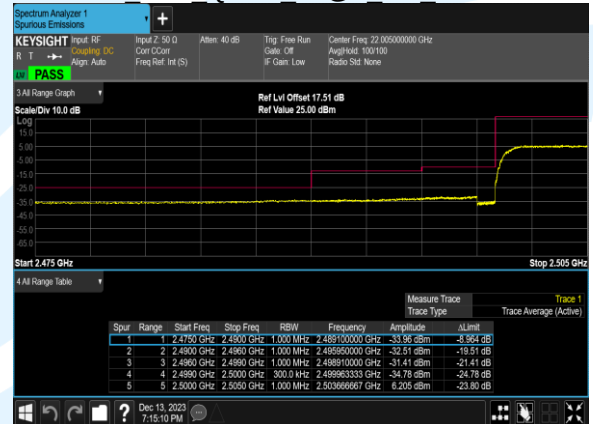
B7 15M QPSK 75@0 CH 20825

| Band | Bandwidth (MHz) | Channel | Freq (MHz) | Modulation | RB | Result | Verdict |
|---|---|---|---|---|---|---|---|
| 7 | 15.0 | 20825 | 2507.5 | QPSK | 75@0 | see graph | PASS |

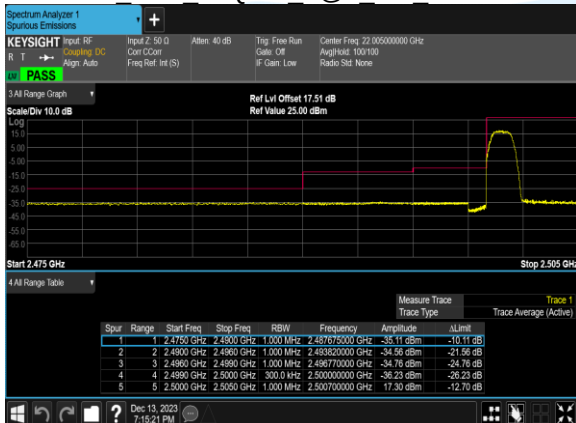
B7 15M 16QAM 1@0 CH 20825

| Band | Bandwidth (MHz) | Channel | Freq (MHz) | Modulation | RB | Result | Verdict |
|---|---|---|---|---|---|---|---|
| 7 | 15.0 | 20825 | 2507.5 | 16QAM | 1@0 | see graph | PASS |

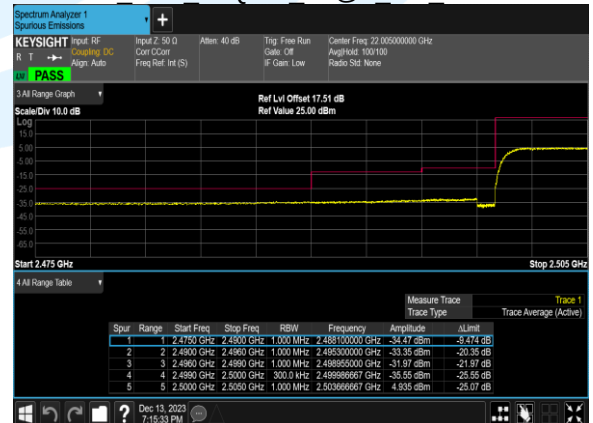
B7 15M 16QAM 75@0 CH 20825

| Band | Bandwidth (MHz) | Channel | Freq (MHz) | Modulation | RB | Result | Verdict |
|---|---|---|---|---|---|---|---|
| 7 | 15.0 | 20825 | 2507.5 | 16QAM | 75@0 | see graph | PASS |

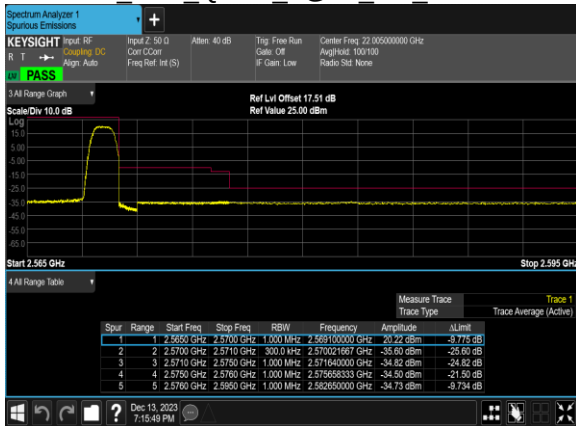
B7 15M QPSK 1@74 CH 21375

| Band | Bandwidth (MHz) | Channel | Freq (MHz) | Modulation | RB | Result | Verdict |
|---|---|---|---|---|---|---|---|
| 7 | 15.0 | 21375 | 2562.5 | QPSK | 1@74 | see graph | PASS |

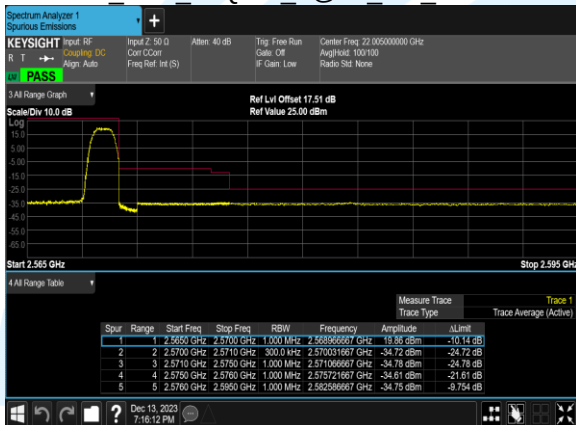
B7 15M 16QAM 1@74 CH 21375

| Band | Bandwidth (MHz) | Channel | Freq (MHz) | Modulation | RB | Result | Verdict |
|---|---|---|---|---|---|---|---|
| 7 | 15.0 | 21375 | 2562.5 | 16QAM | 1@74 | see graph | PASS |

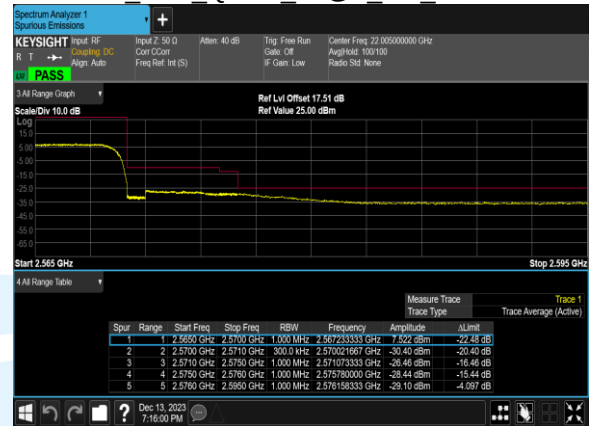
B7 15M QPSK 75@0 CH 21375

| Band | Bandwidth (MHz) | Channel | Freq (MHz) | Modulation | RB | Result | Verdict |
|---|---|---|---|---|---|---|---|
| 7 | 15.0 | 21375 | 2562.5 | QPSK | 75@0 | see graph | PASS |

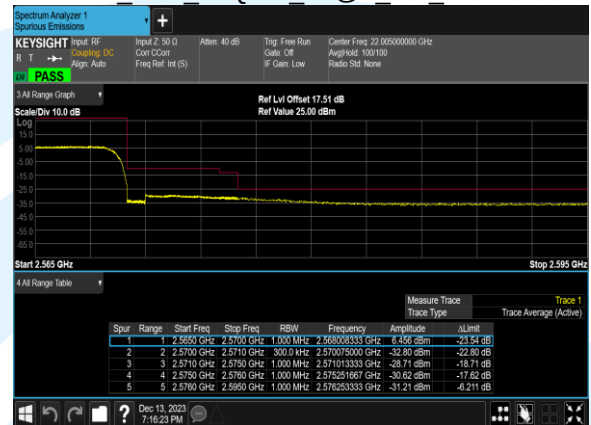
B7 15M 16QAM 75@0 CH 21375

| Band | Bandwidth (MHz) | Channel | Freq (MHz) | Modulation | RB | Result | Verdict |
|---|---|---|---|---|---|---|---|
| 7 | 15.0 | 21375 | 2562.5 | 16QAM | 75@0 | see graph | PASS |

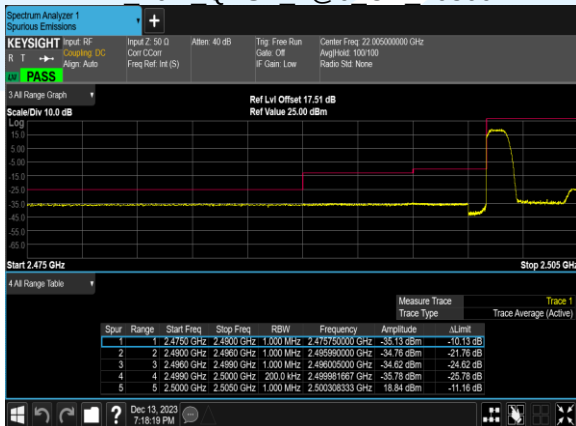
B7 10M QPSK 1@0 CH 20800

| Band | Bandwidth (MHz) | Channel | Freq (MHz) | Modulation | RB | Result | Verdict |
|---|---|---|---|---|---|---|---|
| 7 | 10.0 | 20800 | 2505.0 | QPSK | 1@0 | see graph | PASS |

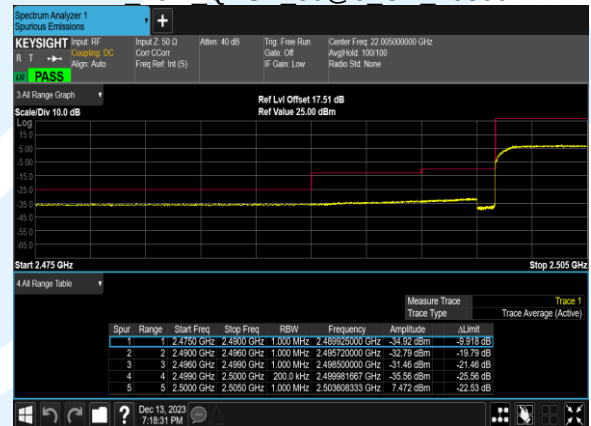
B7 10M QPSK 50@0 CH 20800

| Band | Bandwidth (MHz) | Channel | Freq (MHz) | Modulation | RB | Result | Verdict |
|---|---|---|---|---|---|---|---|
| 7 | 10.0 | 20800 | 2505.0 | QPSK | 50@0 | see graph | PASS |

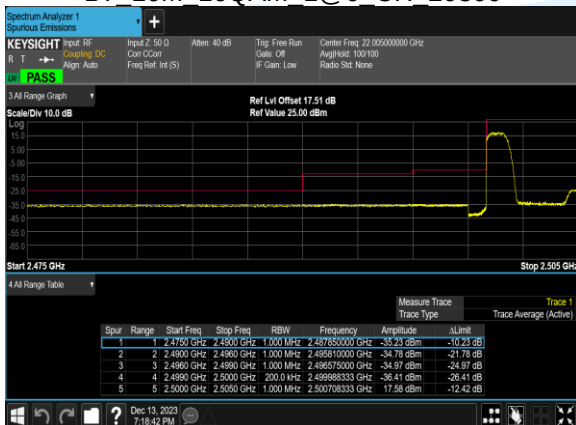
B7 10M 16QAM 1@0 CH 20800

| Band | Bandwidth (MHz) | Channel | Freq (MHz) | Modulation | RB | Result | Verdict |
|---|---|---|---|---|---|---|---|
| 7 | 10.0 | 20800 | 2505.0 | 16QAM | 1@0 | see graph | PASS |

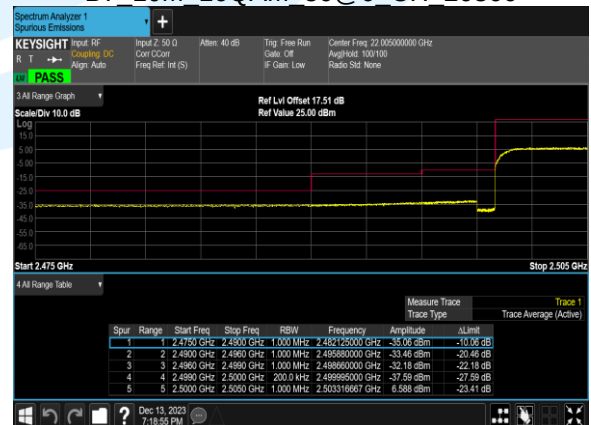
B7 10M 16QAM 50@0 CH 20800

| Band | Bandwidth (MHz) | Channel | Freq (MHz) | Modulation | RB | Result | Verdict |
|---|---|---|---|---|---|---|---|
| 7 | 10.0 | 20800 | 2505.0 | 16QAM | 50@0 | see graph | PASS |

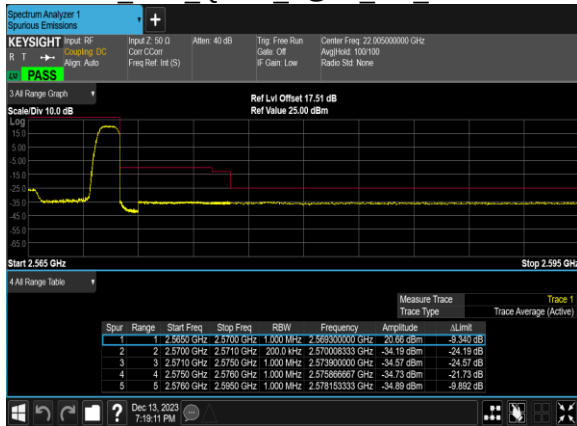
B7 10M QPSK 1@49 CH 21400

| Band | Bandwidth (MHz) | Channel | Freq (MHz) | Modulation | RB | Result | Verdict |
|---|---|---|---|---|---|---|---|
| 7 | 10.0 | 21400 | 2565.0 | QPSK | 1@49 | see graph | PASS |

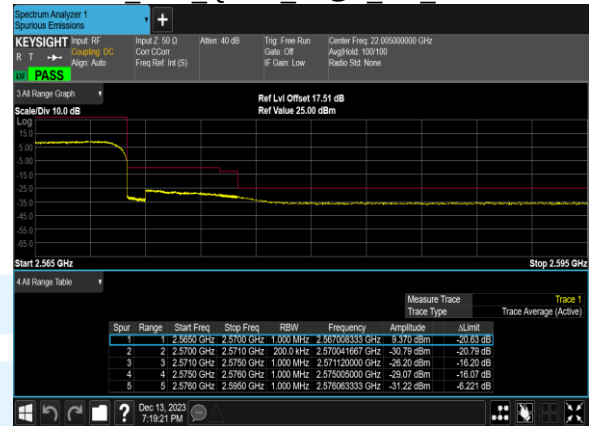
B7 10M QPSK 50@0 CH 21400

| Band | Bandwidth (MHz) | Channel | Freq (MHz) | Modulation | RB | Result | Verdict |
|---|---|---|---|---|---|---|---|
| 7 | 10.0 | 21400 | 2565.0 | QPSK | 50@0 | see graph | PASS |

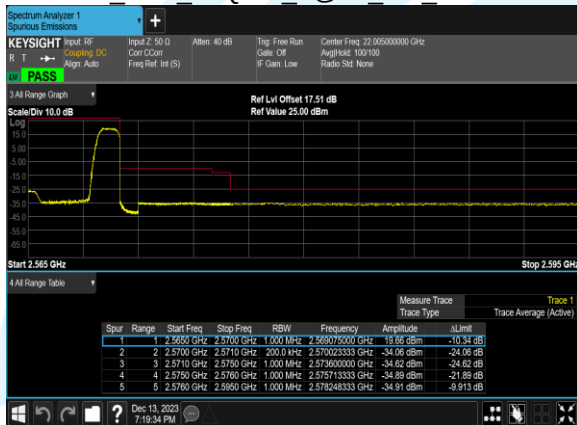
B7 10M 16QAM 1@49 CH 21400

| Band | Bandwidth (MHz) | Channel | Freq (MHz) | Modulation | RB | Result | Verdict |
|---|---|---|---|---|---|---|---|
| 7 | 10.0 | 21400 | 2565.0 | 16QAM | 1@49 | see graph | PASS |

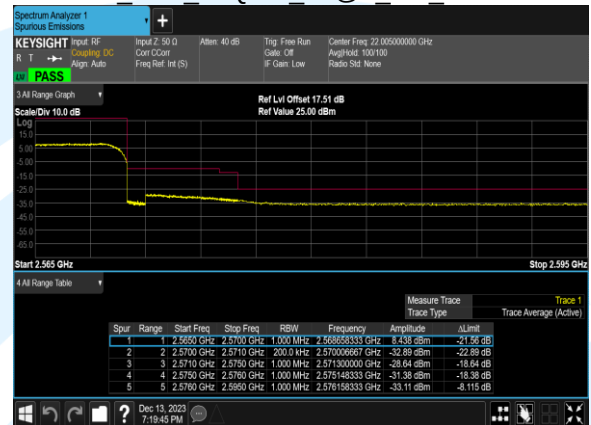
B7 10M 16QAM 50@0 CH 21400

| Band | Bandwidth (MHz) | Channel | Freq (MHz) | Modulation | RB | Result | Verdict |
|---|---|---|---|---|---|---|---|
| 7 | 10.0 | 21400 | 2565.0 | 16QAM | 50@0 | see graph | PASS |

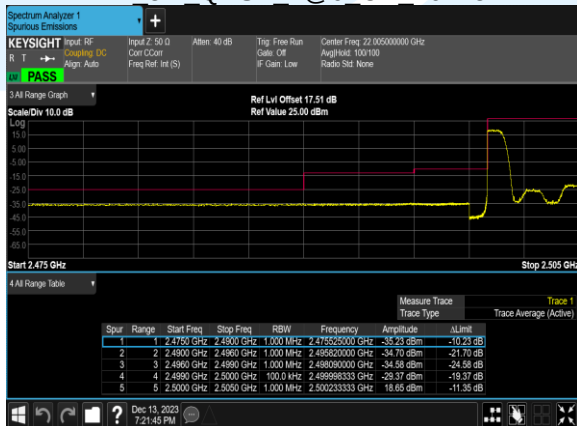
B7 5M QPSK 1@0 CH 20775

| Band | Bandwidth (MHz) | Channel | Freq (MHz) | Modulation | RB | Result | Verdict |
|---|---|---|---|---|---|---|---|
| 7 | 5.0 | 20775 | 2502.5 | QPSK | 1@0 | see graph | PASS |

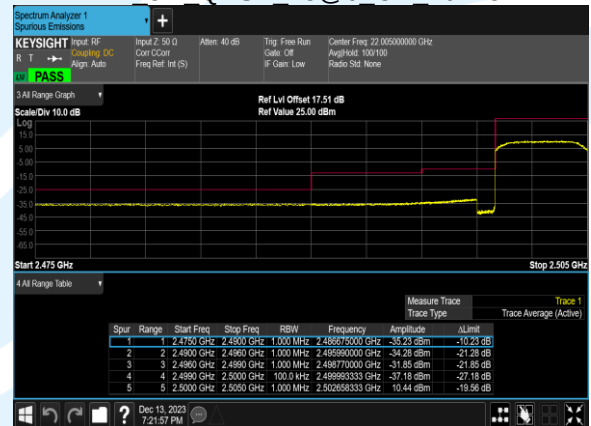
B7 5M QPSK 25@0 CH 20775

| Band | Bandwidth (MHz) | Channel | Freq (MHz) | Modulation | RB | Result | Verdict |
|---|---|---|---|---|---|---|---|
| 7 | 5.0 | 20775 | 2502.5 | QPSK | 25@0 | see graph | PASS |

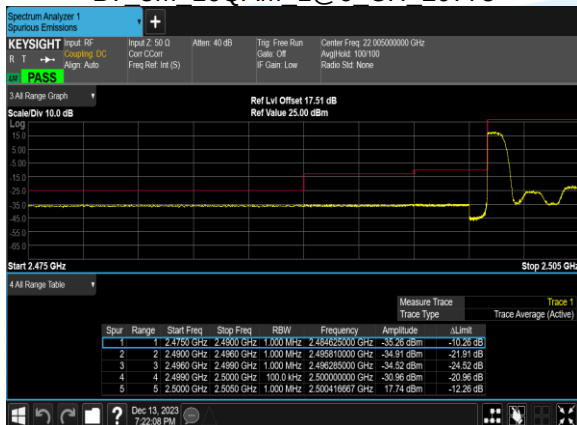
B7 5M 16QAM 1@0 CH 20775

| Band | Bandwidth (MHz) | Channel | Freq (MHz) | Modulation | RB | Result | Verdict |
|---|---|---|---|---|---|---|---|
| 7 | 5.0 | 20775 | 2502.5 | 16QAM | 1@0 | see graph | PASS |

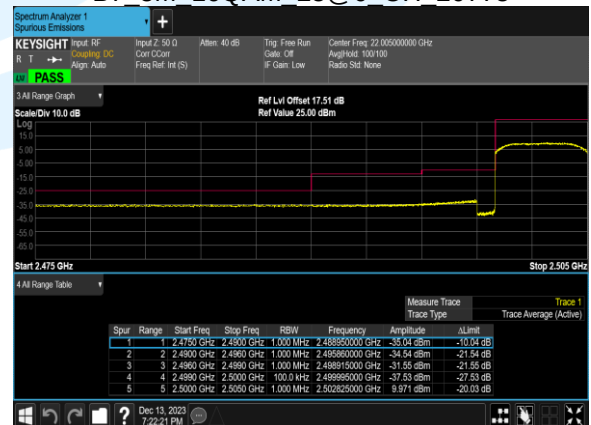
B7 5M 16QAM 25@0 CH 20775

| Band | Bandwidth (MHz) | Channel | Freq (MHz) | Modulation | RB | Result | Verdict |
|---|---|---|---|---|---|---|---|
| 7 | 5.0 | 20775 | 2502.5 | 16QAM | 25@0 | see graph | PASS |

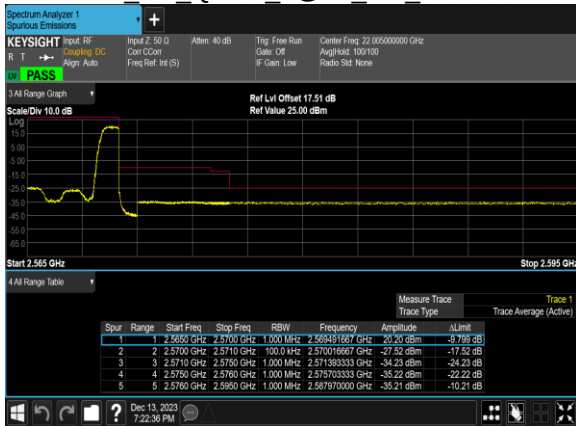
B7 5M QPSK 1@24 CH 21425

| Band | Bandwidth (MHz) | Channel | Freq (MHz) | Modulation | RB | Result | Verdict |
|---|---|---|---|---|---|---|---|
| 7 | 5.0 | 21425 | 2567.5 | QPSK | 1@24 | see graph | PASS |

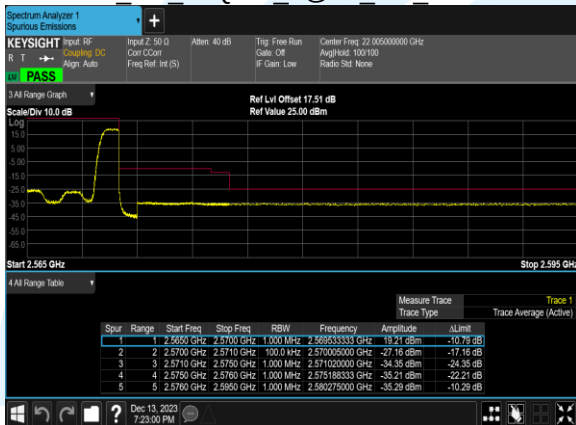
B7 5M 16QAM 1@24 CH 21425

| Band | Bandwidth (MHz) | Channel | Freq (MHz) | Modulation | RB | Result | Verdict |
|---|---|---|---|---|---|---|---|
| 7 | 5.0 | 21425 | 2567.5 | 16QAM | 1@24 | see graph | PASS |

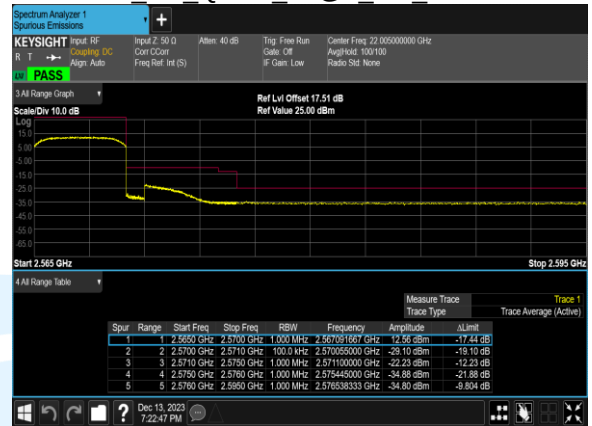
B7 5M QPSK 25@0 CH 21425

| Band | Bandwidth (MHz) | Channel | Freq (MHz) | Modulation | RB | Result | Verdict |
|---|---|---|---|---|---|---|---|
| 7 | 5.0 | 21425 | 2567.5 | QPSK | 25@0 | see graph | PASS |

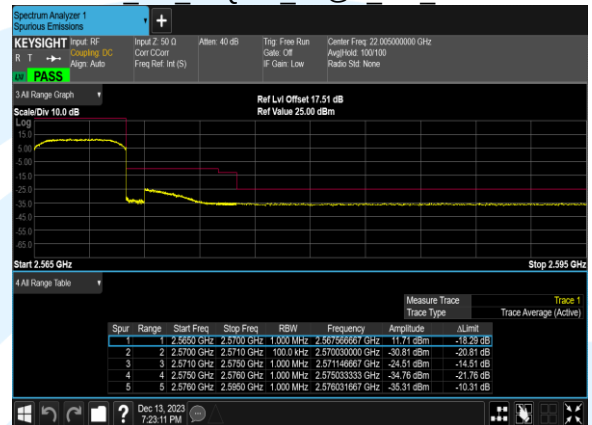
B7 5M 16QAM 25@0 CH 21425

| Band | Bandwidth (MHz) | Channel | Freq (MHz) | Modulation | RB | Result | Verdict |
|---|---|---|---|---|---|---|---|
| 7 | 5.0 | 21425 | 2567.5 | 16QAM | 25@0 | see graph | PASS |
