Radiated Emission Measurement

Condition : FCC\_part 15E RE\_Above 1GHz\_PK

EUT : W6M22403-23316

Test Mode : TX 802.11a CH165

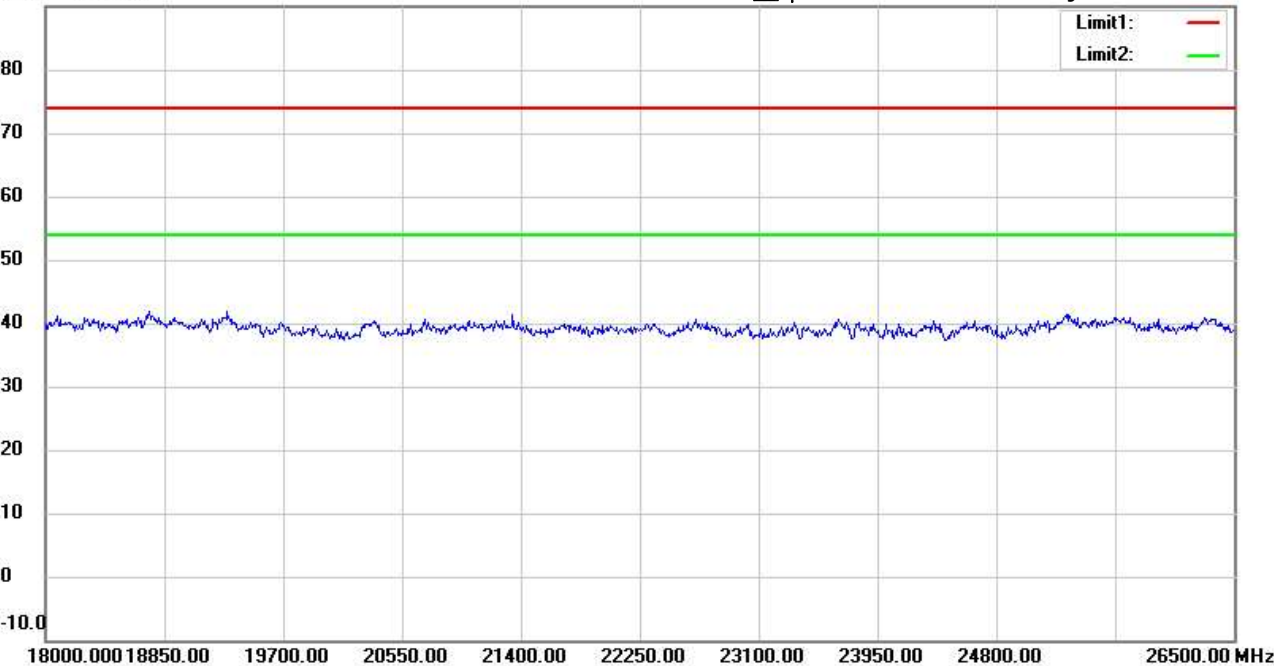
Data :#5

Polarization: *Horizontal*

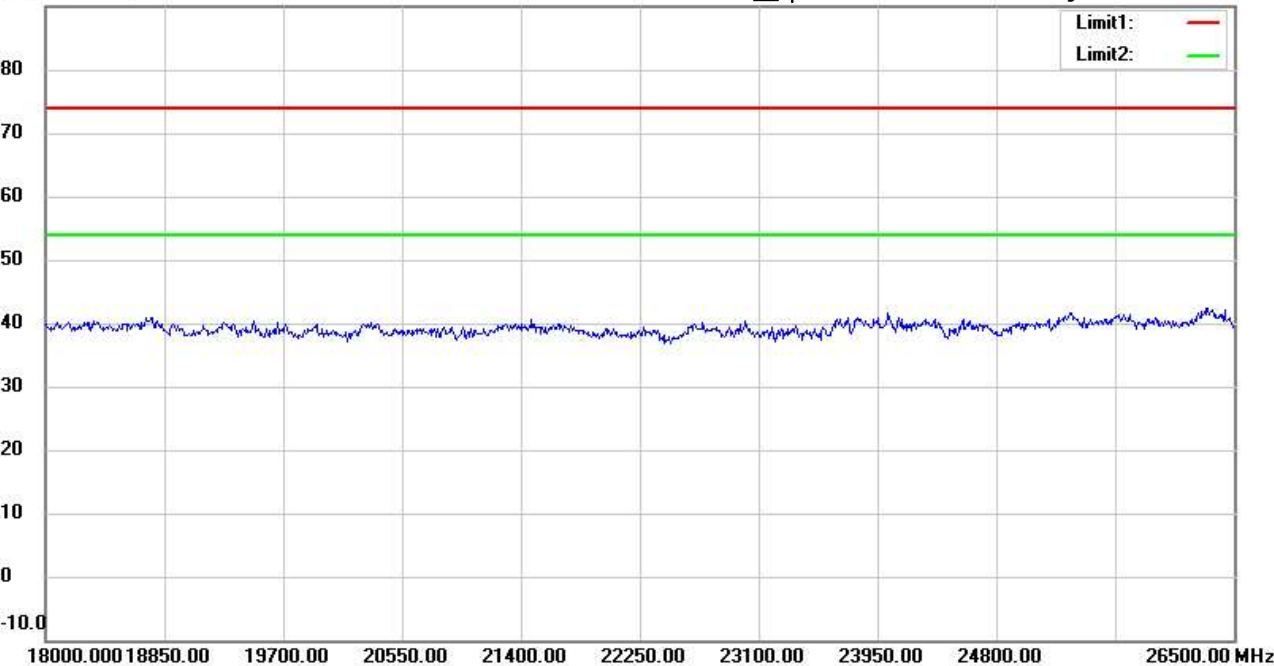
Data :#11

Condition : FCC\_part 15E RE\_Above 1GHz\_PK

Test Mode : TX 802.11a CH165

Polarization: Vertical

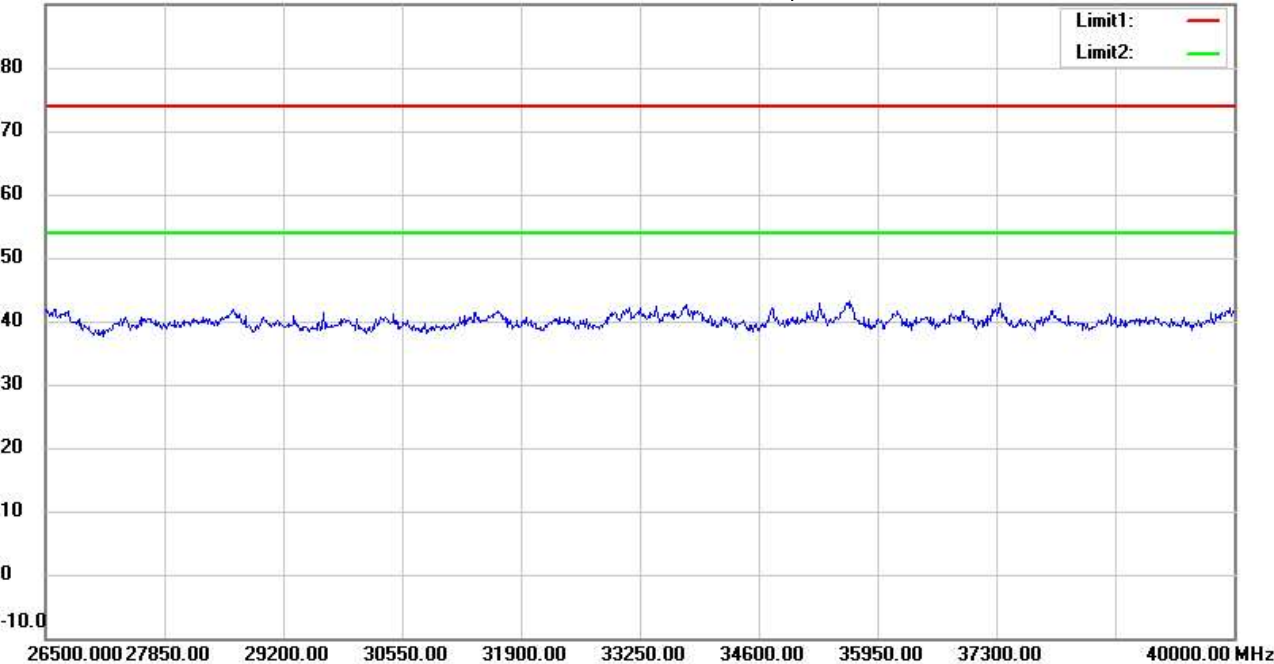
Data :#6

Condition : FCC\_part 15E RE\_Above 1GHz\_PK

Test Mode : TX 802.11a CH165

Polarization: *Horizontal*

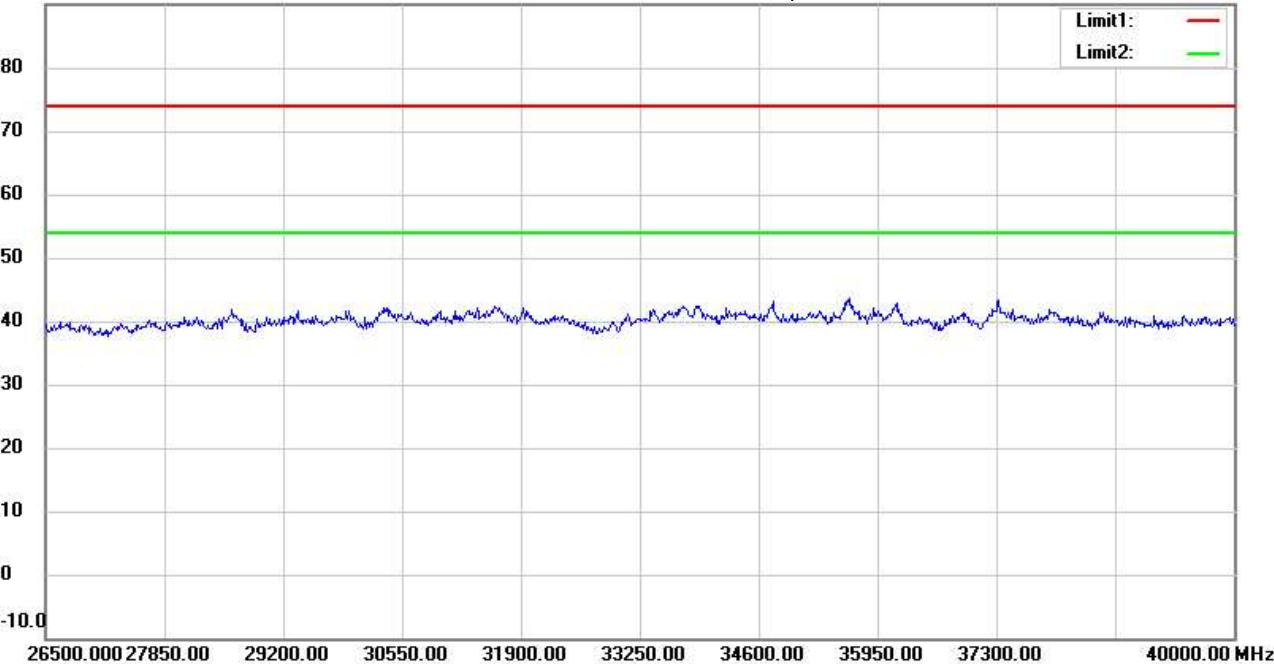
Data :#12

Condition : FCC\_part 15E RE\_Above 1GHz\_PK

Test Mode : TX 802.11a CH165

Polarization: Vertical

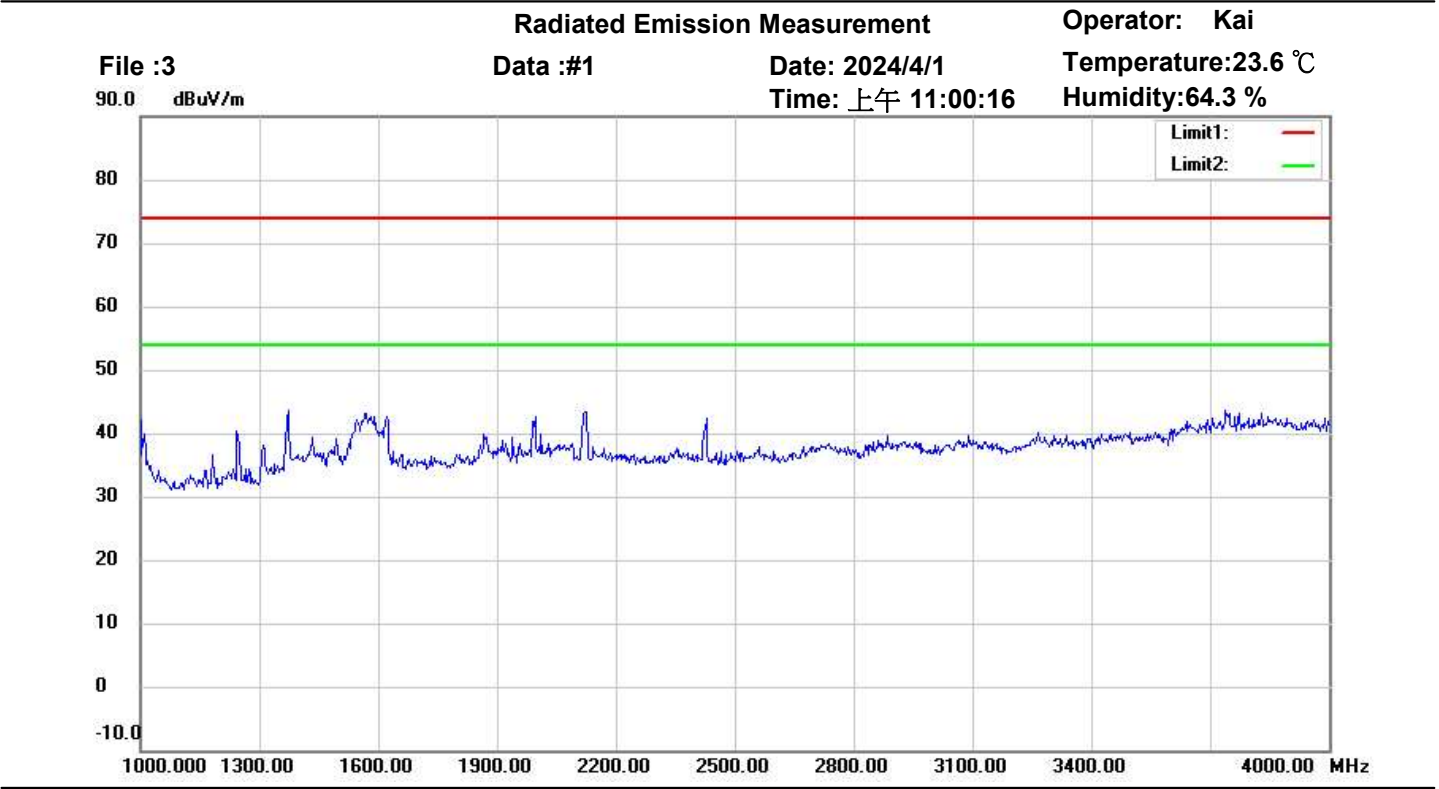
Condition : FCC\_part 15E RE\_Above 1GHz\_PK

Test Mode : TX 802.11a CH149

Polarization: Horizontal

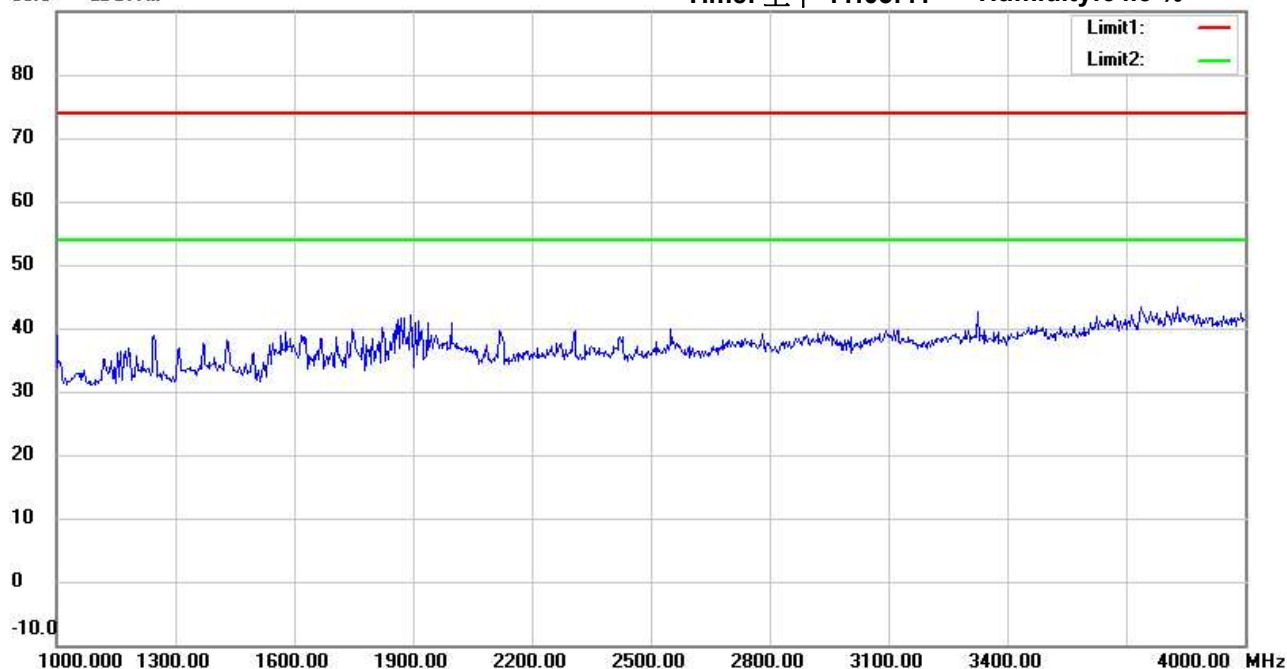
Data : #7

Condition : FCC\_part 15E RE\_Above 1GHz\_PK

Test Mode : TX 802.11a CH149

Polarization: Vertical

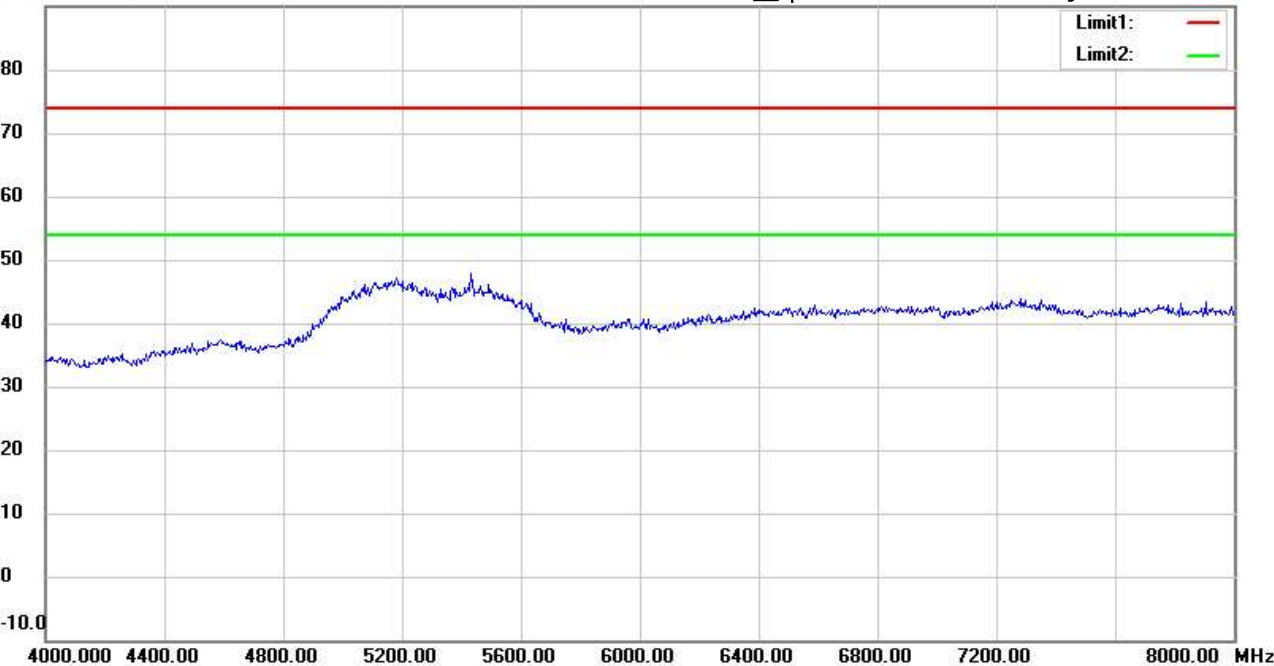
Data :#2

Condition : FCC\_part 15E RE\_Above 1GHz\_PK

Test Mode : TX 802.11a CH149

Polarization: **Horizontal**

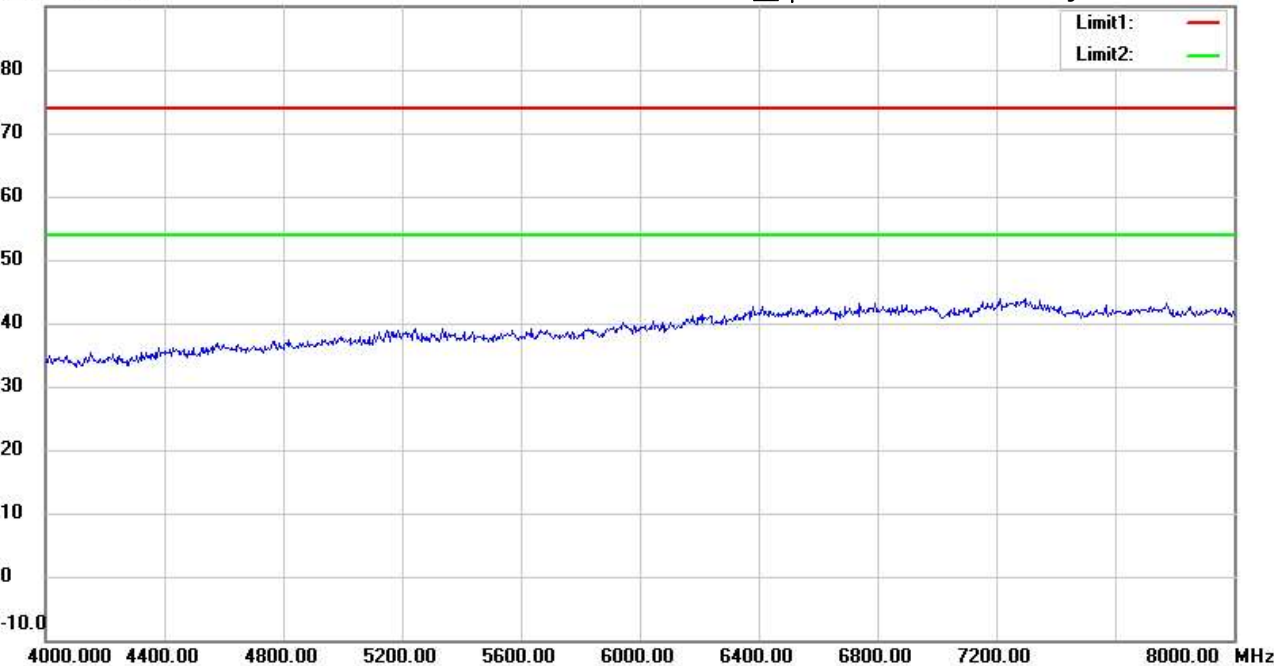
Data :#8

Condition : FCC\_part 15E RE\_Above 1GHz\_PK

Test Mode : TX 802.11a CH149

Polarization: Vertical

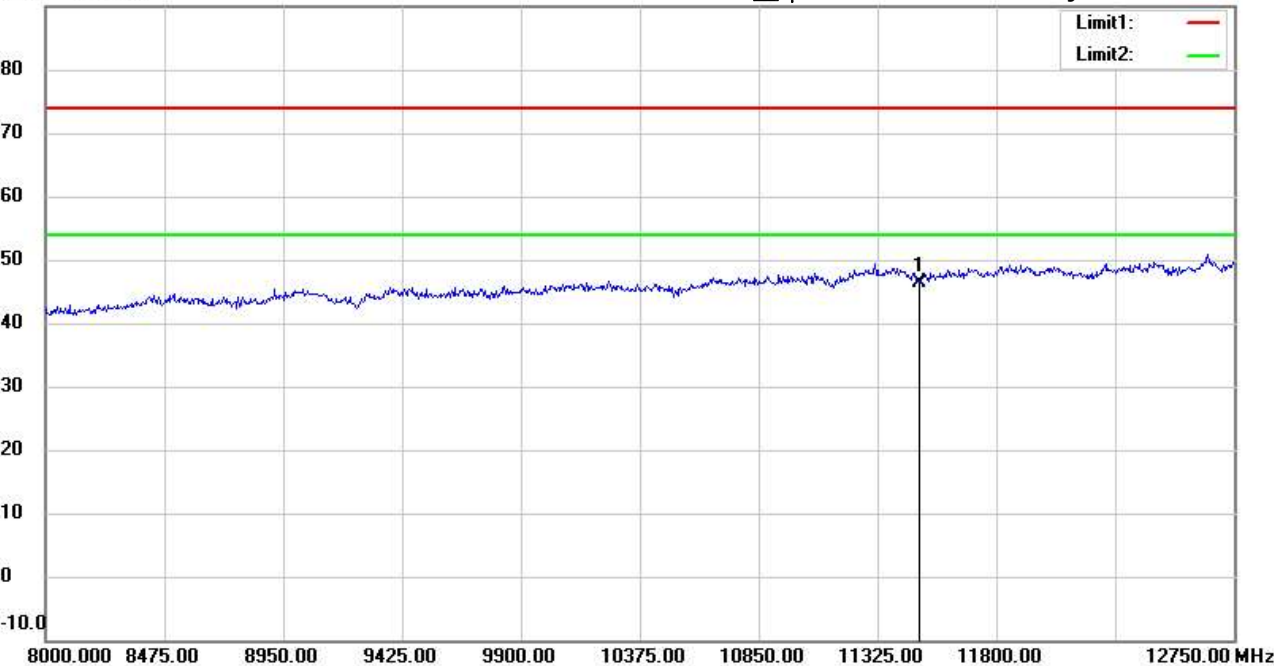
Data :#3

Condition : FCC\_part 15E RE\_Above 1GHz\_PK

Test Mode : TX 802.11a CH149

Polarization: **Horizontal**

| Mk. | Frequency (MHz) | Reading (dBuV) | Detector | Corr. factor (dB/m) | Result (dBuV/m) | Limit (dBuV/m) | Ant.Pos (cm) | Tab.Pos (deg.) | Margin (dB) | Comment |
|---|---|---|---|---|---|---|---|---|---|---|
| * | 11490.000 | 30.40 | peak | 15.91 | 46.31 | 74.00 | 150 | 84 | -27.69 | |

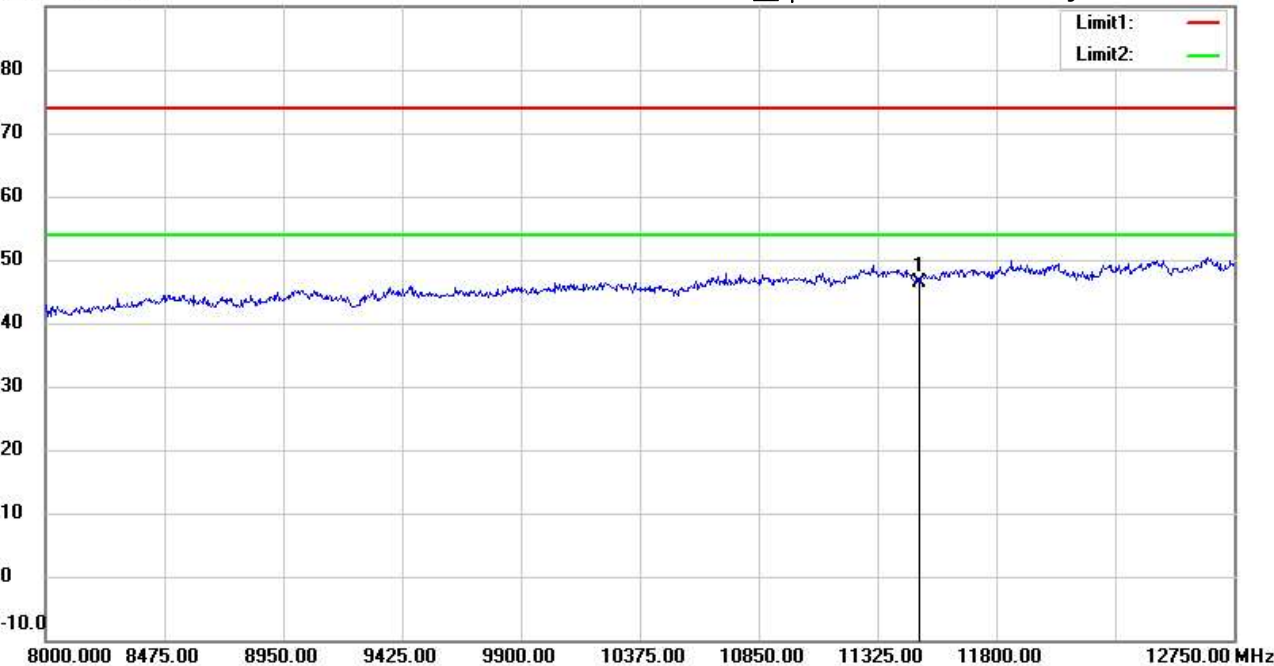
Data :#9

Condition : FCC\_part 15E RE\_Above 1GHz\_PK

Test Mode : TX 802.11a CH149

Polarization: Vertical

| Mk. | Frequency (MHz) | Reading (dBuV) | Detector | Corr. factor (dB/m) | Result (dBuV/m) | Limit (dBuV/m) | Ant.Pos (cm) | Tab.Pos (deg.) | Margin (dB) | Comment |
|---|---|---|---|---|---|---|---|---|---|---|
| * | 11490.000 | 30.40 | peak | 15.91 | 46.31 | 74.00 | 150 | 151 | -27.69 | |

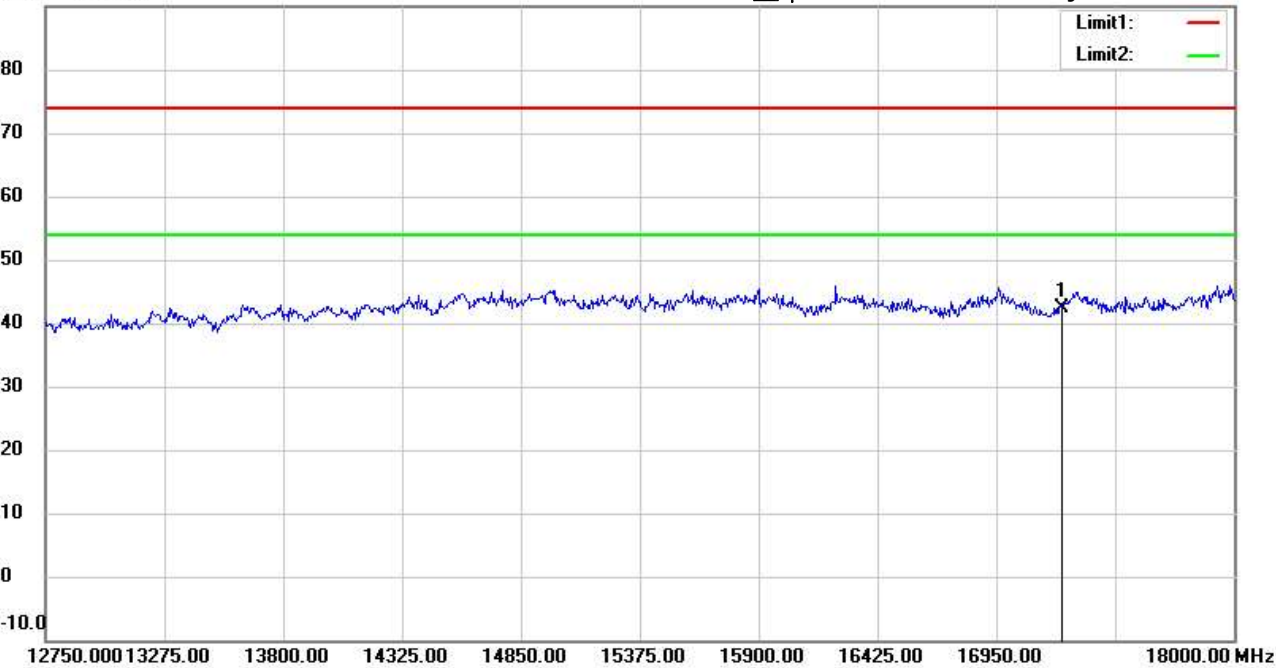
Data :#4

Condition : FCC\_part 15E RE\_Above 1GHz\_PK

Test Mode : TX 802.11a CH149

Polarization: **Horizontal**

| Mk. | Frequency (MHz) | Reading (dBuV) | Detector | Corr. factor (dB/m) | Result (dBuV/m) | Limit (dBuV/m) | Ant.Pos (cm) | Tab.Pos (deg.) | Margin (dB) | Comment |
|---|---|---|---|---|---|---|---|---|---|---|
| * | 17235.000 | 19.01 | peak | 23.34 | 42.35 | 74.00 | 150 | 197 | -31.65 | |

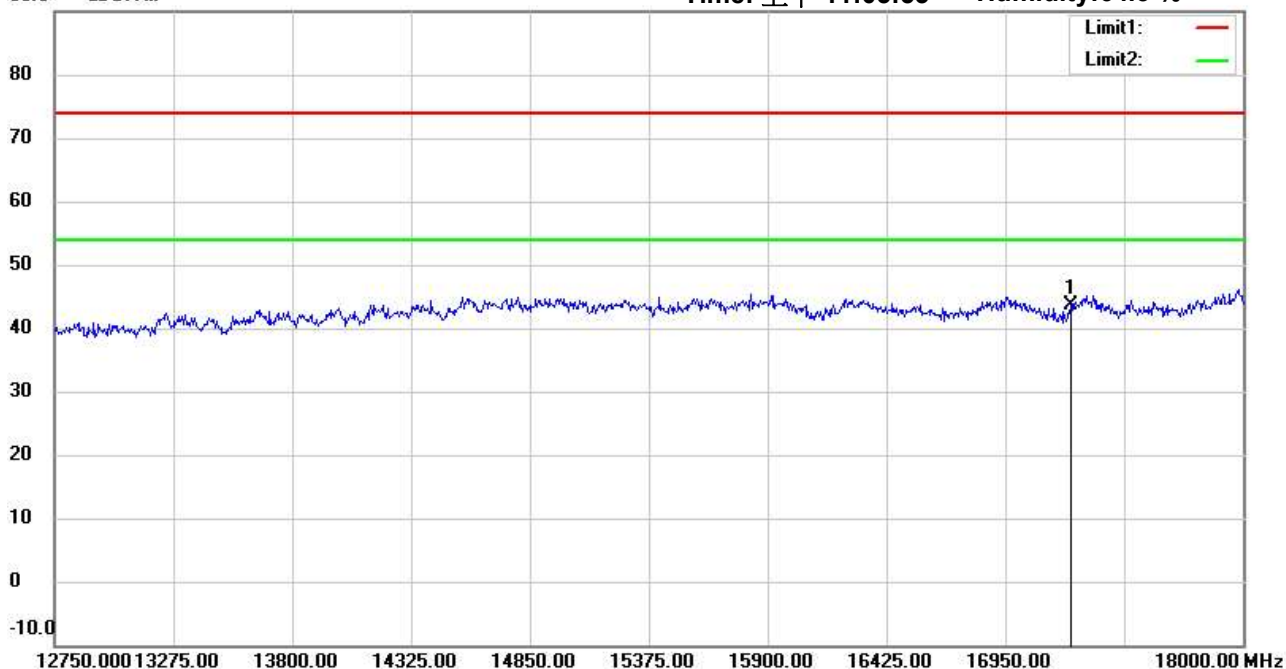
Data : #10

Condition : FCC\_part 15E RE\_Above 1GHz\_PK

Test Mode : TX 802.11a CH149

Polarization: Vertical

| Mk. | Frequency (MHz) | Reading (dBuV) | Detector | Corr. factor (dB/m) | Result (dBuV/m) | Limit (dBuV/m) | Ant.Pos (cm) | Tab.Pos (deg.) | Margin (dB) | Comment |
|---|---|---|---|---|---|---|---|---|---|---|
| * | 17235.000 | 20.24 | peak | 23.34 | 43.58 | 74.00 | 150 | 159 | -30.42 | |

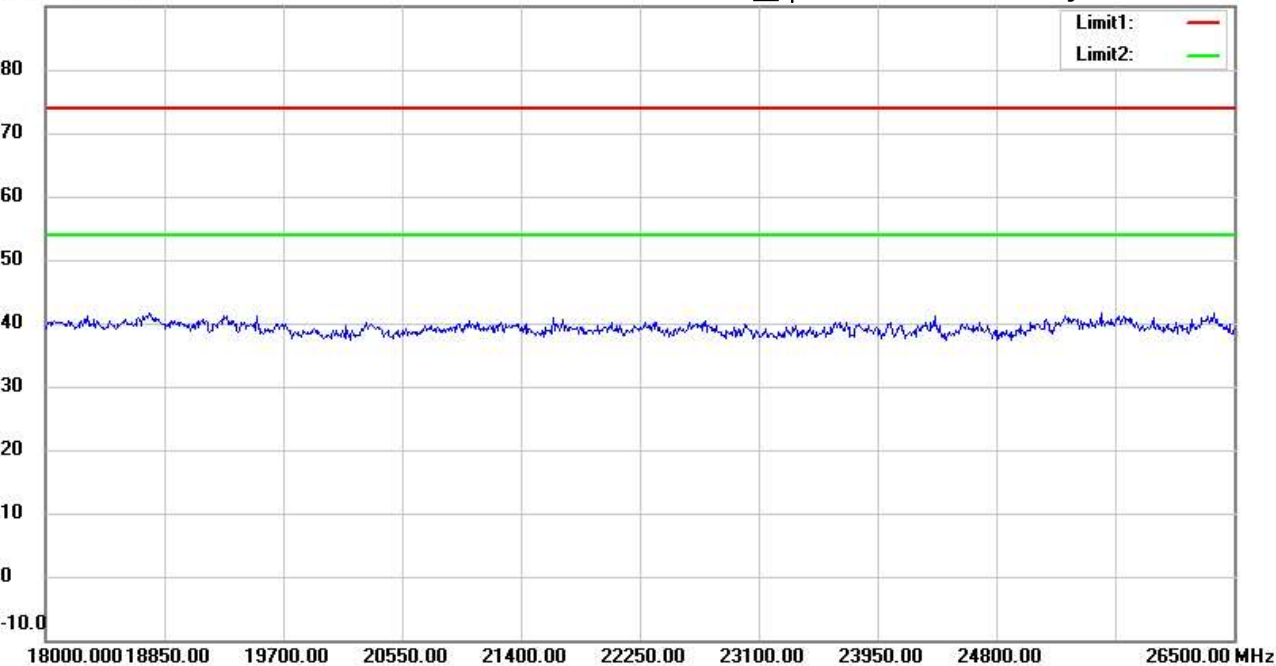
Data :#5

Condition : FCC\_part 15E RE\_Above 1GHz\_PK

Test Mode : TX 802.11a CH149

Polarization: Horizontal

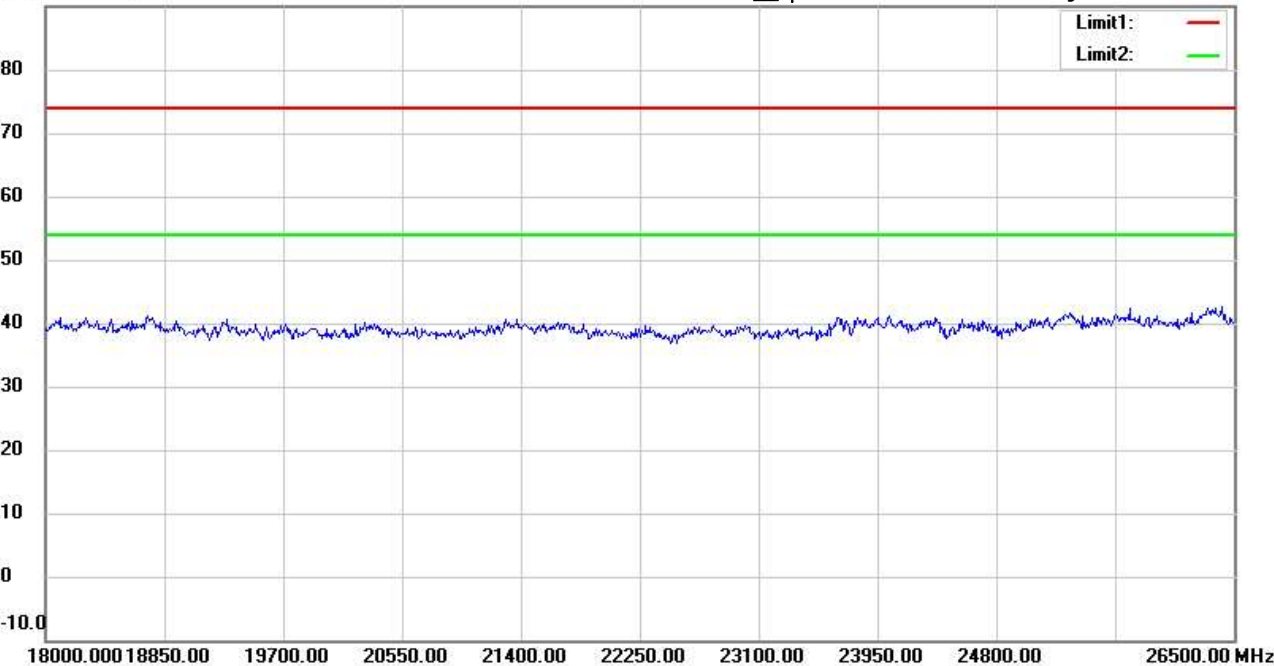
Data :#11

Condition : FCC\_part 15E RE\_Above 1GHz\_PK

Test Mode : TX 802.11a CH149

Polarization: Vertical

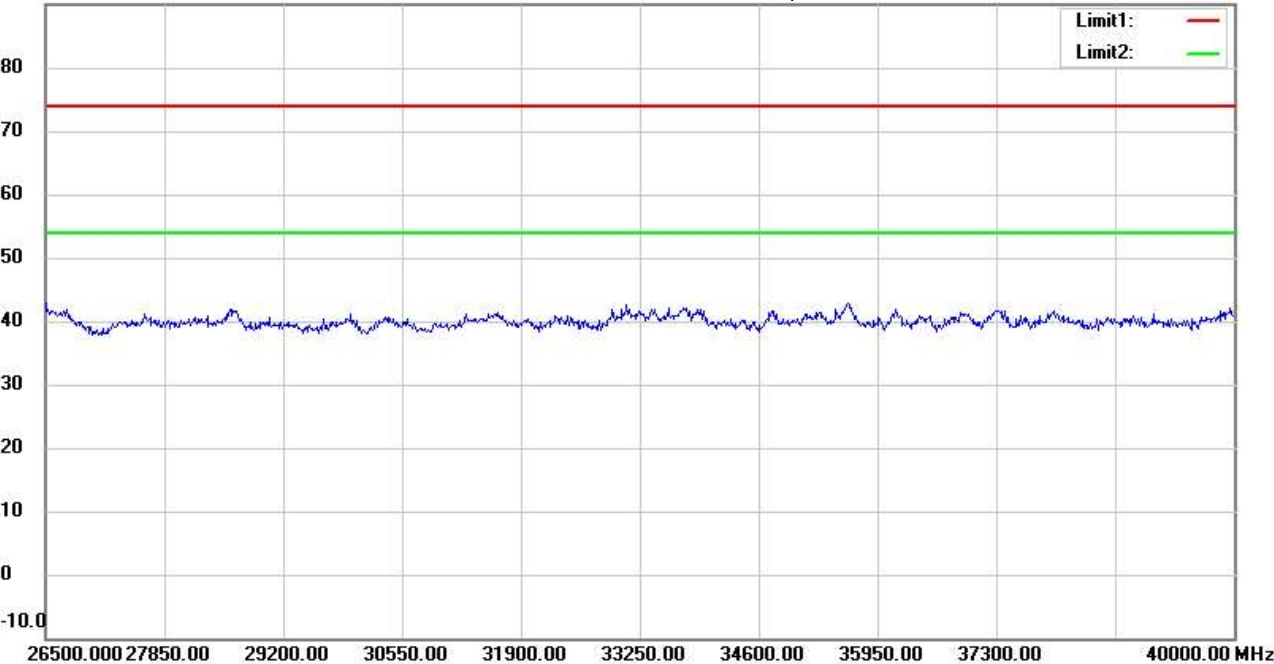
Data :#6

Condition : FCC\_part 15E RE\_Above 1GHz\_PK

Test Mode : TX 802.11a CH149

Polarization: *Horizontal*

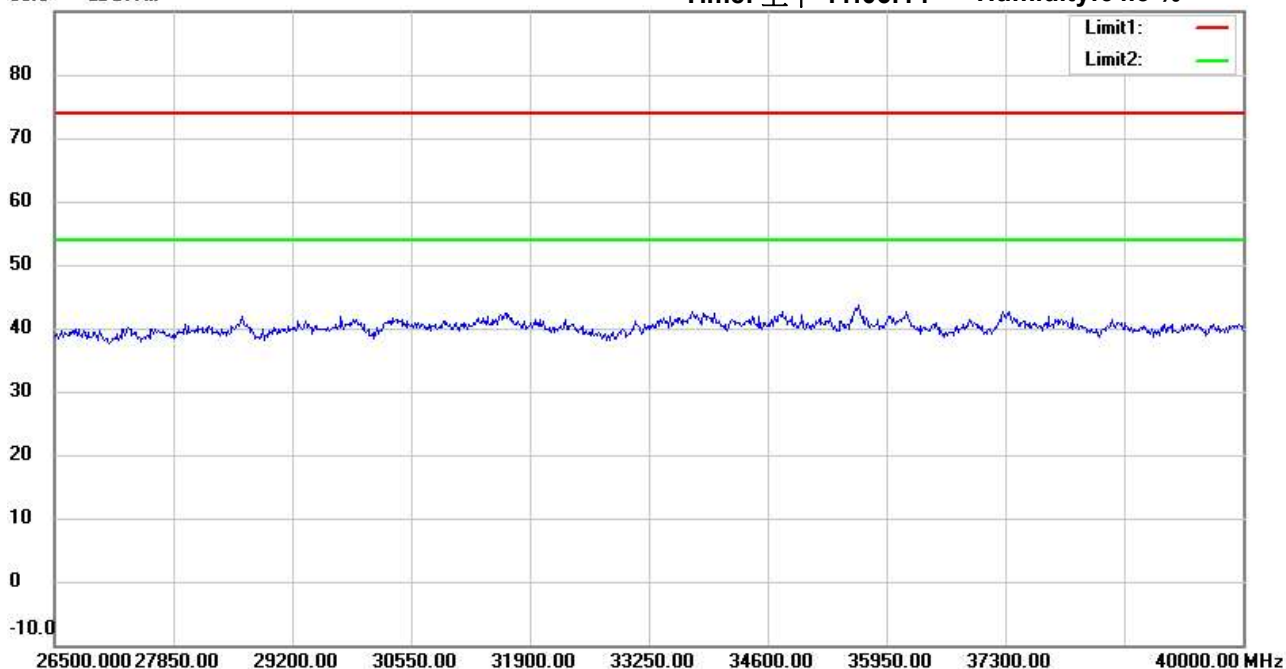
Data : #12

Condition : FCC\_part 15E RE\_Above 1GHz\_PK

Test Mode : TX 802.11a CH149

Polarization: Vertical

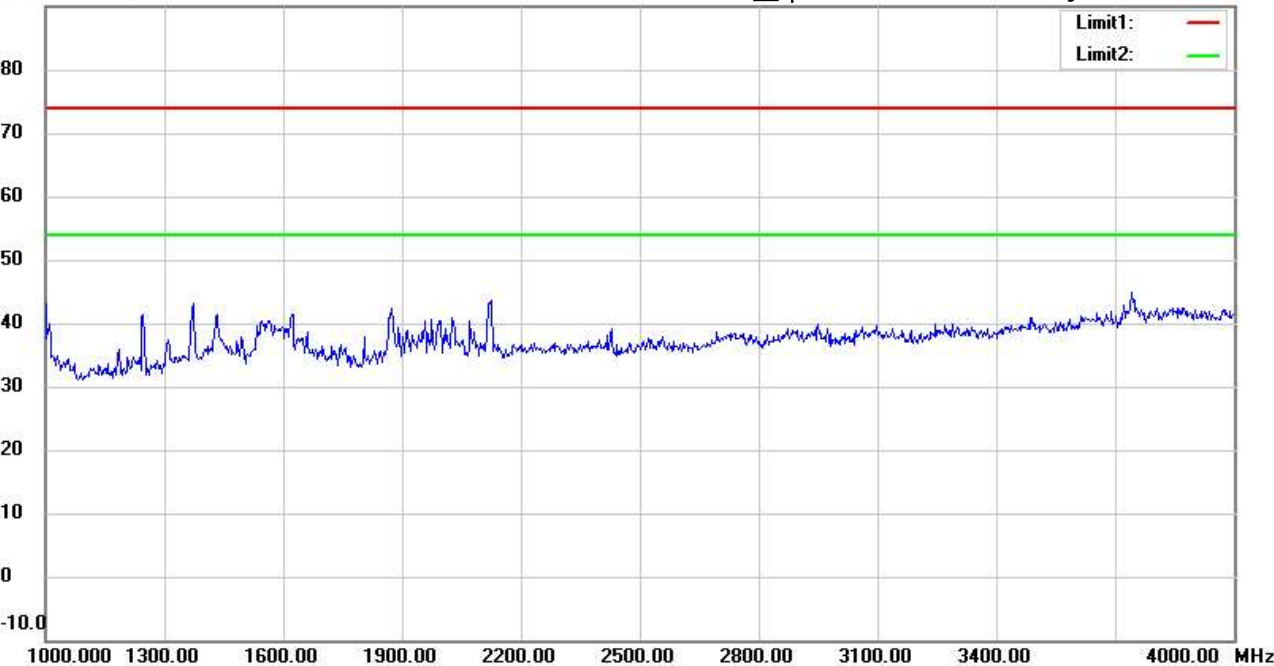
Data :#1

Condition : FCC\_part 15E RE\_Above 1GHz\_PK

Test Mode : TX 802.11a CH157

Polarization: **Horizontal**

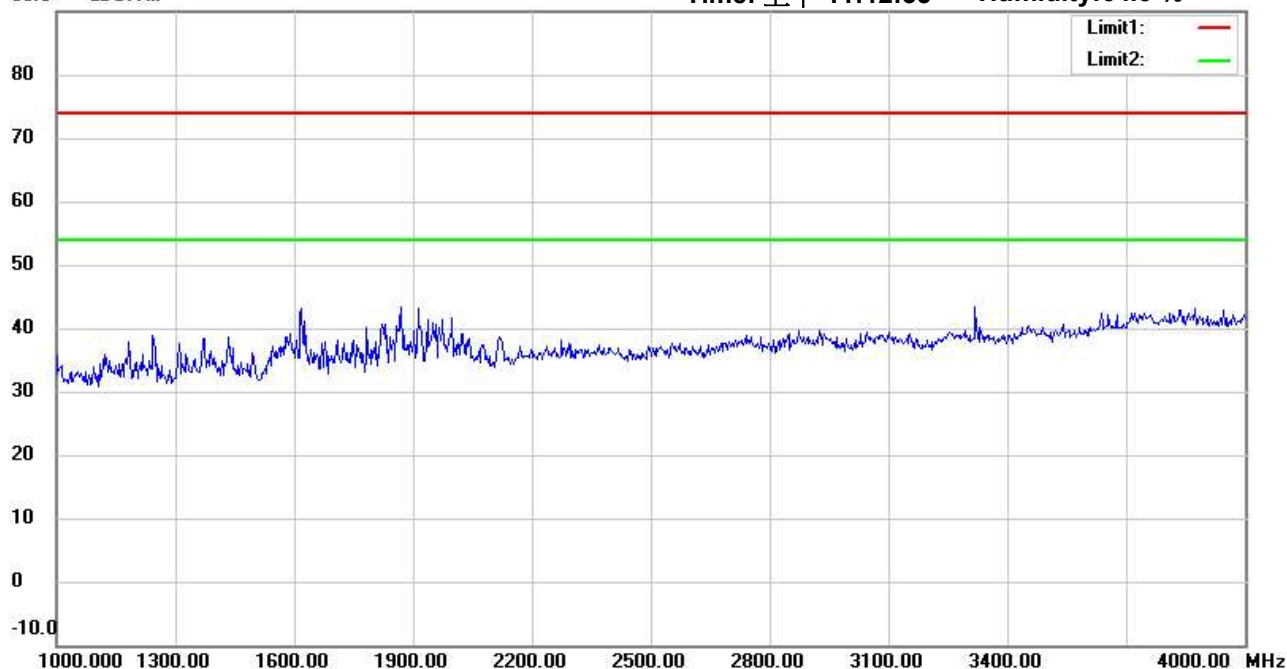
Data : #7

Condition : FCC\_part 15E RE\_Above 1GHz\_PK

Test Mode : TX 802.11a CH157

Polarization: Vertical

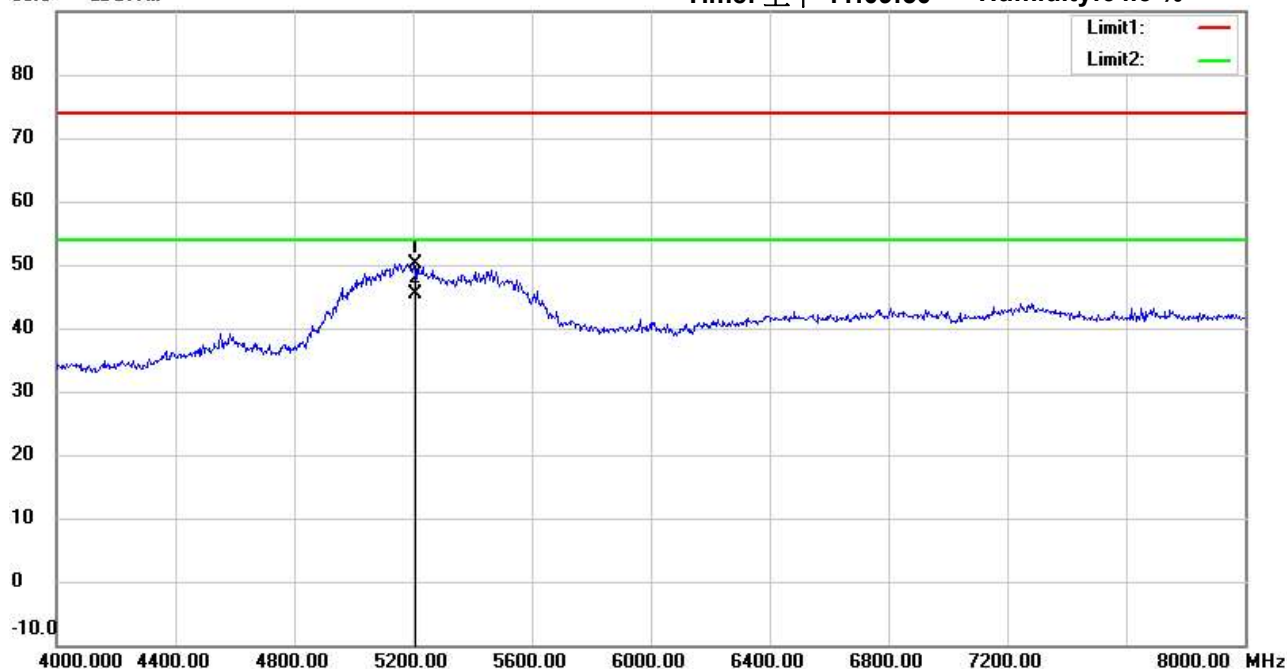
Data : #2

Condition : FCC\_part 15E RE\_Above 1GHz\_PK

Test Mode : TX 802.11a CH157

Polarization: **Horizontal**

| Mk. | Frequency (MHz) | Reading (dBuV) | Detector | Corr. factor (dB/m) | Result (dBuV/m) | Limit (dBuV/m) | Ant.Pos (cm) | Tab.Pos (deg.) | Margin (dB) | Comment |
|---|---|---|---|---|---|---|---|---|---|---|
| | 5206.000 | 45.50 | peak | 4.73 | 50.23 | 74.00 | 150 | 33 | -23.77 | |
| * | 5206.000 | 40.55 | AVG | 4.73 | 45.28 | 54.00 | 150 | 33 | -8.72 | |

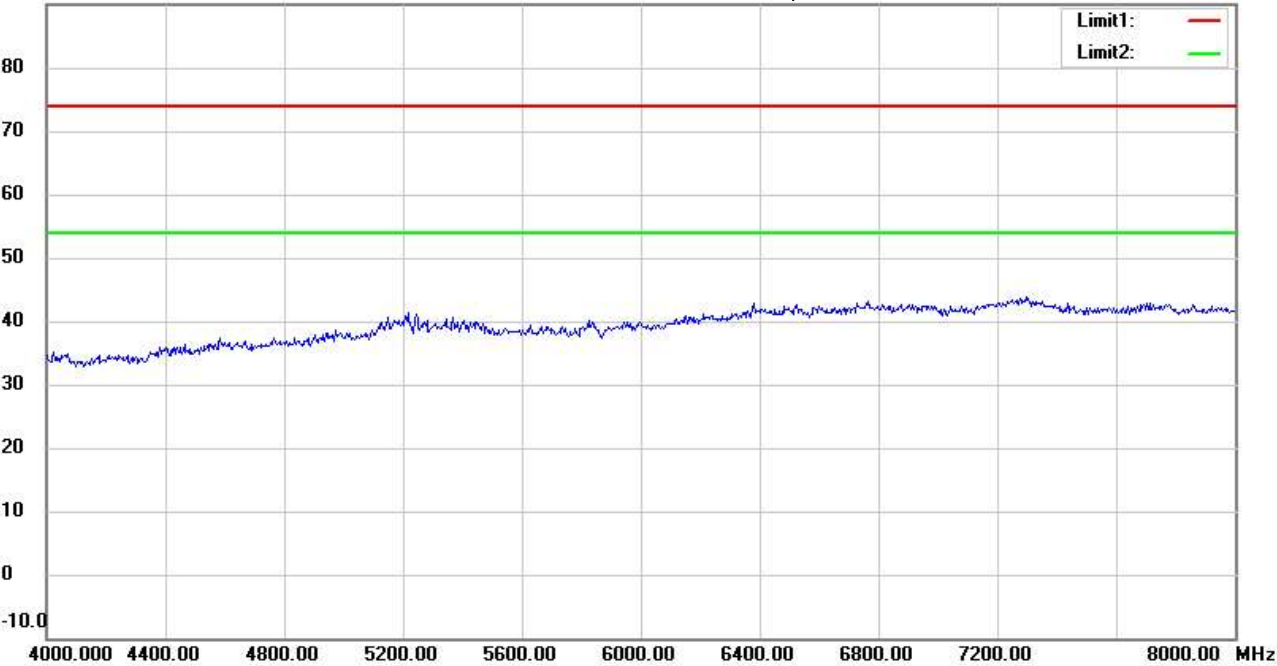
Data :#8

Condition : FCC\_part 15E RE\_Above 1GHz\_PK

Test Mode : TX 802.11a CH157

Polarization: Vertical

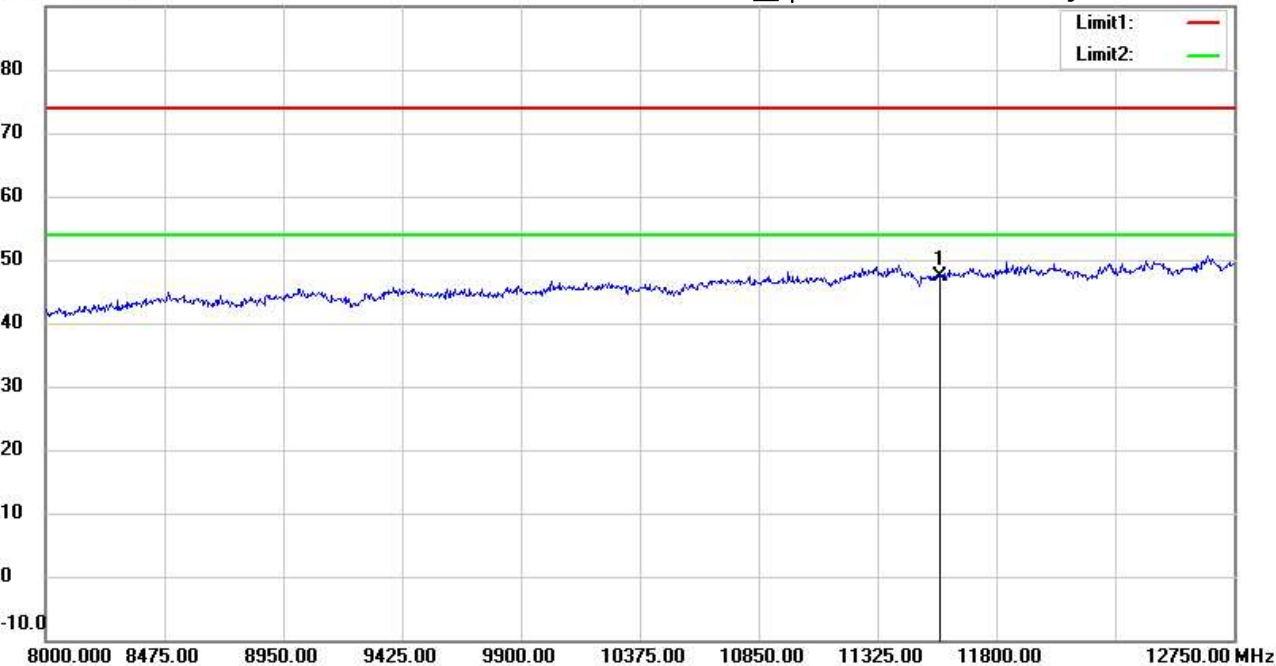
Data :#3

Condition : FCC\_part 15E RE\_Above 1GHz\_PK

Test Mode : TX 802.11a CH157

Polarization: **Horizontal**

| Mk. | Frequency (MHz) | Reading (dBuV) | Detector | Corr. factor (dB/m) | Result (dBuV/m) | Limit (dBuV/m) | Ant.Pos (cm) | Tab.Pos (deg.) | Margin (dB) | Comment |
|---|---|---|---|---|---|---|---|---|---|---|
| * | 11570.000 | 31.24 | peak | 16.10 | 47.34 | 74.00 | 150 | 345 | -26.66 | |

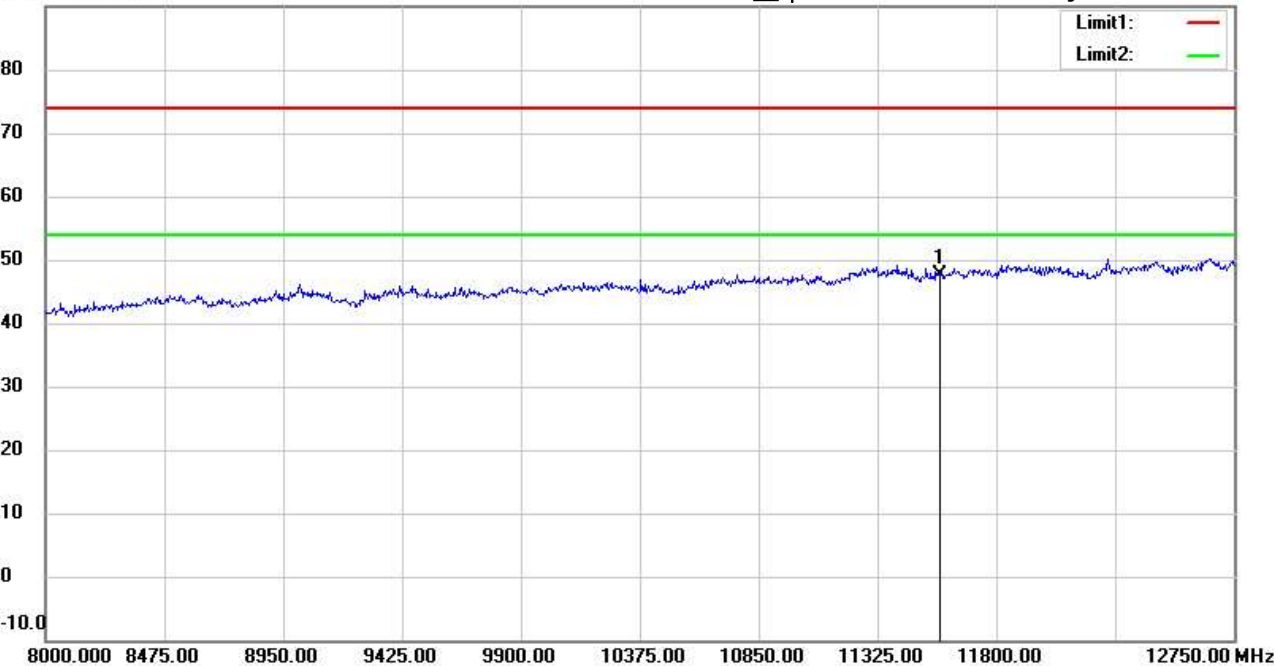
Data :#9

Condition : FCC\_part 15E RE\_Above 1GHz\_PK

Test Mode : TX 802.11a CH157

Polarization: Vertical

| Mk. | Frequency (MHz) | Reading (dBuV) | Detector | Corr. factor (dB/m) | Result (dBuV/m) | Limit (dBuV/m) | Ant.Pos (cm) | Tab.Pos (deg.) | Margin (dB) | Comment |
|---|---|---|---|---|---|---|---|---|---|---|
| * | 11570.000 | 31.41 | peak | 16.10 | 47.51 | 74.00 | 150 | 260 | -26.49 | |

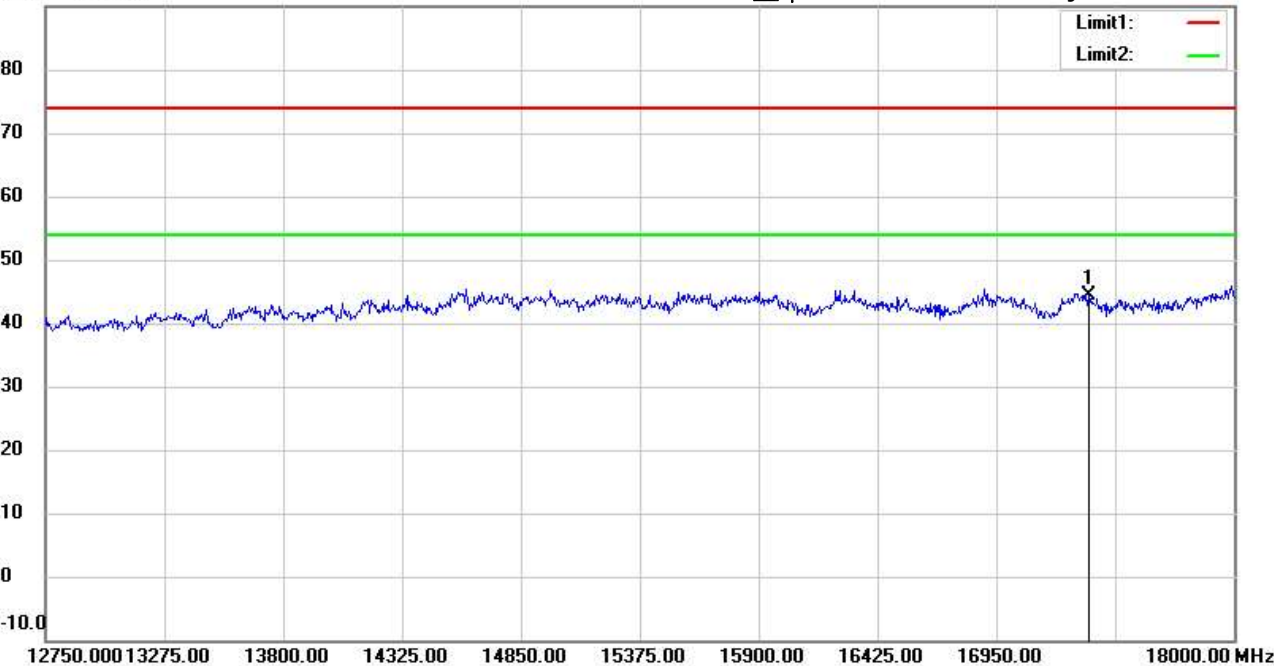
Data :#4

Condition : FCC\_part 15E RE\_Above 1GHz\_PK

Test Mode : TX 802.11a CH157

Polarization: **Horizontal**

| Mk. | Frequency (MHz) | Reading (dBuV) | Detector | Corr. factor (dB/m) | Result (dBuV/m) | Limit (dBuV/m) | Ant.Pos (cm) | Tab.Pos (deg.) | Margin (dB) | Comment |
|---|---|---|---|---|---|---|---|---|---|---|
| * | 17355.000 | 20.91 | peak | 23.57 | 44.48 | 74.00 | 150 | 200 | -29.52 | |

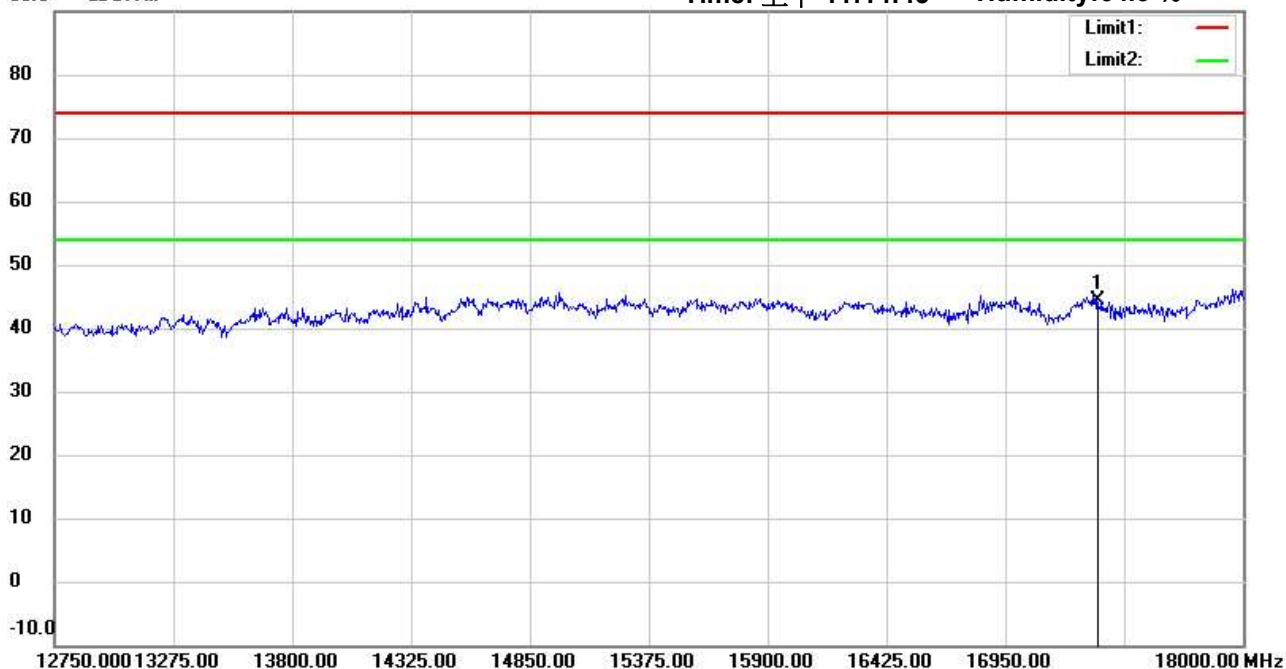
Data : #10

Condition : FCC\_part 15E RE\_Above 1GHz\_PK

Test Mode : TX 802.11a CH157

Polarization: Vertical

| Mk. | Frequency (MHz) | Reading (dBuV) | Detector | Corr. factor (dB/m) | Result (dBuV/m) | Limit (dBuV/m) | Ant.Pos (cm) | Tab.Pos (deg.) | Margin (dB) | Comment |
|---|---|---|---|---|---|---|---|---|---|---|
| * | 17355.000 | 20.82 | peak | 23.57 | 44.39 | 74.00 | 150 | 280 | -29.61 | |

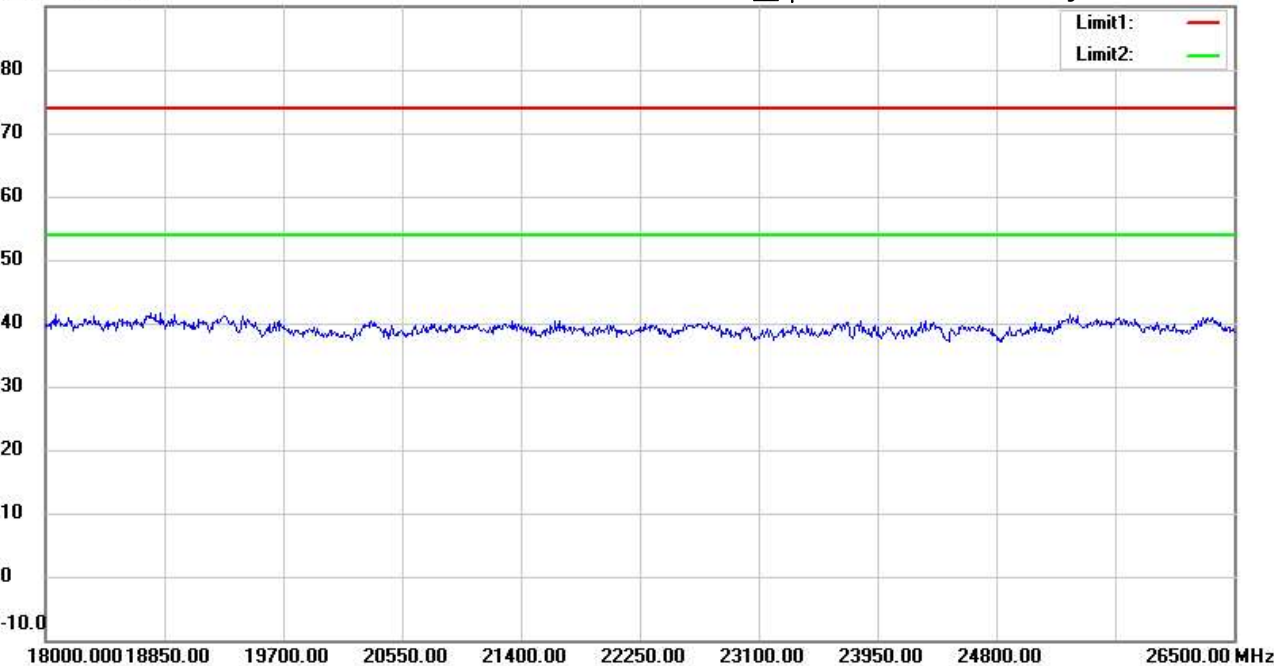
Data :#5

Condition : FCC\_part 15E RE\_Above 1GHz\_PK

Test Mode : TX 802.11a CH157

Polarization: Horizontal
