Radiated Emission Measurement

Condition : FCC\_part 15E RE\_Above 1GHz\_PK

EUT : W6M22403-23316

Test Mode : TX 802.11a CH165

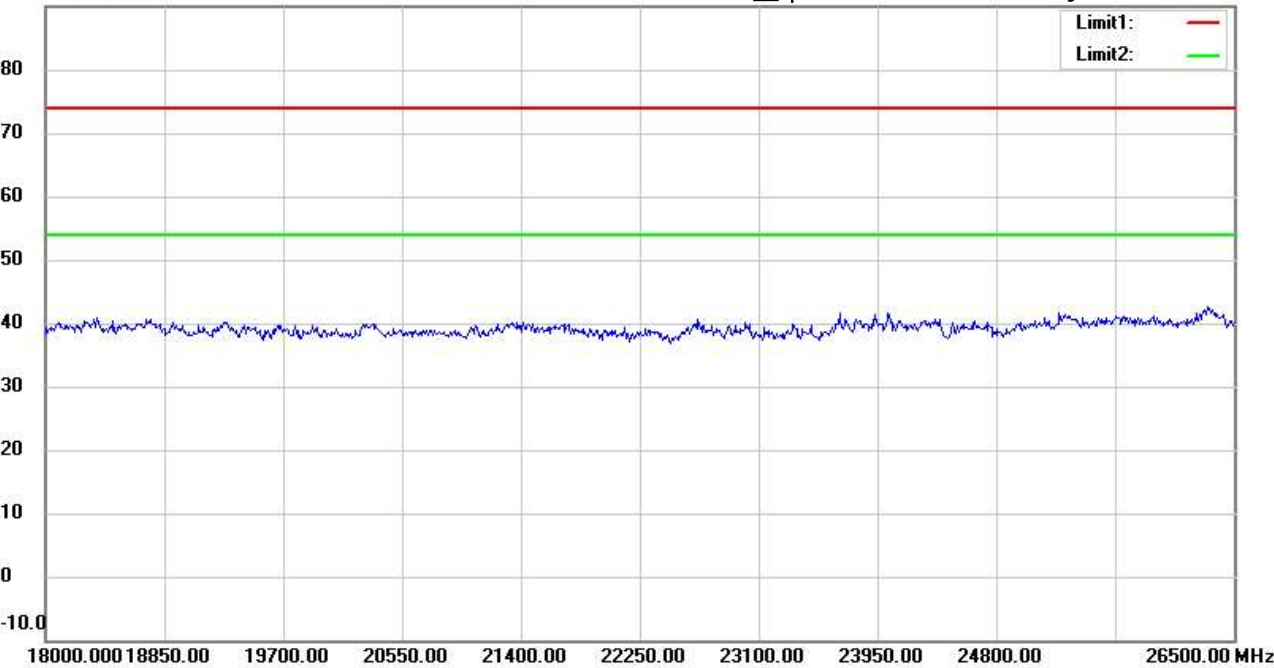
Data :#11

Condition : FCC\_part 15E RE\_Above 1GHz\_PK

Test Mode : TX 802.11a CH157

Polarization: Vertical

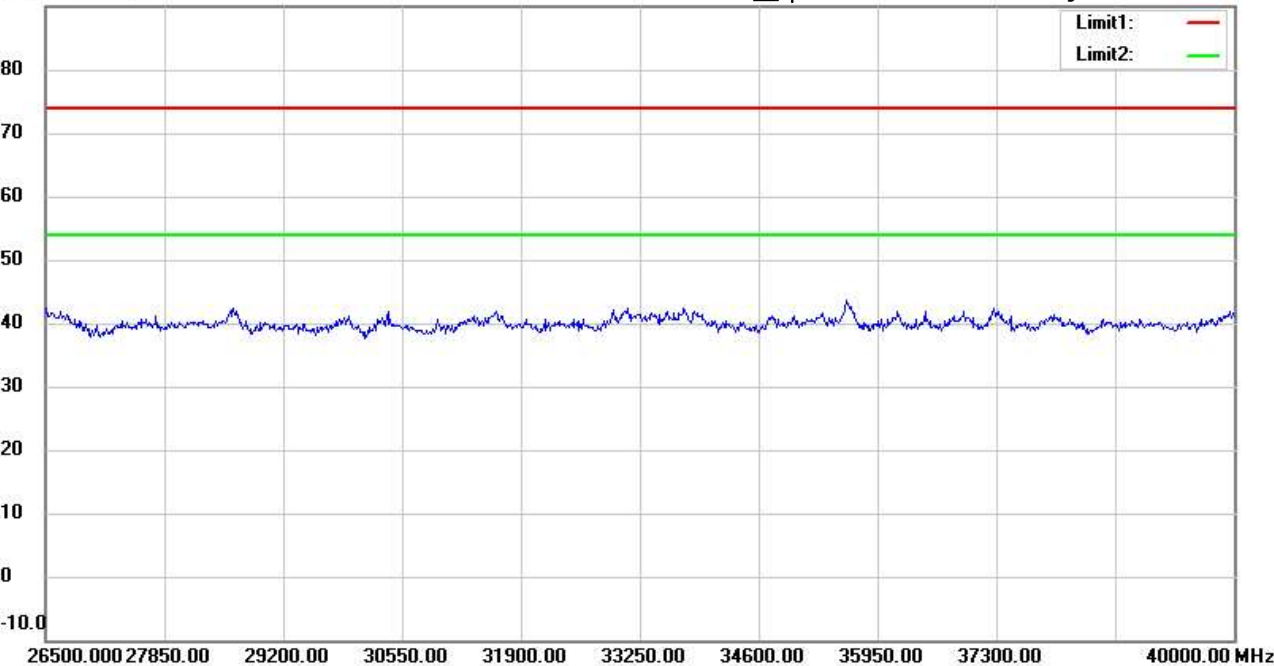
Data :#6

Condition : FCC\_part 15E RE\_Above 1GHz\_PK

Test Mode : TX 802.11a CH157

Polarization: *Horizontal*
