## 4.EUT TEST PHOTOS

## 5. PHOTOGRAPHS OF EUT CONSTRUCTIONAL

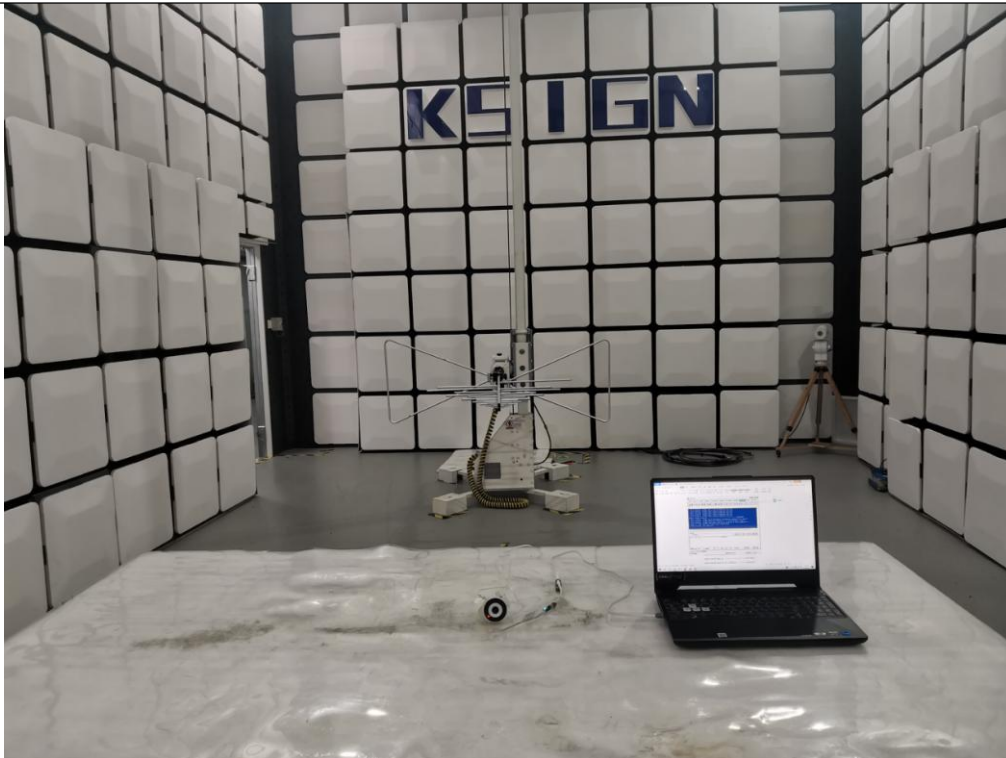
Radiated Measurement (Below 1GHz)

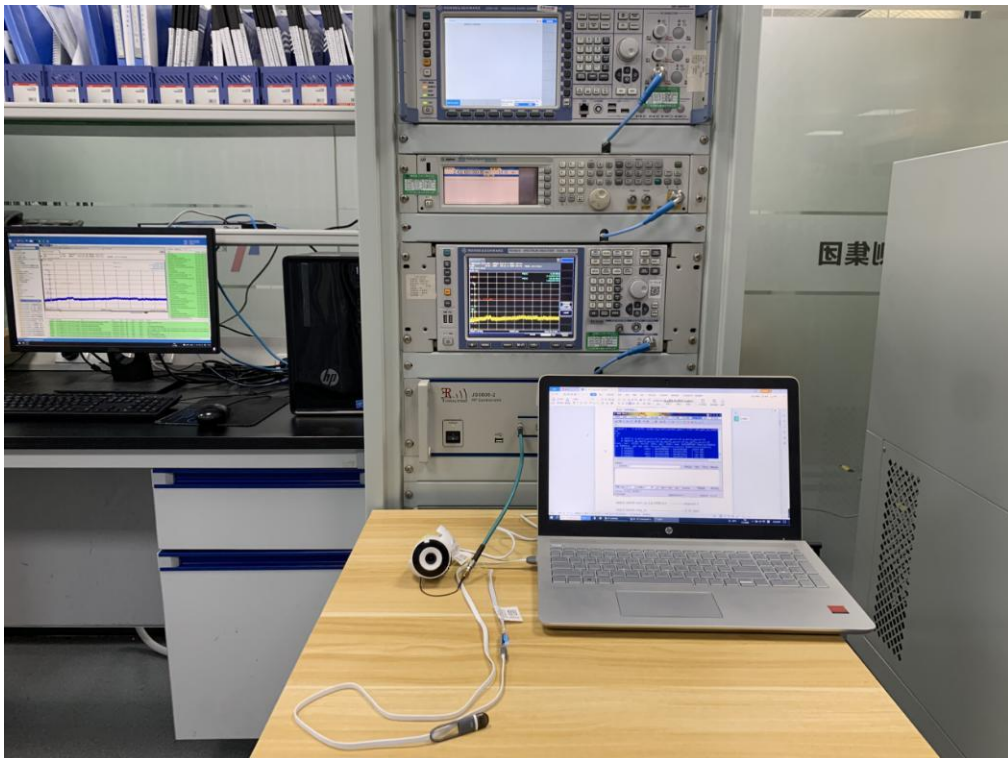
RF Conducted
