## Appendix F: Band edge measurements

## Appendix G: Conducted Spurious Emission Test Result

## Appendix H: Duty Cycle

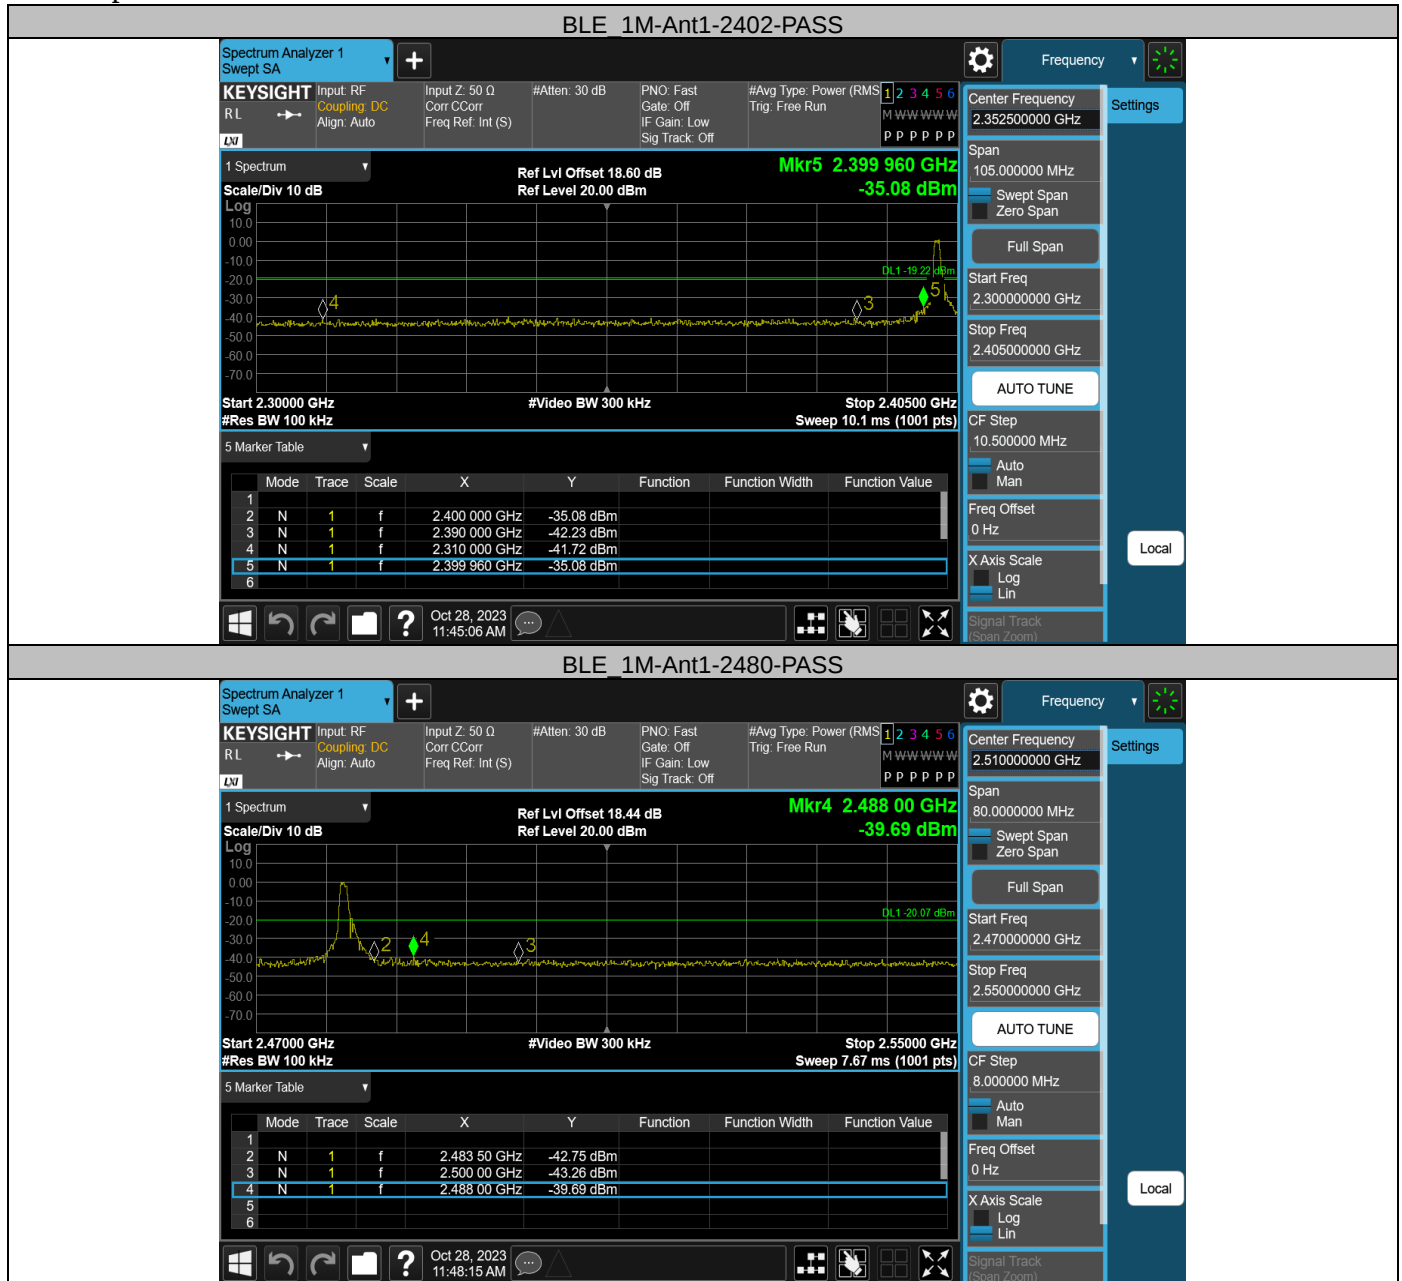
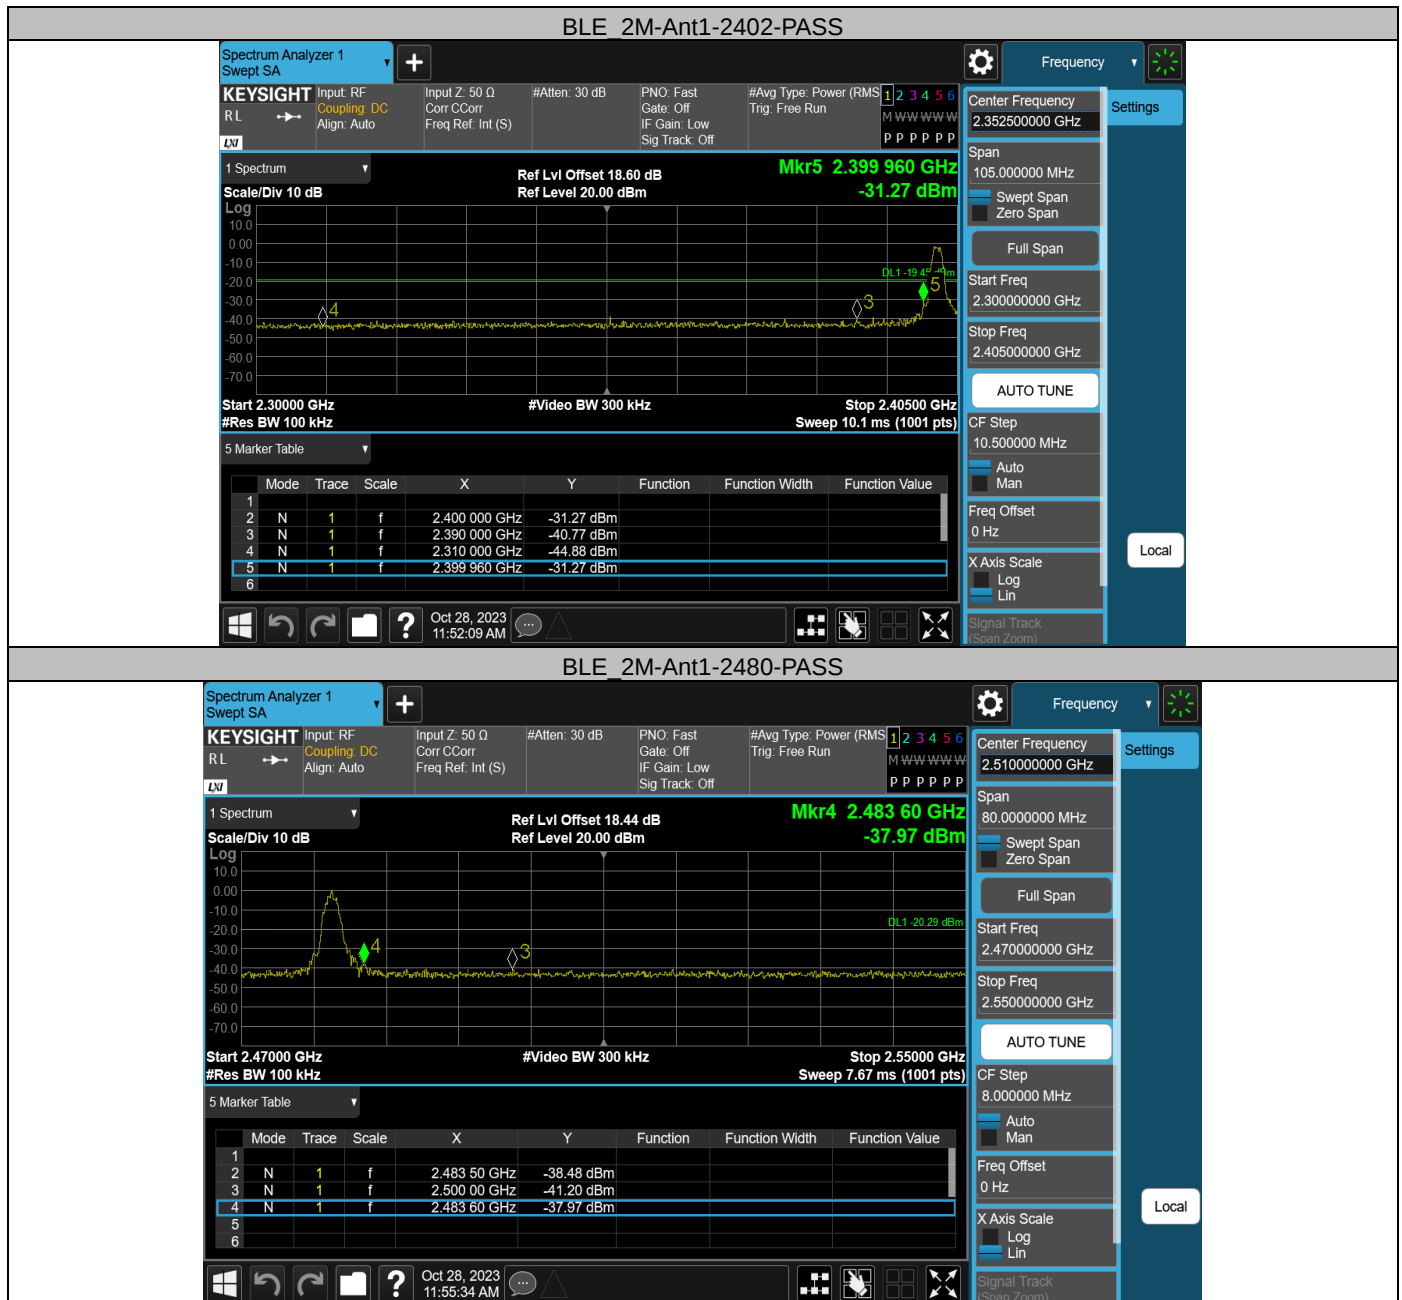
## Test Graphs

| TestMode | Antenna | ChName | Frequency[MHz] | RefLevel[dBm] | Result[dBm] | Limit[dBm] | Verdict |
| BLE_1M | Ant1 | Low | 2402 | 0.78 | -35.08 | $\leq -19.22$ | PASS |
| BLE_1M | Ant1 | High | 2480 | -0.07 | -39.69 | $\leq -20.07$ | PASS |
| BLE_2M | Ant1 | Low | 2402 | 0.55 | -31.27 | $\leq -19.45$ | PASS |
| BLE_2M | Ant1 | High | 2480 | -0.29 | -37.97 | $\leq -20.29$ | PASS |

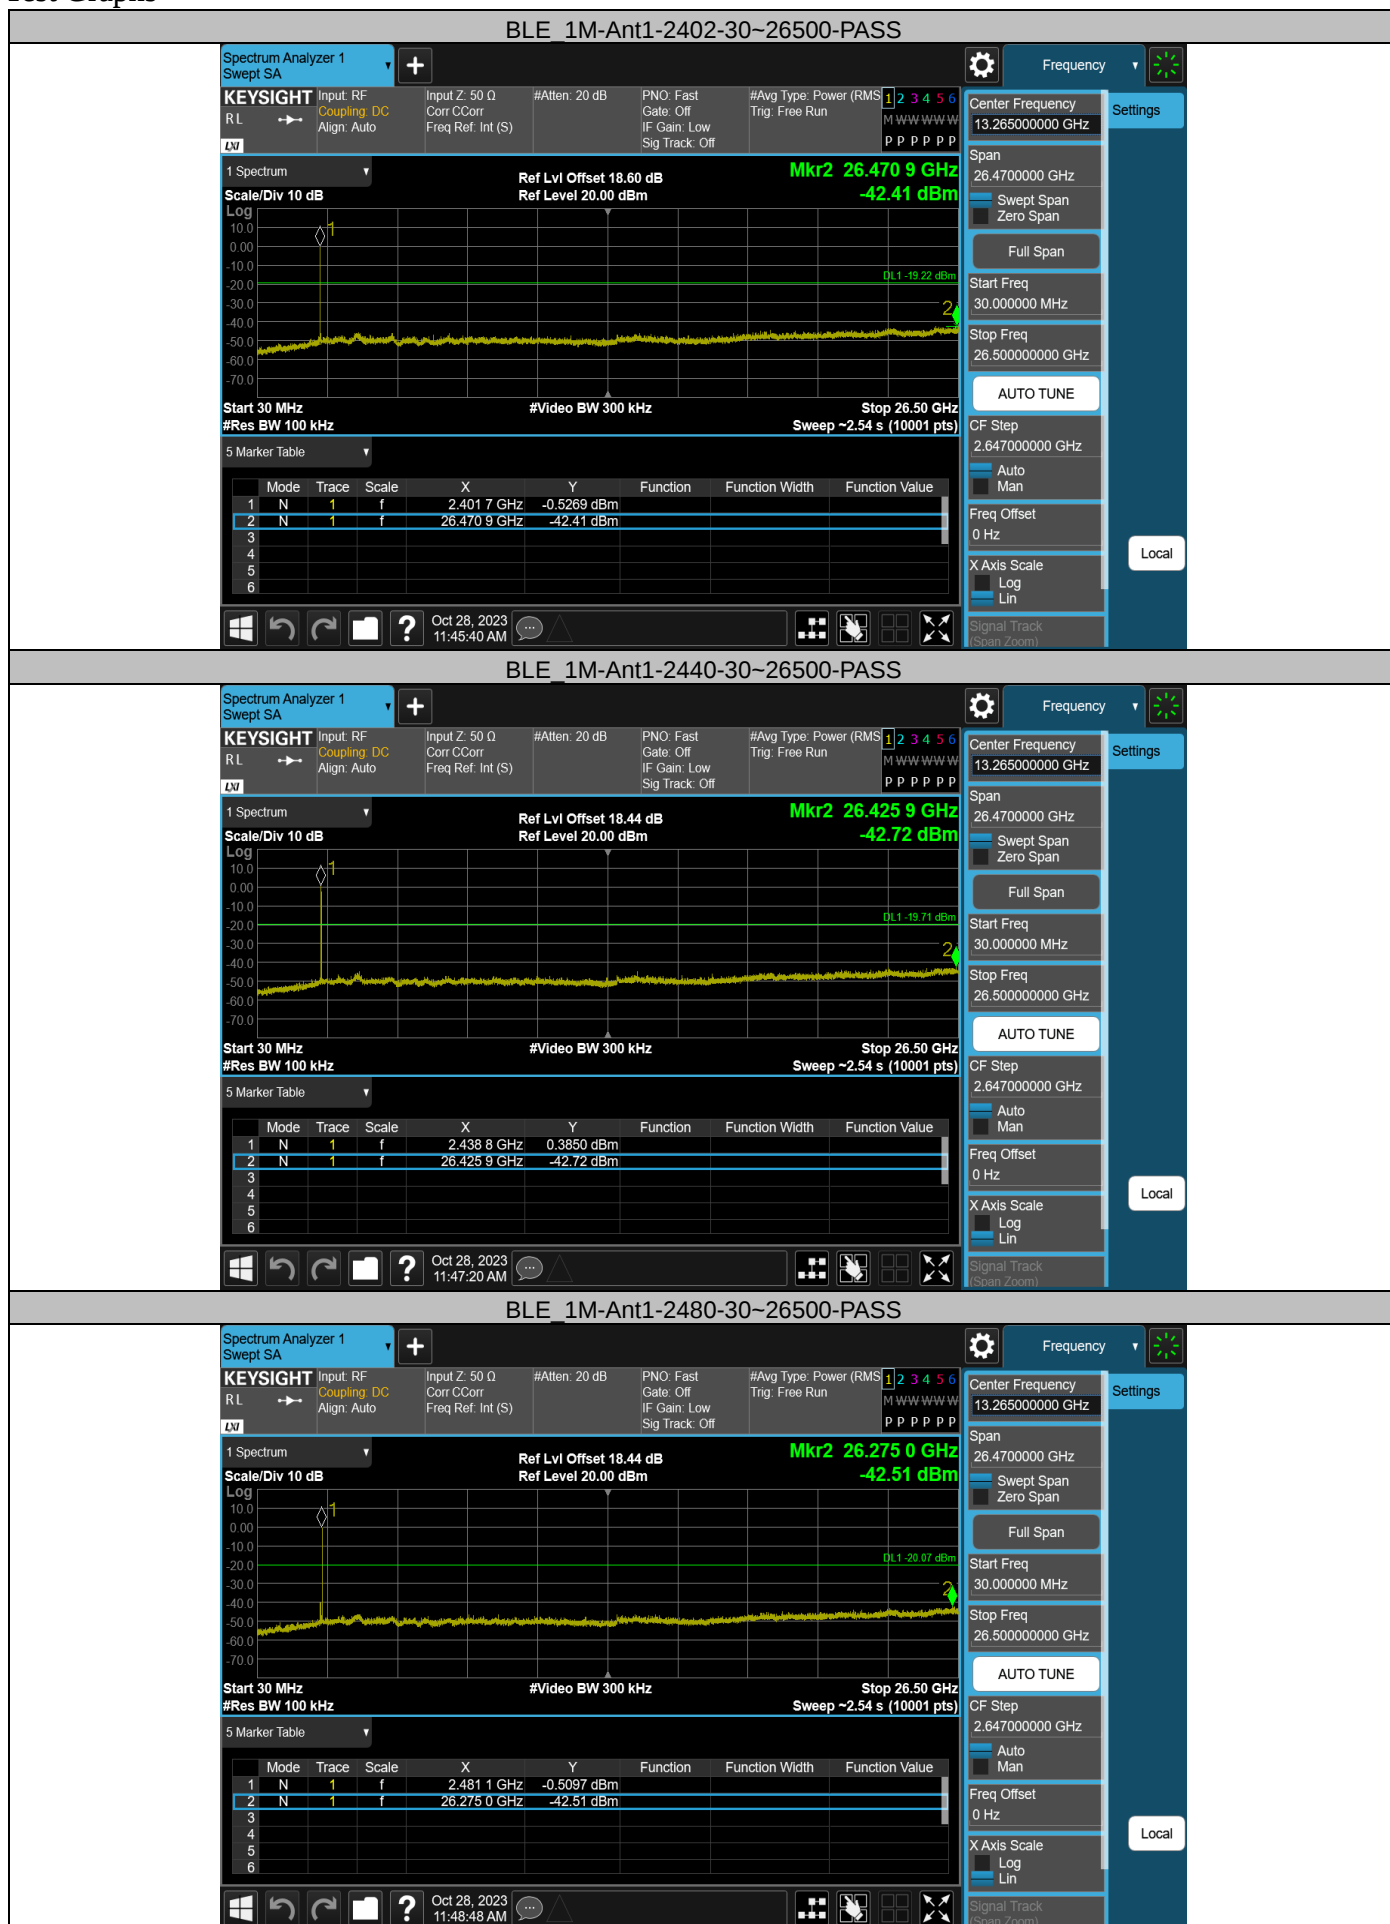
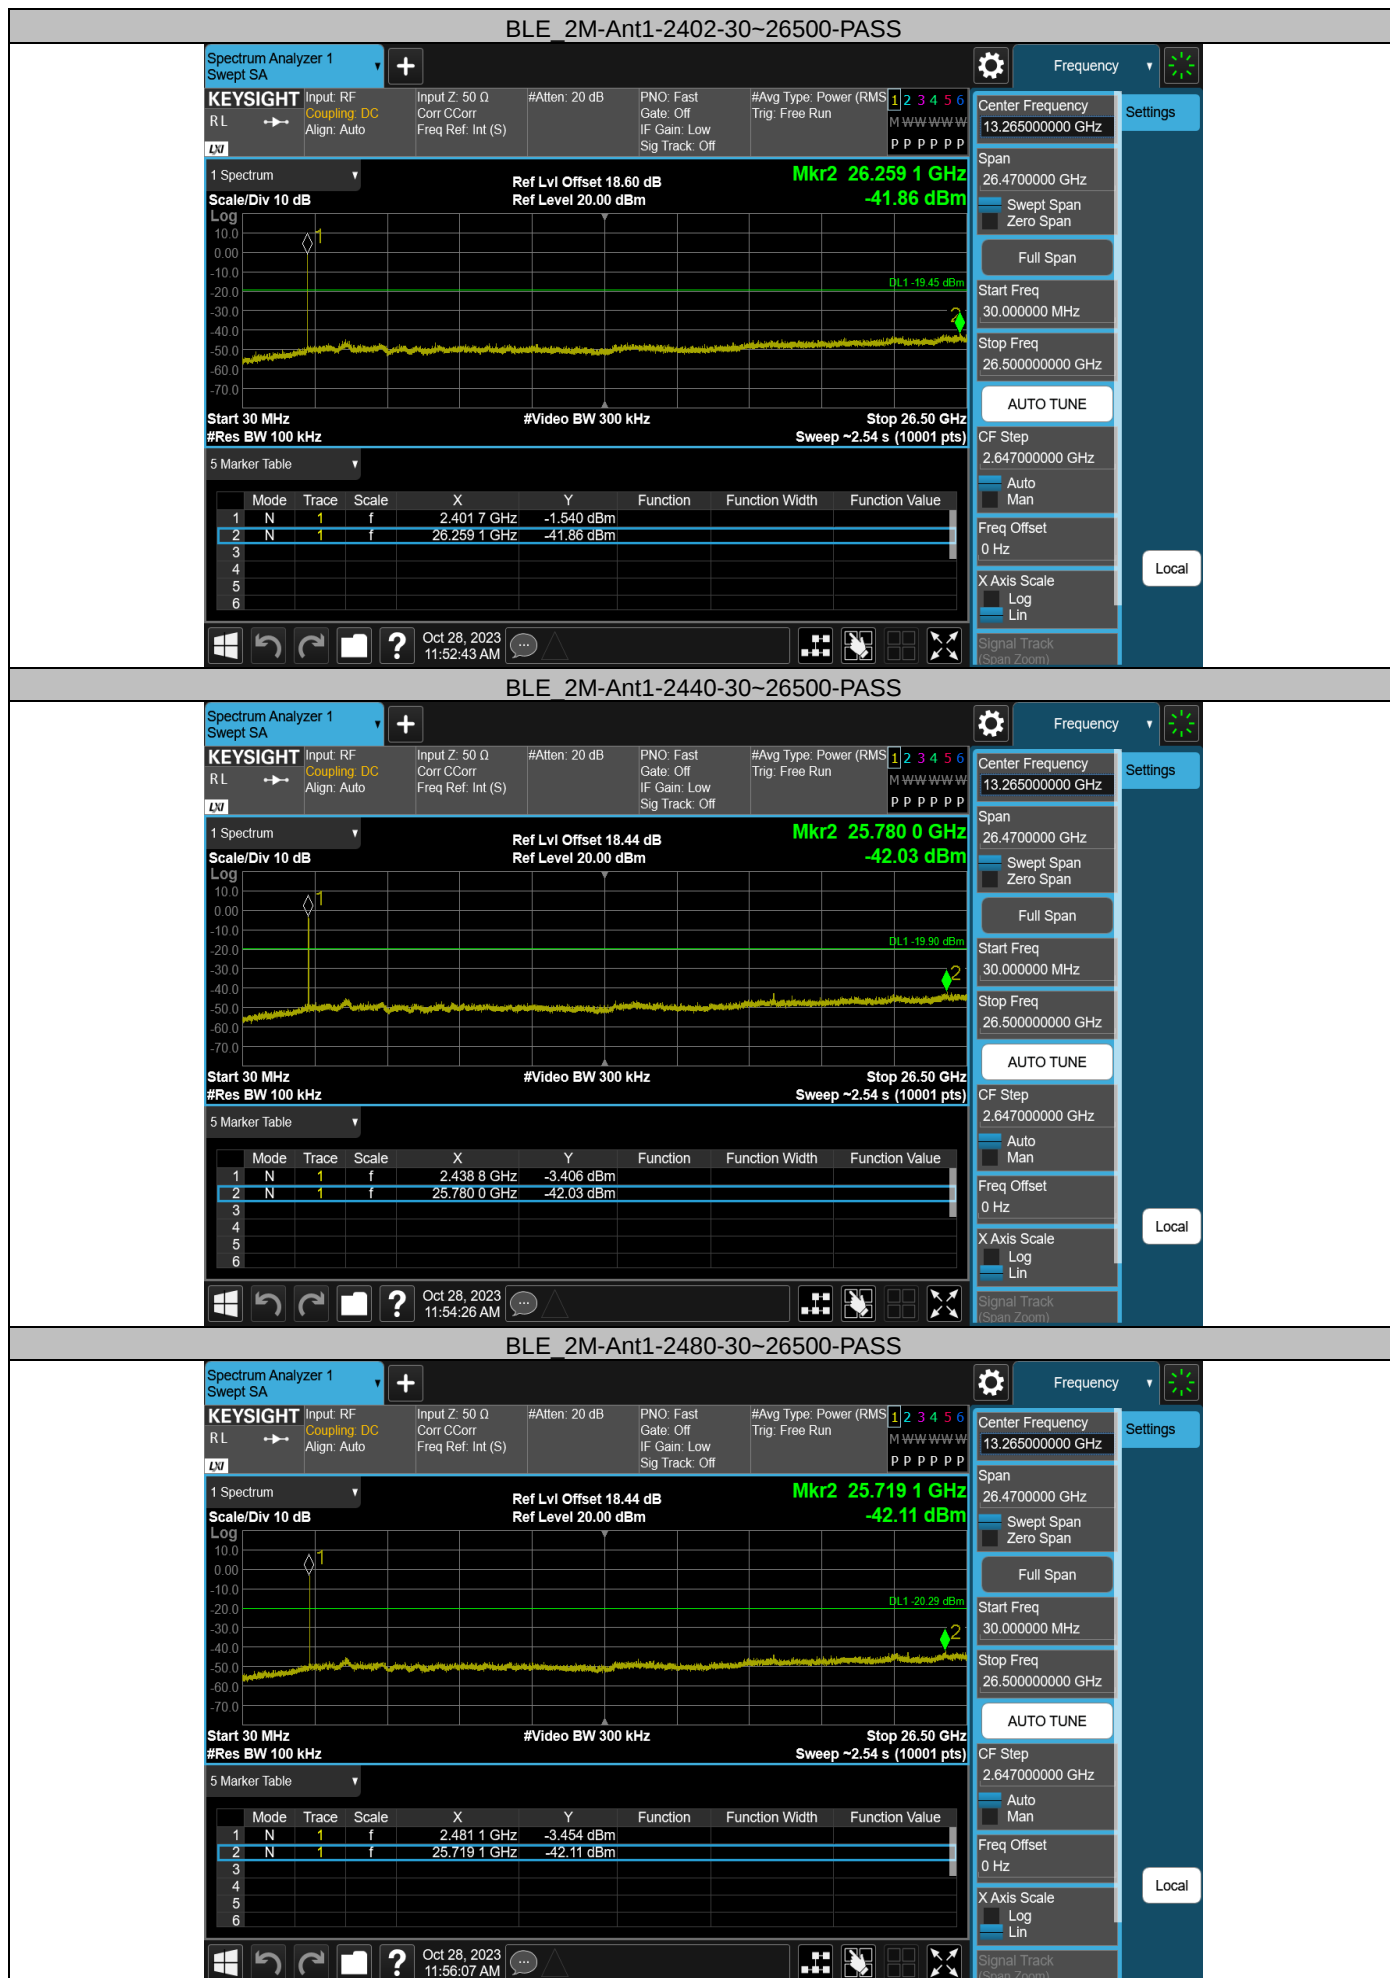
## Test Graphs

| TestMode | Antenna | Frequency[MHz] | FreqRange<br>[MHz] | RefLevel<br>[dBm] | Result[dBm] | Limit[dBm] | Verdict |
| BLE_1M | Ant1 | 2402 | 30~26500 | 0.78 | -42.41 | ≤-19.22 | PASS |
| BLE_1M | Ant1 | 2440 | 30~26500 | 0.29 | -42.72 | ≤-19.71 | PASS |
| BLE_1M | Ant1 | 2480 | 30~26500 | -0.07 | -42.51 | ≤-20.07 | PASS |
| BLE_2M | Ant1 | 2402 | 30~26500 | 0.55 | -41.87 | ≤-19.45 | PASS |
| BLE_2M | Ant1 | 2440 | 30~26500 | 0.10 | -42.03 | ≤-19.9 | PASS |
| BLE_2M | Ant1 | 2480 | 30~26500 | -0.29 | -42.11 | ≤-20.29 | PASS |

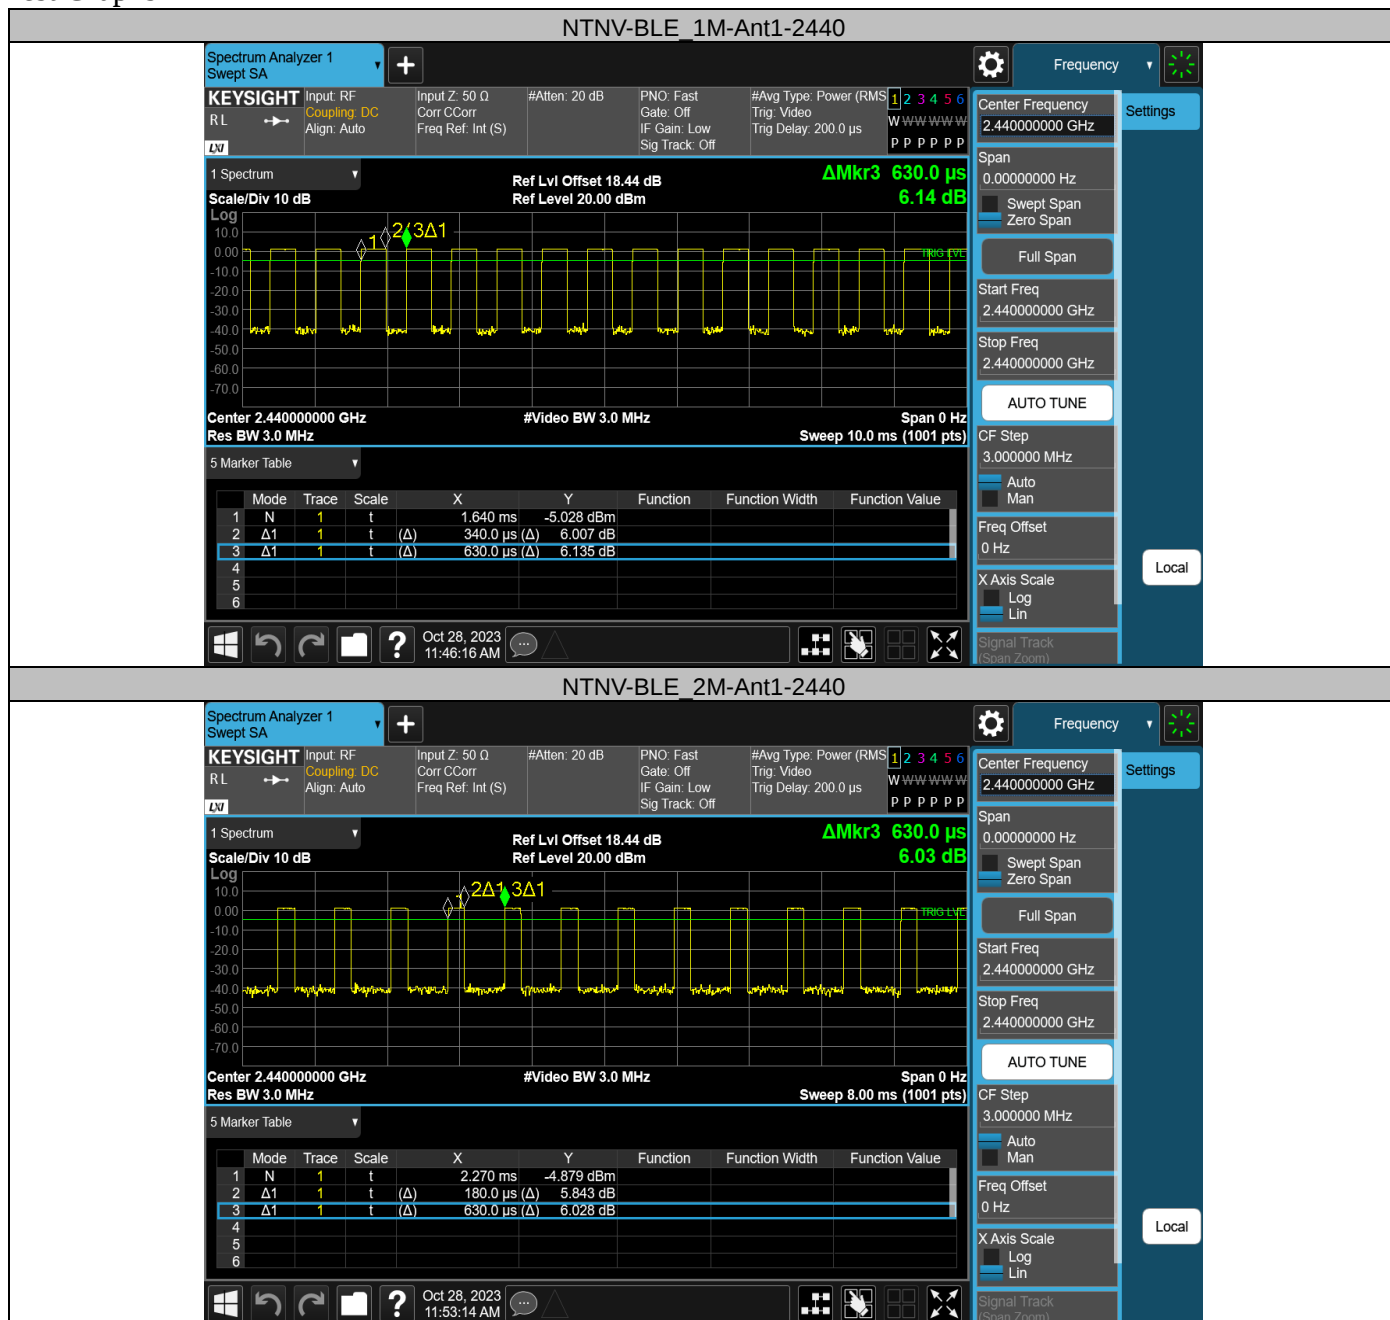
## Test Graphs

| TestMode | Antenna | Frequency[MHz] | ON Time<br>[ms] | Period<br>[ms] | Duty Cycle<br>[%] | Duty Cycle<br>Factor[dB] |
| BLE_1M | Ant1 | 2440 | 0.34 | 0.63 | 53.97 | 2.68 |
| BLE_2M | Ant1 | 2440 | 0.18 | 0.63 | 28.57 | 5.44 |

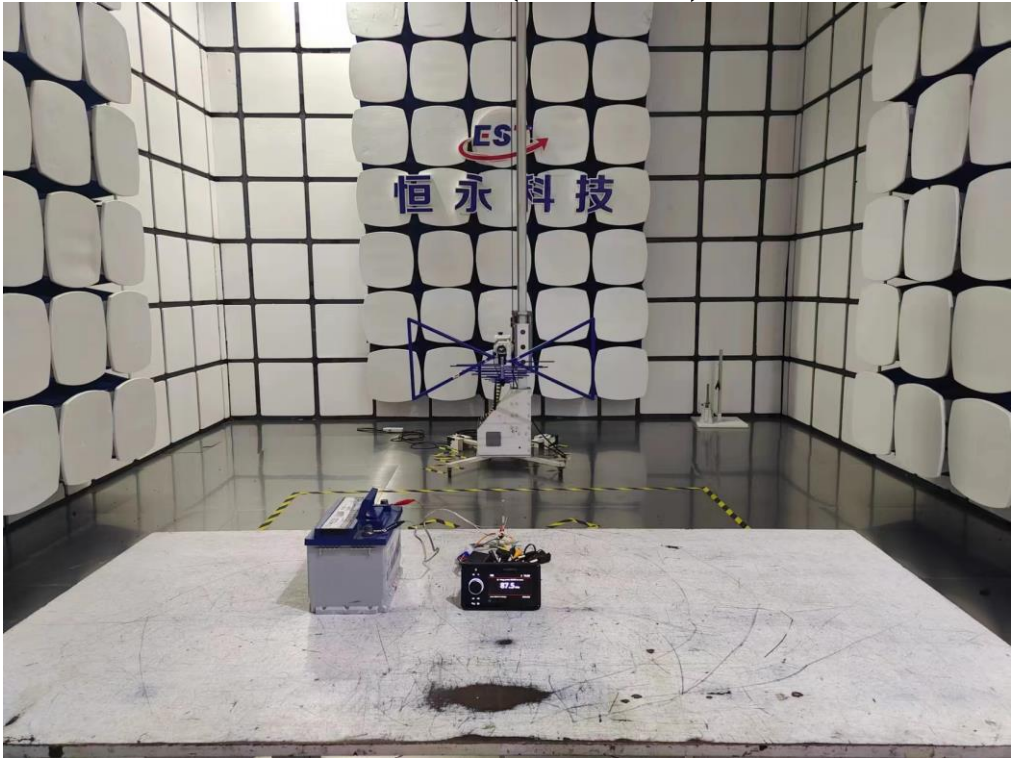
Radiated Test (Below 1GHz)

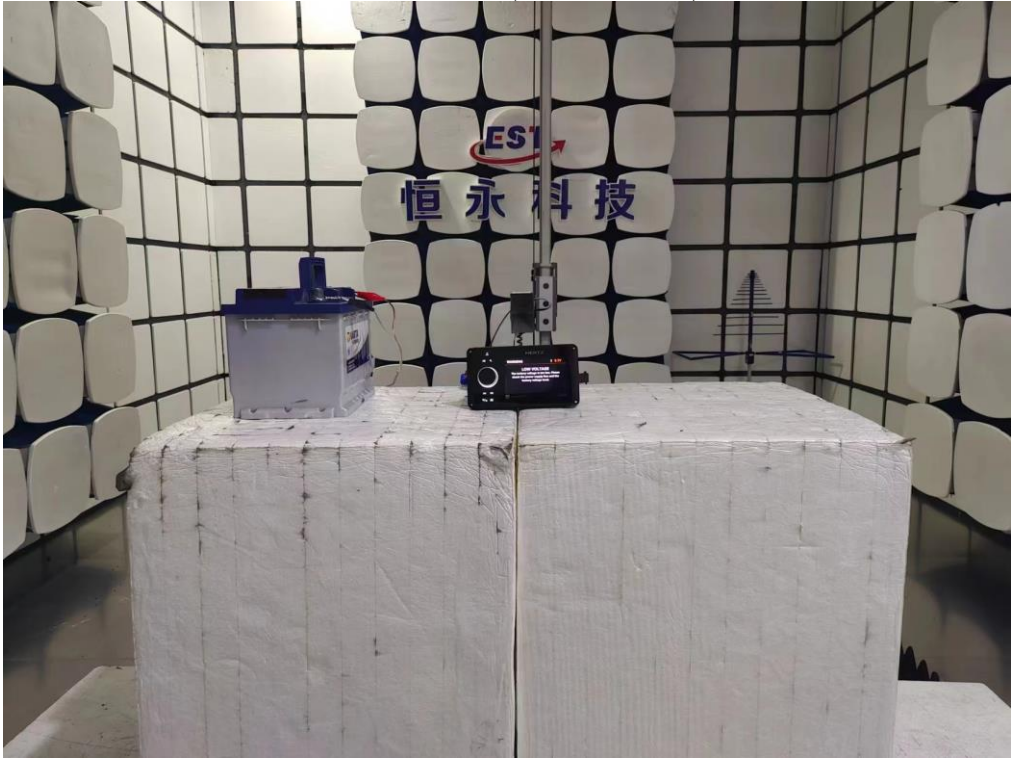
Radiated Test (Above 1GHz)

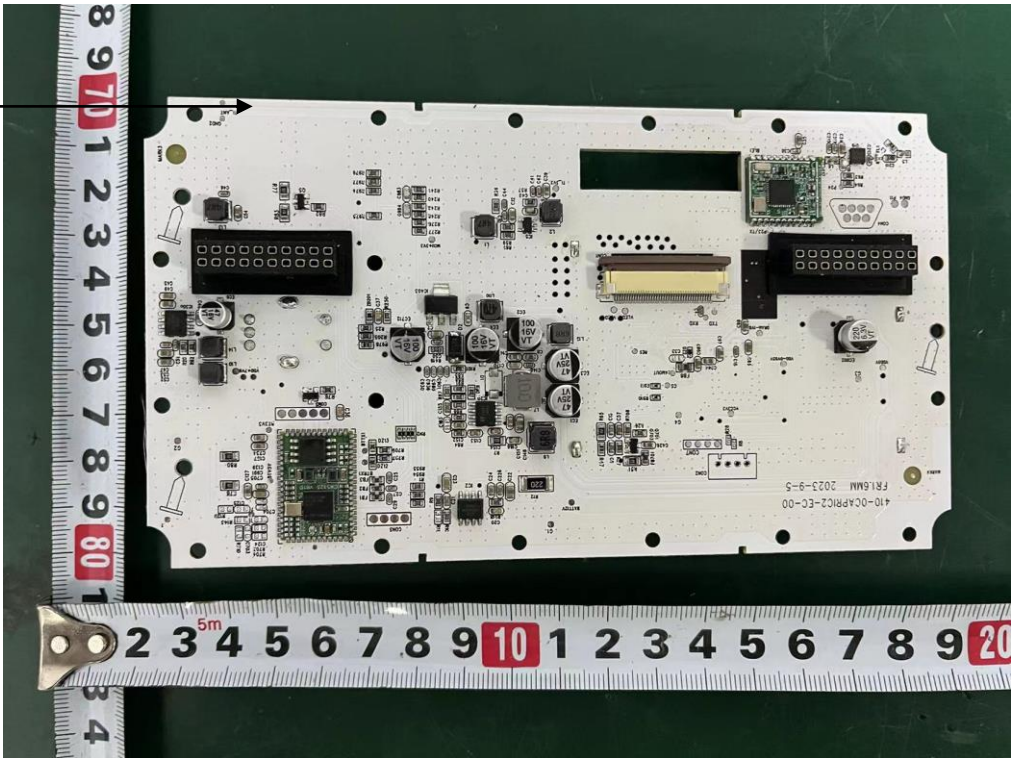
BLE  
Antenna
