Radiated Emission Measurement

Condition : FCC\_part 15E RE\_Above 1GHz\_PK

EUT : W6M22409-23739

Test Mode : TX 802.11a CH149

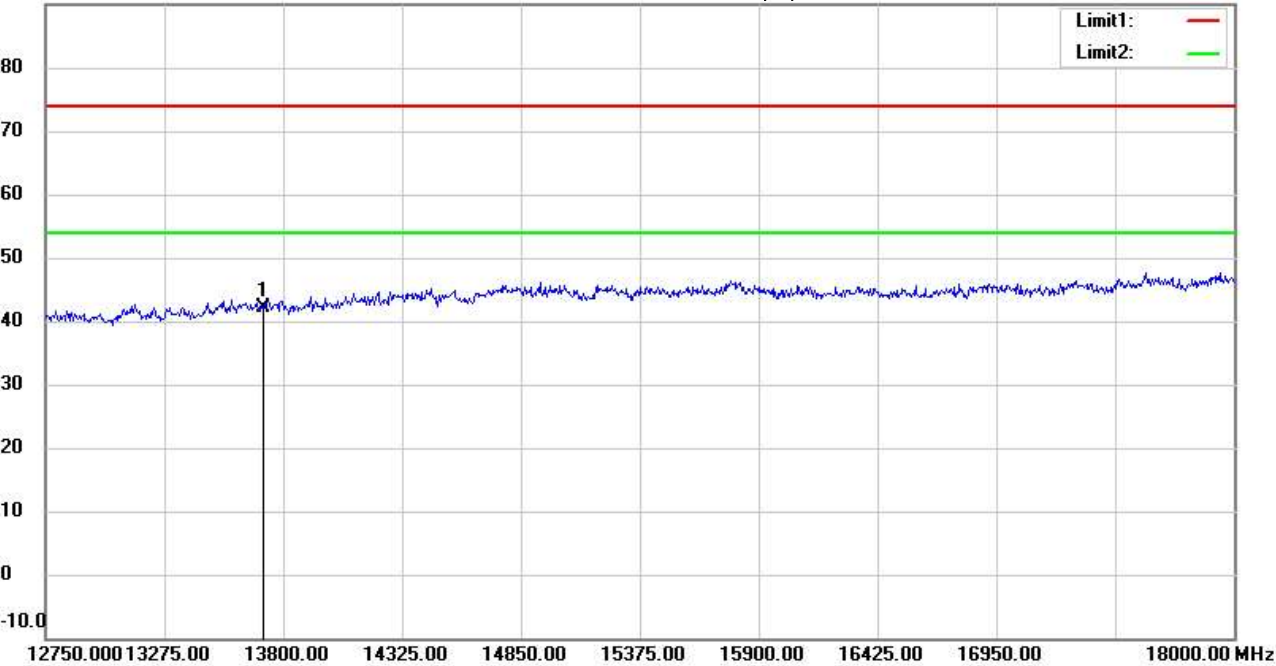
Site : 966A Chamber  
Condition : FCC\_part 15E RE\_Above 1GHz\_PK  
EUT : W6M22409-23739  
M/N:  
Test Mode : TX 802.11a CH181  
Note :

Polarization: **Horizontal**  
Power : 120 Va.c.  
Distance: 3m

| Mk. | Frequency (MHz) | Reading (dBuV) | Detector | Corr. factor (dB/m) | Result (dBuV/m) | Limit (dBuV/m) | Ant.Pos (cm) | Tab.Pos (deg.) | Margin (dB) | Comment |
|---|---|---|---|---|---|---|---|---|---|---|
| * | 13710.000 | 22.09 | peak | 20.03 | 42.12 | 74.00 | 150 | 65 | -31.88 | |

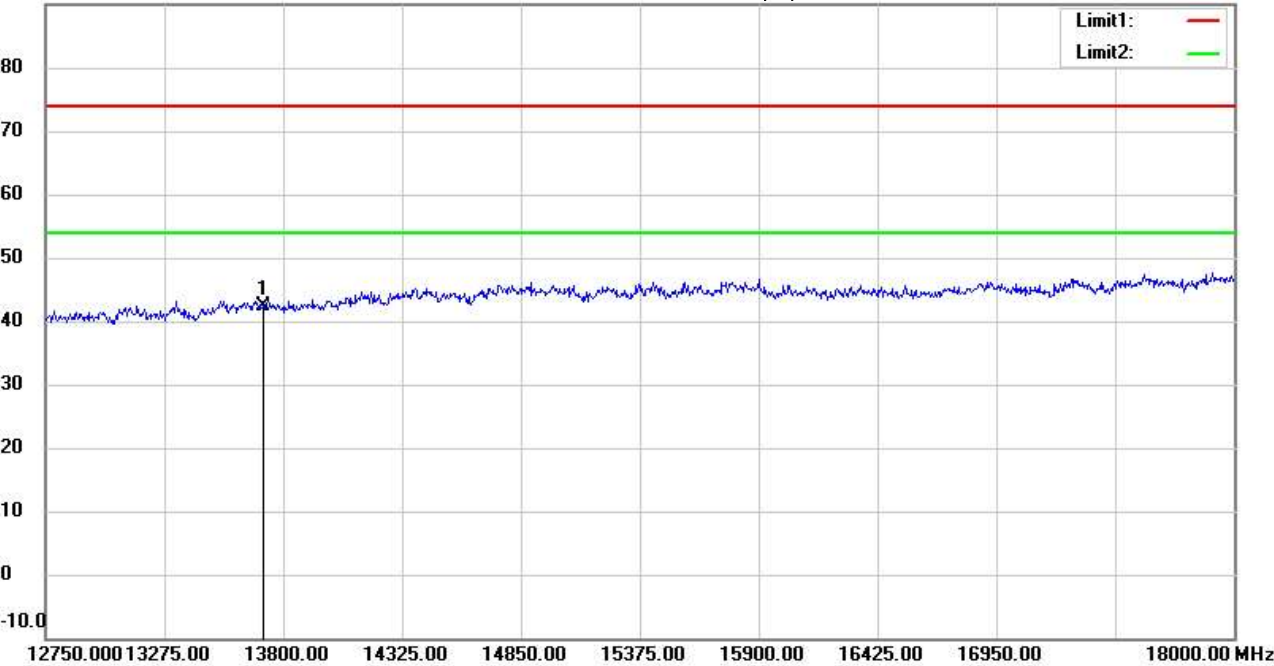
Site : 966A Chamber  
Condition : FCC\_part 15E RE\_Above 1GHz\_PK  
EUT : W6M22409-23739  
M/N:  
Test Mode : TX 802.11a CH181  
Note :

Polarization: Vertical  
Power : 120 Va.c.  
Distance: 3m

| Mk. | Frequency (MHz) | Reading (dBuV) | Detector | Corr. factor (dB/m) | Result (dBuV/m) | Limit (dBuV/m) | Ant.Pos (cm) | Tab.Pos (deg.) | Margin (dB) | Comment |
|---|---|---|---|---|---|---|---|---|---|---|
| * | 13710.000 | 22.31 | peak | 20.03 | 42.34 | 74.00 | 150 | 143 | -31.66 | |

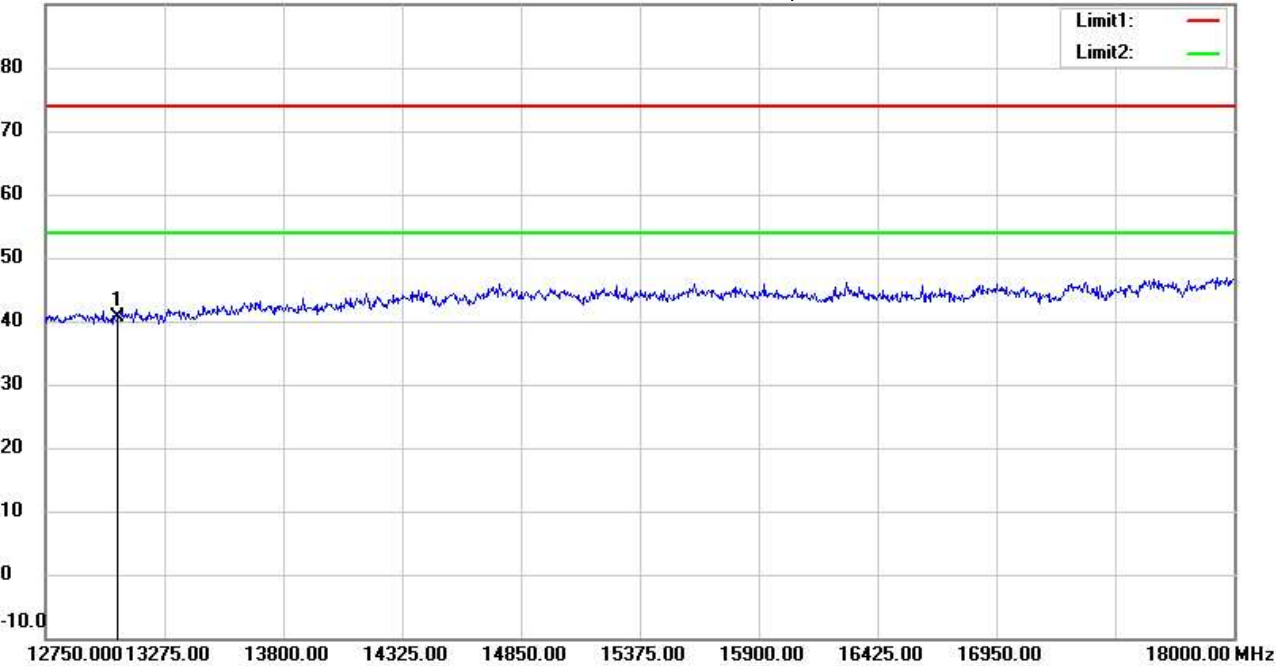
Test Mode : TX 802.11ax20 CH117

Polarization: **Horizontal**

| Mk. | Frequency (MHz) | Reading (dBuV) | Detector | Corr. factor (dB/m) | Result (dBuV/m) | Limit (dBuV/m) | Ant.Pos (cm) | Tab.Pos (deg.) | Margin (dB) | Comment |
|---|---|---|---|---|---|---|---|---|---|---|
| * | 13070.000 | 23.41 | peak | 17.21 | 40.62 | 74.00 | 150 | 149 | -33.38 | |
