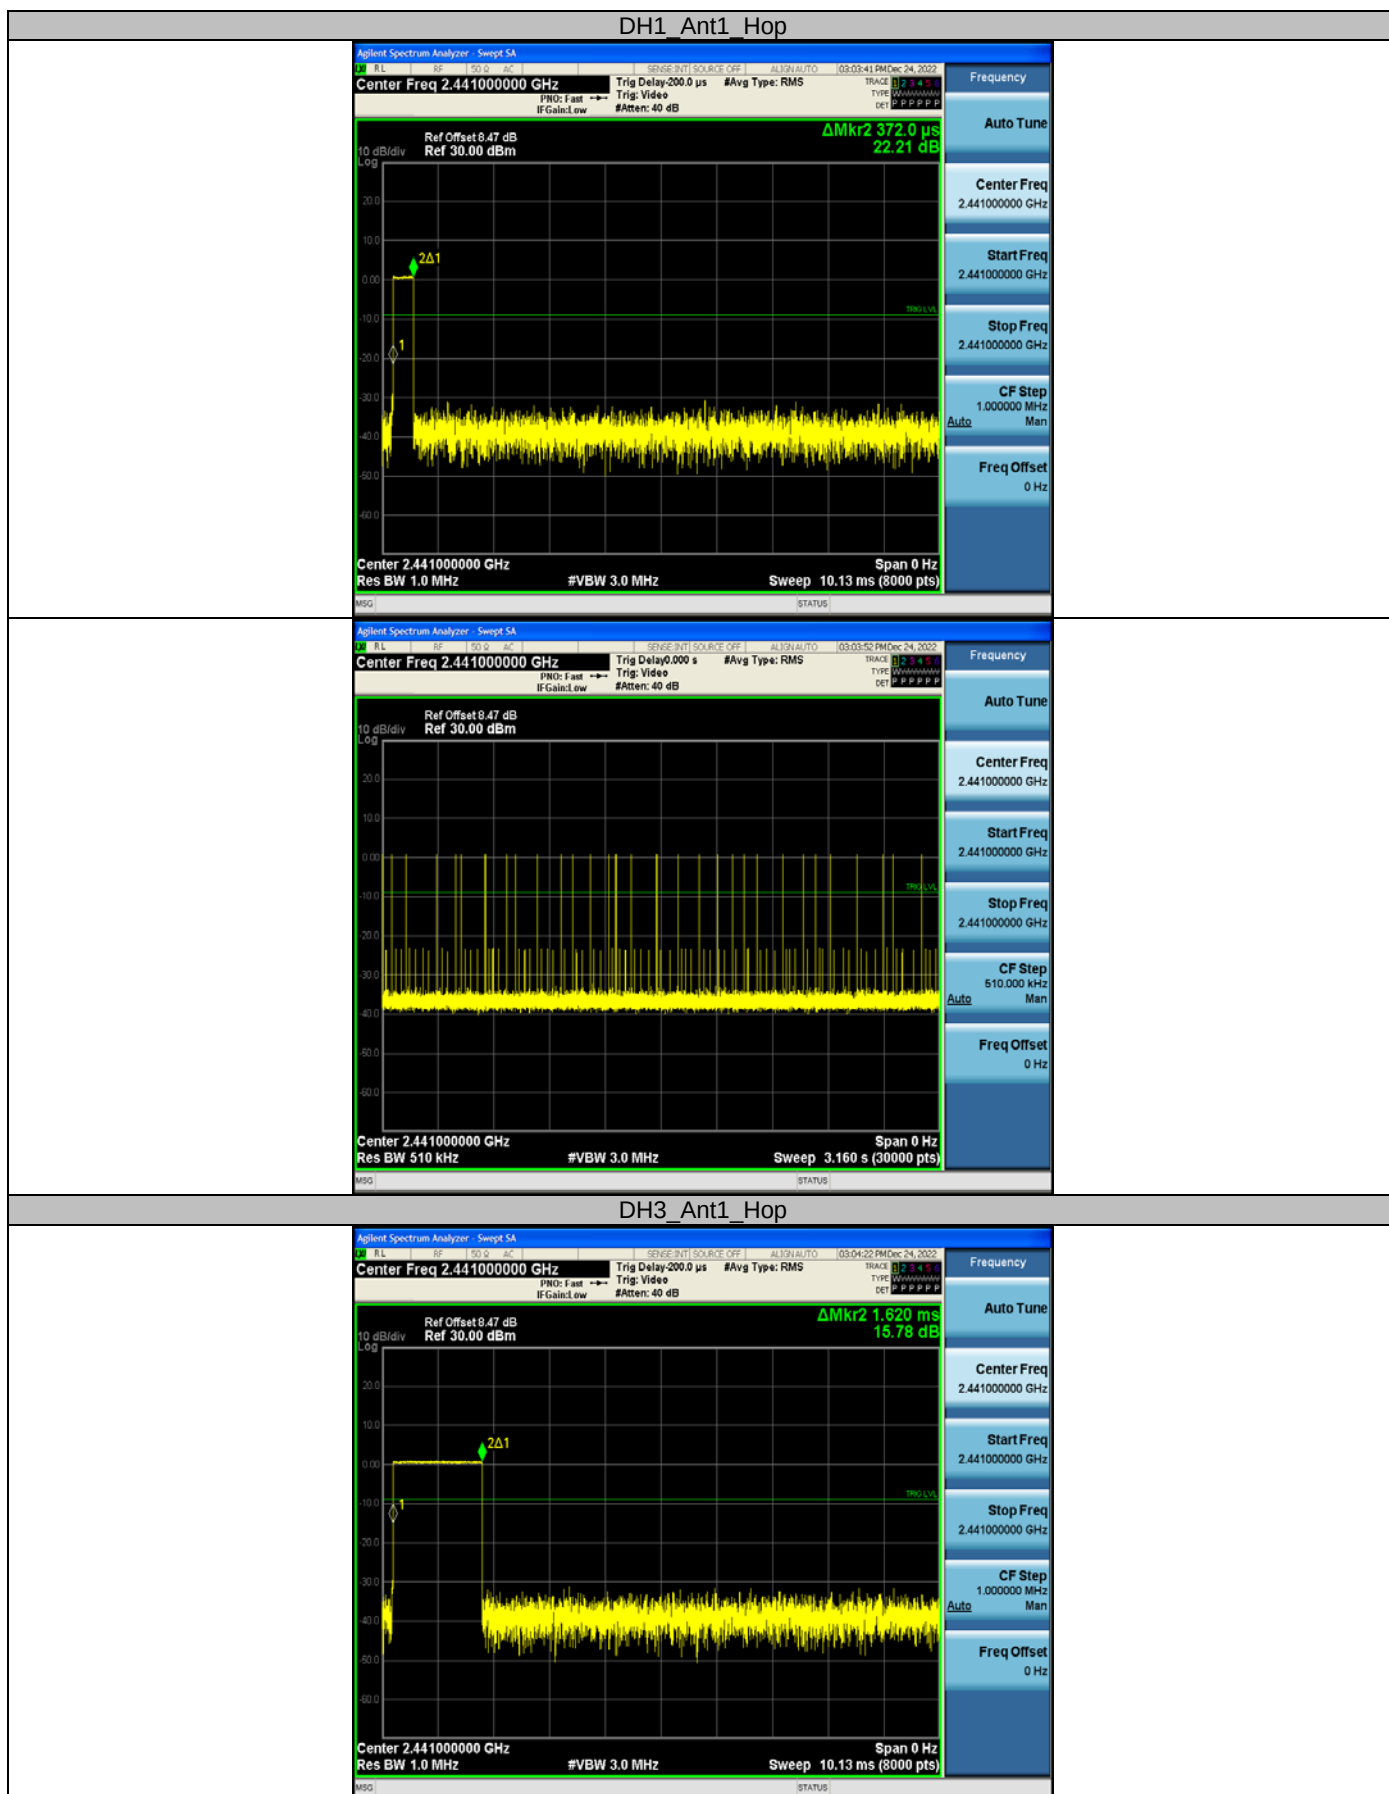
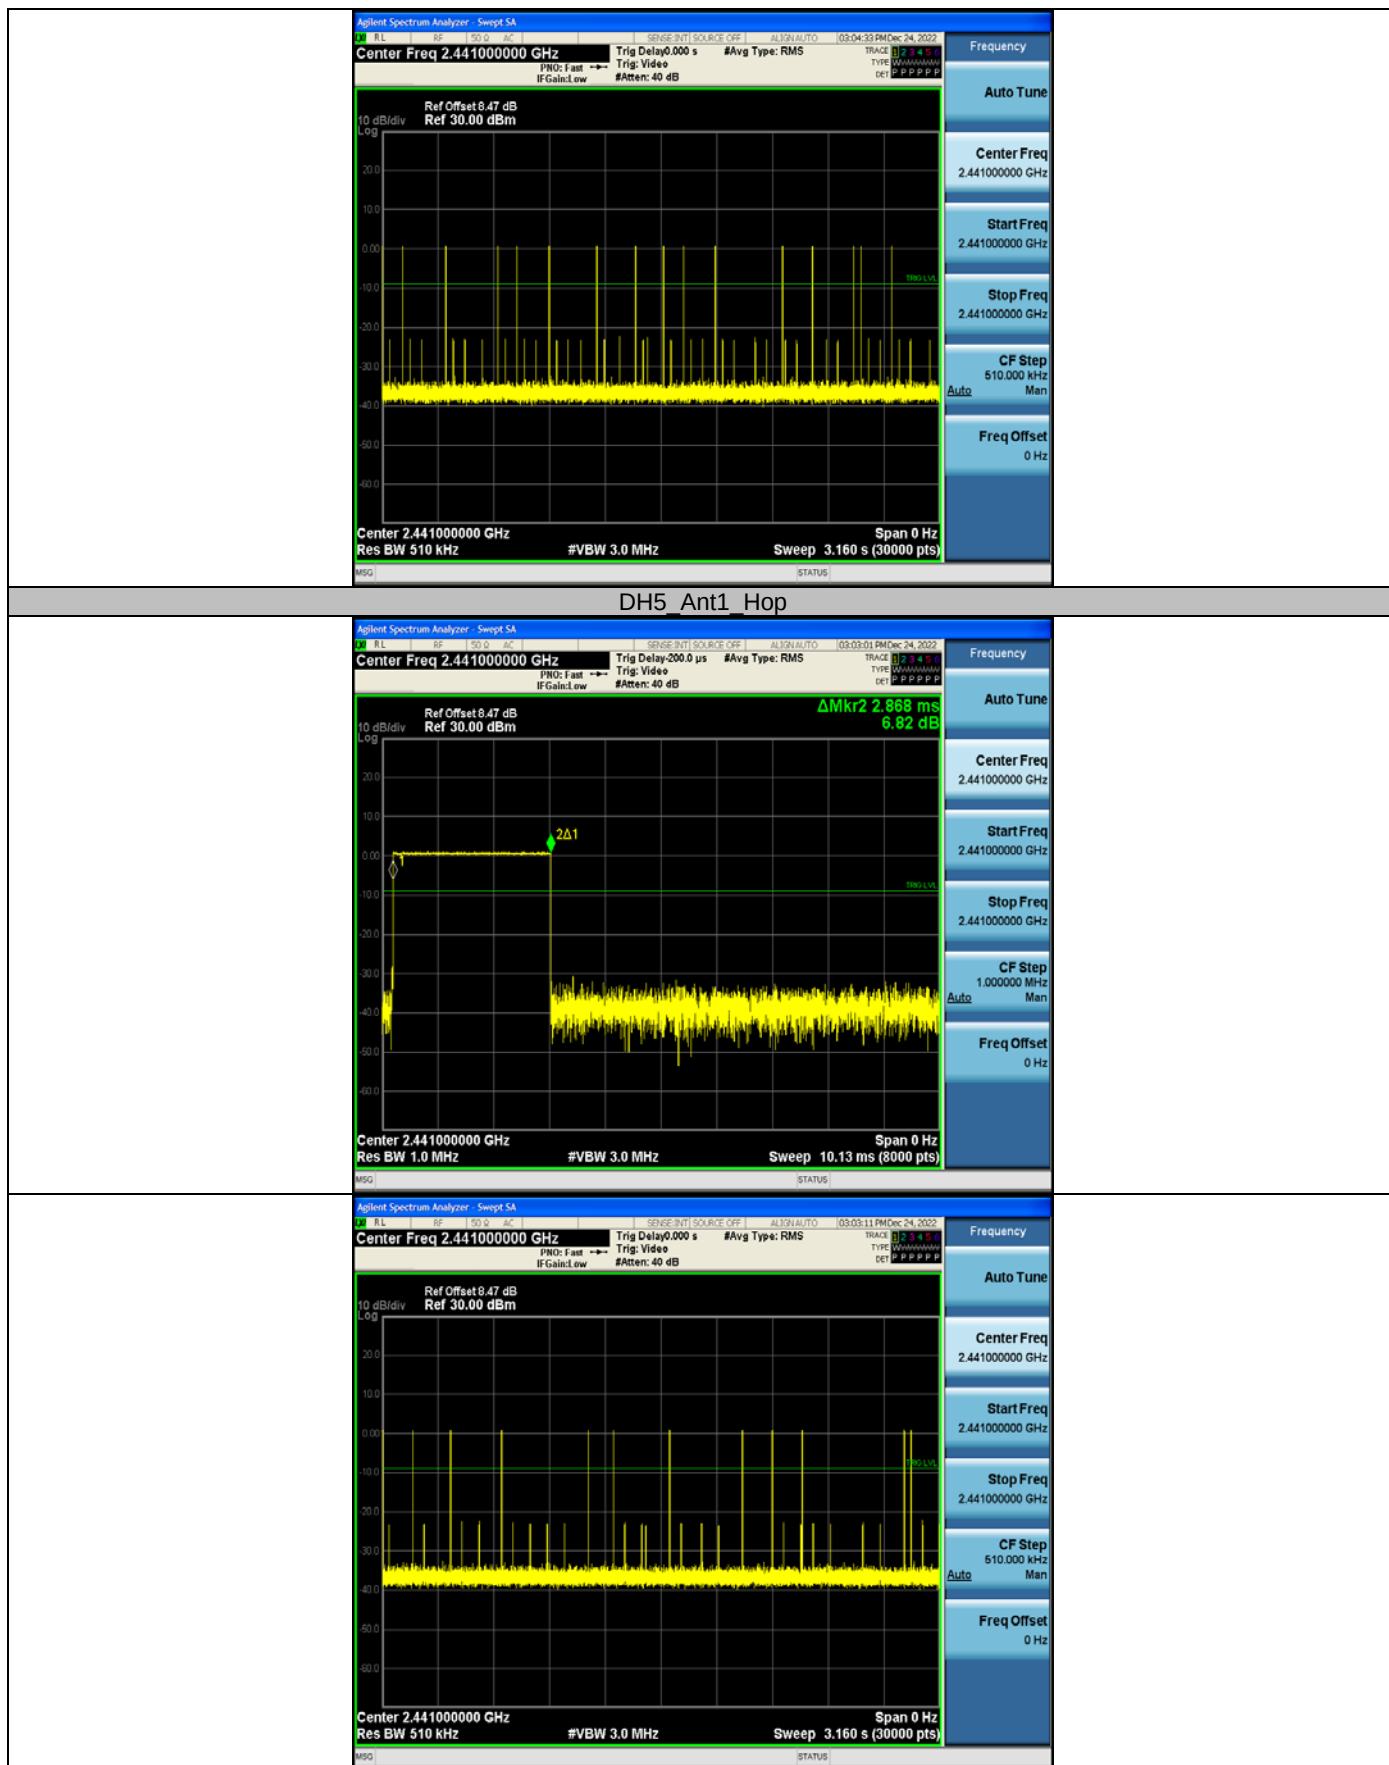
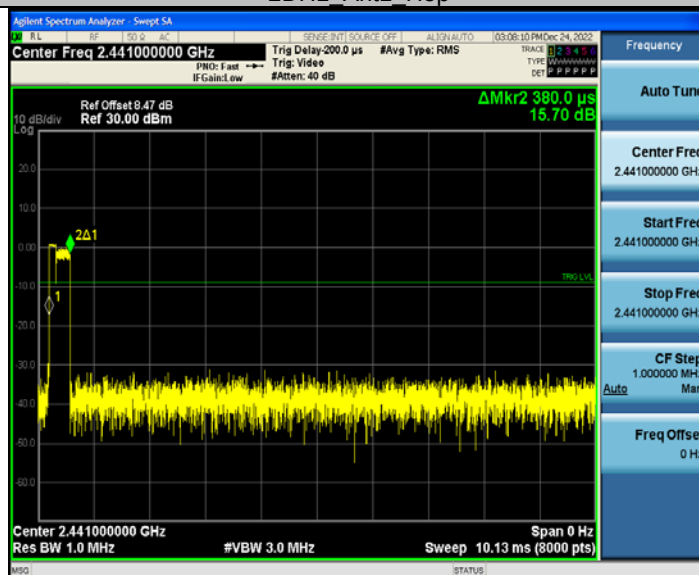
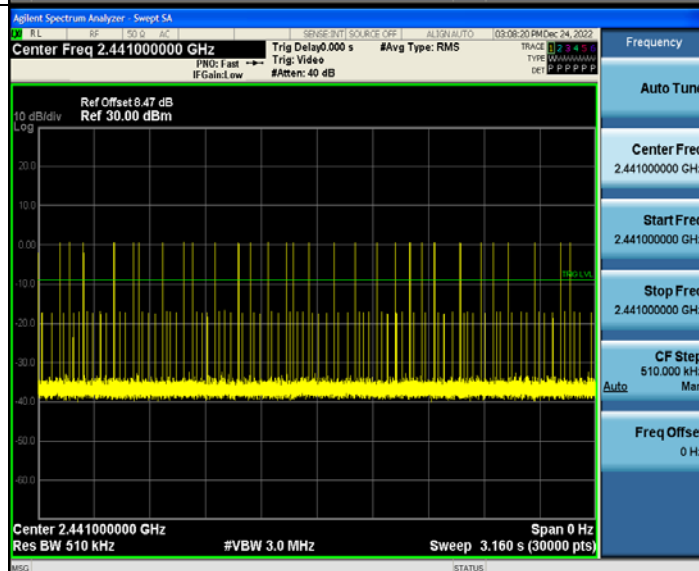
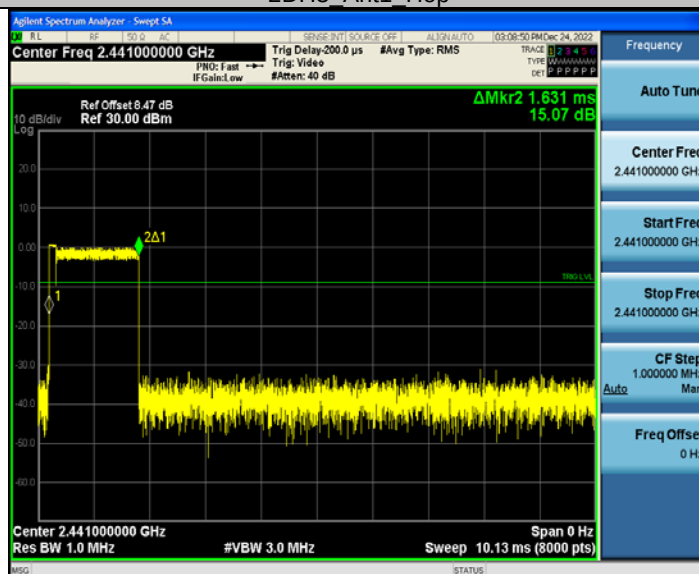
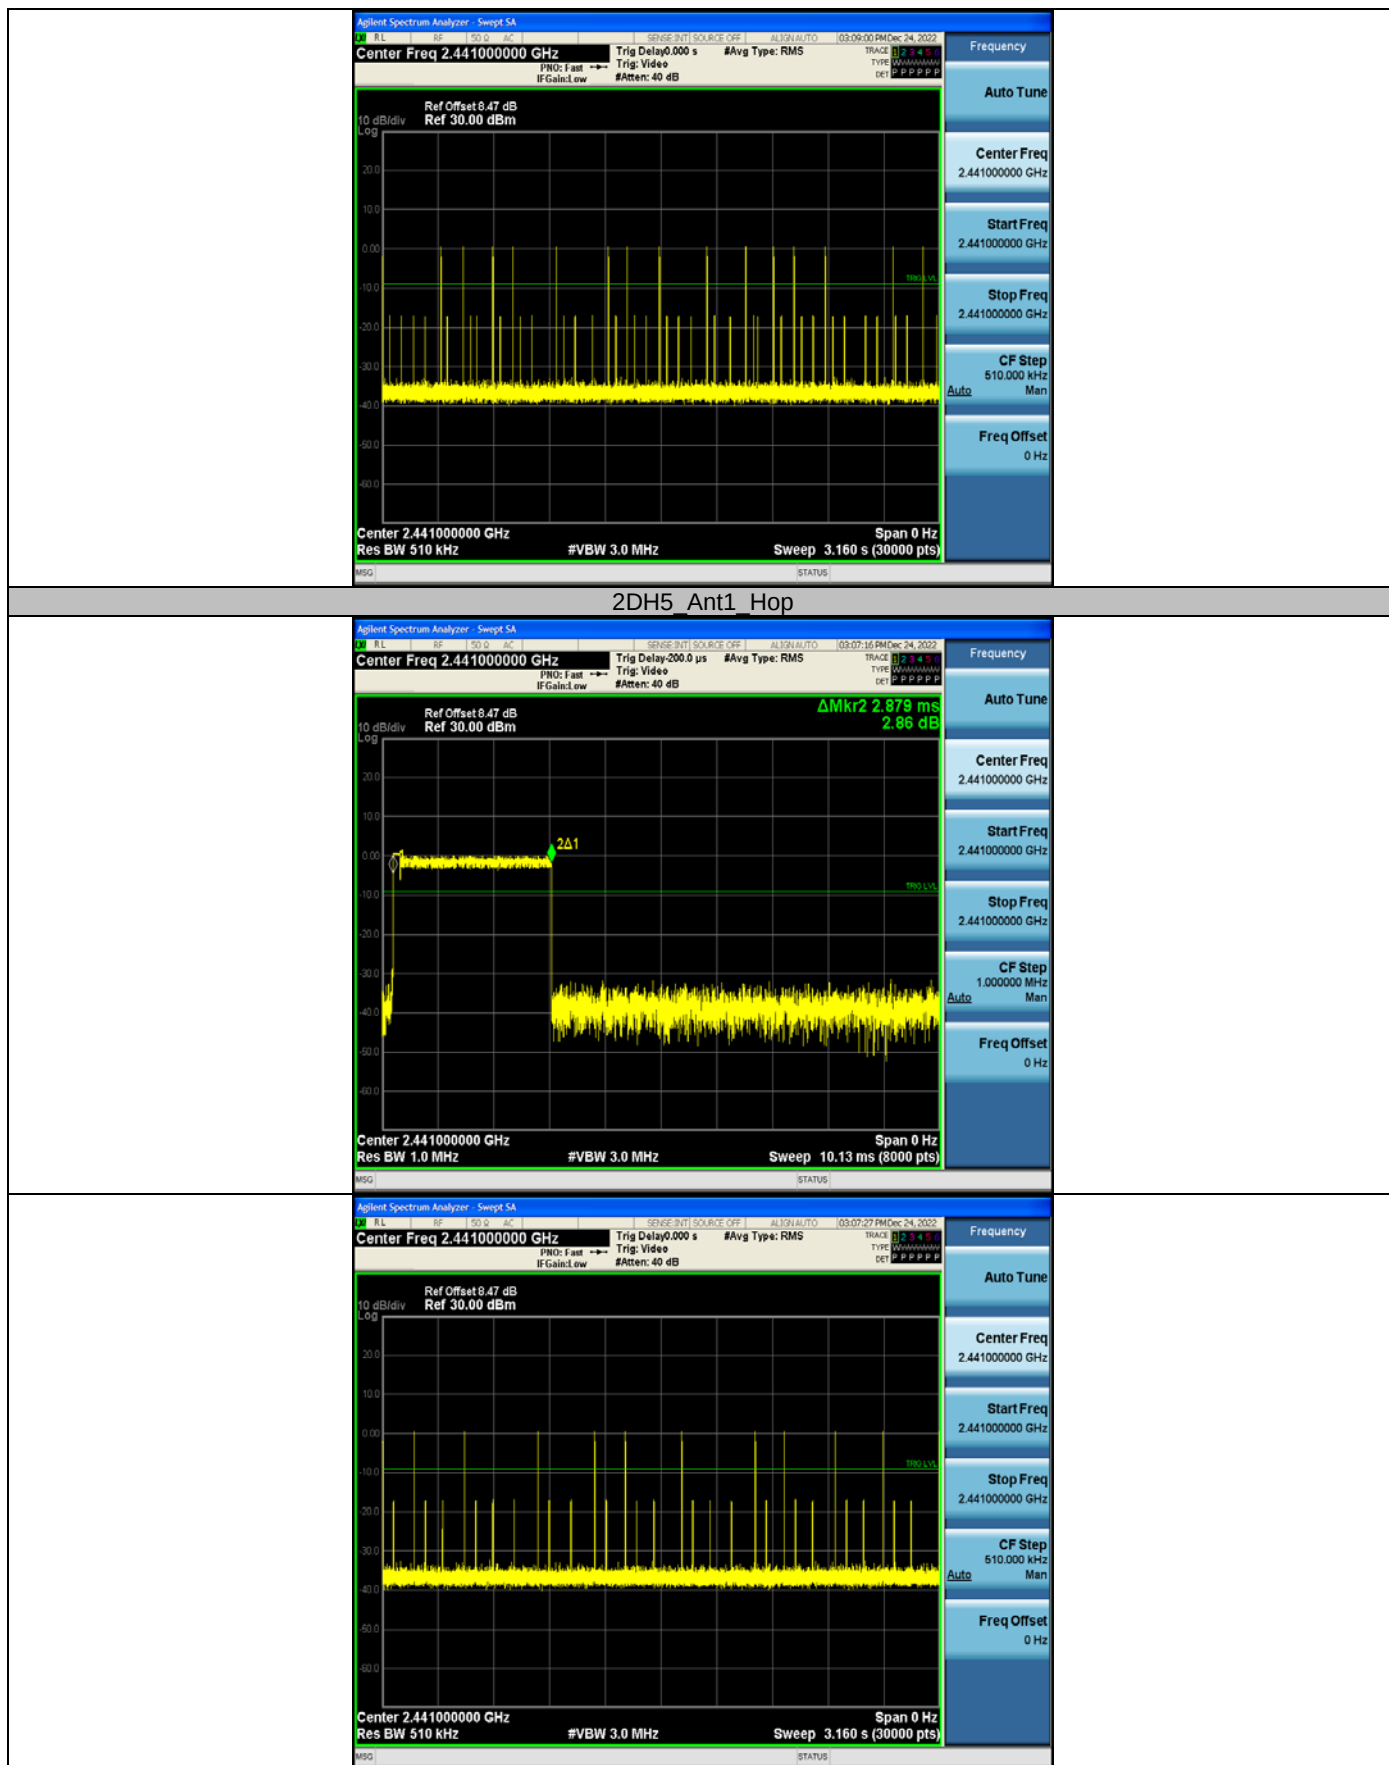
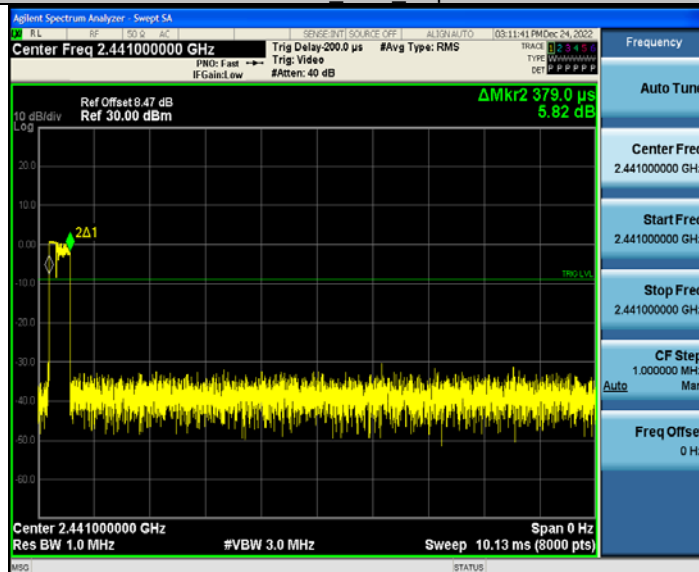
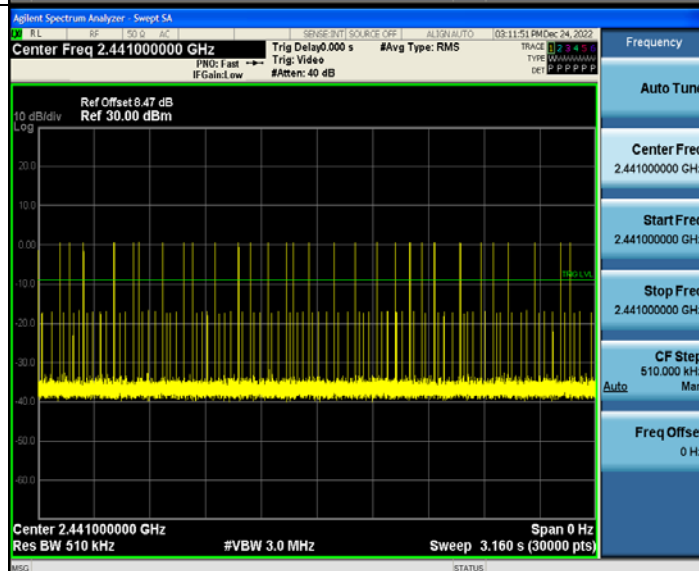
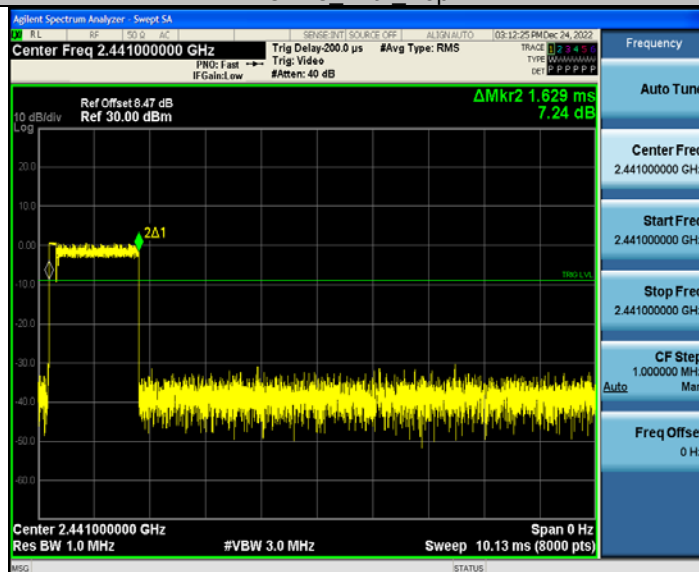
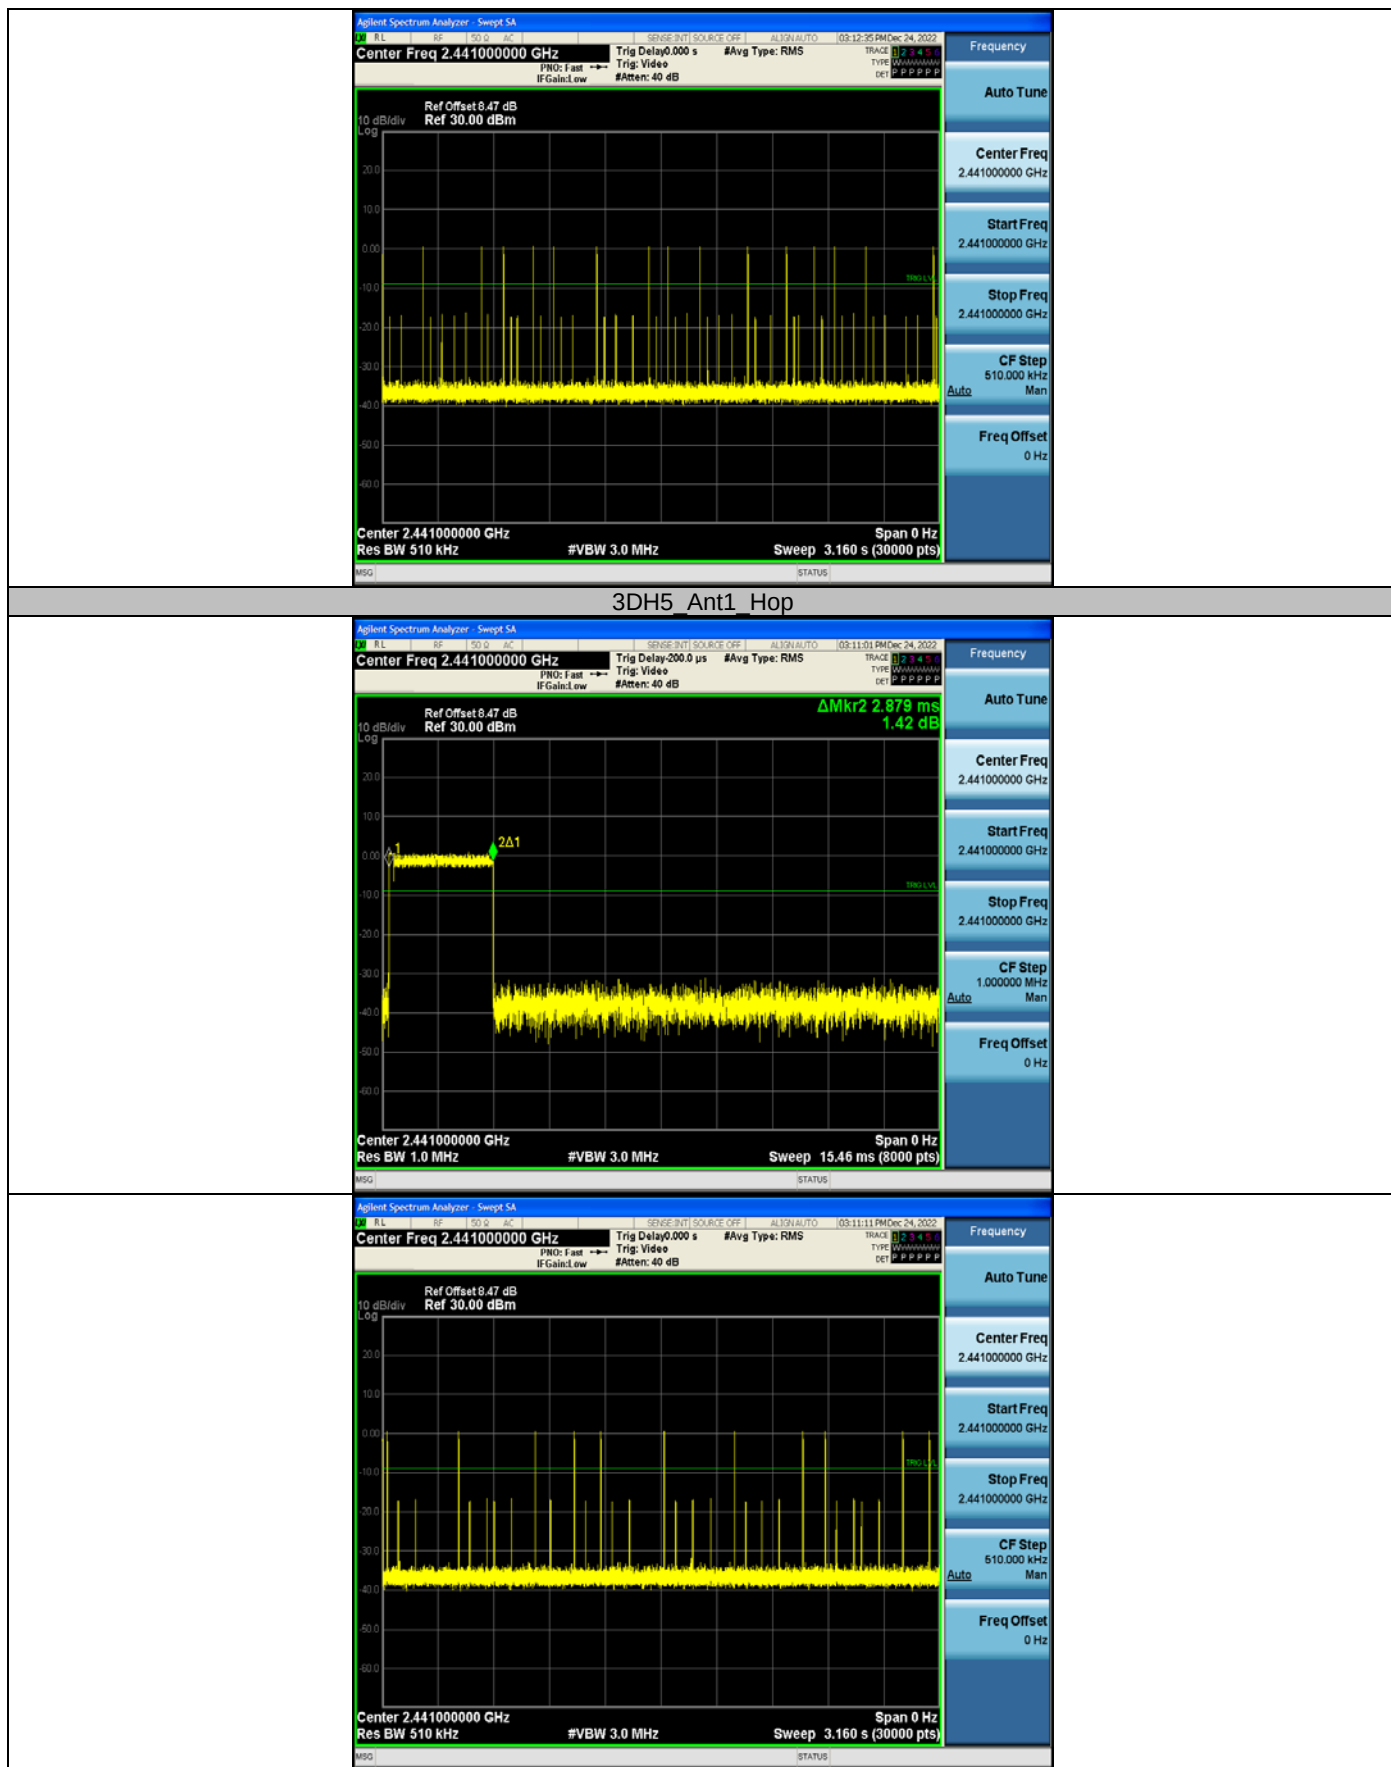
| Test Mode | Antenna | Frequency [MHz] | BurstWidth [ms] | Hops in 3.16s [Num] | Result [s] | Limit [s] | Verdict |
| DH1 | Ant1 | Hop | 0.372 | 32 | 0.119 | ≤0.4 | PASS |
| DH3 | Ant1 | Hop | 1.620 | 16 | 0.259 | ≤0.4 | PASS |
| DH5 | Ant1 | Hop | 2.868 | 12 | 0.344 | ≤0.4 | PASS |
| 2DH1 | Ant1 | Hop | 0.380 | 32 | 0.122 | ≤0.4 | PASS |
| 2DH3 | Ant1 | Hop | 1.631 | 16 | 0.261 | ≤0.4 | PASS |
| 2DH5 | Ant1 | Hop | 2.879 | 11 | 0.317 | ≤0.4 | PASS |
| 3DH1 | Ant1 | Hop | 0.379 | 32 | 0.121 | ≤0.4 | PASS |
| 3DH3 | Ant1 | Hop | 1.629 | 16 | 0.261 | ≤0.4 | PASS |
| 3DH5 | Ant1 | Hop | 2.879 | 12 | 0.346 | ≤0.4 | PASS |

1. Period time =  $0.4s * 79 = 31.6s$
2. Result (Time of occupancy) = BurstWidth[ms] \* Hops in 3.16s [Num] \* 10

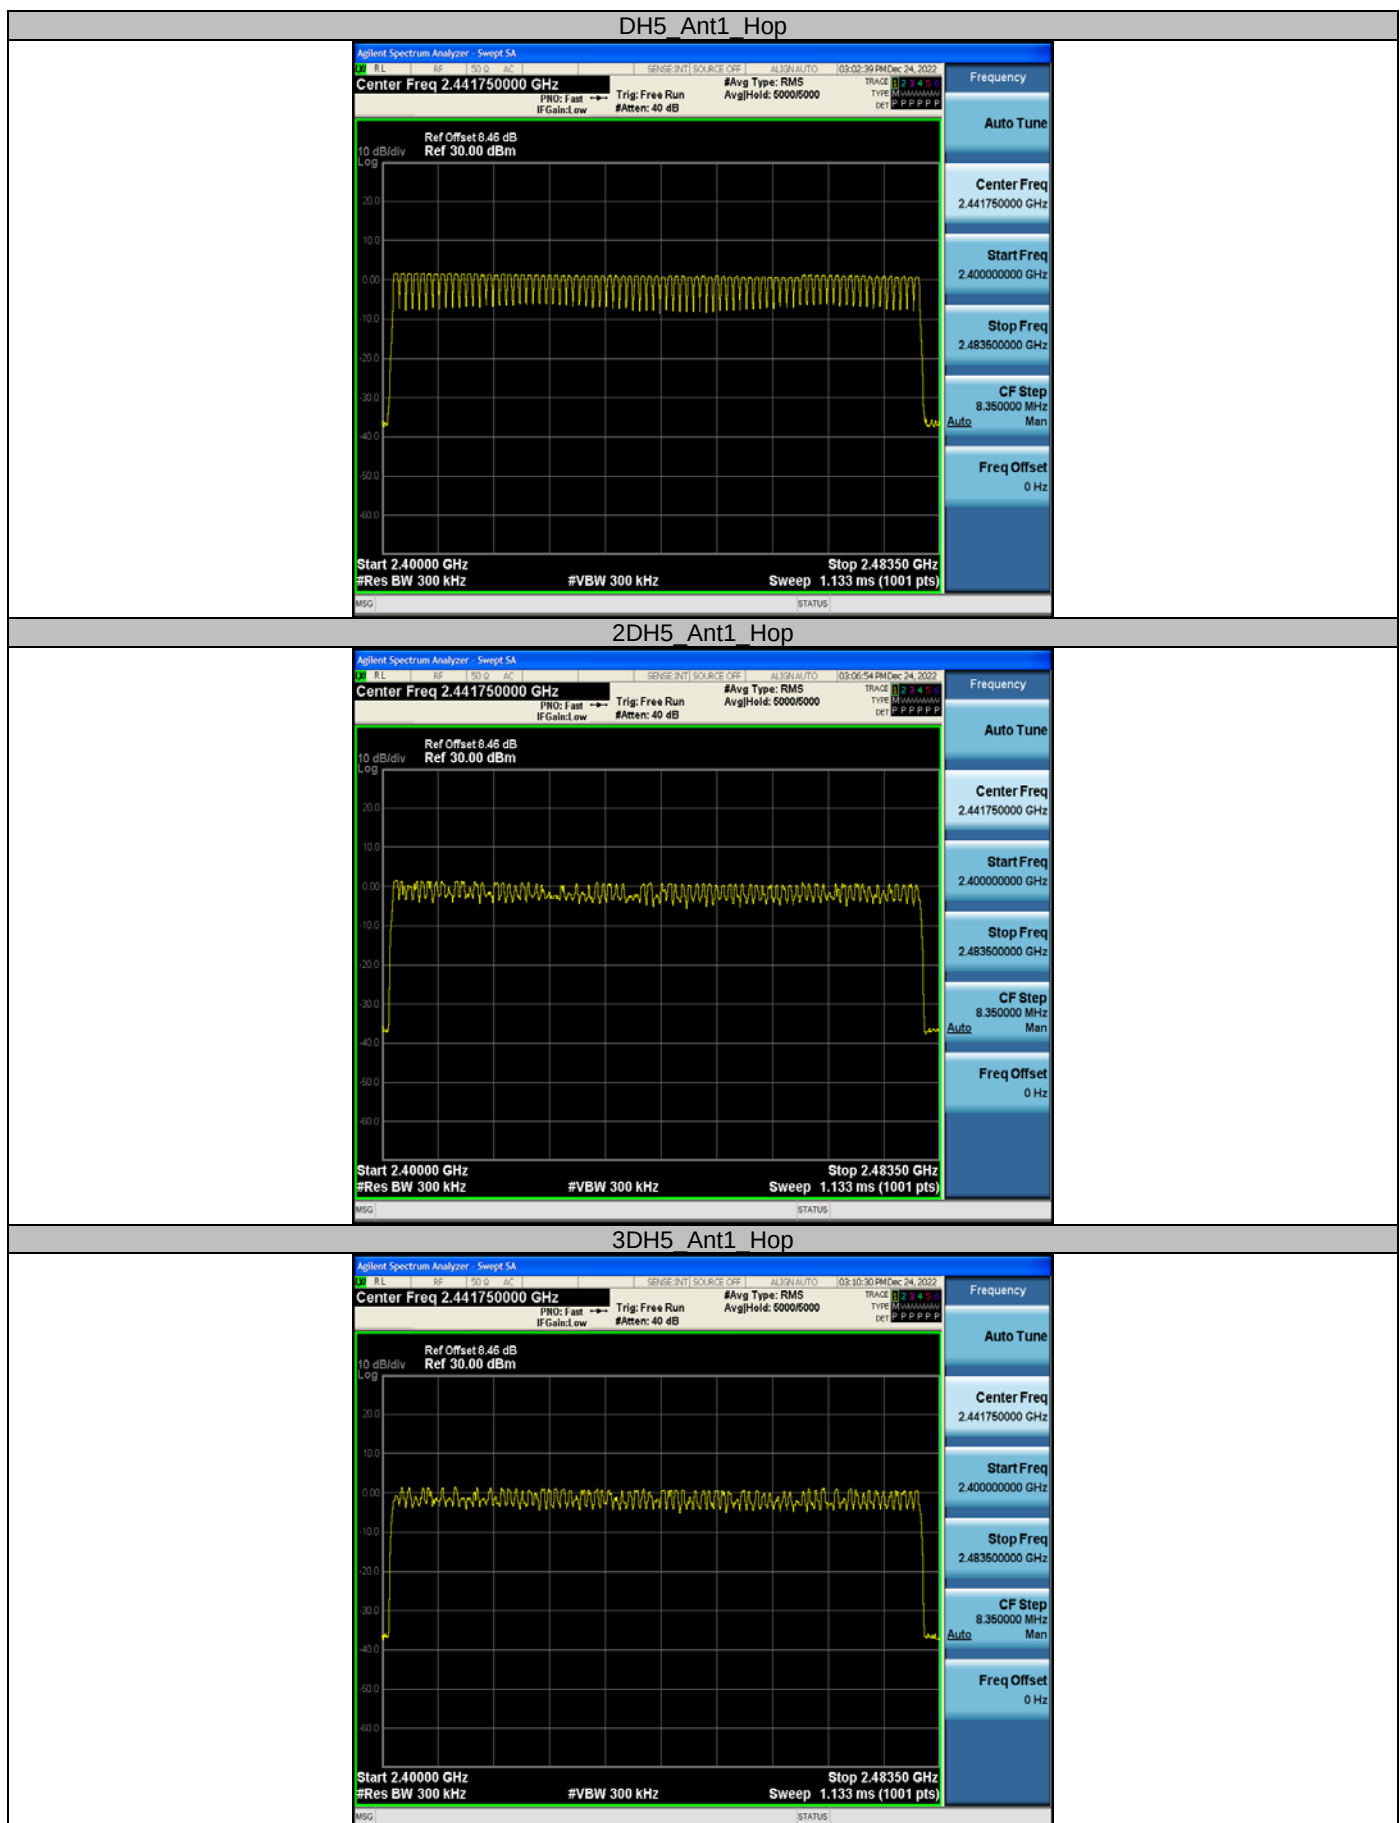
| Test Mode | Antenna | Frequency<br>[MHz] | Result<br>[Num] | Limit<br>[Num] | Verdict |
| DH5 | Ant1 | Hop | 79 | ≥15 | PASS |
| 2DH5 | Ant1 | Hop | 79 | ≥15 | PASS |
| 3DH5 | Ant1 | Hop | 79 | ≥15 | PASS |
