### **APPENDIX 3: Photographs of test setup**

#### **Radiated emission** **(Below 1GHz)**

**Radiated emission**  
**(Above 1GHz)**

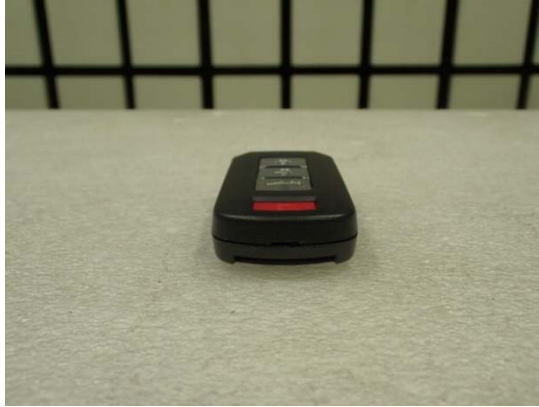
**X-axis**

**Worst case position**

**Below 1 GHz: (Horizontal: X-axis / Vertical: Y-axis)**

**Above 1 GHz: (Horizontal: X-axis / Vertical: Y-axis)**

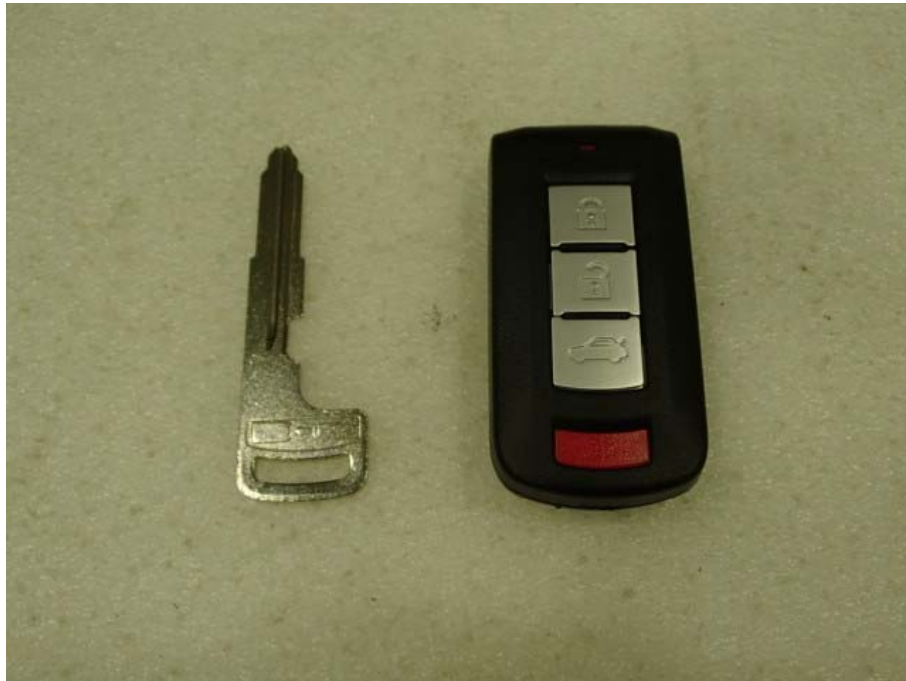
**Worst case position**

**Mechanical Key (Not Inserted) Worst**

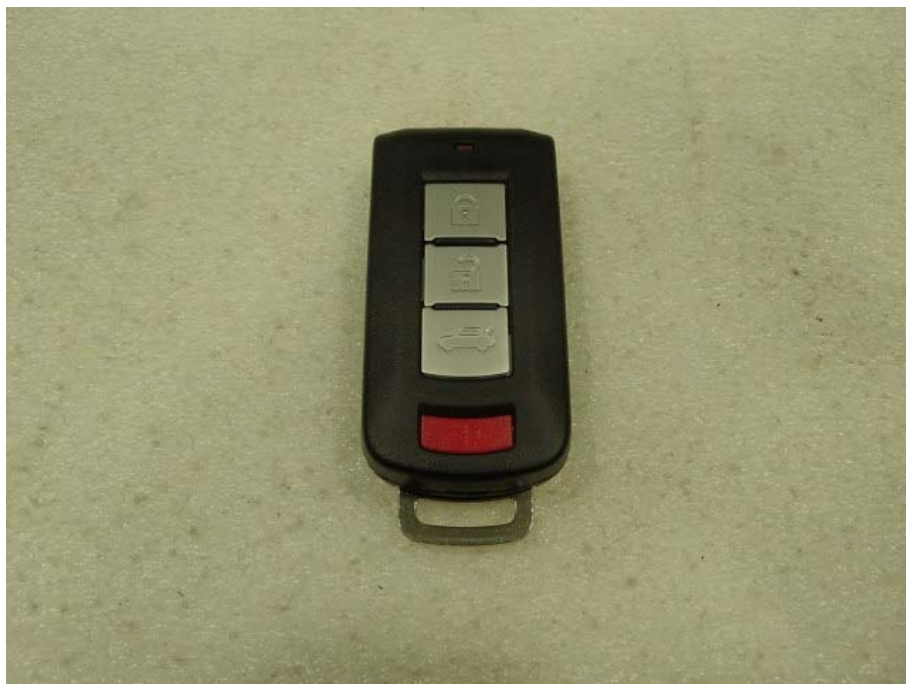
**Mechanical Key (Inserted)**
