## Antenna Test Report

REPORT NO. OQ221117003  
APPLICANT : Tesla  
MANUFACTURER : Tesla  
EQUIPMENT : Antenna  
DATE OF RECEIPT : November 18, 2022  
DATE OF TEST : November 18, 2022  
ISSUE DATE : December 1, 2022

| Product Feature & Specification | |
|---|---|
| Model Name | Glovebox BT |

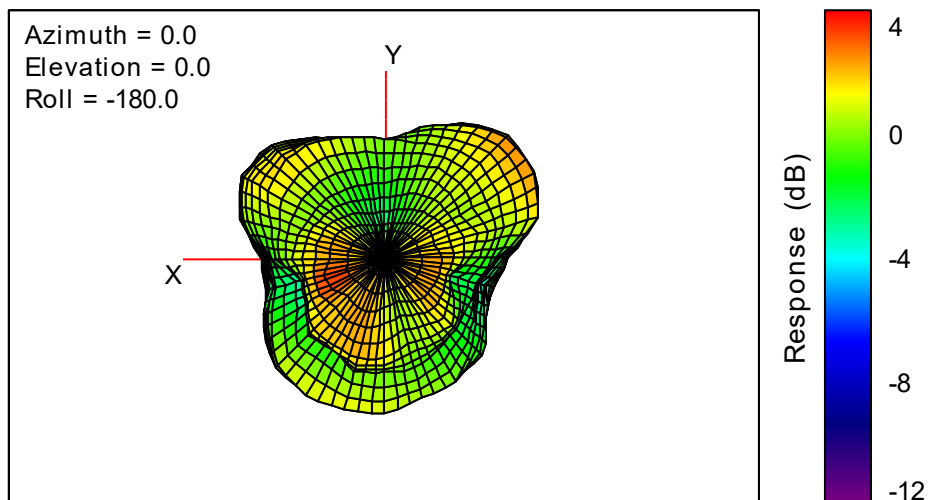
2480MHz

Total
