Dongguan Zhongshang Tongda Plastic Wuquan Co., Ltd  
No. 751 Yangwu Section, Guanchang Road, Dalingshan Town, Dongguan City  
S666 Antenna Report

Main content of the report

Optimization test results: 1. Arm GPS antenna efficiency debugging around 7%, 2. Arm BT antenna efficiency debugging around 5%

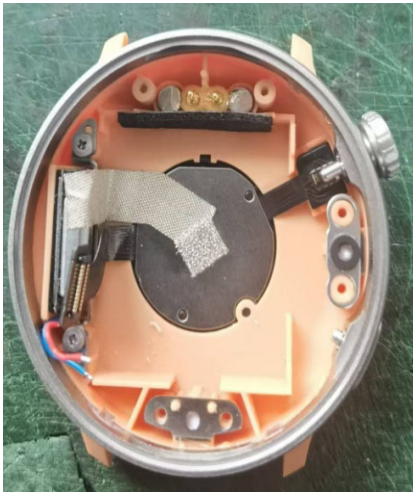
3、The horn pressing steel plate is connected to the heart rate small plate with conductive cloth
