Antenna 1 / Ant M / n258 SB2

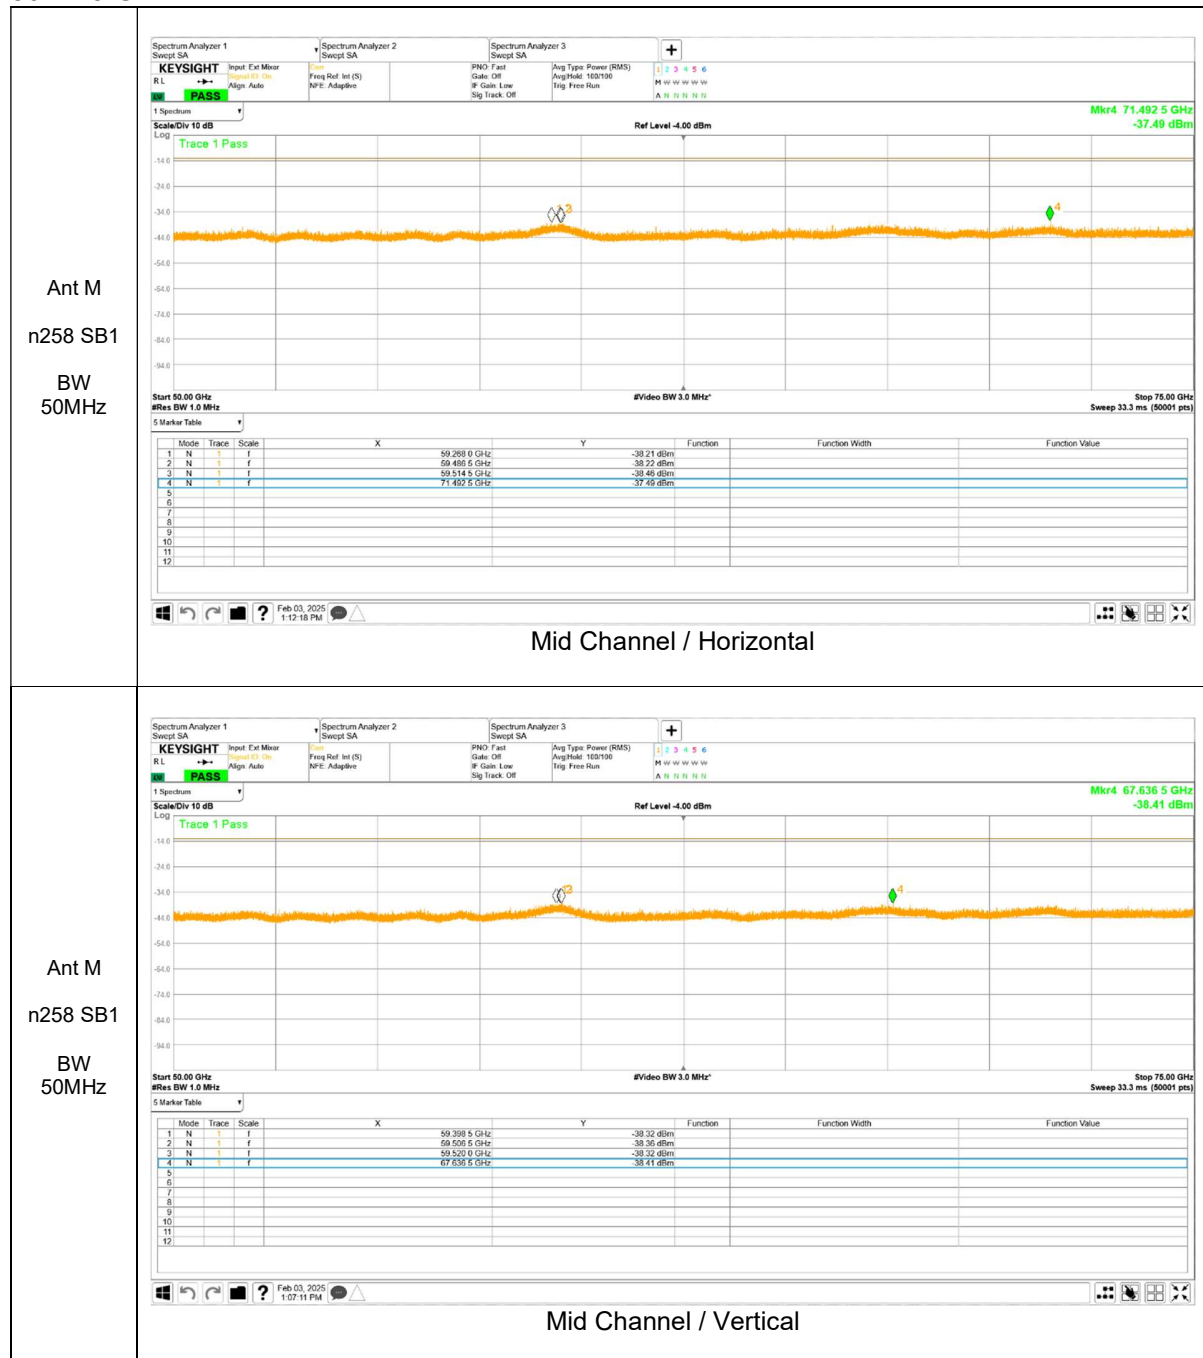
50 – 75 GHz Result

All channels were investigated, but no emission above the noise floor was detected.

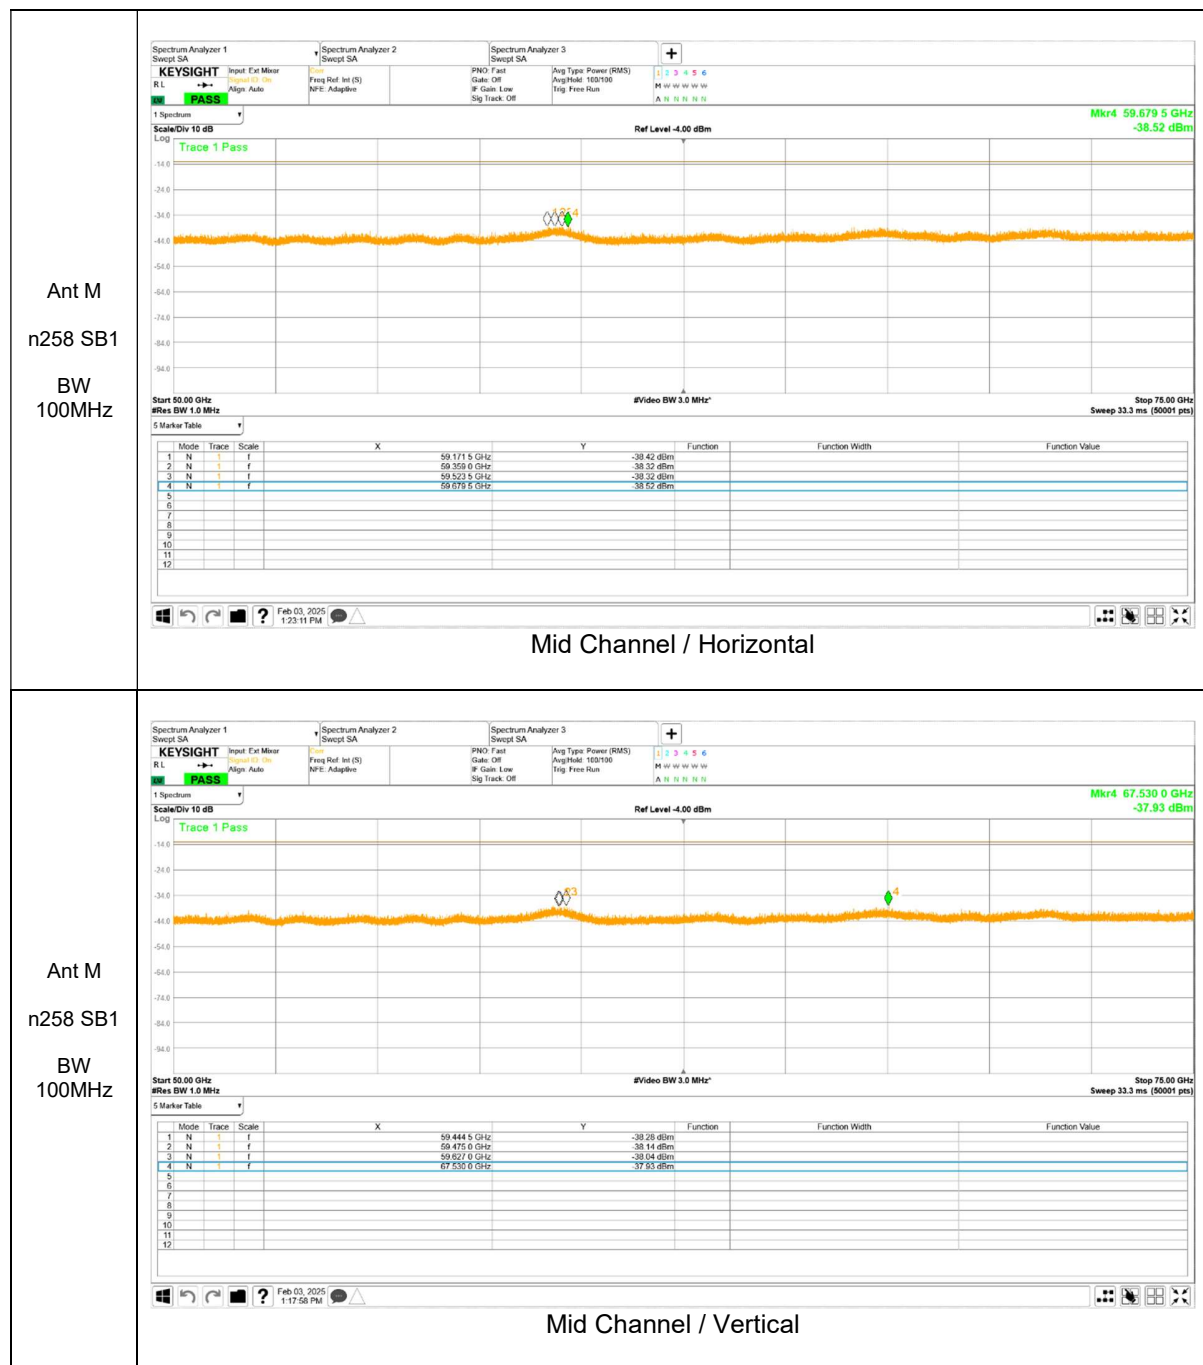
All channels were investigated, but no emission above the noise floor was detected.

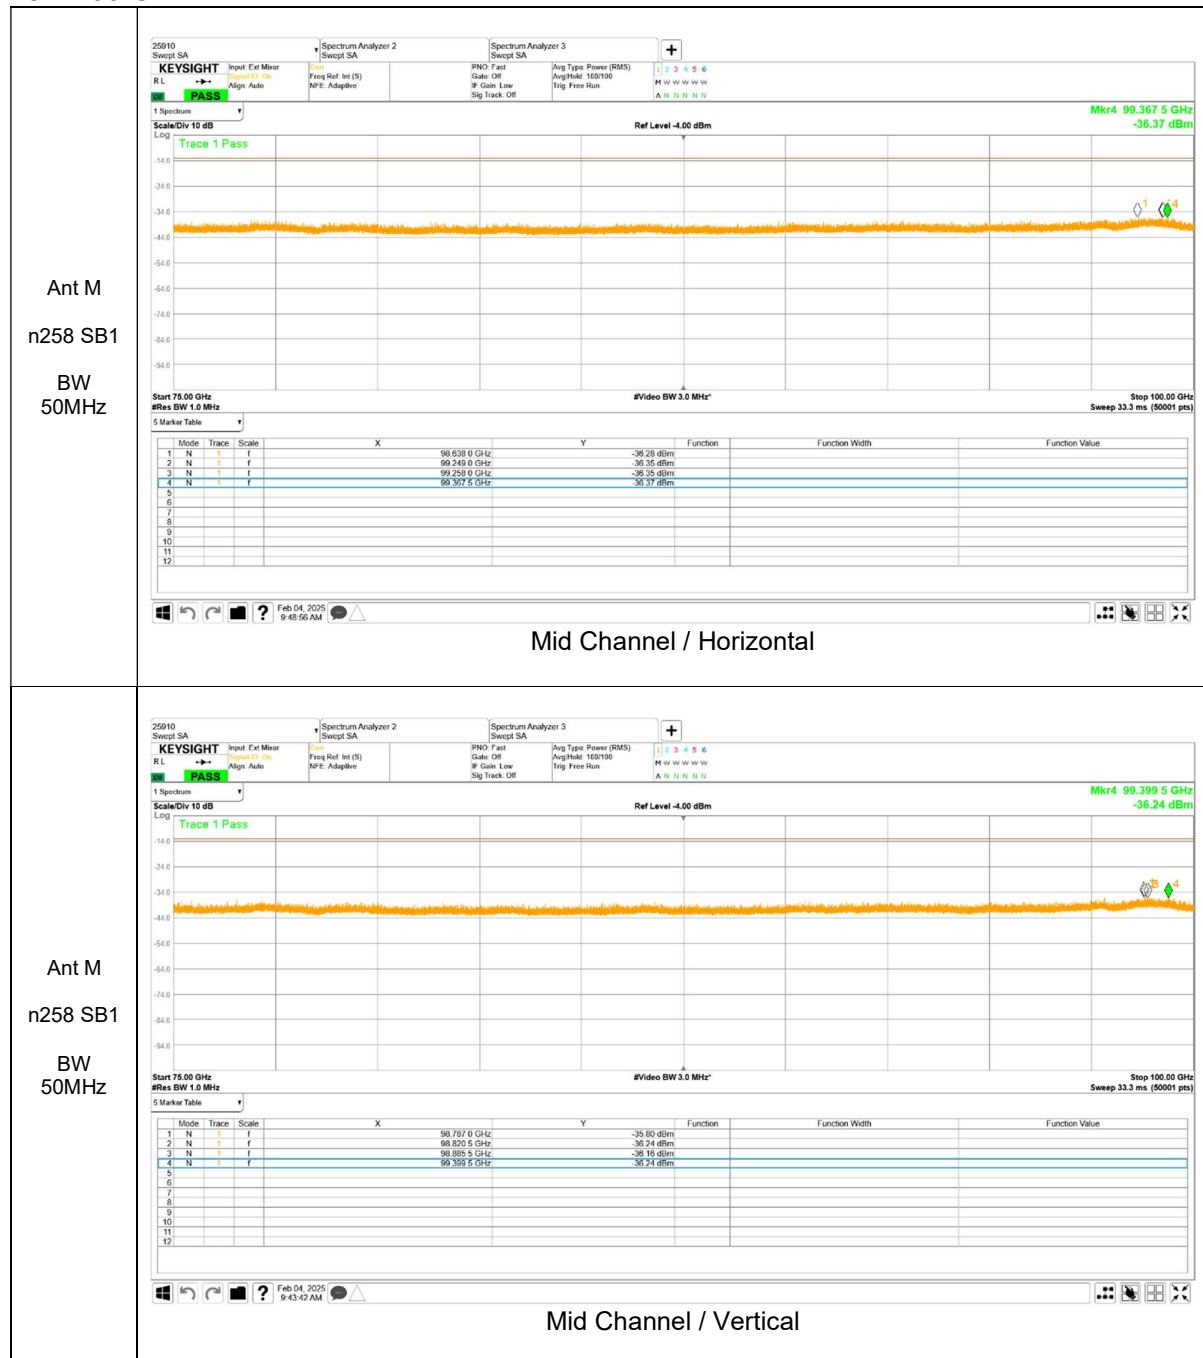
75 – 100 GHz Result

All channels were investigated, but no emission above the noise floor was detected.

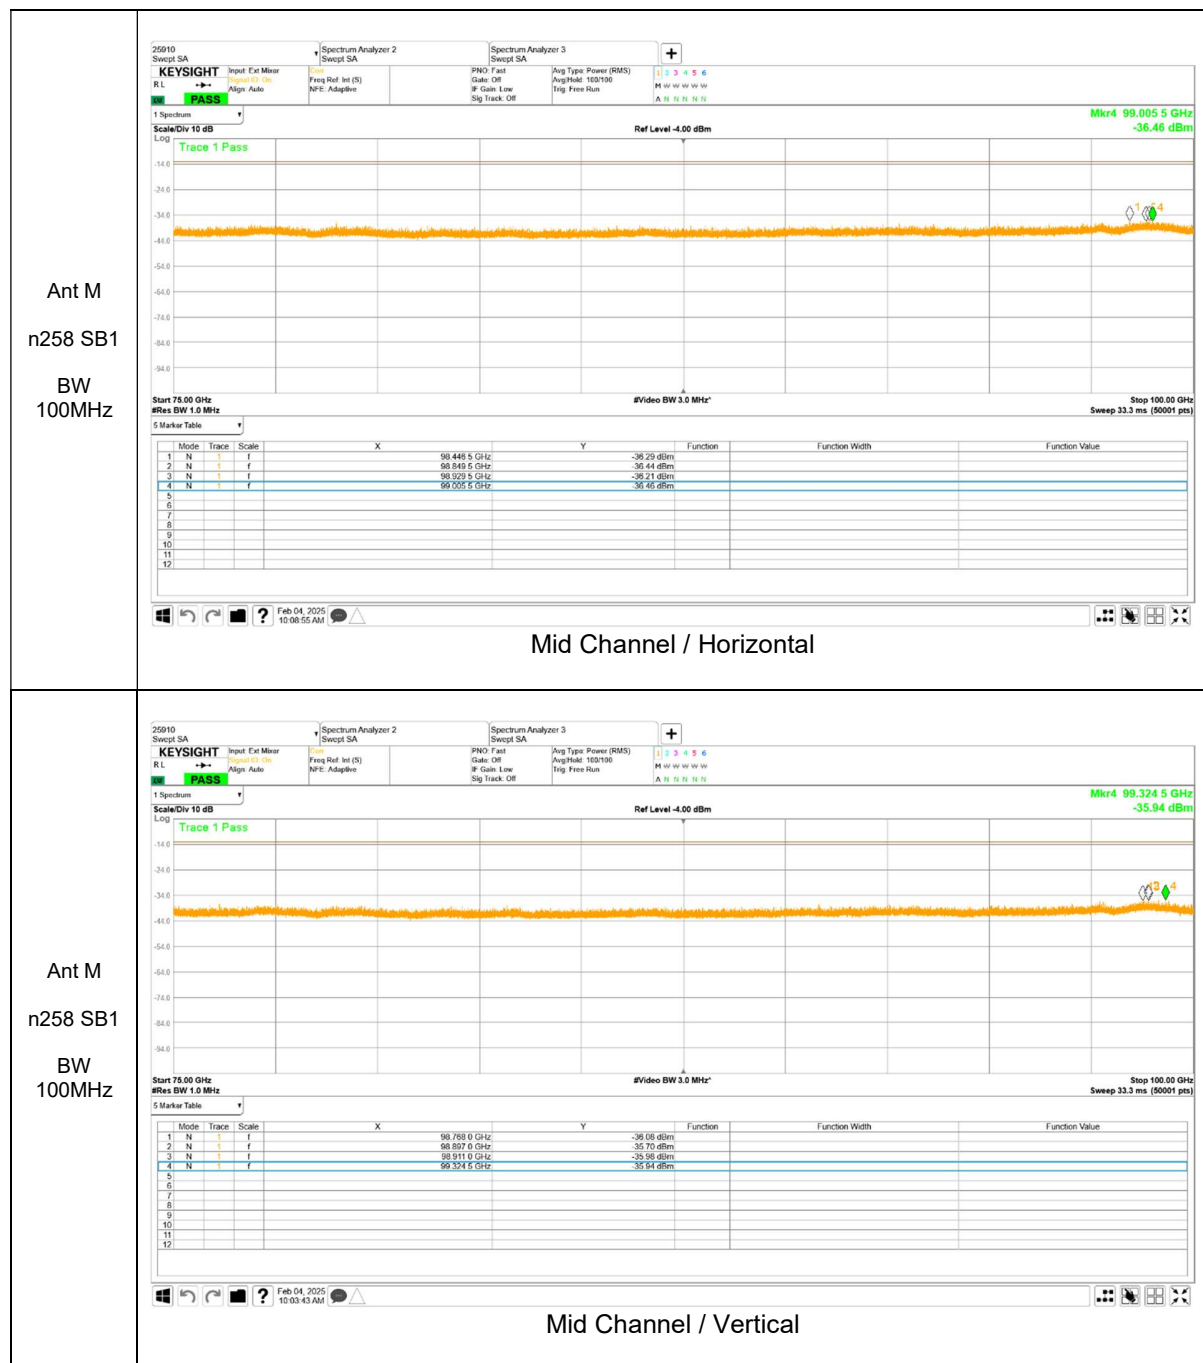
All channels were investigated, but no emission above the noise floor was detected.

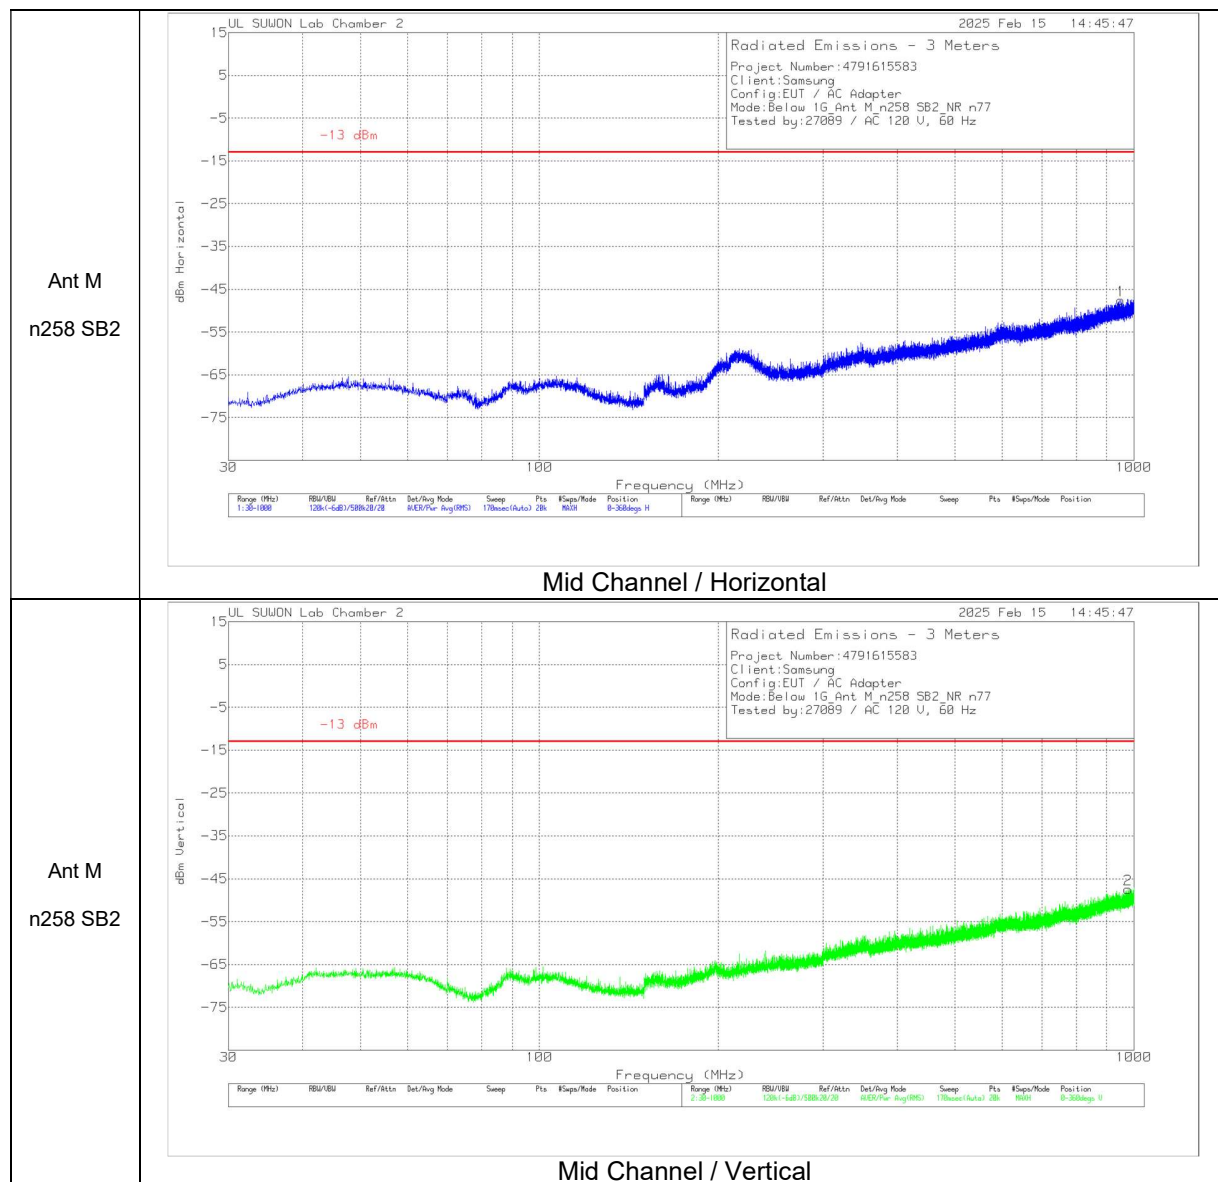
30 – 1000 MHz Result

Marker	Frequency (MHz)	Meter Reading (dBm)	Det	Antenna Correction Factor (dB/m)	Loss (dB)	Conversion Factor (dB)	Corrected Reading (dBm)	Limit (dBm)	Margin (dB)	Azimuth (Degs)	Height (cm)	Polarity
1	950.1526	-59.79	RMS	27.9	-27.5	11.8	-47.59	-13	-34.59	0-360	200	H
2	976.584	-60.16	RMS	28	-27.1	11.8	-47.46	-13	-34.46	0-360	300	V

No emissions were detected above noise floor this antenna and band.

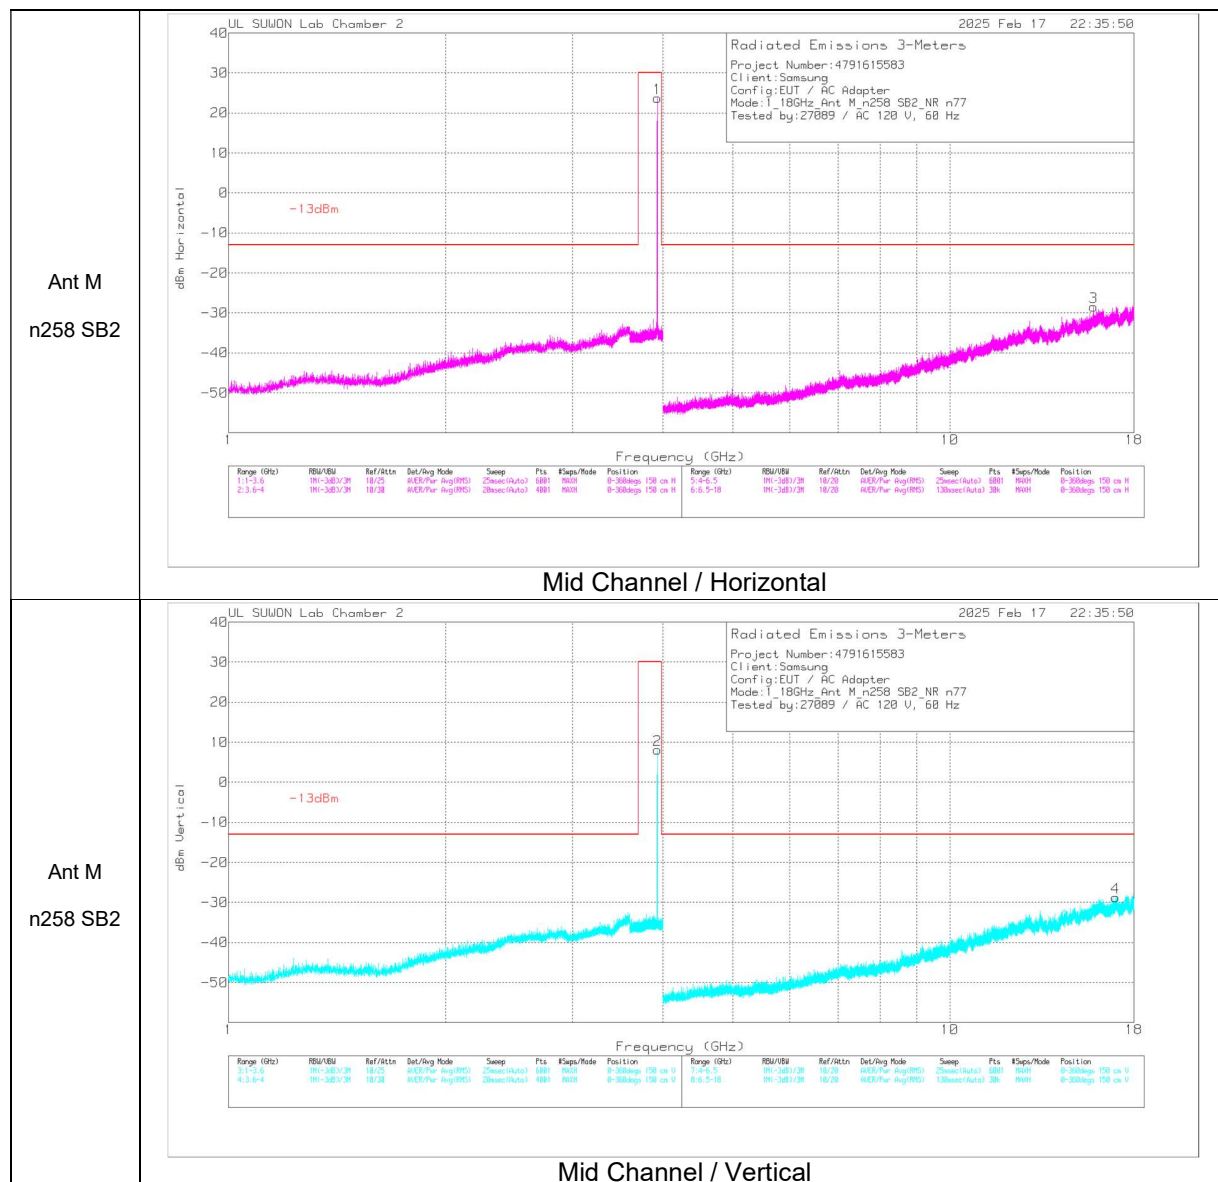
1 – 18 GHz Result

Marker	Frequency (MHz)	Meter Reading (dBm)	Det	Antenna Correction Factor (dBm)	Loss (dB)	Conversion Factor (dB)	Corrected Reading (dBm)	Limit (dBm)	Margin (dB)	Azimuth (Degs)	Height (cm)	Polarity
**1	3.9307	1.67	RMS	33.2	-22.9	11.8	23.77	30	-6.23	0-360	150	H
**2	3.9305	-13.98	RMS	33.2	-22.9	11.8	8.12	30	-21.88	0-360	150	V
3	15.8147	-61.14	RMS	40.2	-19.3	11.8	-28.44	-13	-15.44	0-360	150	H
4	16.97578	-62.48	RMS	41	-19	11.8	-28.68	-13	-15.68	0-360	150	V

** Marker 1 and 2 were the fundamental signal of 5GNR Band 77 that was used as a representative anchor band for NR-DC investigations.
No emissions were detected above the noise floor which was at least 20dB below the specification limit.
