### **APPENDIX 3: Photographs of test setup**

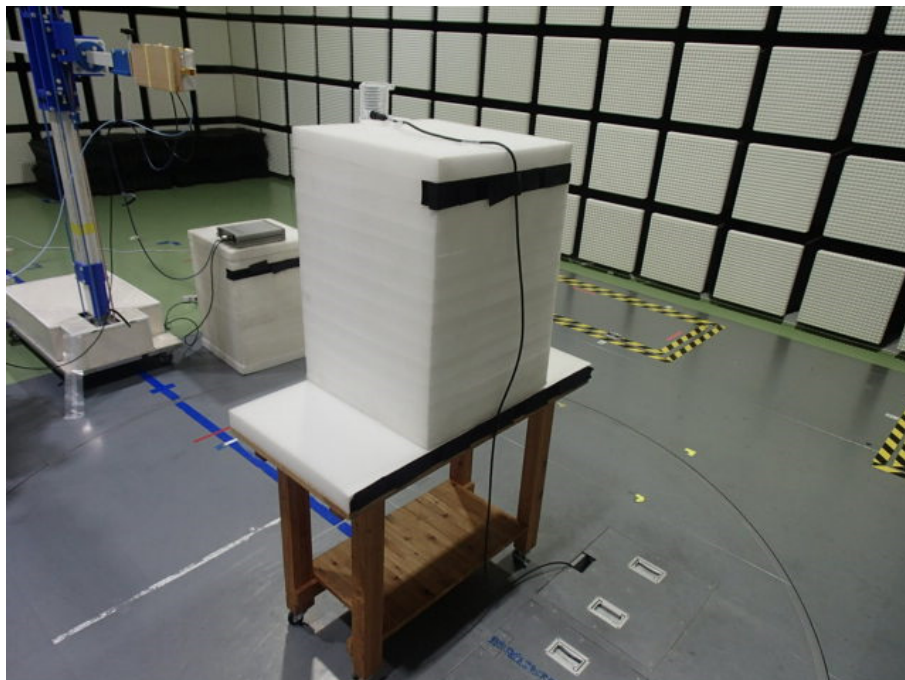
#### **Radiated Power**

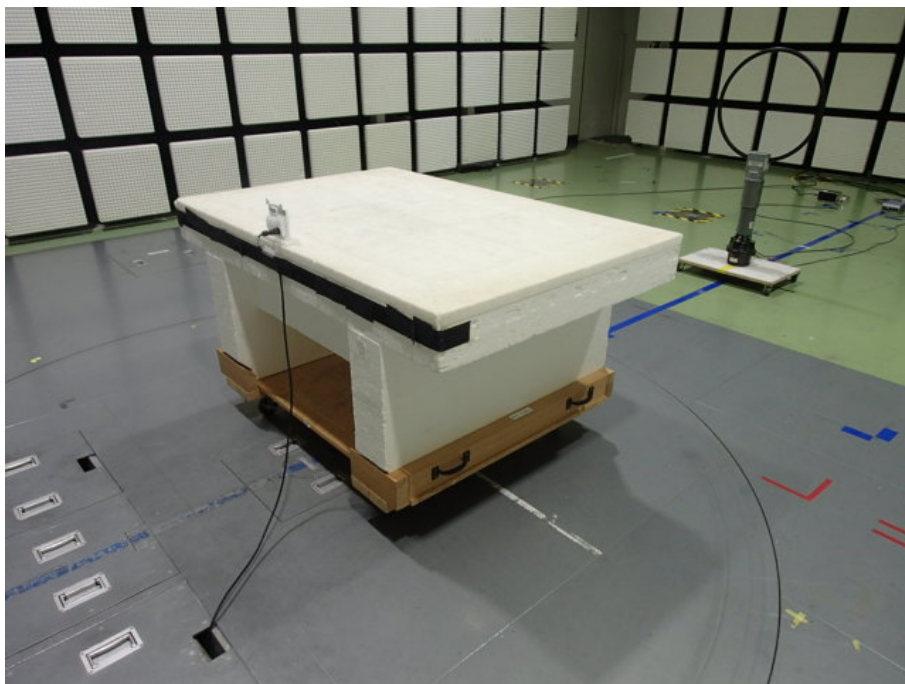
**Field strength of spurious radiation**  
**(Below 30 MHz)**

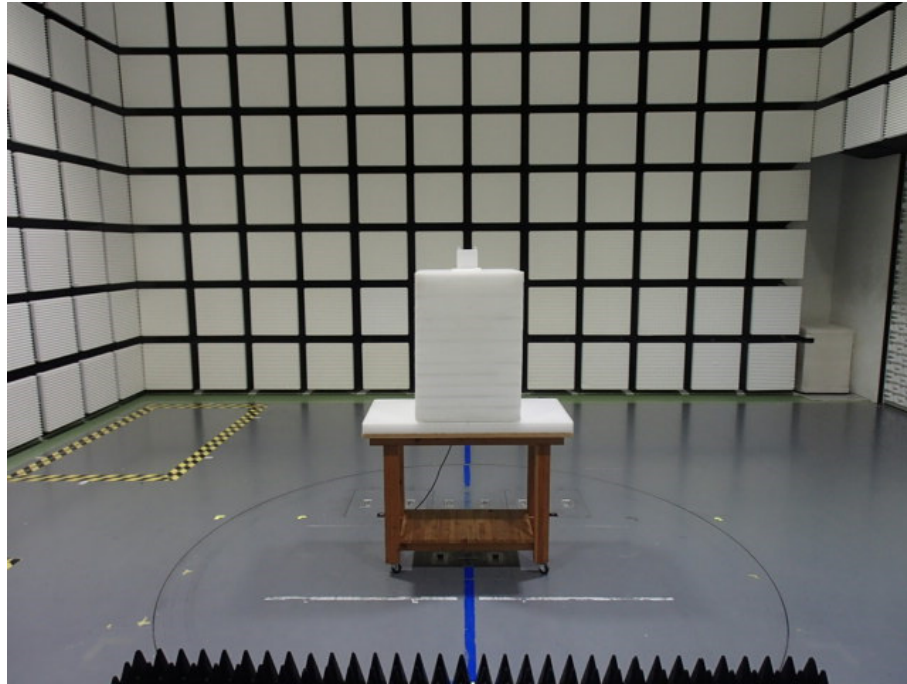
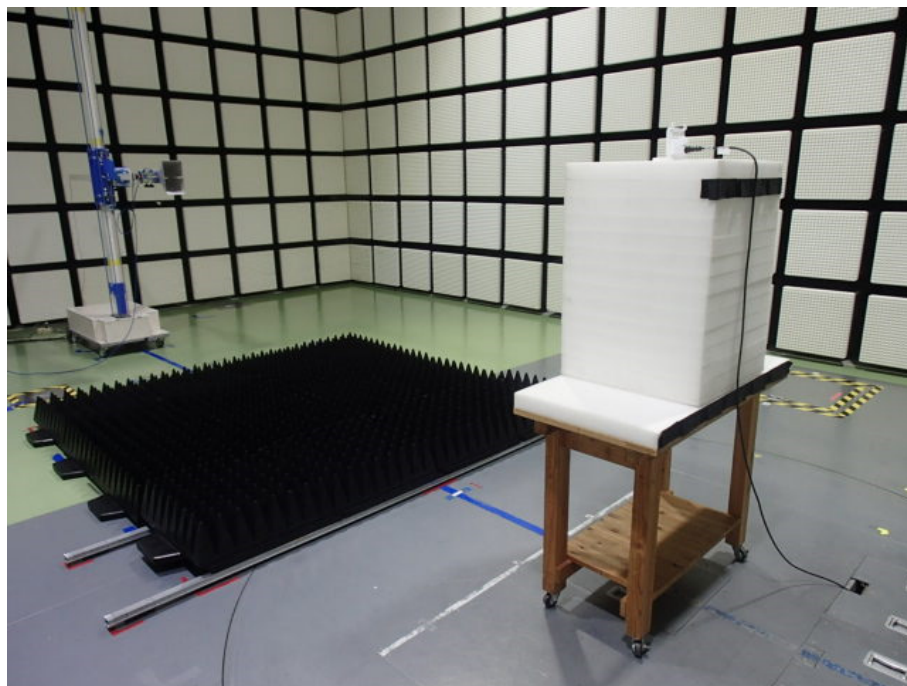
**Field strength of spurious radiation**  
**(Above 1 GHz)**
